FAILURE ANALYSIS HANDBOOK

C. R. Walker, K. K. Starr

Pratt & Whitney
P.O. Box 109600
West Palm Beach, FL 33410-9600

August 1989

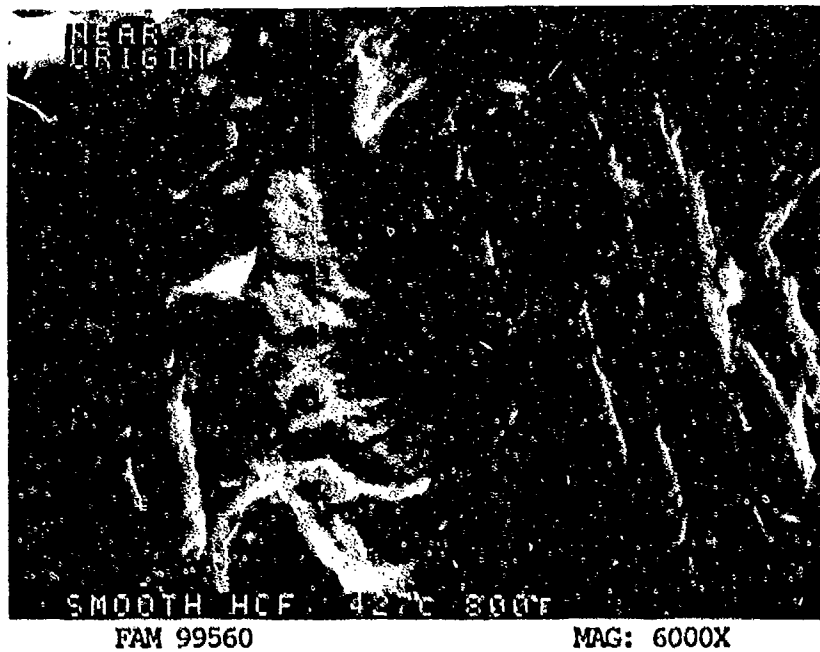
FIGURE 11-41: Higher magnification view of the area shown in Figure 11-40.

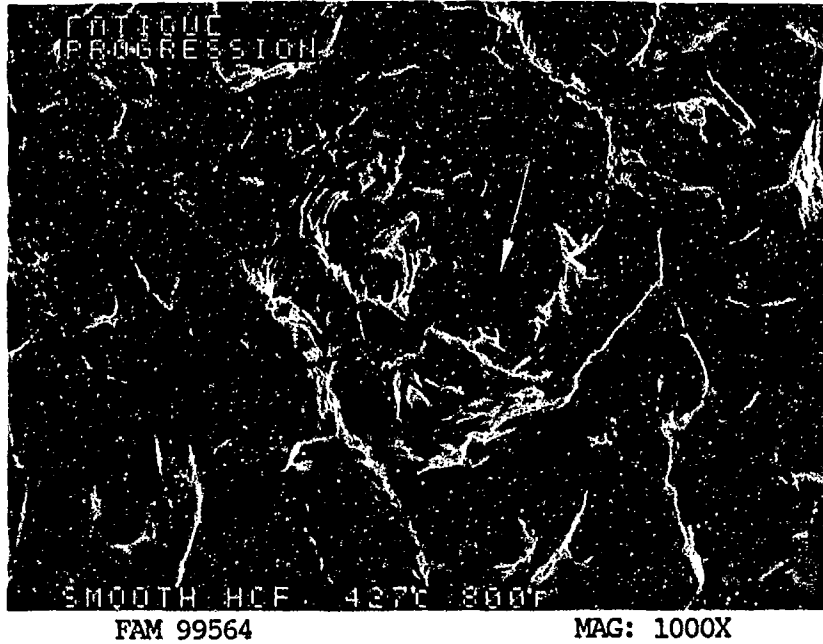
FIGURE 11-42: Relatively coarse striations in the fatigue progression zone away from the origin area (compare to Figure 11-39). Some void coalescence is also visible (arrow).

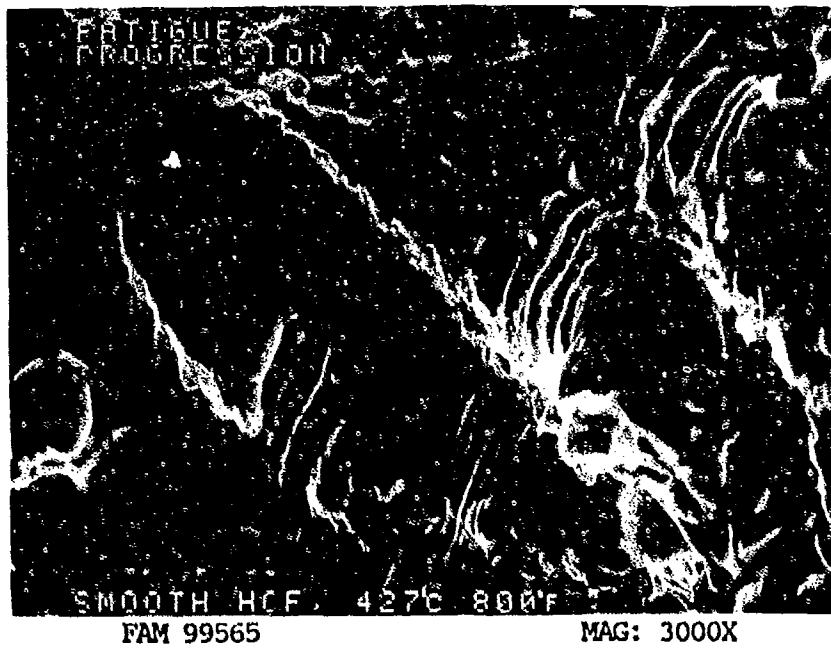
FIGURE 11-43: Higher magnification photograph of the fatigue striations shown in Figure 11-42.

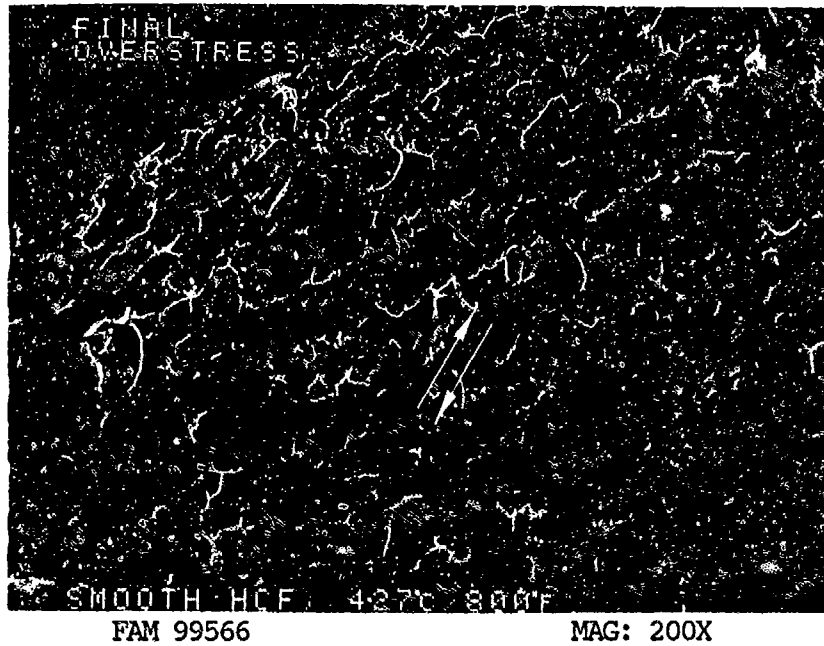
FIGURE 11-44: Shear dimples in the final overstress area. The directions of relative motion is shown by arrows.

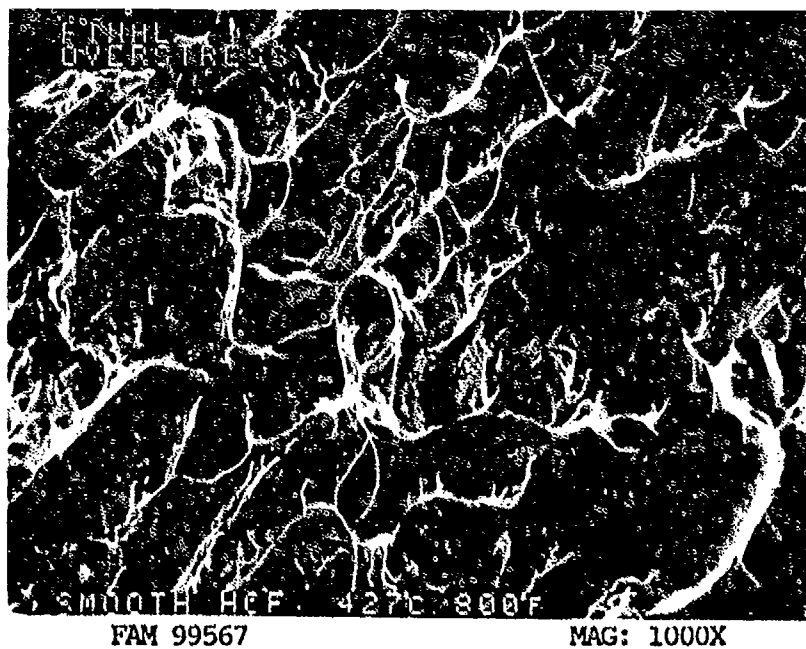
FIGURE 11-45: Higher magnification photograph of the final overstress area shown in Figure 11-44, again showing shear dimples.

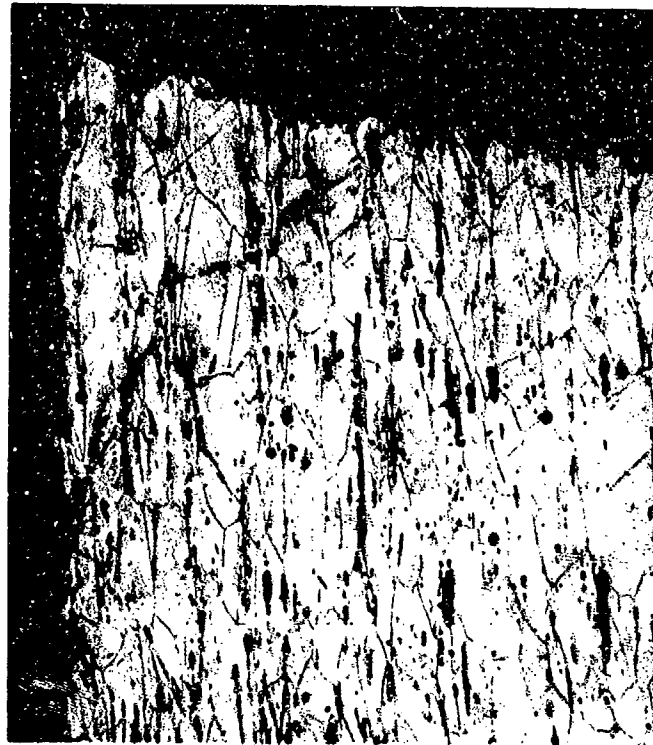
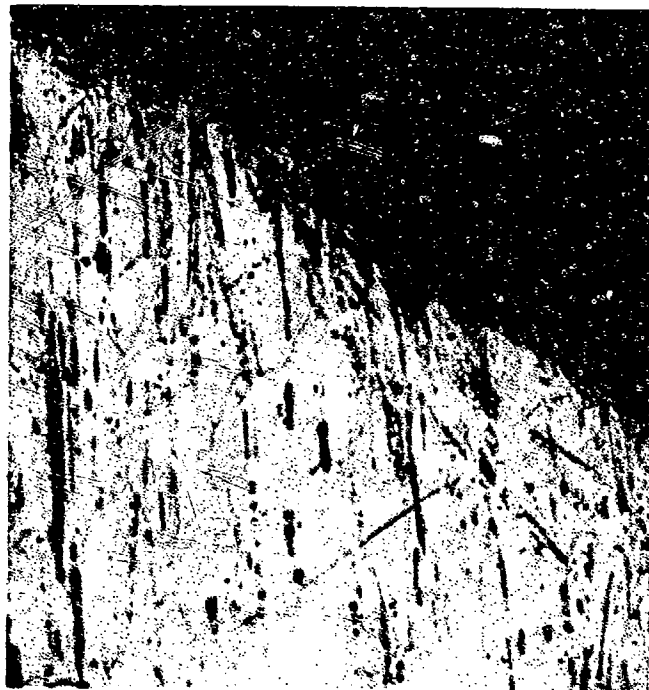
FIGURE 11-47: Optical photomicrographs showing the fatigue progression area (top) and the final overstress area (bottom). The fatigue progressed on a plane perpendicular to the stress axis with little grain deformation in the grains adjacent to the fracture. Final overstress occurred at an angle to the primary stress axis and was accompanied by grain elongation (brackets, bottom). Oxidation is visible on the fracture surface and on the gage section (compare with Figures 11-23 through 11-35). The fracture was predominantly transgranular.

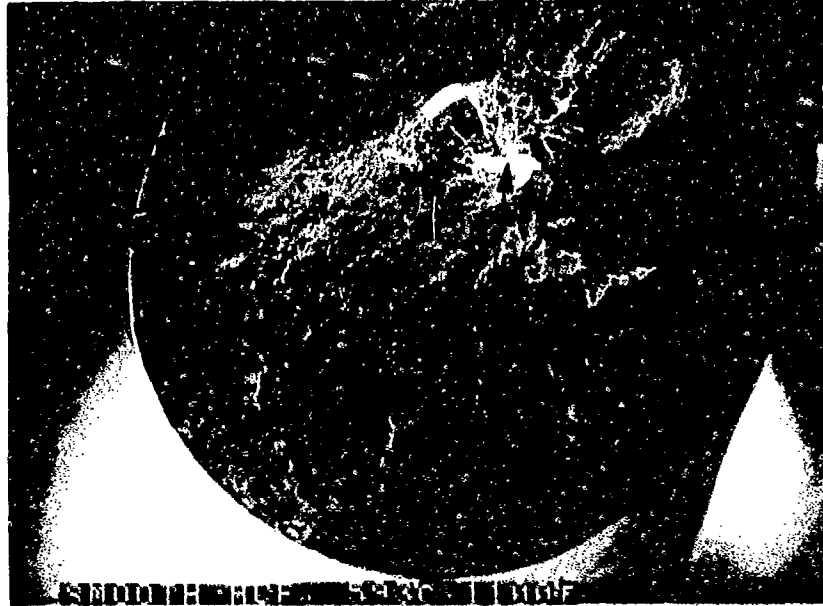
FIGURE 11-48: Low magnification photograph showing fatigue initiation at an internal origin (arrow). Features can be seen radiating from the origin.

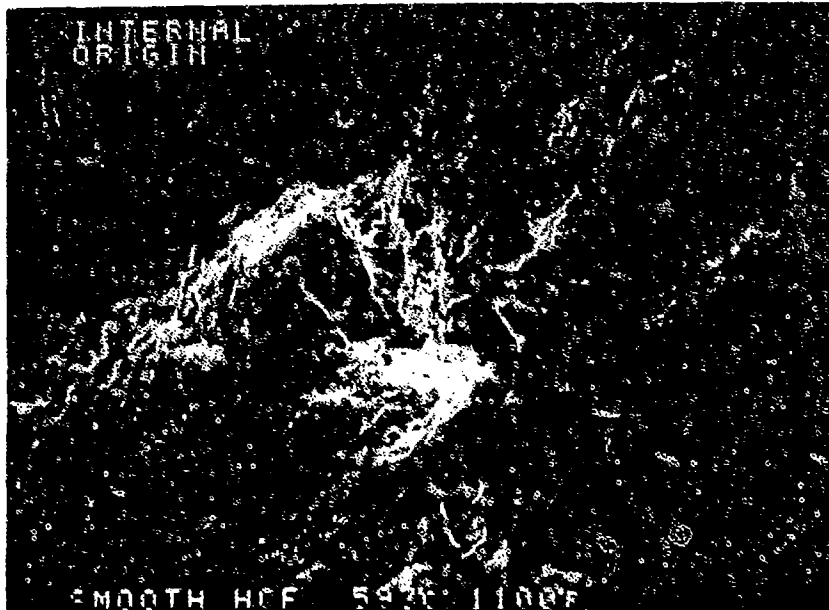
FIGURE 11-49: Higher magnification view of the origin area near the center of the fracture surface. No material defects were found associated with the origin.

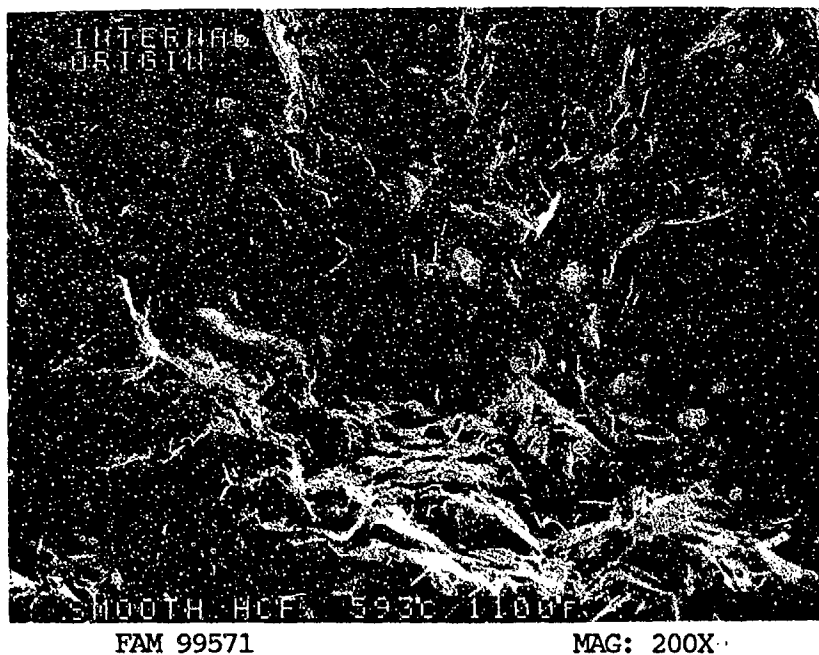
FIGURE 11-50: Higher magnification view of the origin shown in Figure 11-49. No defects are visible.

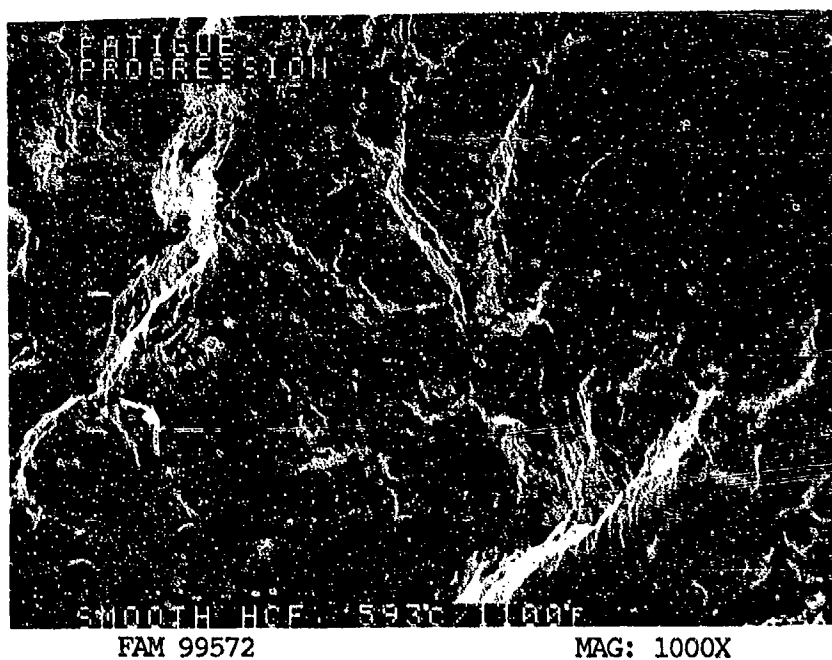
FIGURE 11-51: Remnant fatigue striations in the fatigue progression area. The direction of propagation is shown by an arrow.

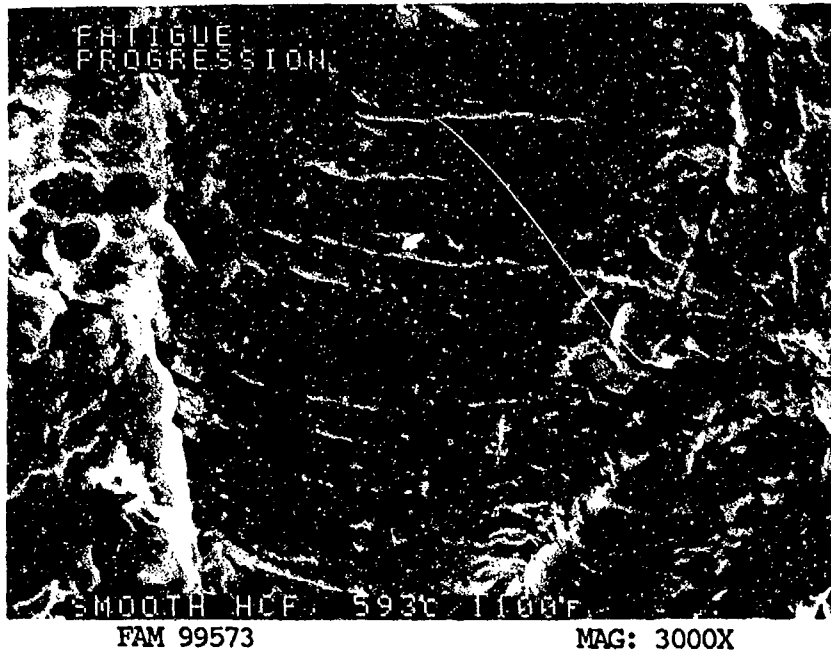
FIGURE 11-52: Higher magnification view of the area shown in Figure 11-51. Remnant fatigue striations are visible. The direction of propagation is shown by an arrow.

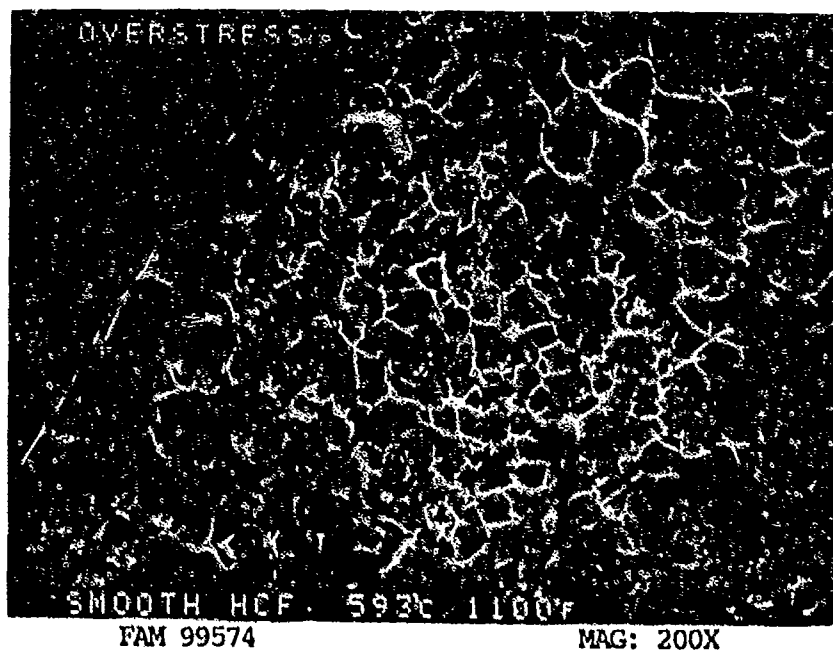
FIGURE 11-53: Final overstress area near the edge of the specimen. No shear lip is visible.

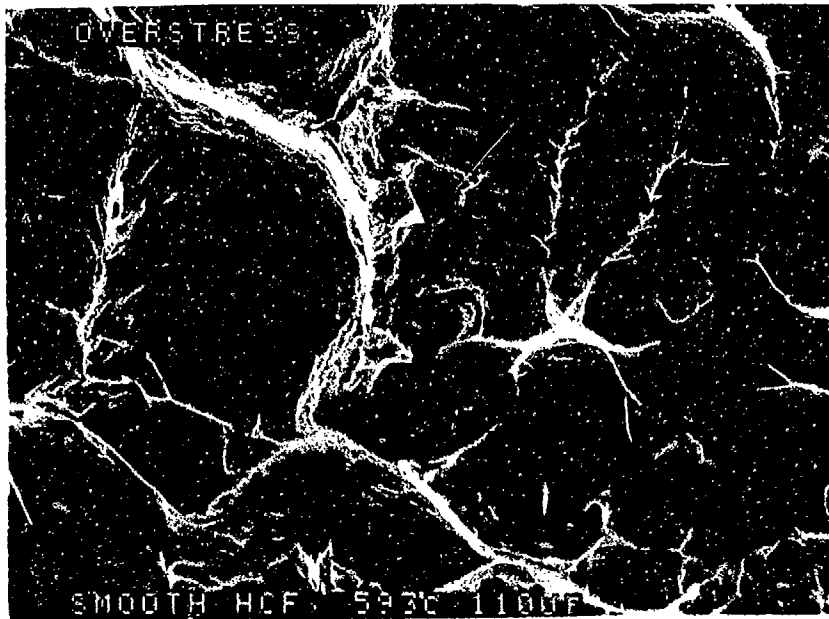
FIGURE 11-54: Coarse dimpled overstress with poorly defined dimples in the final overstress area.

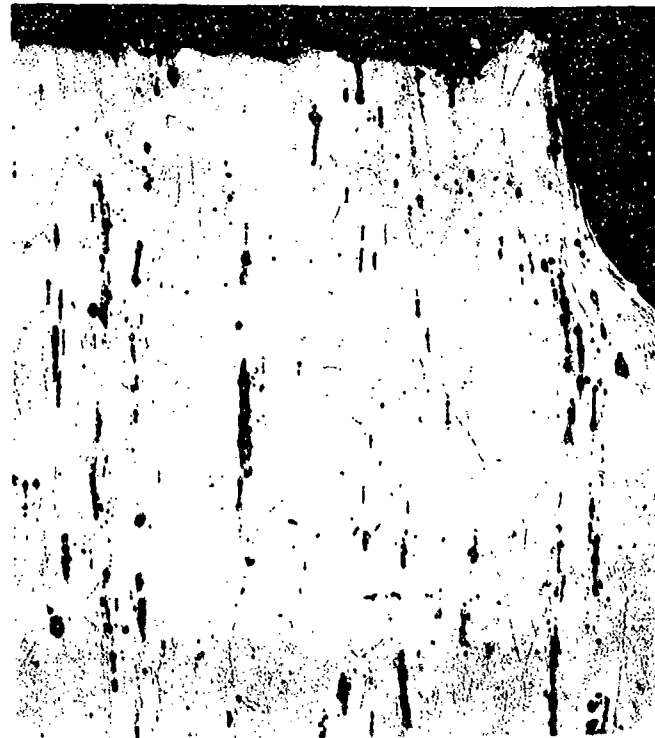
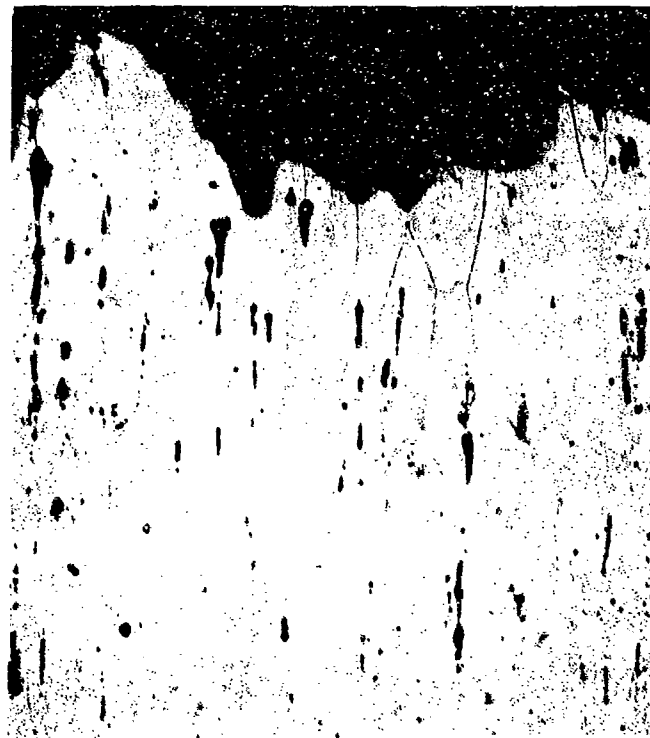
FIGURE 11-56: Optical photomicrographs showing the fatigue progression area (top) and the final overstress area (bottom). The fatigue progressed with little grain deformation in the grains adjacent to the fracture. Final overstress area exhibits grain deformation and dimpled overstress features. The fatigue progression is predominantly transgranular.

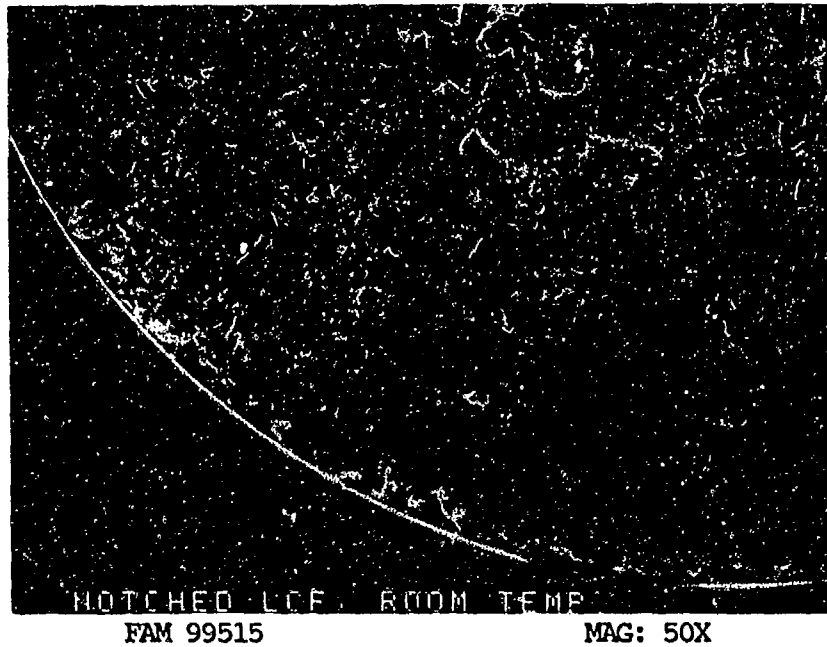
FIGURE 11-57: Low magnification photograph showing fatigue initiation and progression on a plane perpendicular to the stress axis. The fatigue progression appears smoother than the final overstress area.

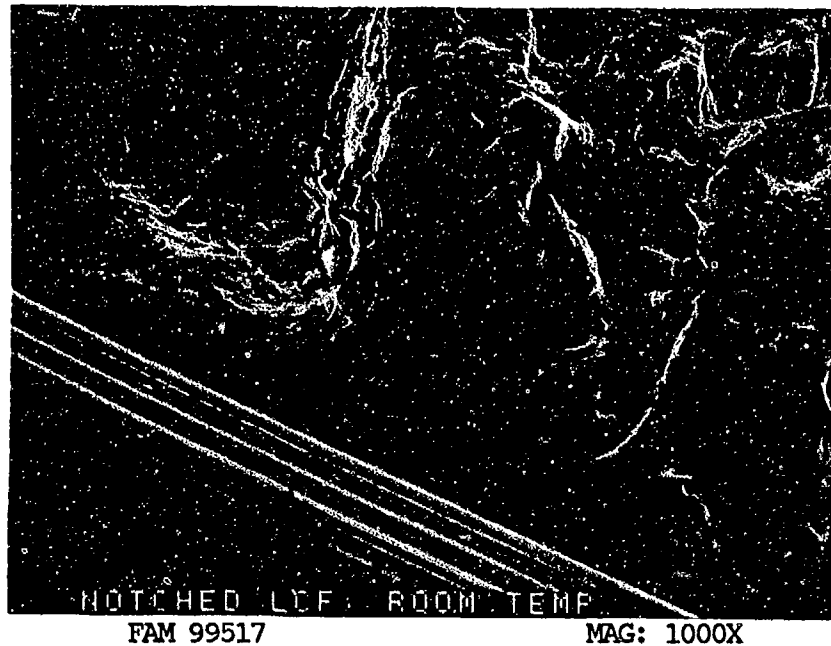
FIGURE 11-59: Fatigue origin area at the surface of the specimen at the base of the notch. Machining lines are visible adjacent to the fracture. Remnant fatigue features are visible just inboard of the notch surface (arrow). No localized origin can be identified.

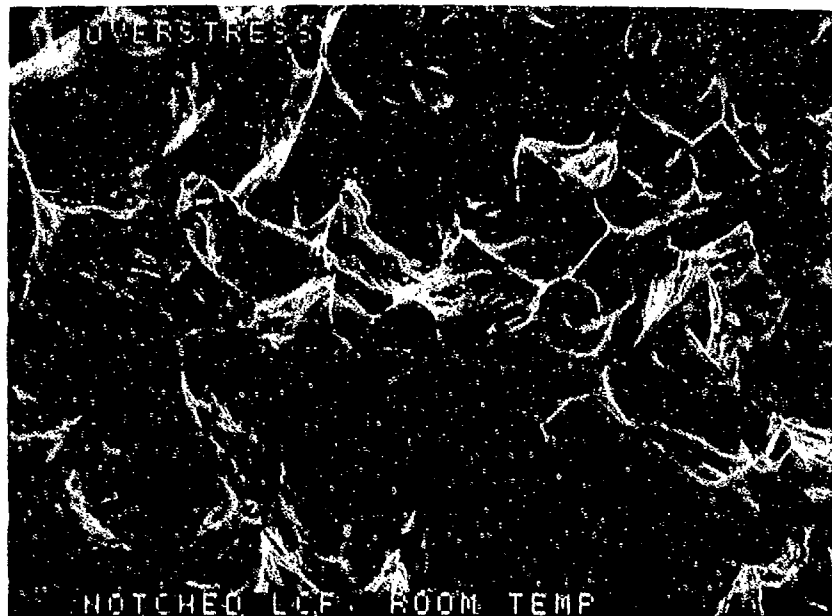
FIGURE 11-64: Higher magnification view of the area shown in Figure 11-63.

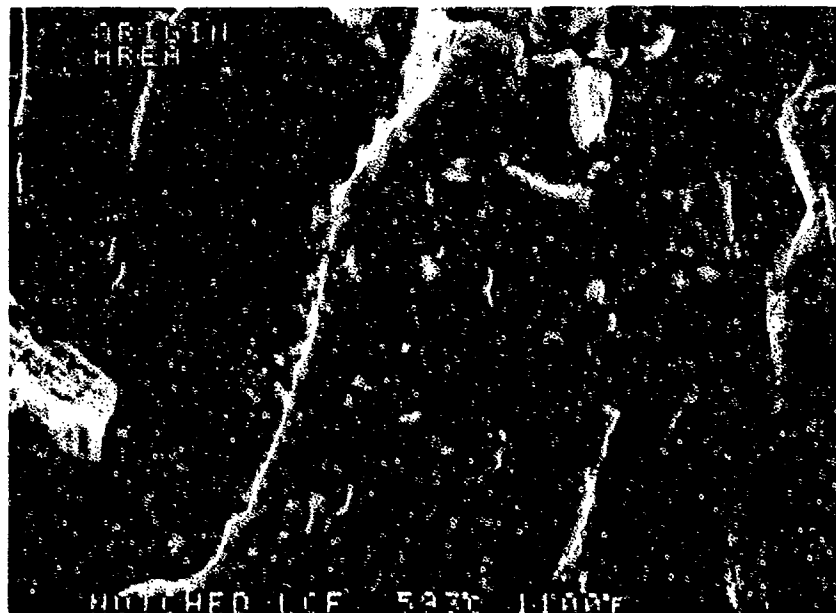
FIGURE 11-70: Higher magnification photograph of the area shown in Figure 11-69. Oxidized striations can be seen propagating on several plateaus separated by steps.

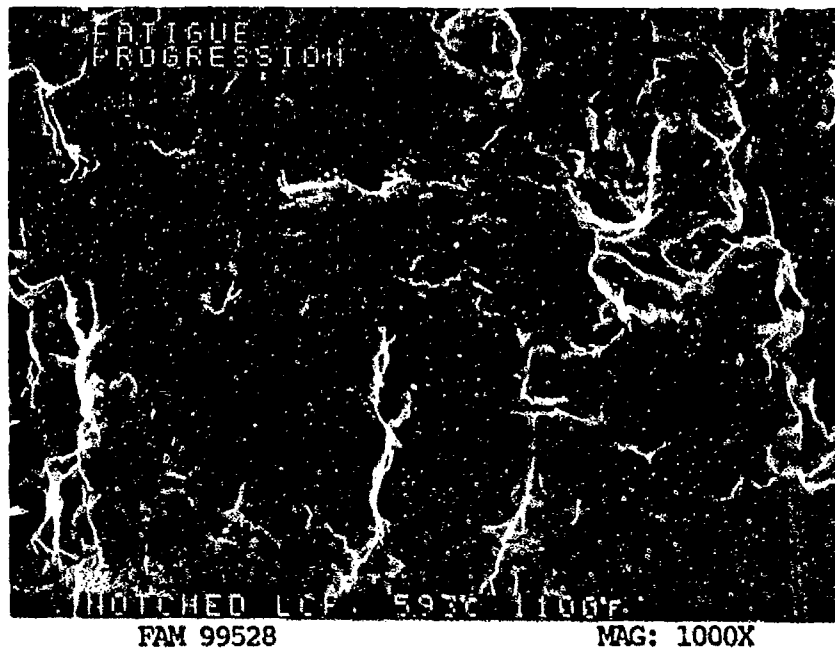
FIGURE 11-71: Well defined striations in the fatigue propagation area. The direction of propagation is from bottom to top of the photograph.

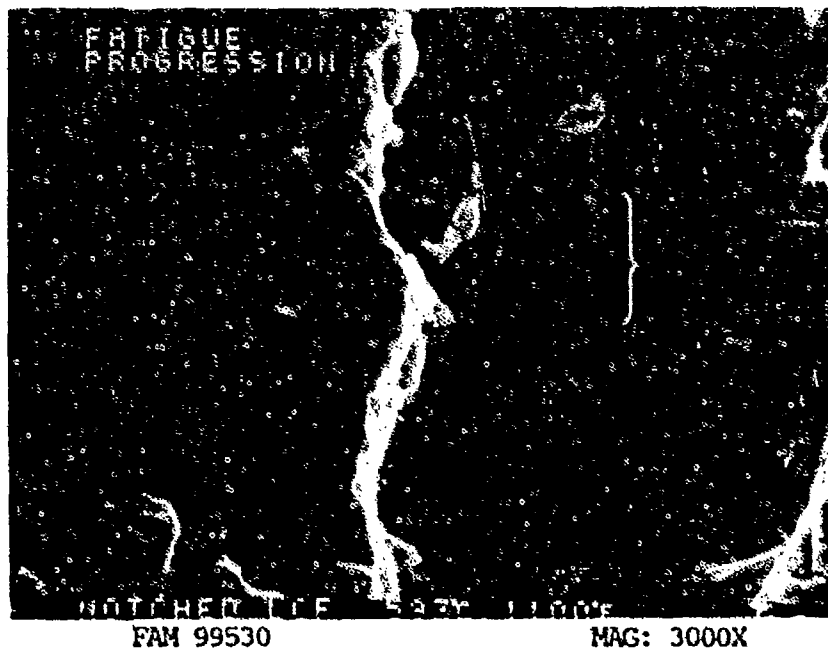
FIGURE 11-72: Higher magnification view of the area shown in Figure 11-71. Well developed striations can be seen propagating on adjacent plateaus separated by a step. Bracket contains ten striations.

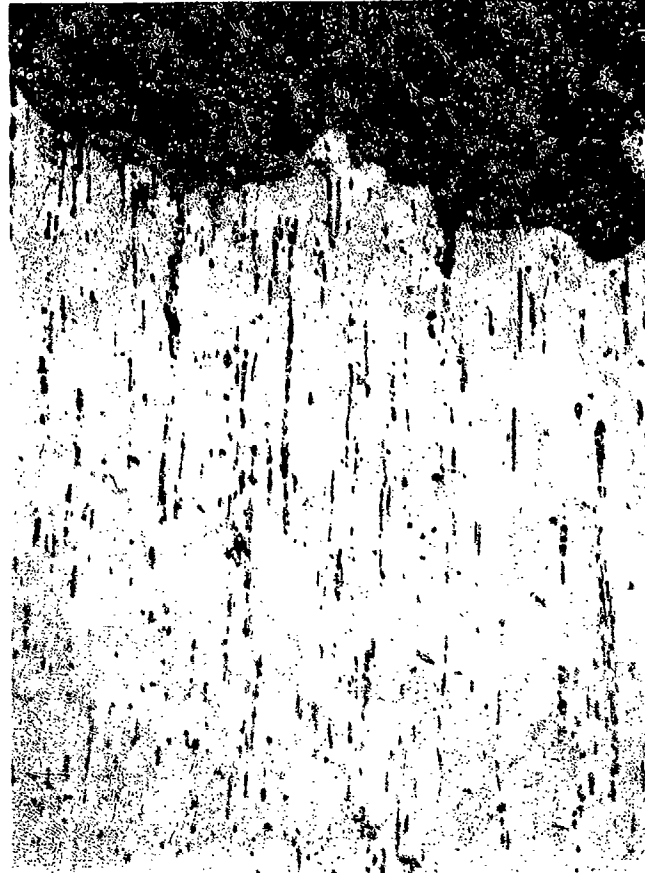
FIGURE 11-76: Optical photomicrograph showing dimpled overstress features in the final overstress area.

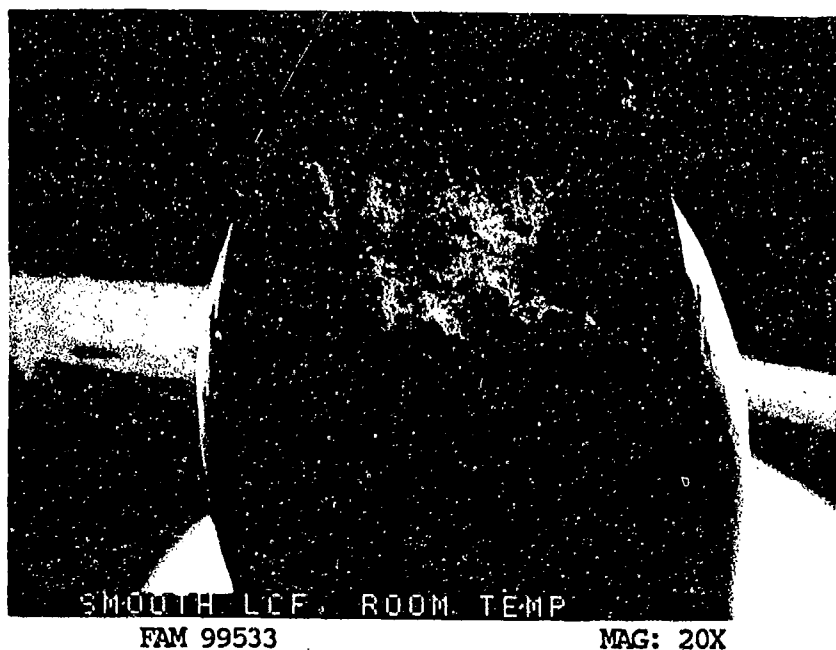
FIGURE 11-77: Low magnification photograph showing a central primary overstress area and a large final overstress area (shear lip). No evidence of fatigue is visible.

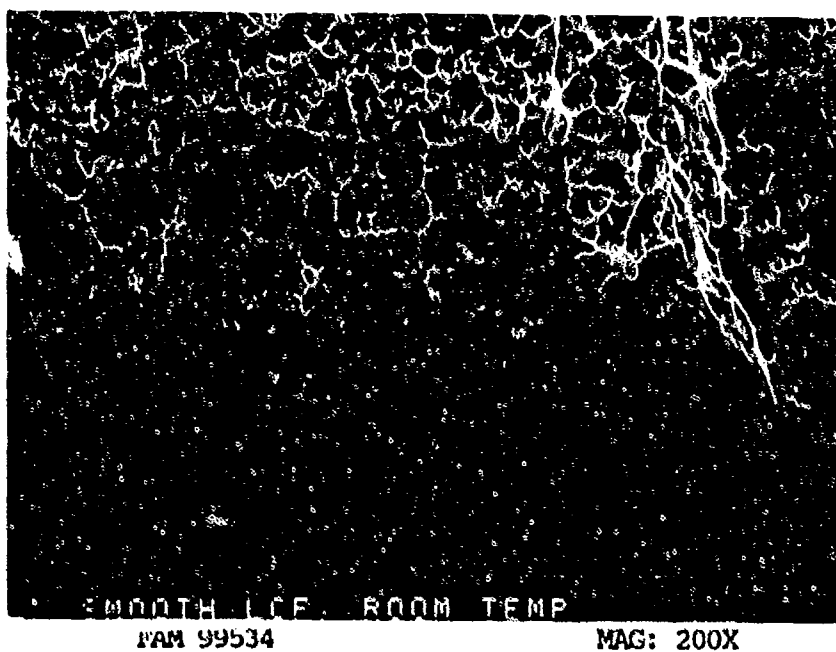
FIGURE 11-78: Shear dimples in the final overstress area.

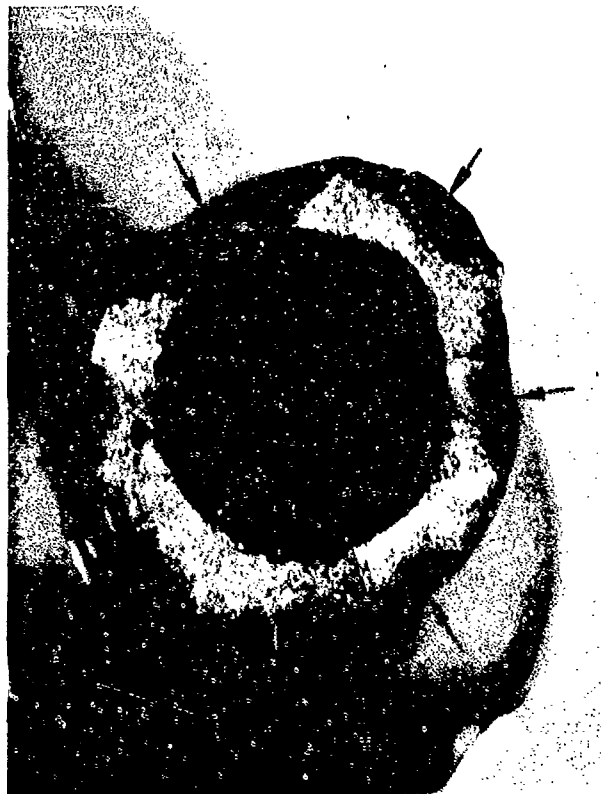
FIGURE 11-79: Test results and fractography of MP-159 in-phase TMF test. Seven thumbnails are visible propagating from origins (arrows) along the outside surface of the specimen. The thumbnails appear to be heavily oxidized.

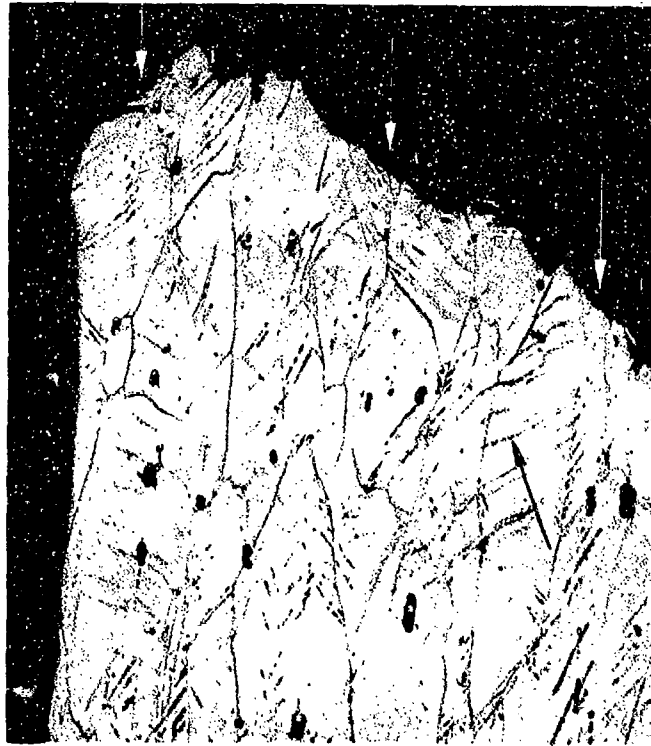
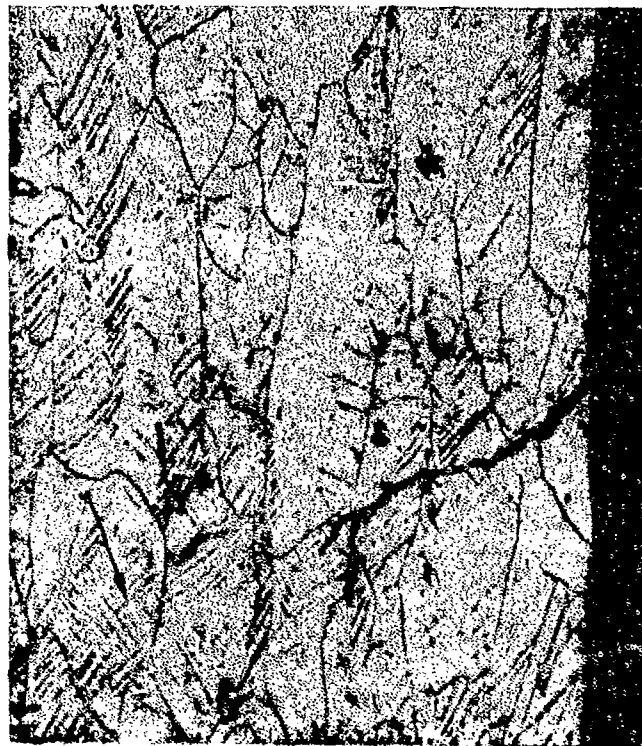
FIGURE 11-80: Optical photomicrographs showing a primary thermal-mechanical fatigue progression area (top) and a secondary crack in the gage section (bottom). Strain lines are visible in both photographs (arrows). The primary progression surface exhibits oxidation (white arrows, top).

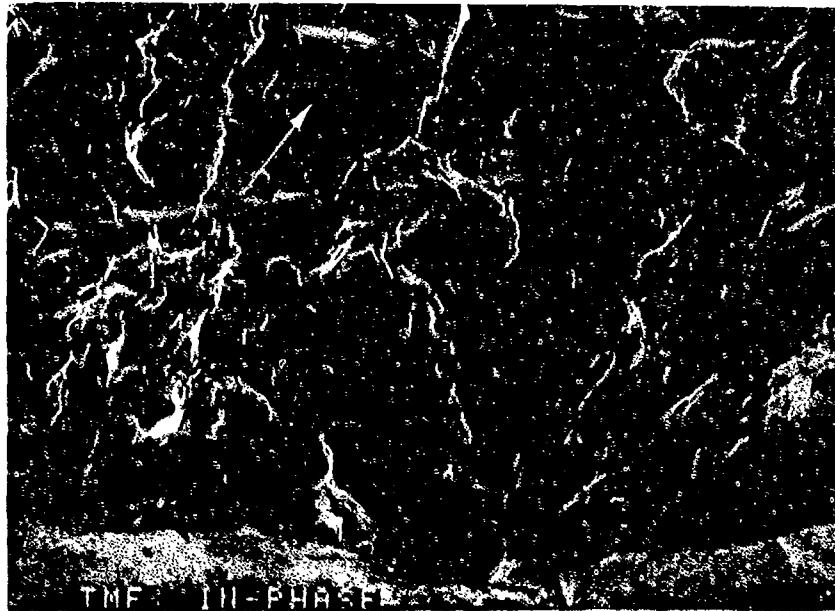
FIGURE 11-82: Stage I fatigue facet at one of several origins in the thumbnail (arrow A). Features indicative of fatigue are visible (arrow B).

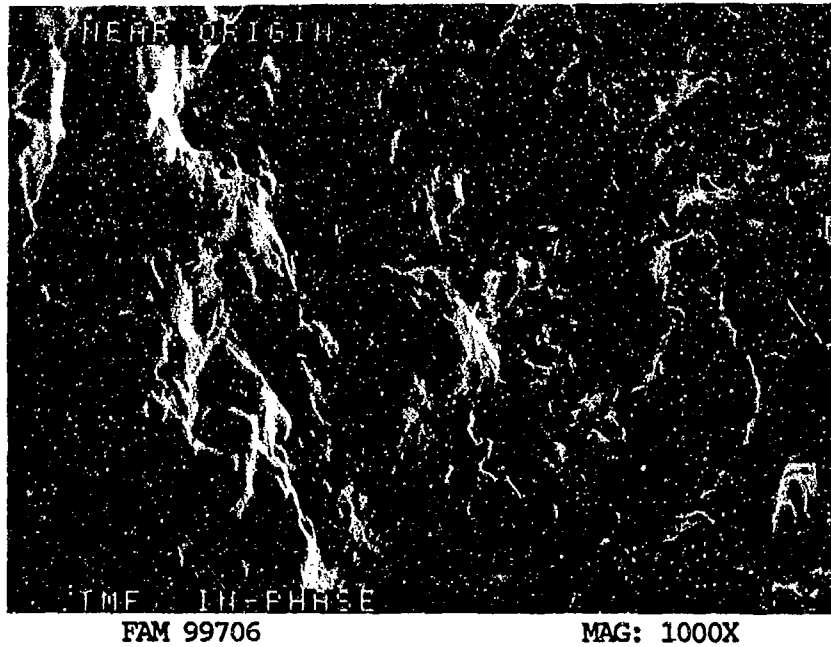
FIGURE 11-83: Higher magnification photograph of an area near the origin. Fatigue striations are visible indicating divergent directions of propagation.

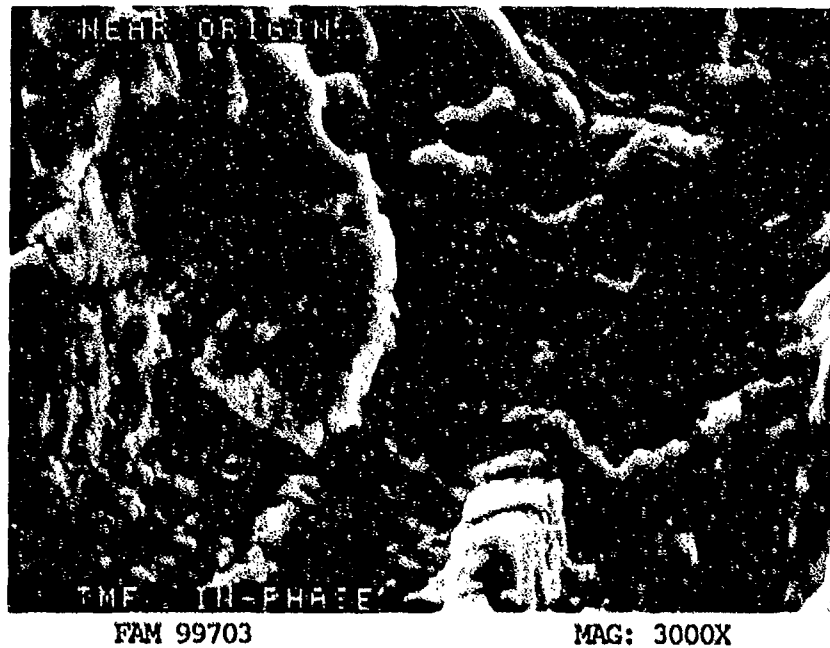
FIGURE 11-84: Higher magnification view of the fatigue striations shown in Figure 11-83. The direction of propagation is shown by an arrow.

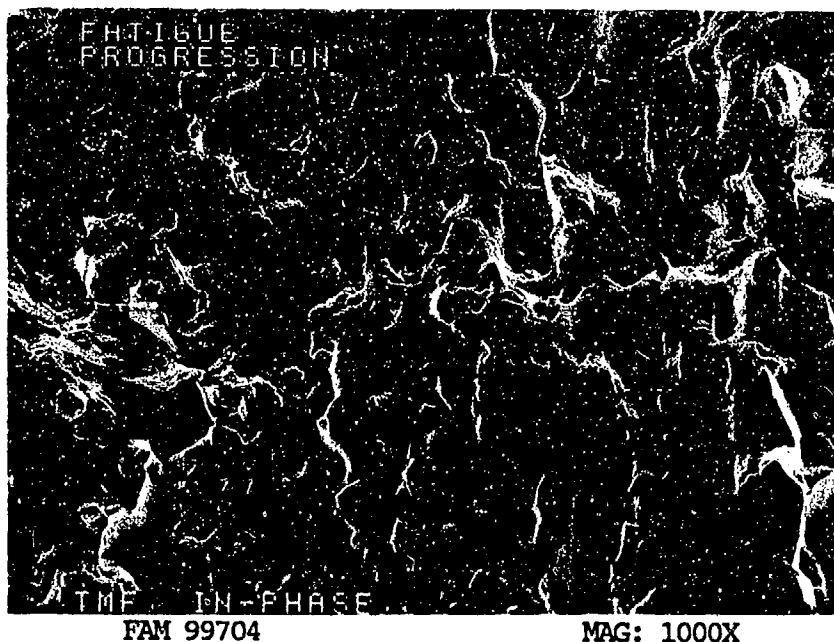
FIGURE 11-85: Fatigue propagation area exhibiting striations and crack-like striations. The direction of propagation is from bottom to top of the photograph.

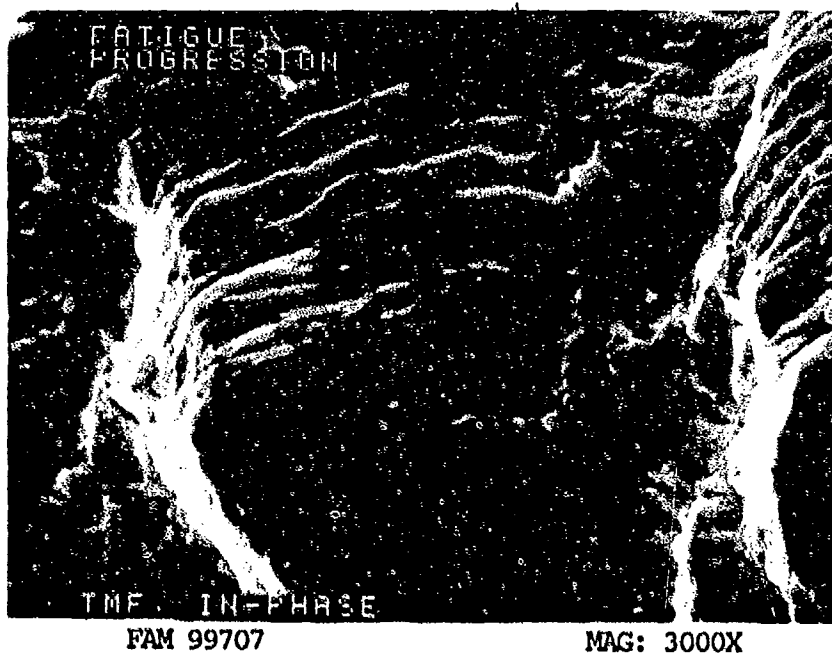
FIGURE 11-86: Higher magnification view of the area shown in Figure 11-85 exhibiting striations and crack-like striations.

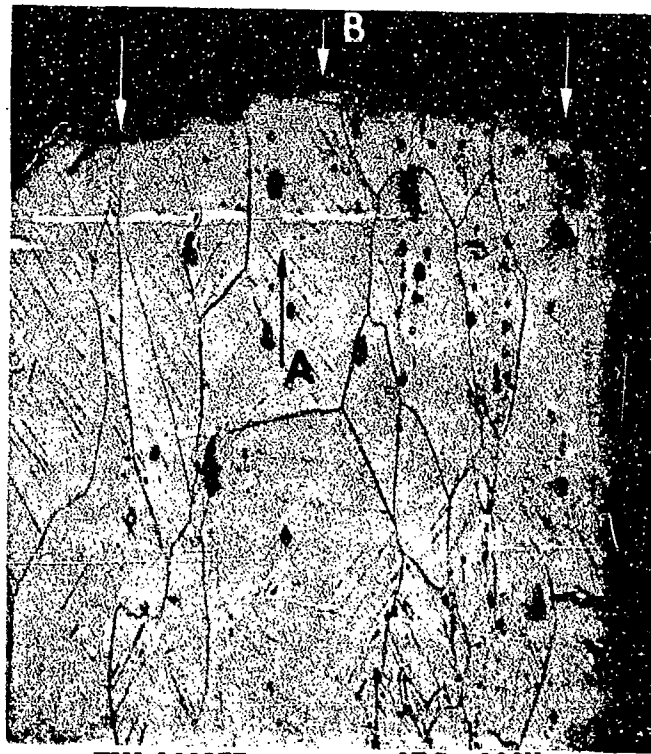
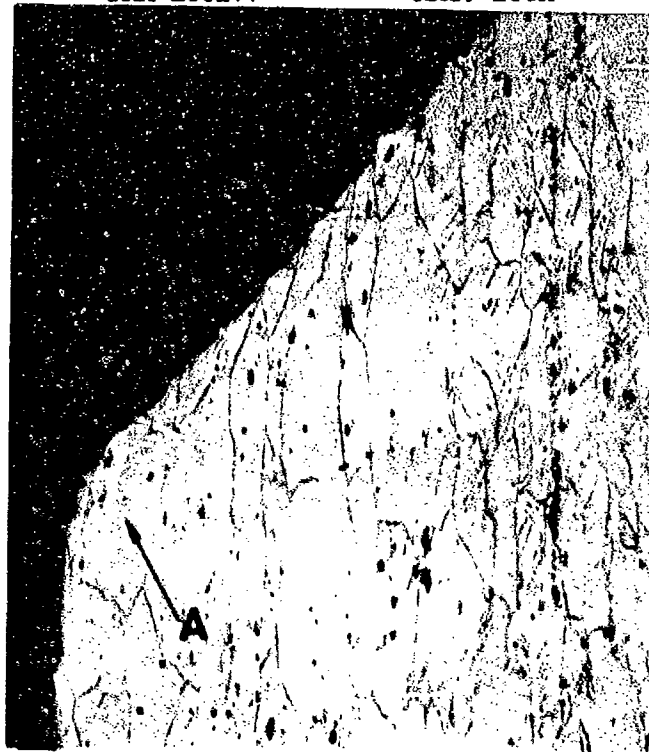
FIGURE 11-90: Optical photomicrographs showing the primary thermal-mechanical fatigue progression area and a secondary crack in the gage section (top) and the final overstress area oriented at an angle to the stress axis (bottom). Strain lines are visible in both photographs (arrows A). The primary progression surface exhibits oxidation (arrows B).

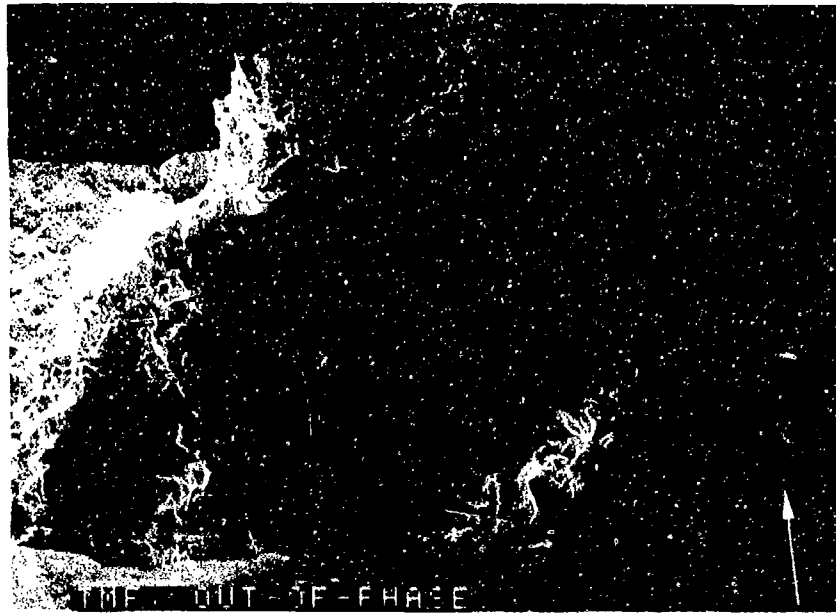
FIGURE 11-91: Low magnification photograph showing fatigue initiation and progression (thumbnail). A secondary crack is visible on the specimen surface (arrow).

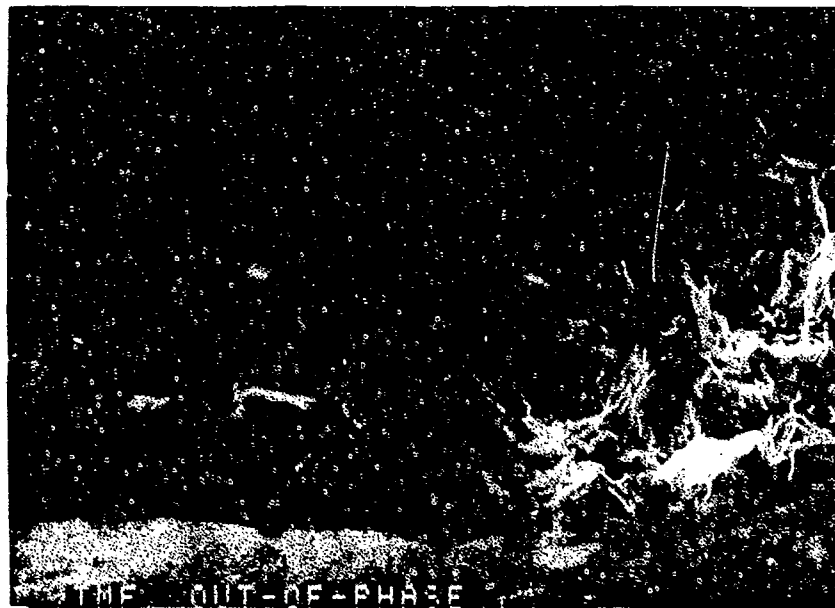
FIGURE 11-92: Higher magnification view of the origin area. No fatigue striations are visible at this magnification (compare to Figure 11-82).

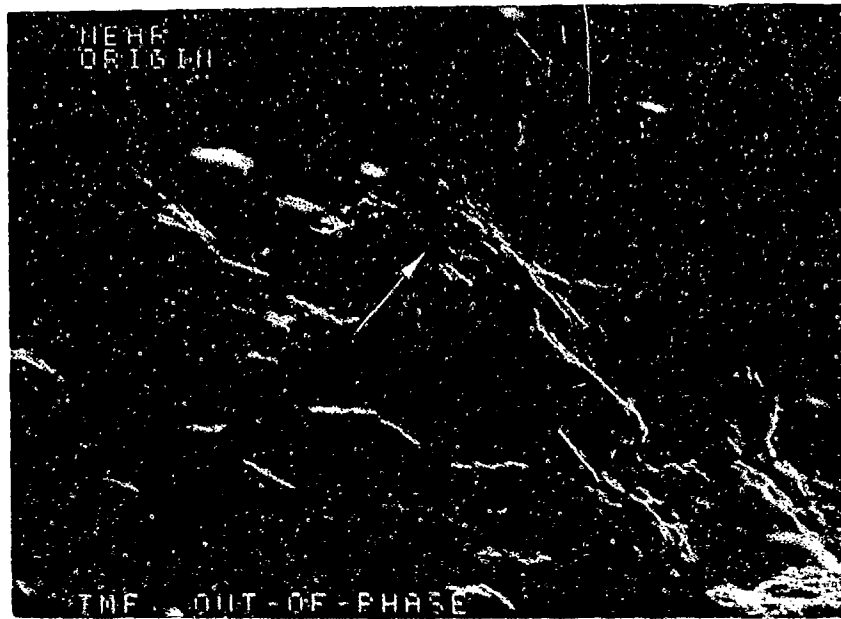
FIGURE 11-93: Remnant fatigue striations and crack-like striations near the origin. The direction of propagation is shown by an arrow.

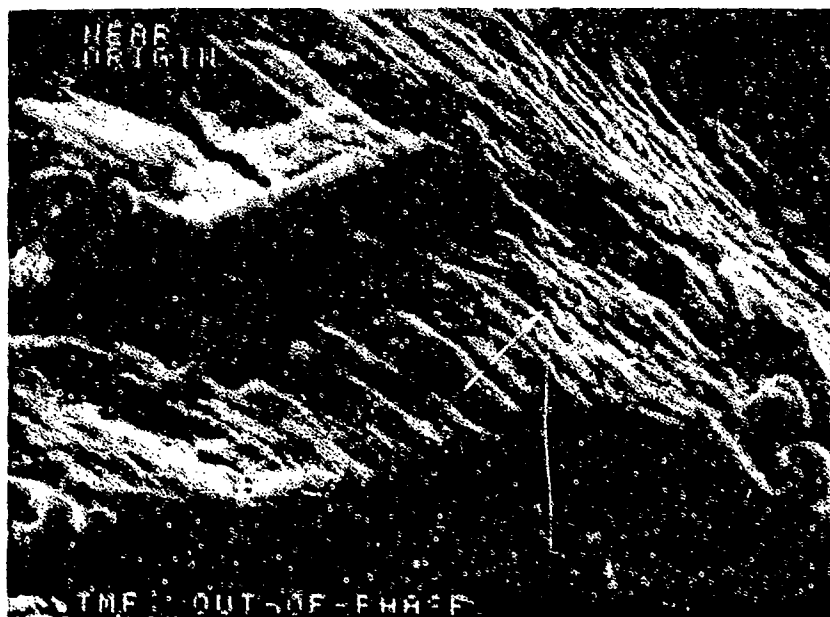
FIGURE 11-94: Higher magnification photograph of the area shown in Figure 11-93. Remnant crack-like striations are visible. The direction of propagation is shown by an arrow.

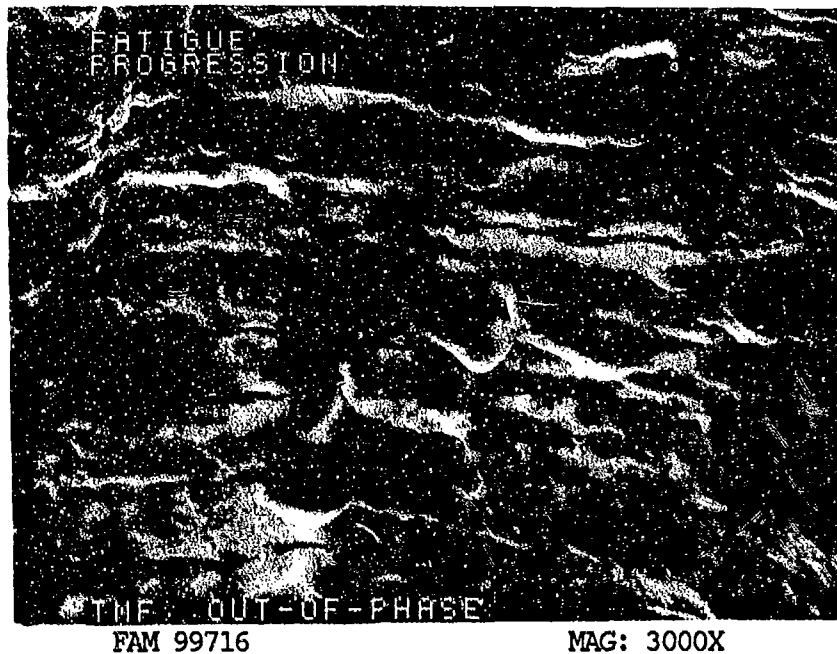
FIGURE 11-96: Higher magnification view of a portion of the area shown in Figure 11-95, showing crack-like striations.

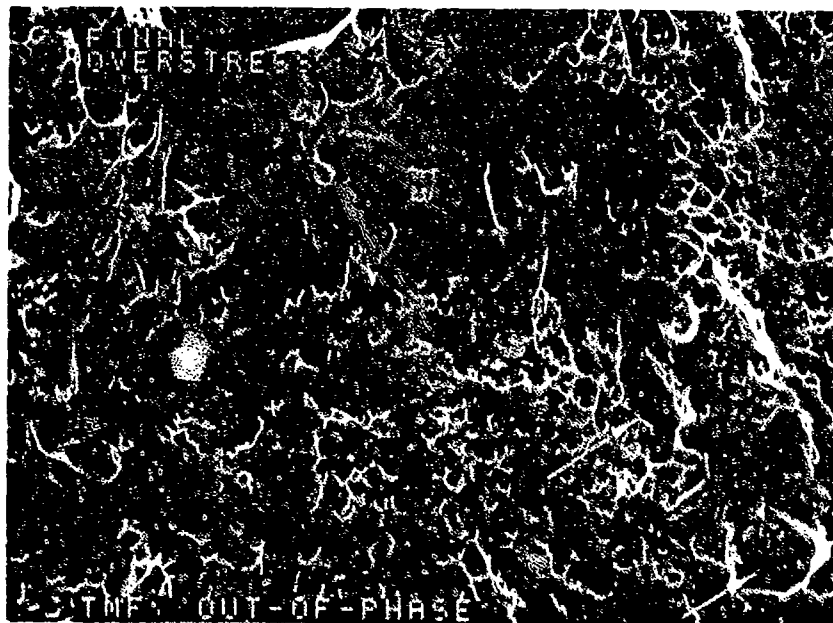
FAM 99718

FIGURE 11-98: Higher magnification photograph of the final overstress area (Figure 11-97) exhibiting shallow dimples and deep voids (arrows).
