FAILURE ANALYSIS HANDBOOK

C. R. Walker, K. K. Starr

Pratt & Whitney
P.O. Box 109600
West Palm Beach, FL 33410-9600

August 1989

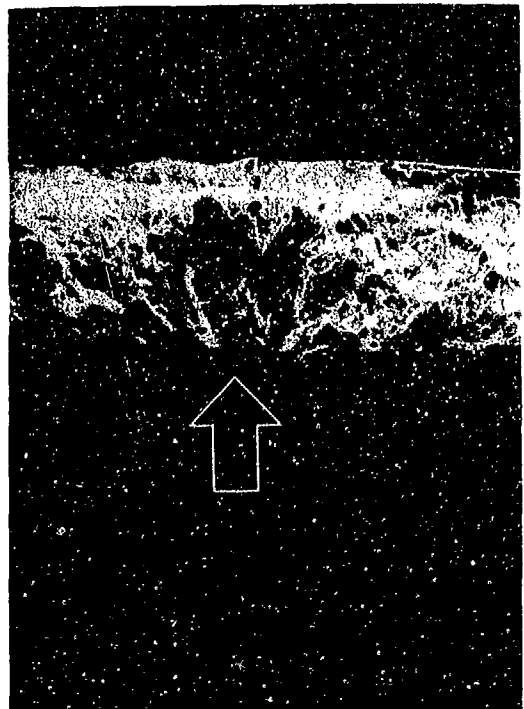
FAL 93352

FIGURE 11-100: One of several possible origin areas (arrow).

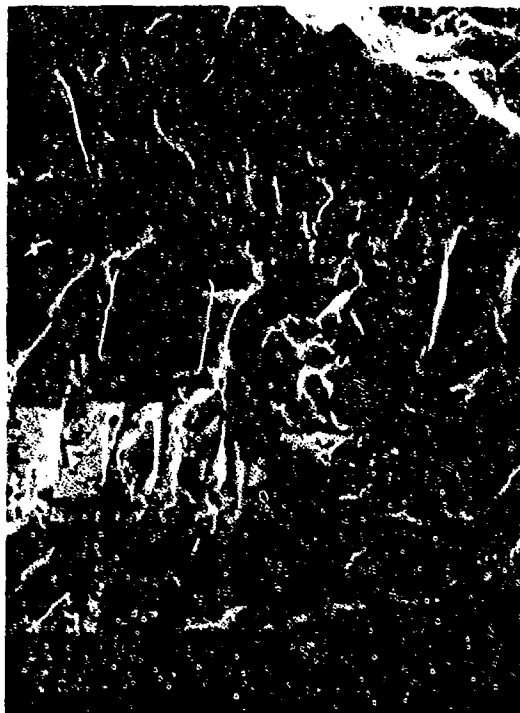
FAL 93417

FIGURE 11-101: Remnant striations indicative of fatigue.

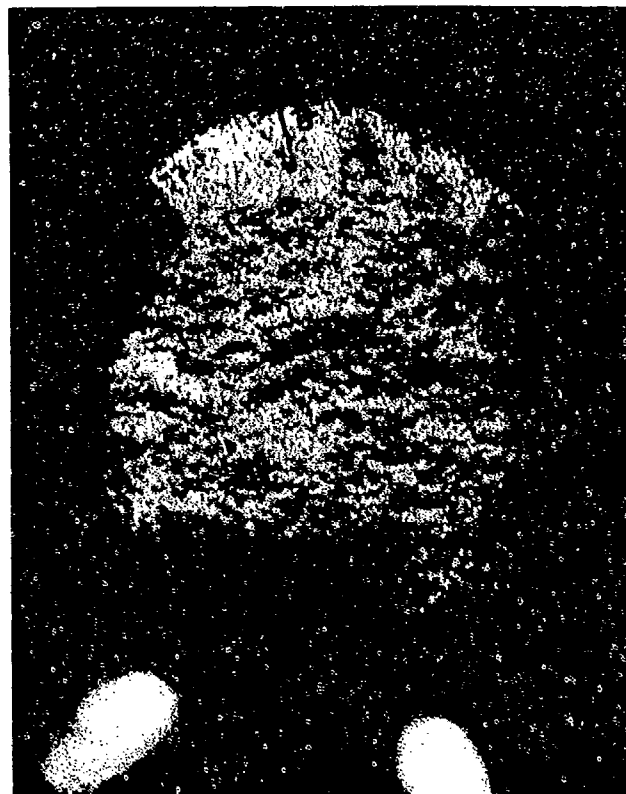
FAL 92935

FIGURE 12-1: Test results and fractography of Ti-6-2-4-2 smooth tensile test. The fracture exhibits a distinct shear lip (bracket). The size of the shear lip varies with location around the specimen.

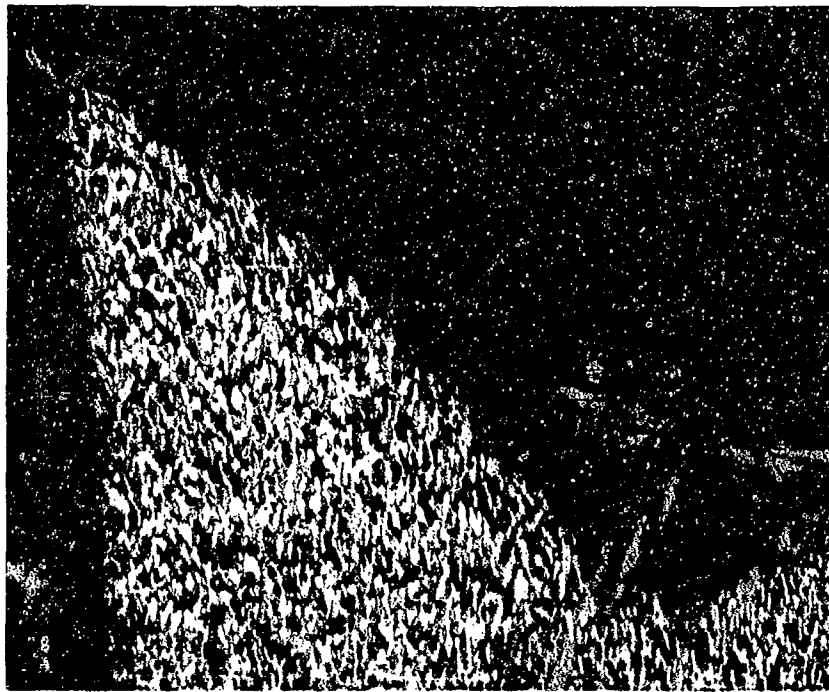
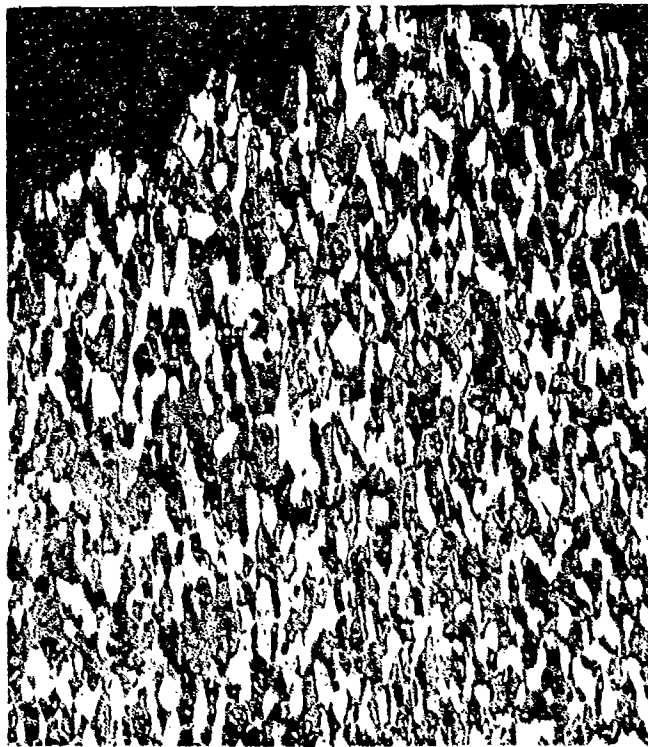
FIGURE 12-2: Optical photomicrographs showing the final overstress area (shear lip) (top) and the primary fracture area (bottom). Both areas exhibit elongated grains indicating plastic deformation.

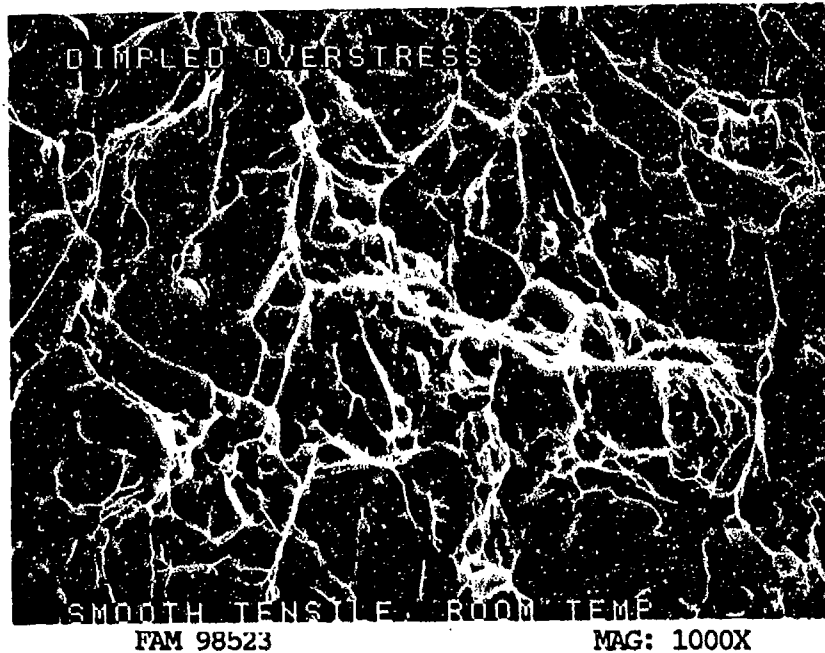
FIGURE 12-5: Higher magnification photograph of the area shown in Figure 12-4, showing dimpled overstress in the primary fracture area.

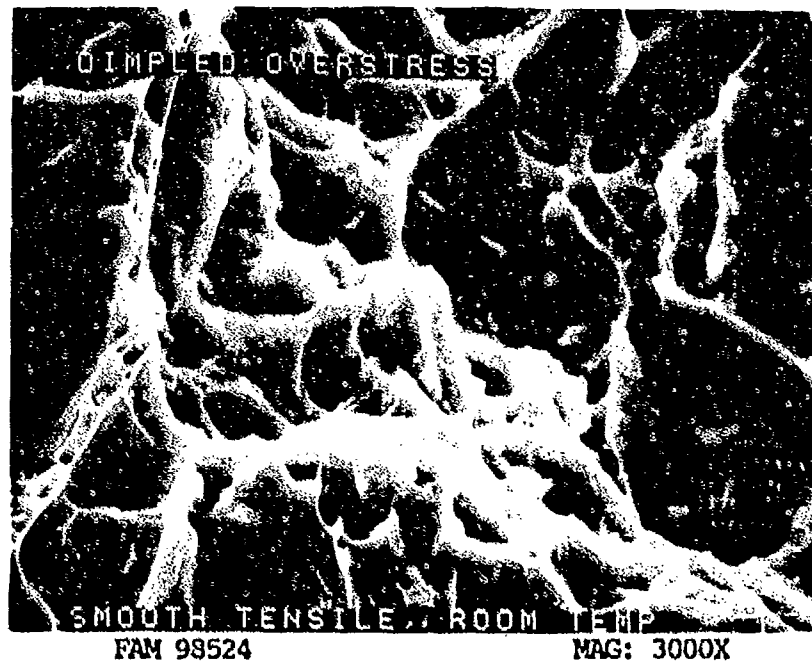
FIGURE 12-6: Dimpled overstress in the primary fracture area, exhibiting variation in dimple size.

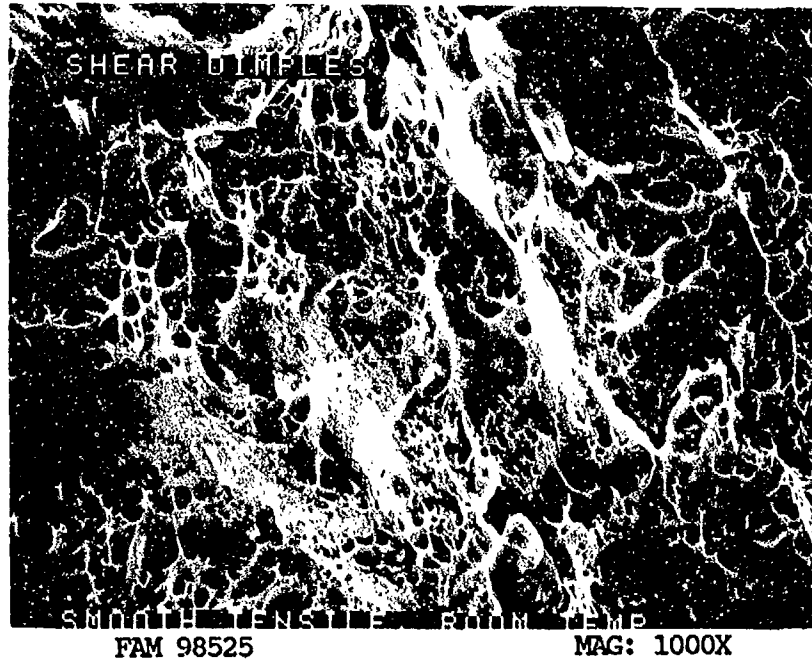
FIGURE 12-7: Shear dimpled overstress in the final fracture area (shear lip).

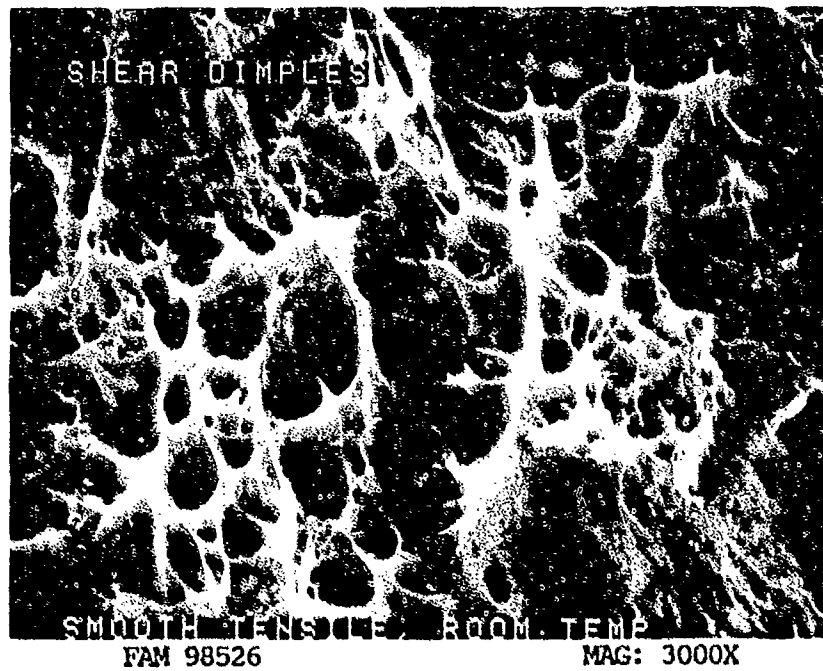
FIGURE 12-8: Shear dimpled overstress in the final fracture area. The directions of relative motion are shown by arrows.

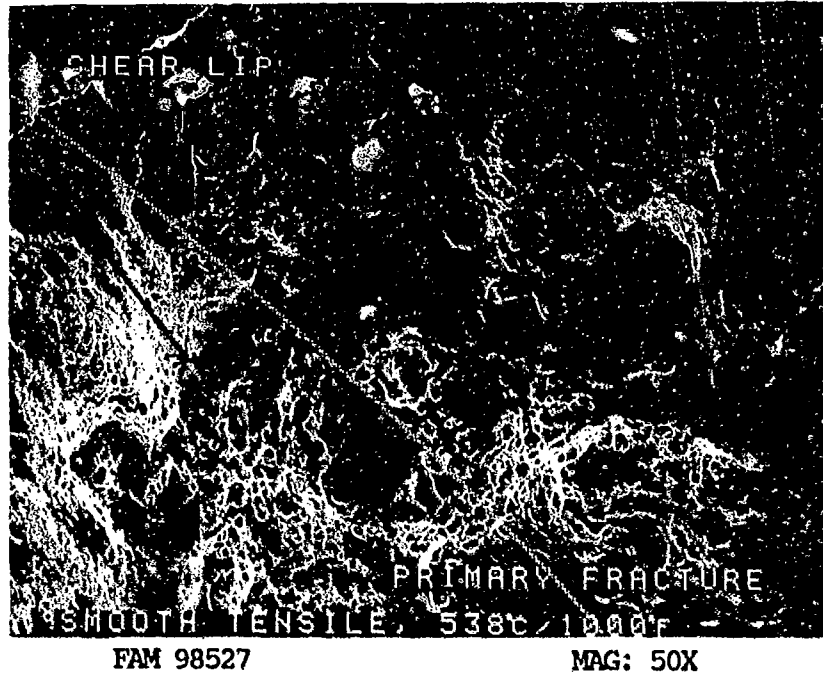
FIGURE 12-11: Low magnification photograph showing primary fracture area and large shear lip. A bracket indicates the extent of the shear lip.

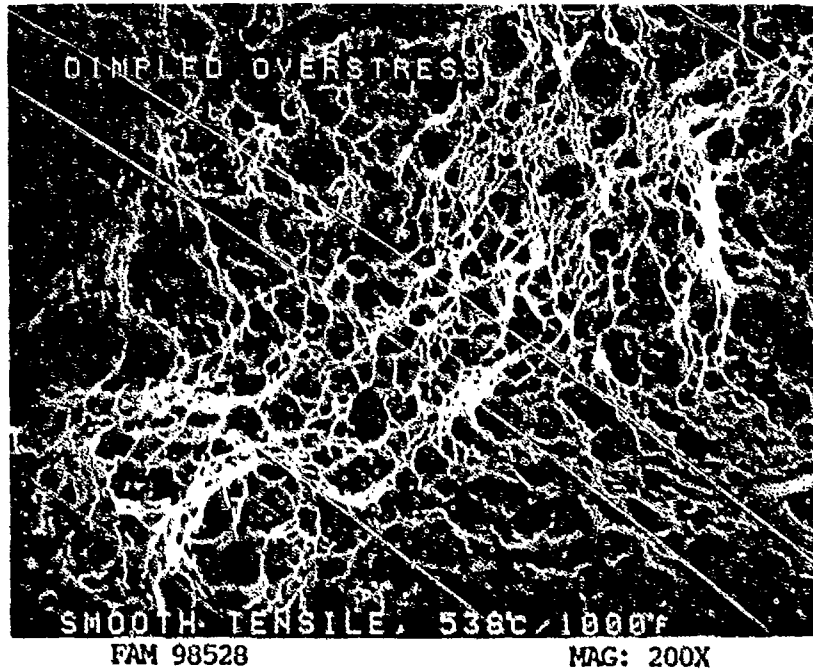
FIGURE 12-12: Equiaxed dimpled overstress in the primary fracture area.

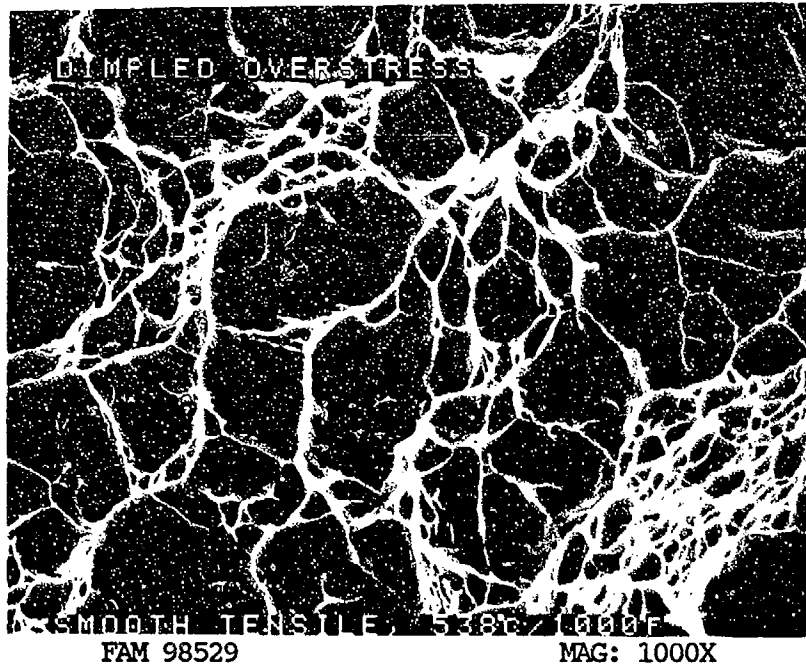
FIGURE 12-13: Higher magnification photograph of the area shown in Figure 12-12, showing oxidized equiaxed dimpled overstress in the primary fracture area.

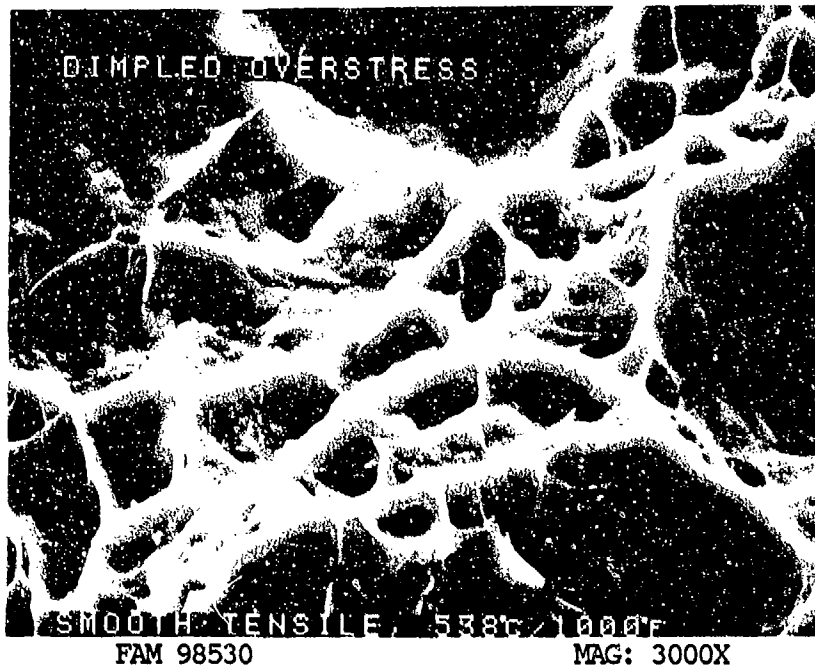
FIGURE 12-14: Shallow oxidized equiaxed dimpled overstress in the primary fracture area.

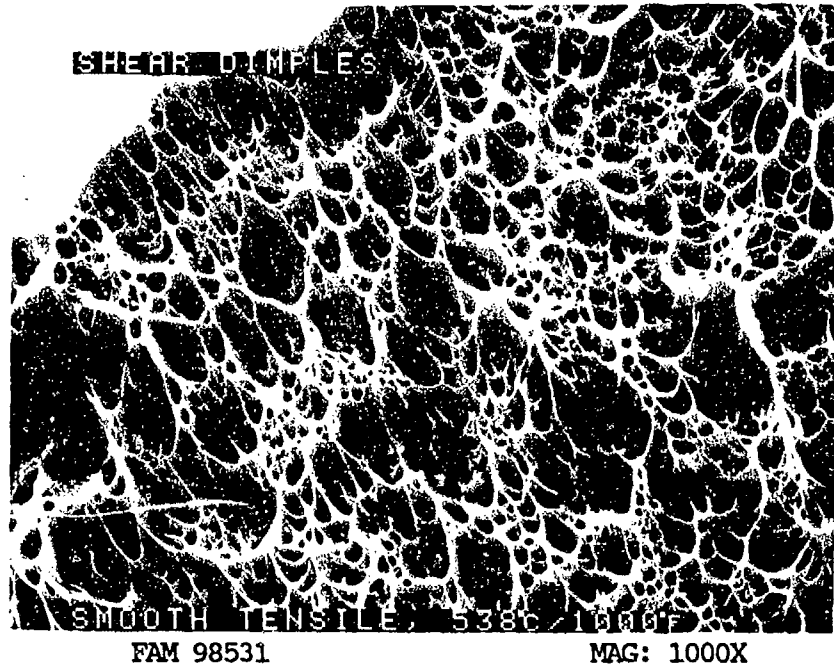
FIGURE 12-15: Shear dimpled overstress in the final fracture area (shear lip).

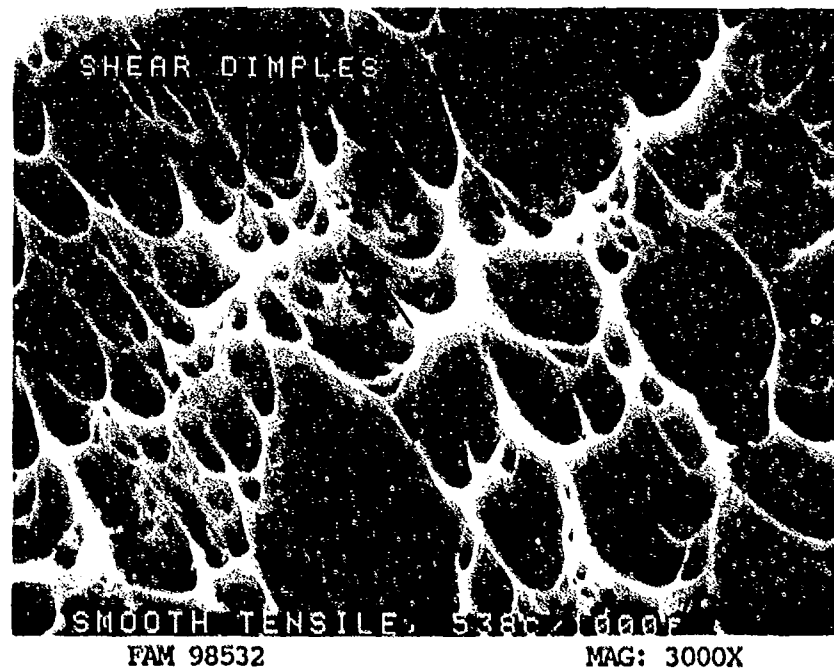
FIGURE 12-16: Shear dimpled overstress in the final fracture area. The directions of relative motion are shown by arrows.

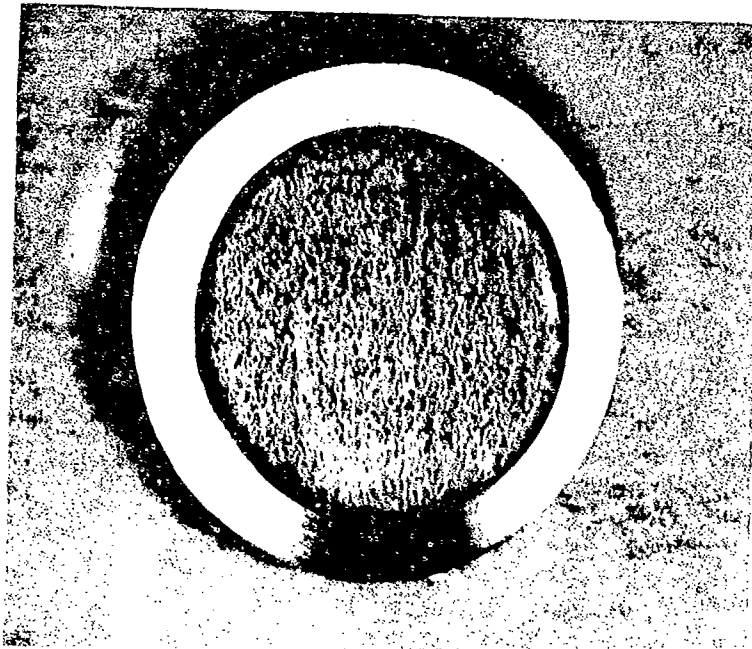
FAL 92494

FIGURE 12-17: Test results and fractography of Ti-6-2-4-2 notched tensile test. No shear lip is visible.

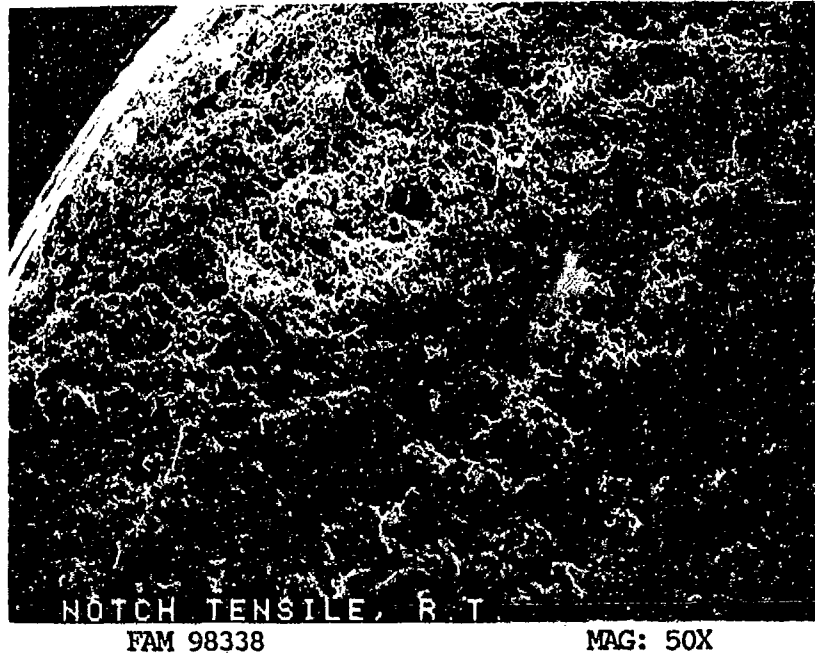
FIGURE 12-19: Low magnification photograph showing no apparent shear lip. The base of the notch is visible (top left).

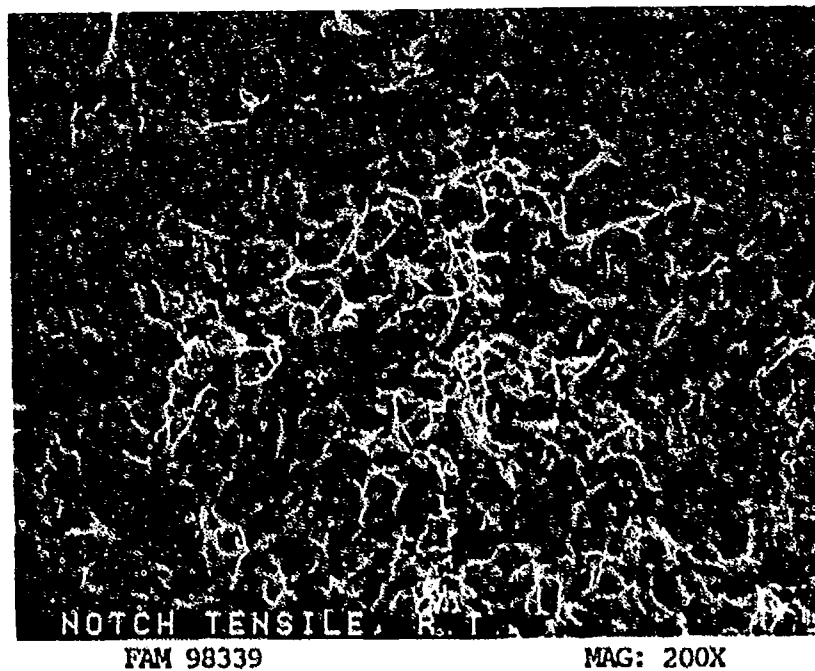
FIGURE 12-20: Dimpled overstress in the center of the specimen.

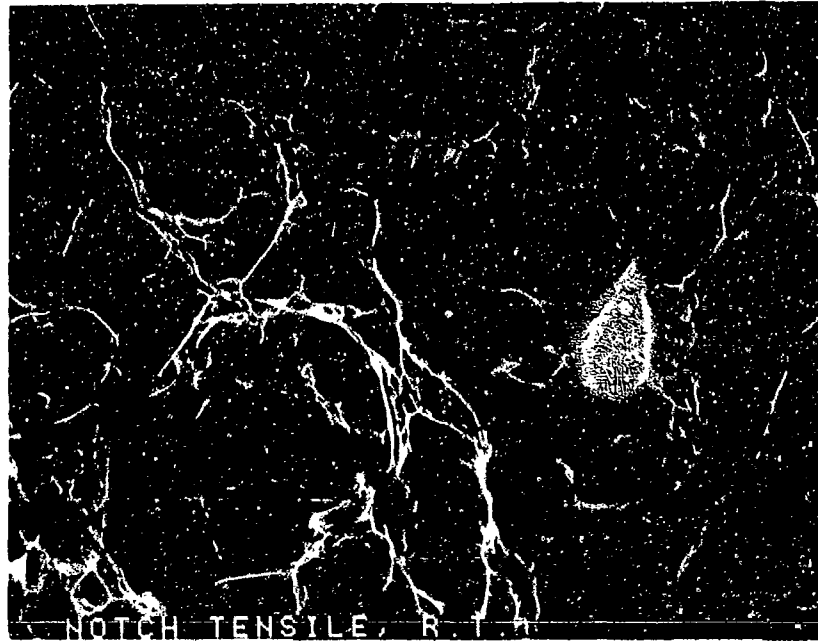
FAM 98342

FIGURE 12-21: Higher magnification photograph of the area shown in Figure 12-20, showing dimpled overstress.

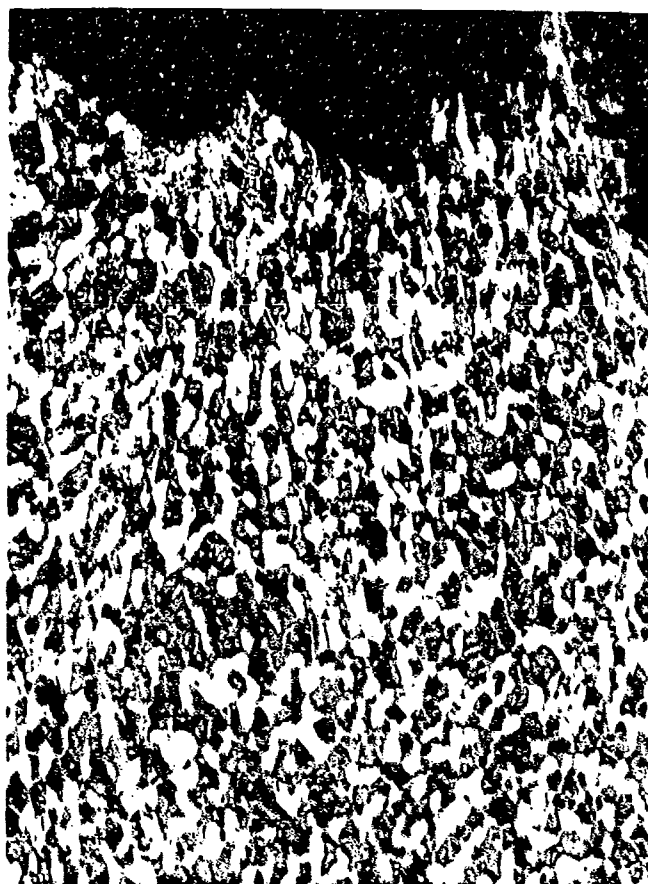
FAM 99788

FIGURE 12-24: Optical photomicrograph of the base of the notch (arrow). The final overstress area is the only region exhibiting elongated grains. Just inboard of the notch, the grains are equiaxed. The grains remain equiaxed adjacent to the fracture surface, indicating that little or no plastic deformation accompanied the fracture.

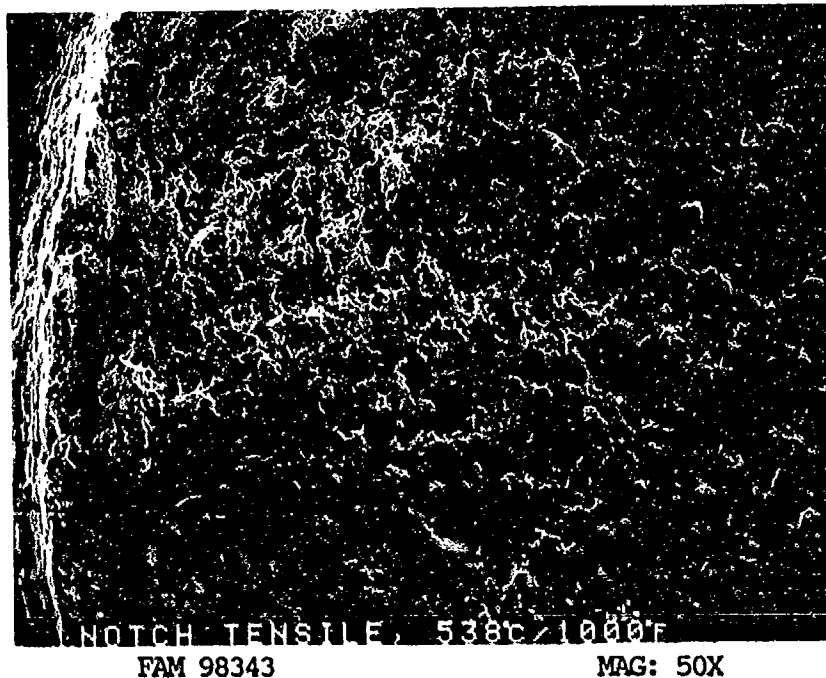
FIGURE 12-25: Low magnification photograph showing no apparent shear lip. The base of the notch is visible on the left side of the photograph.

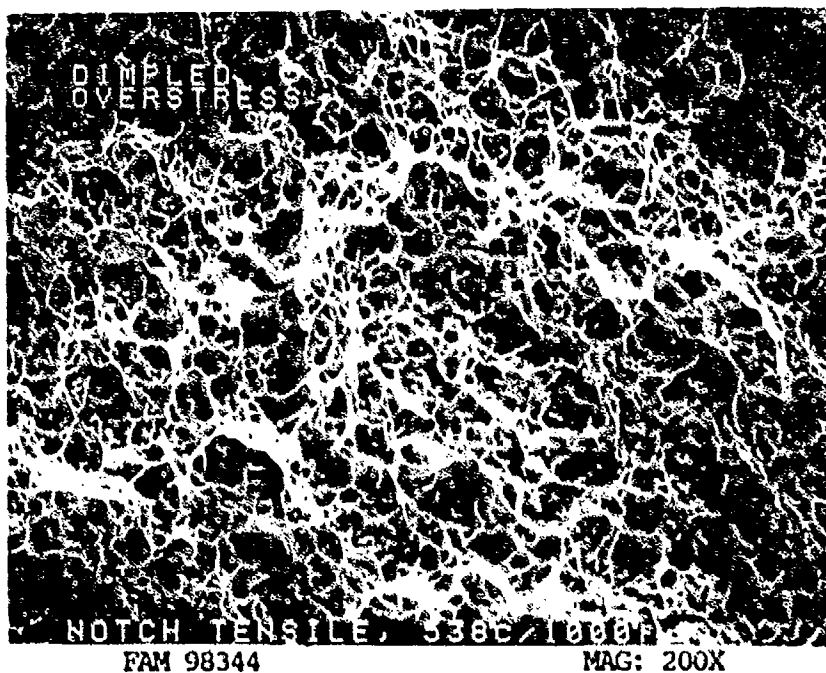
FIGURE 12-26: Equiaxed dimpled overstress in the center of the specimen.

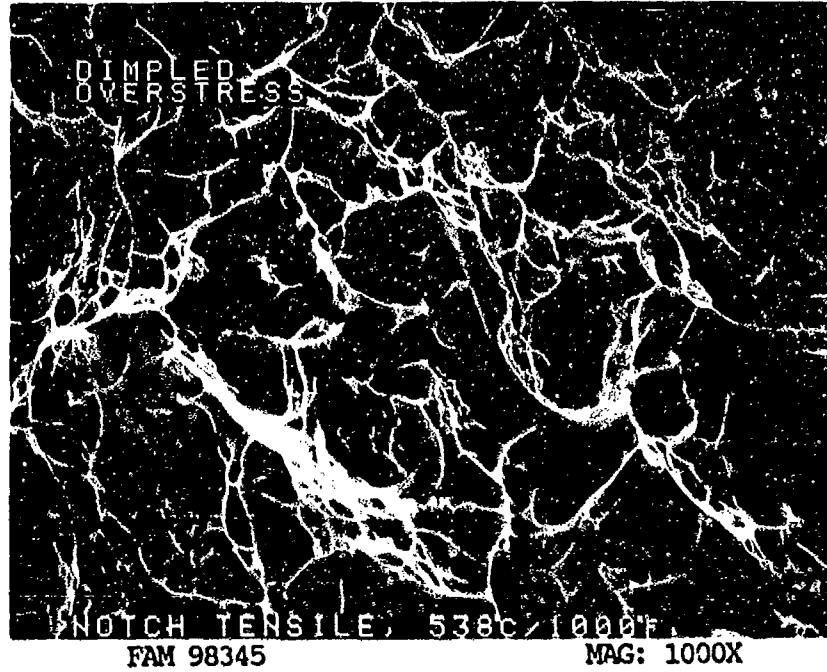
FIGURE 12-27: Higher magnification photograph of the center of the fracture surface, showing equiaxed dimpled overstress.

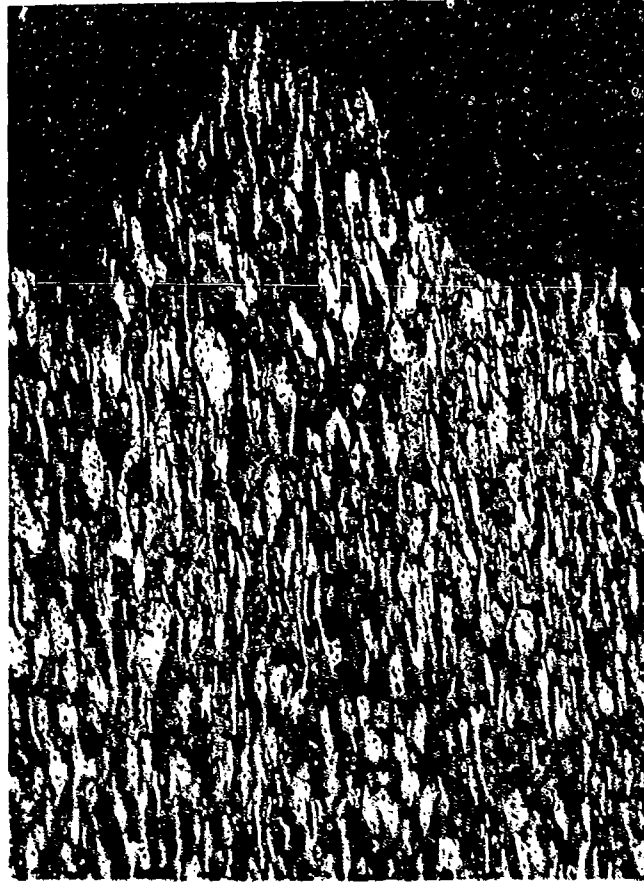
FAM 99759

FIGURE 12-30: Optical photomicrograph showing severely elongated grains near the center of the specimen. The fracture is predominantly transgranular.

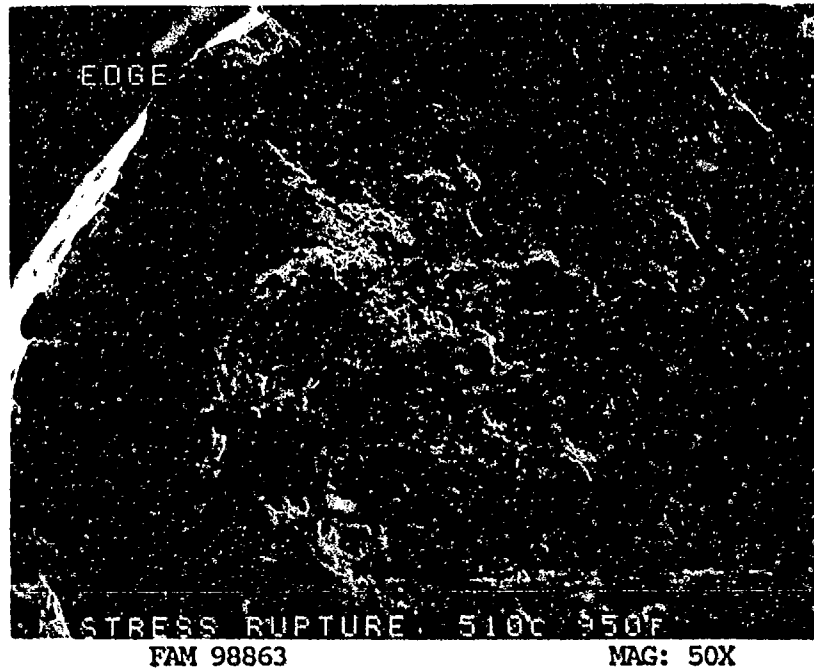
FIGURE 12-31: Low magnification photograph showing primary overstress area near the center of the specimen and a shear lip near the edge.

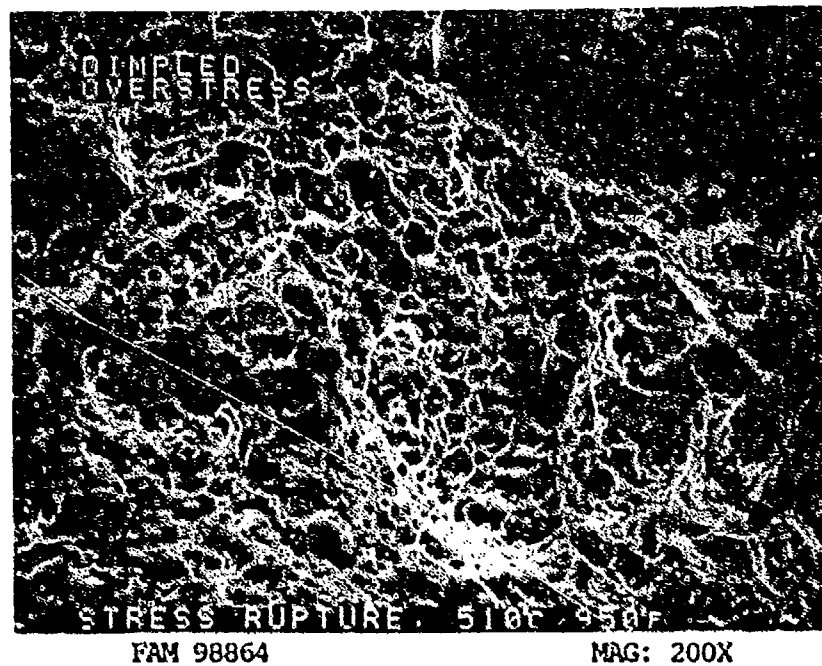
FIGURE 12-32: Equiaxed dimpled overstress in the primary fracture area. Small areas of void coalescence are visible near the center of the specimen (arrows).

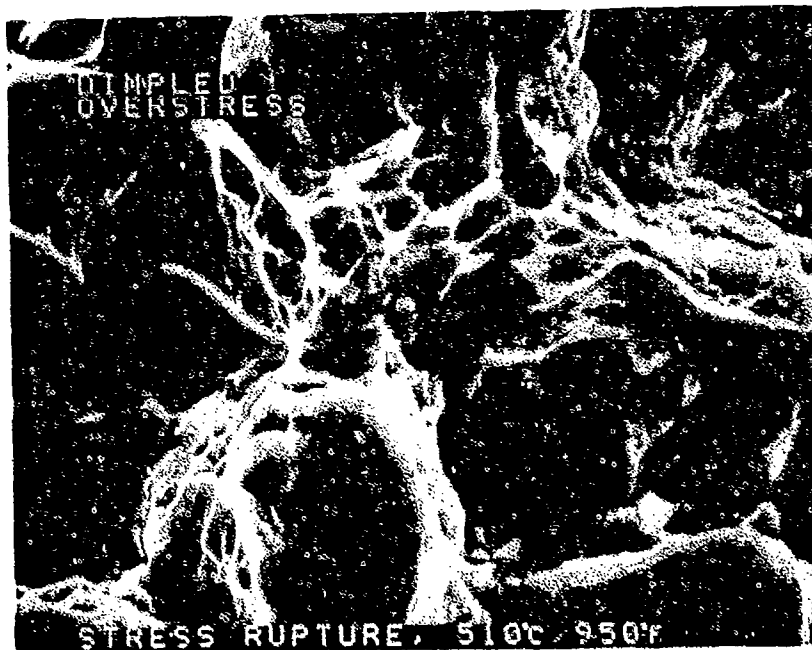
FIGURE 12-34: Higher magnification photograph of the area shown in Figure 12-33, showing fine equiaxed dimples between areas of void coalescence.

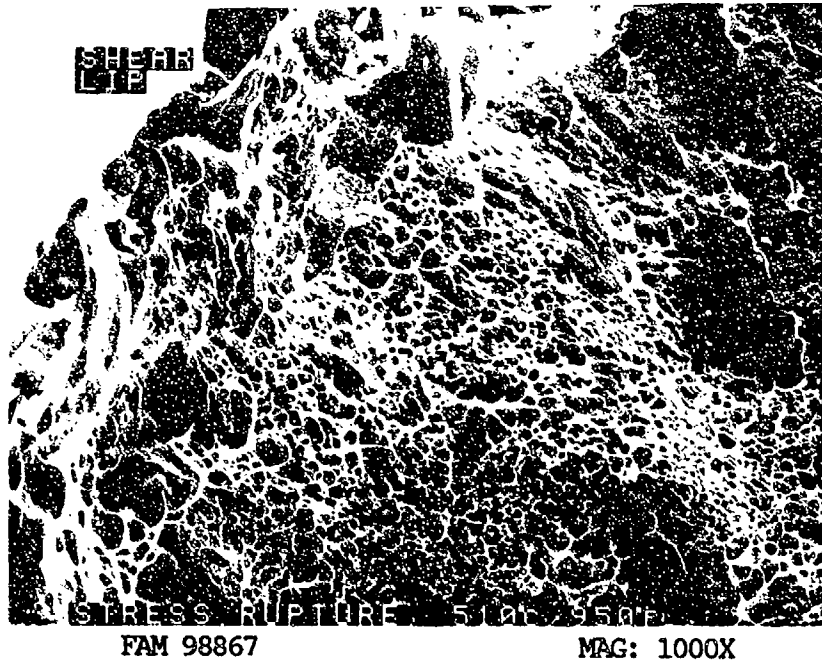
FIGURE 12-35: Shear dimples in the final fracture area.

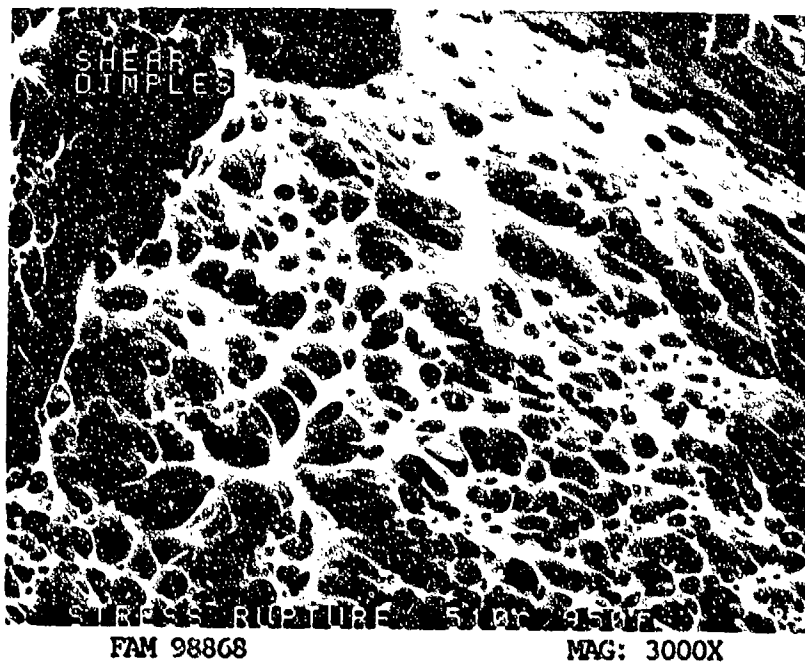
FIGURE 12-36: Fine shear dimples in the final overstress area. Arrows show the directions of relative motion.

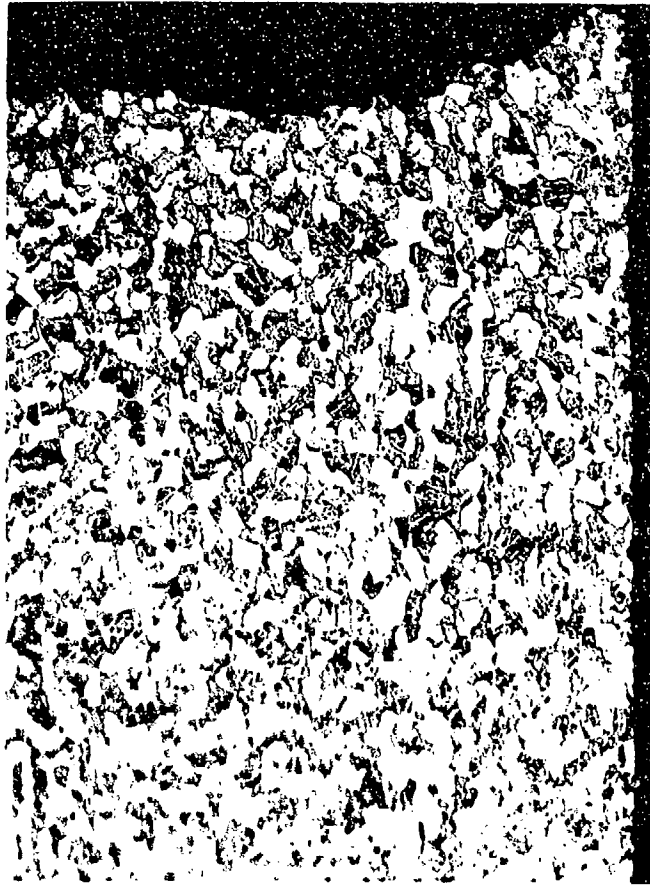
FIGURE 12-38: Optical photomicrograph showing the fatigue progression zone, exhibiting a relatively flat transgranular fracture path.

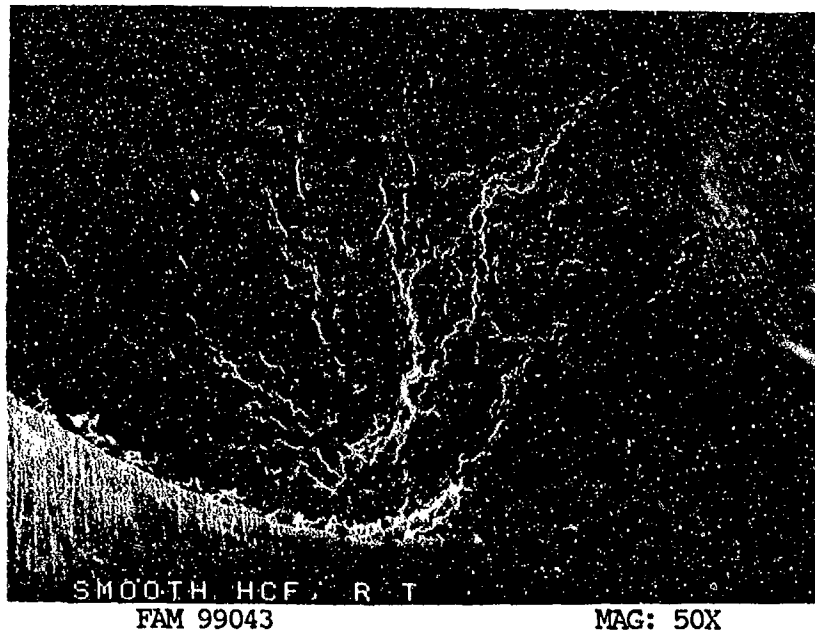
FIGURE 12-39: Low magnification view of the origin area. The specimen exhibited a single surface origin (arrow).

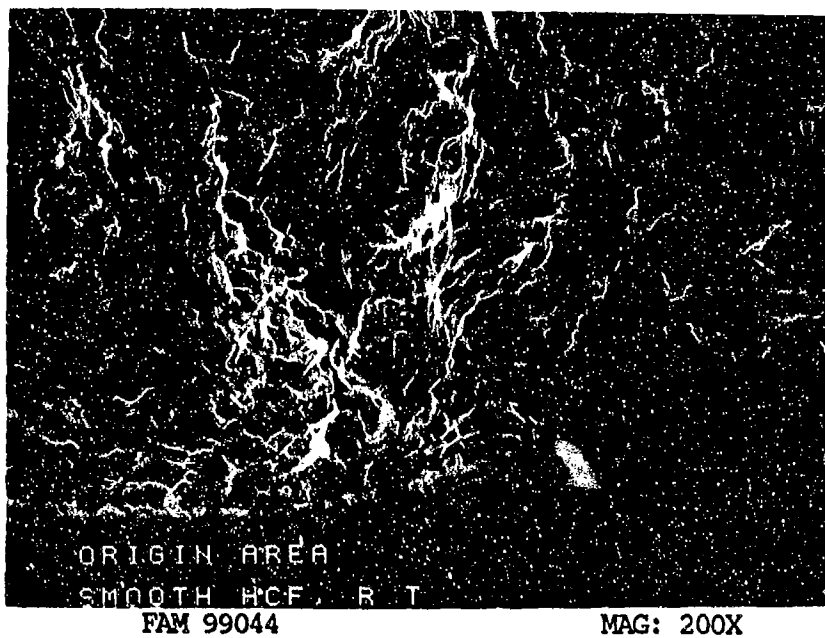
FIGURE 12-40: Higher magnification view of the origin area shown in Figure 12-39. A Stage I fatigue facet is visible at the origin (arrow). Features can be seen radiating from the facet.

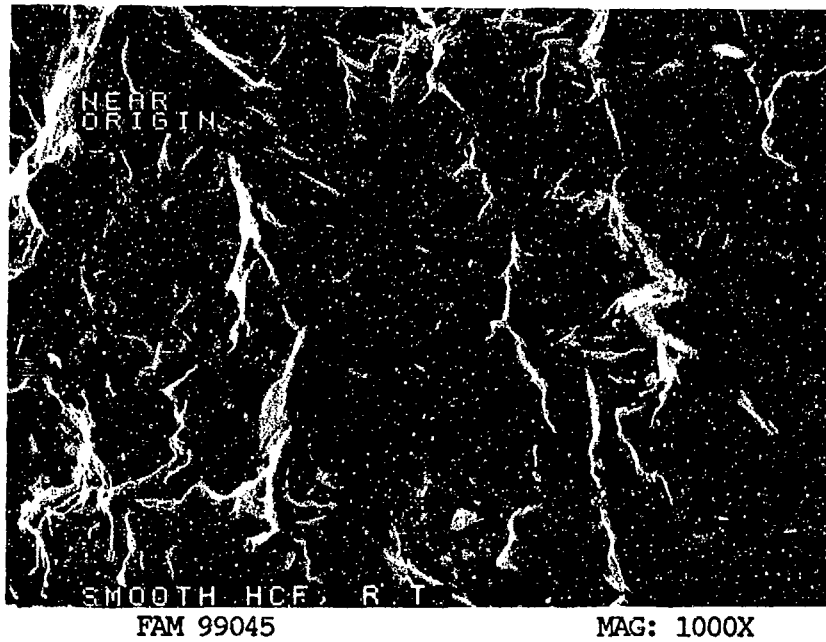
FIGURE 12-41: Feathery cleavage near the origin area. The direction of propagation is from bottom to top of the photograph.

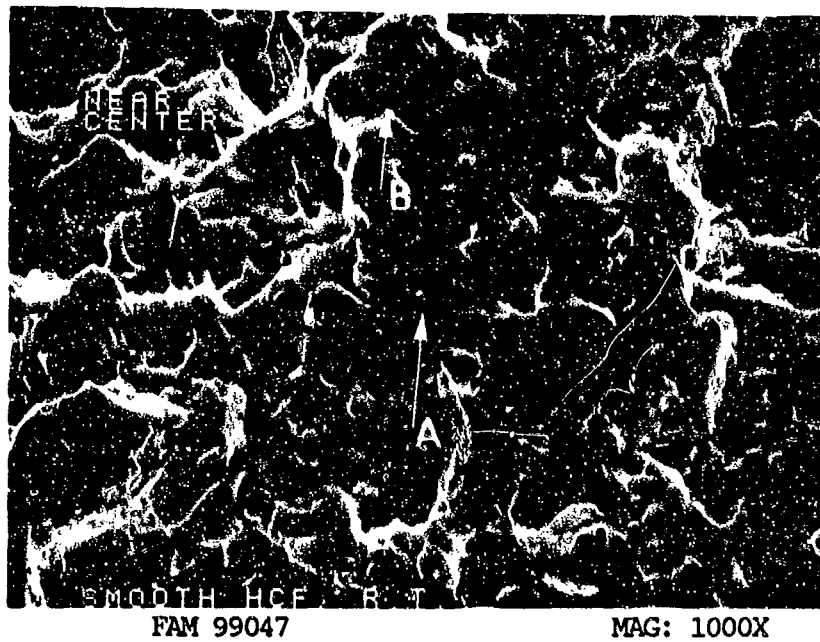
FIGURE 12-42: Fatigue progression near the center of the specimen. The fracture surface is characterized by remnant fatigue striations (arrow A) and secondary cracking (remnant crack-like striations) (arrow B) perpendicular to the direction of propagation.

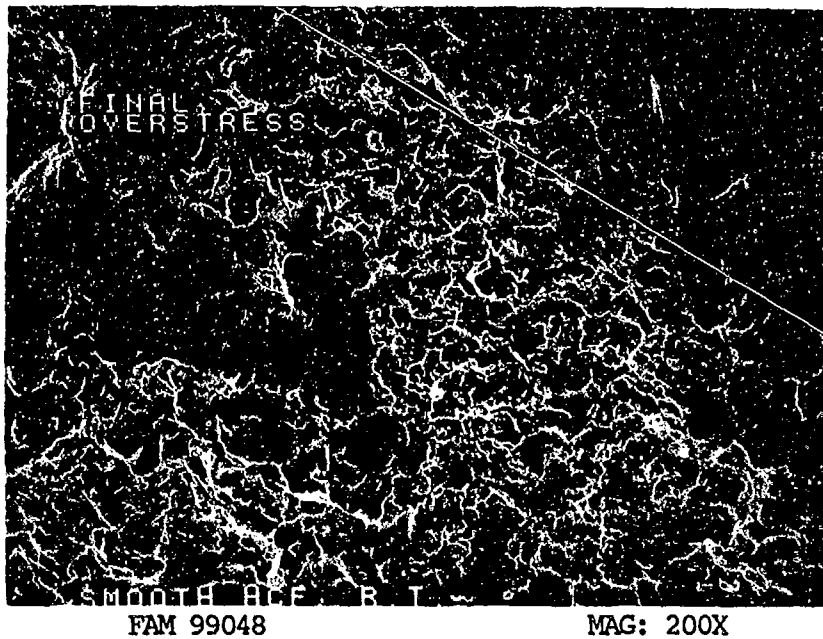
FIGURE 12-43: Partially smeared overstress features in the final overstress area. Arrows indicate areas of smear.

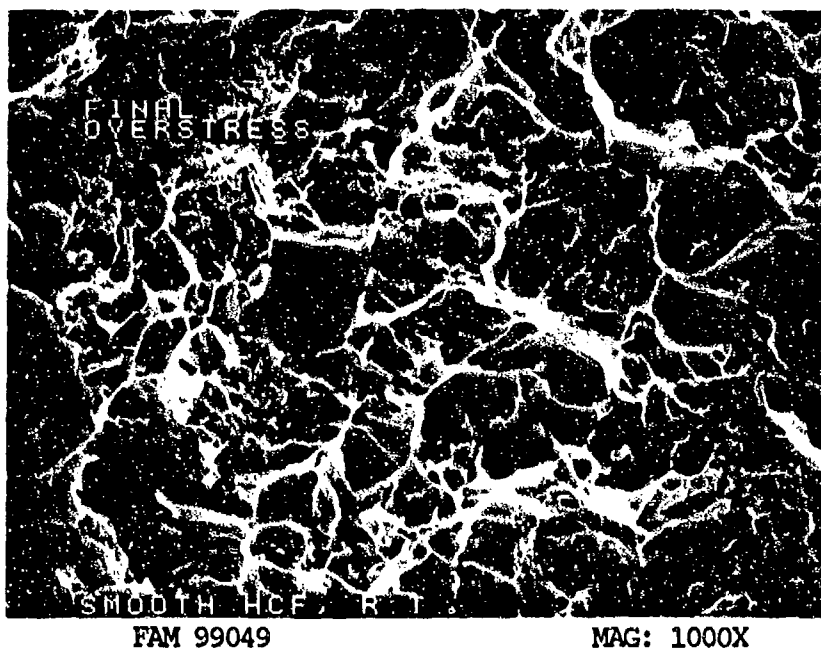
FIGURE 12-44: Higher magnification photograph of the final overstress area. Fine dimples (arrow A) are separated by patches of cleavage.

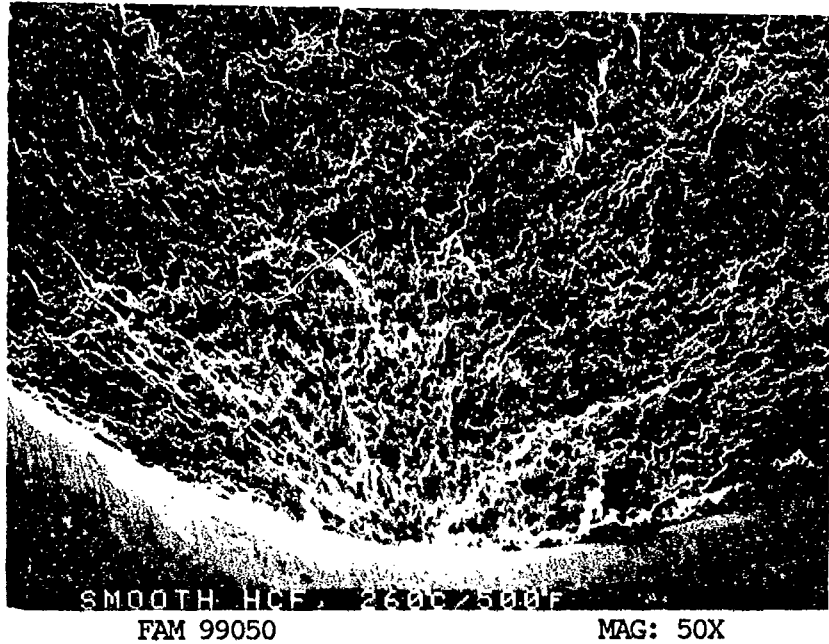
FIGURE 12-47: Low magnification view of the origin area and initial fatigue progression area. Features can be seen radiating from the origin.

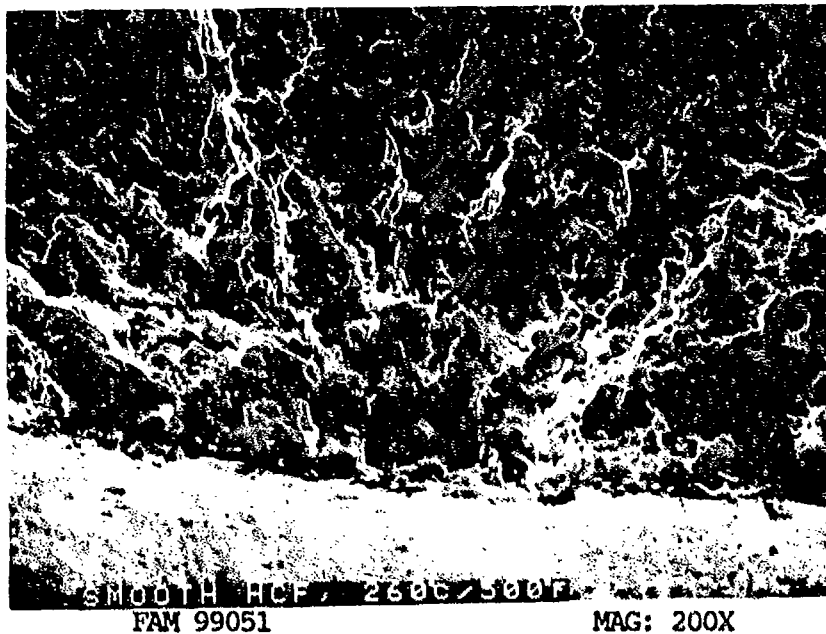
FIGURE 12-48: Higher magnification view of the origin area. The features are relatively flat with no localized origin discernible.

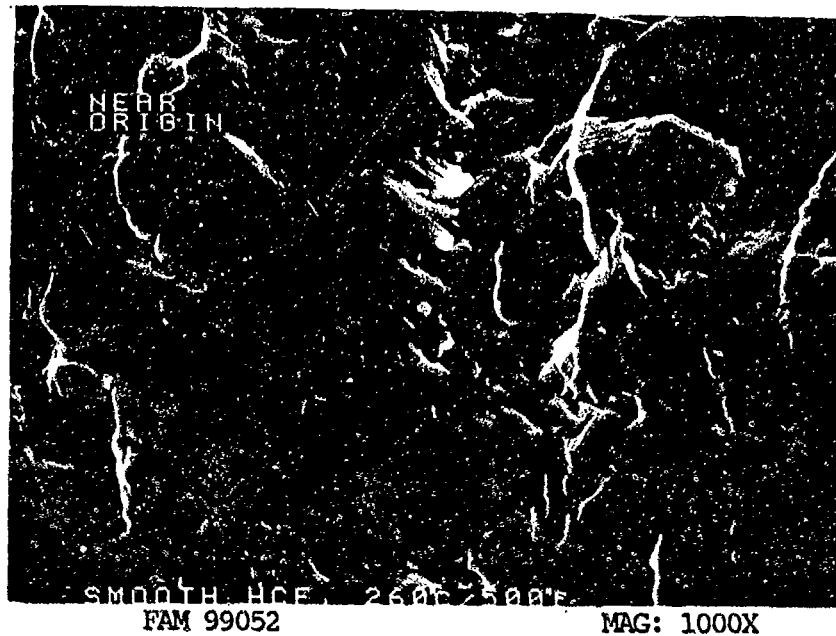
FIGURE 12-49: Combination of remnant fatigue features (arrow A) and smear (arrow B) near the origin area. The fracture propagated from bottom to top of the photograph.

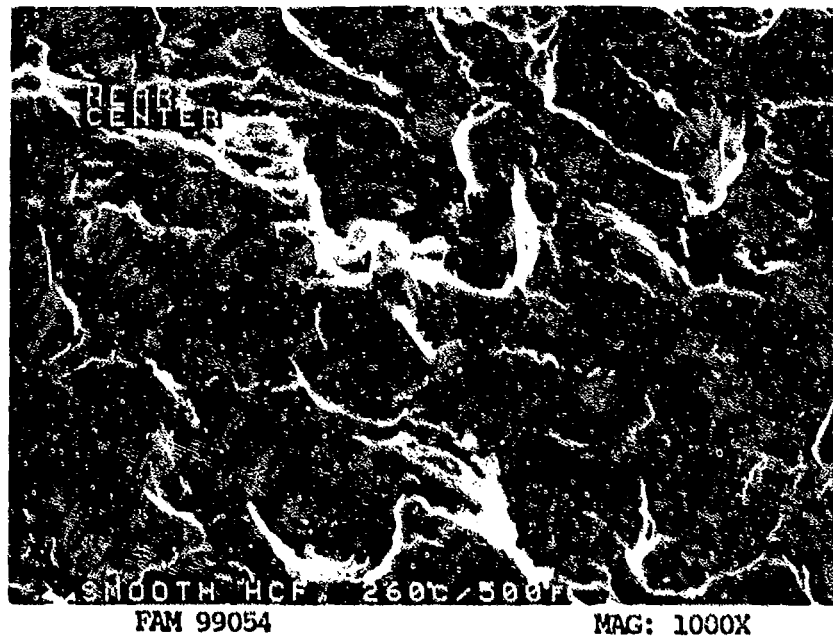
FIGURE 12-50: Crack-like striations near the center of the specimen (end of fatigue thumbnail). The direction of propagation is from bottom to top of the photograph.

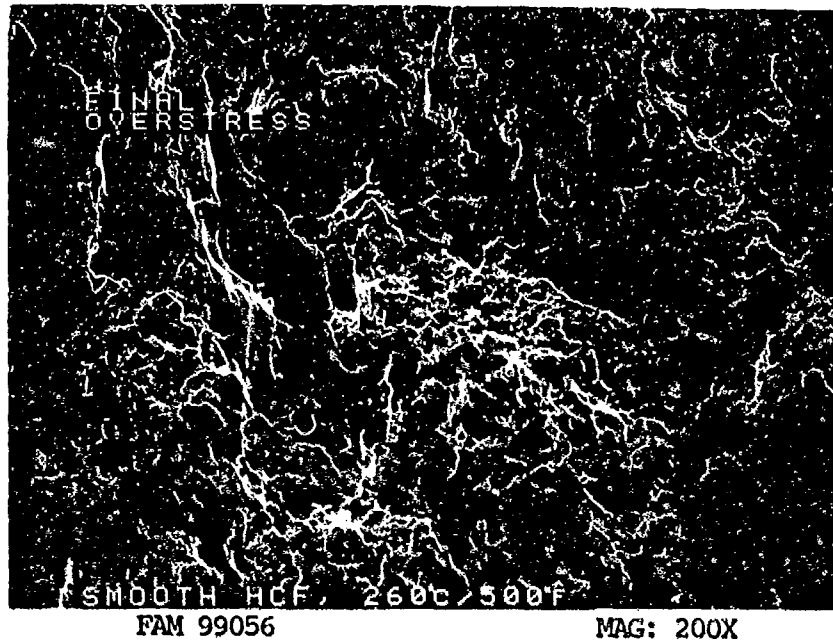
FIGURE 12-51: Mixture of overstress and smear features (arrows) in the final overstress area.
