FAILURE ANALYSIS HANDBOOK

C. R. Walker, K. K. Starr

Pratt & Whitney
P.O. Box 109600
West Palm Beach, FL 33410-9600

August 1989

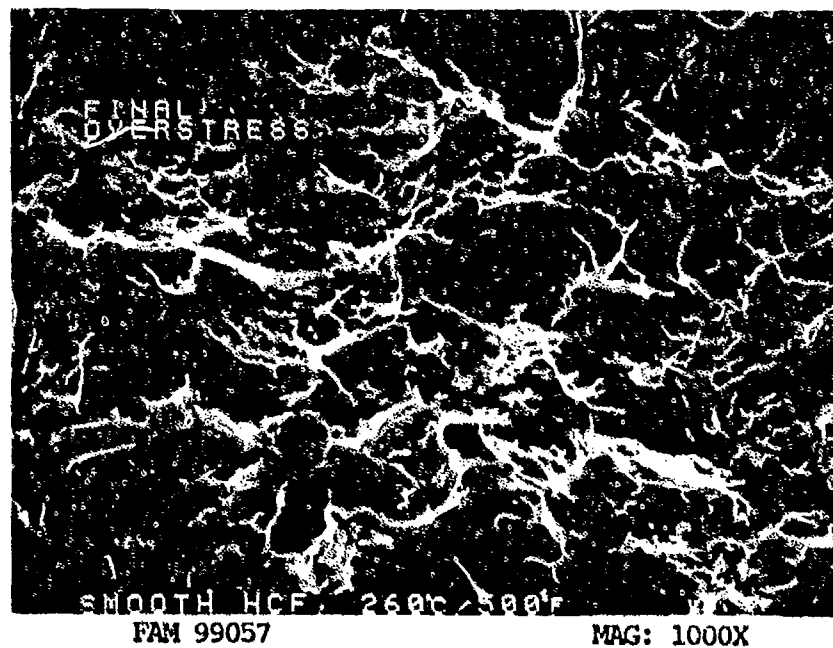
FIGURE 12-52: Higher magnification photograph of the area shown in Figure 12-51, showing fine dimples and smear features in the final overstress area.

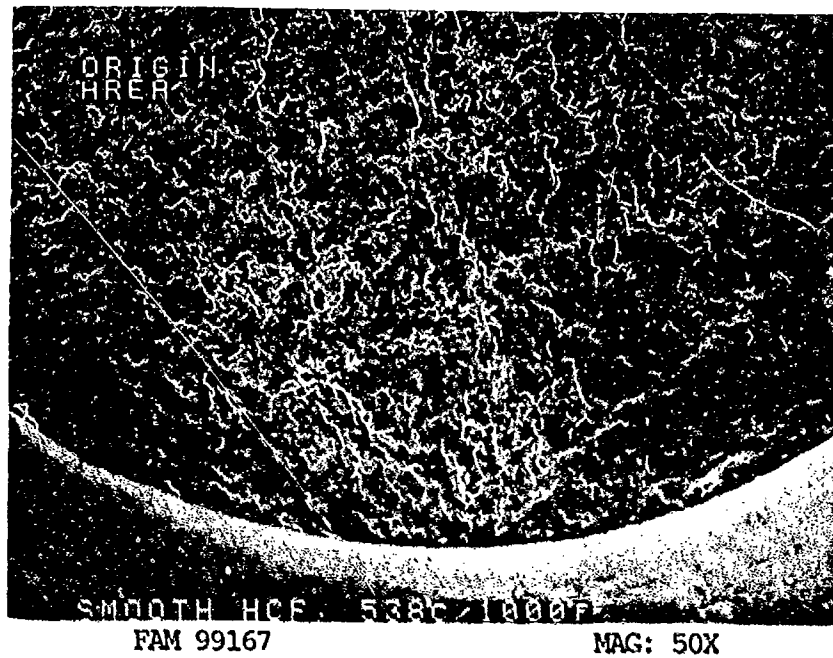
FIGURE 12-55: Low magnification view of the origin area and initial fatigue progression area.

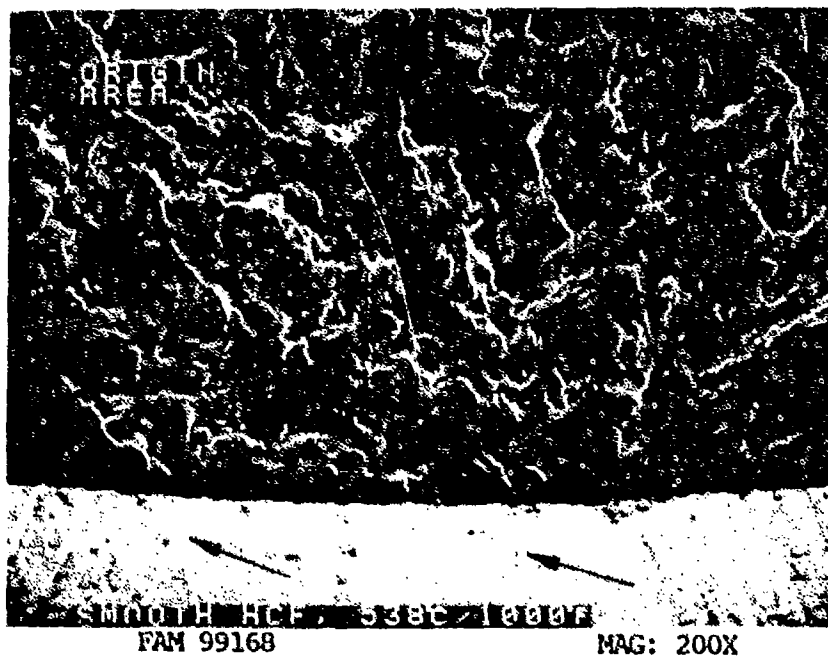
FIGURE 12-56: Higher magnification view of the origin area. The features are relatively flat with no localized origin discernible. Machining/polishing marks (arrows) are visible on the specimen surface, adjacent to the origin. These probably did not contribute to the fracture.

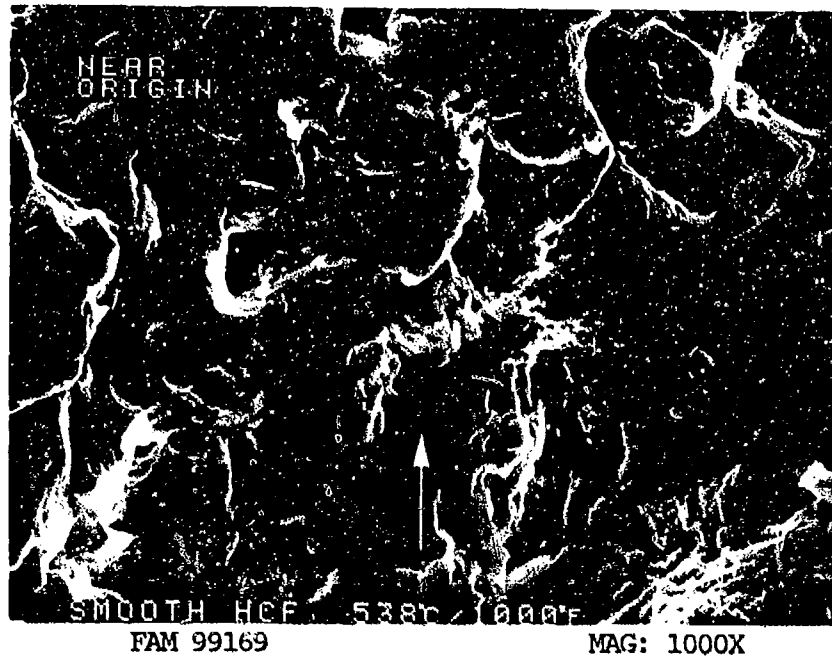
FIGURE 12-57: Combination of remnant fatigue features and smear near the origin. The fracture propagated from bottom to top of the photograph. Arrow indicates a patch of remnant striations.

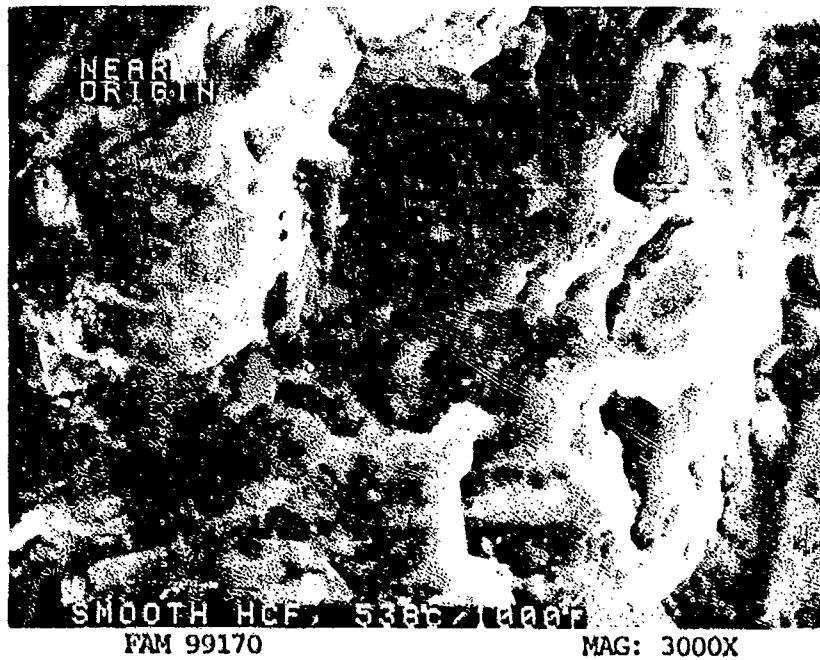
FIGURE 12-58: High magnification view of the remnant striations pointed out in Figure 12-57.

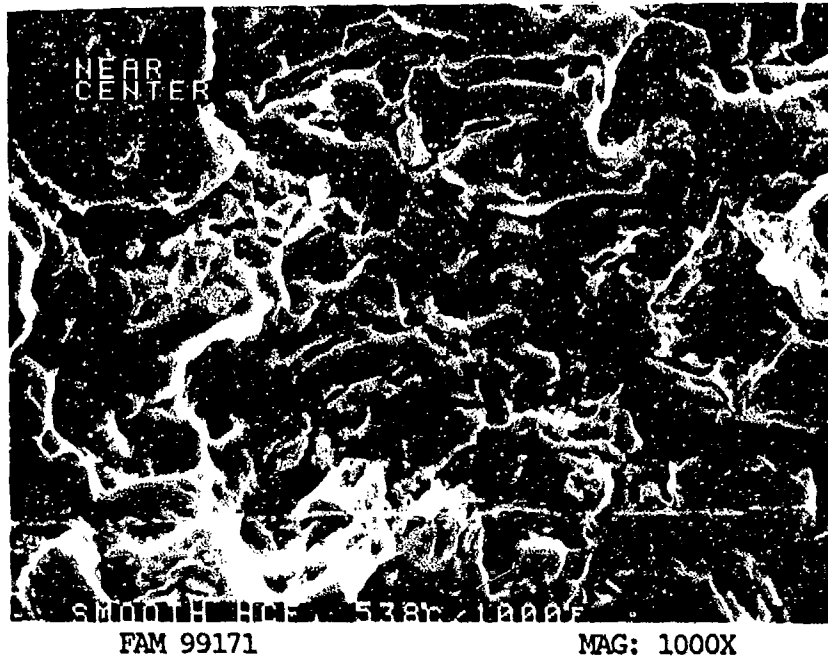
FIGURE 12-59: Oxidized crack-like fatigue striations near the center of the specimen (end of fatigue thumbnail). The direction of propagation is from the bottom to the top of the photograph. Compare these striations with those near the origin (Figure 12-58).

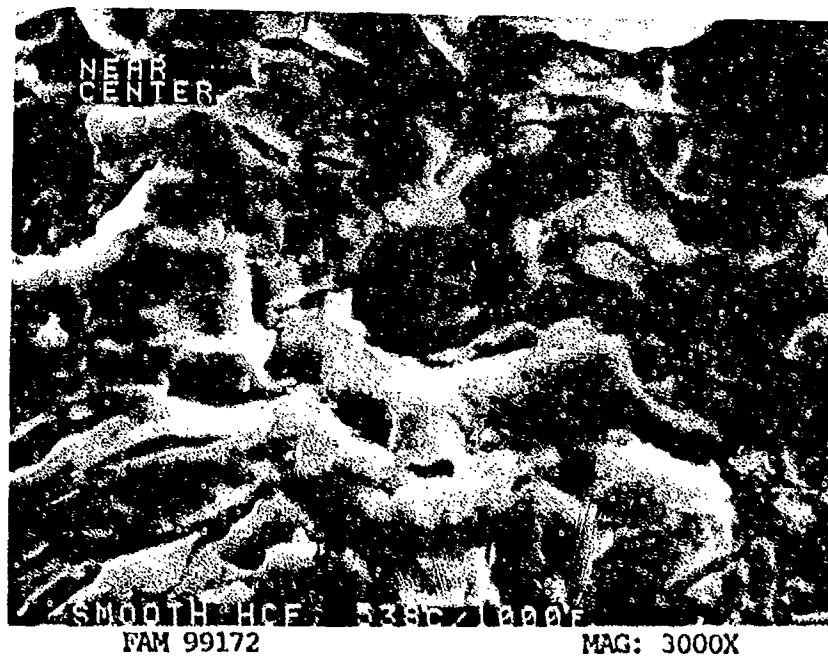
FIGURE 12-60: Higher magnification view of the oxidized crack-like striations shown in Figure 12-59.

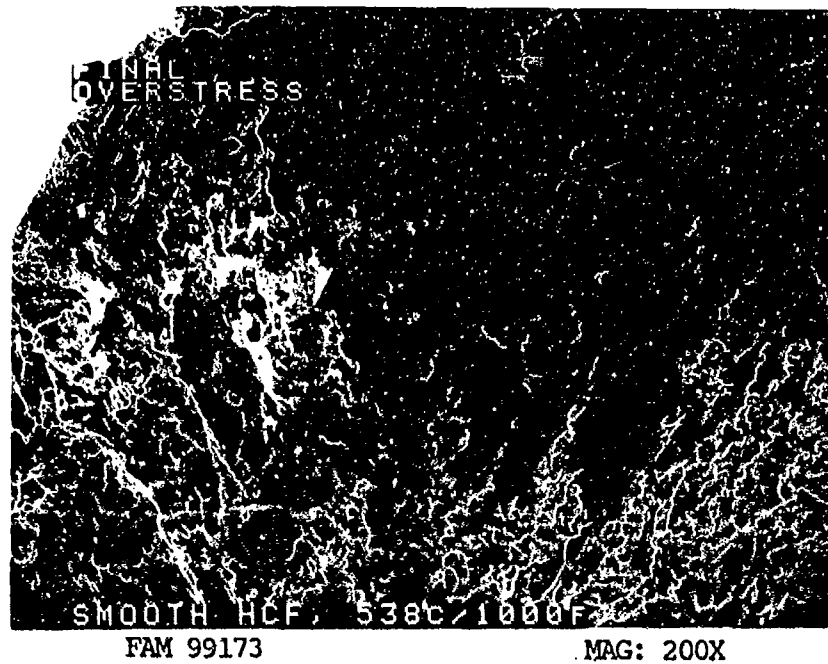
FIGURE 12-61: Mixture of overstress and smear features in the final overstress area.

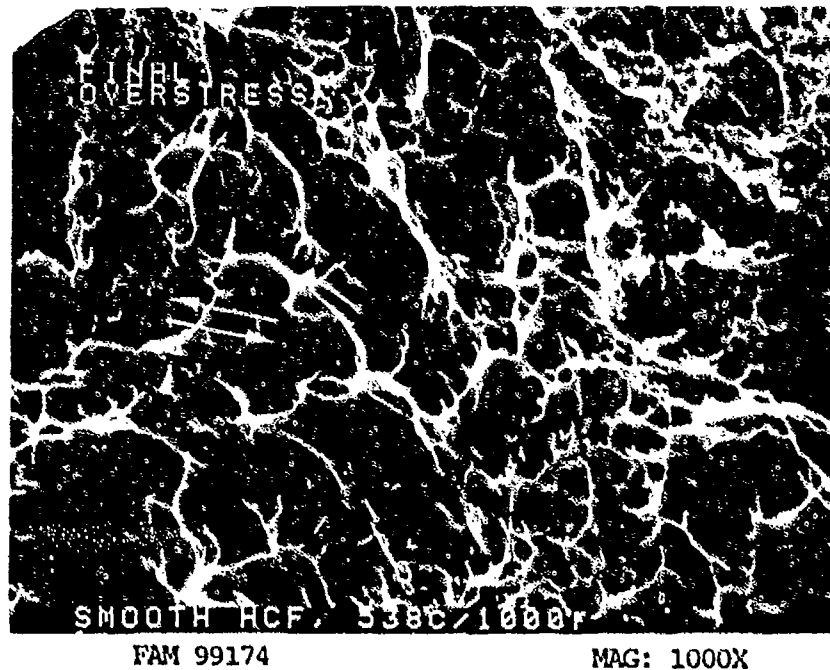
FIGURE 12-62: Higher magnification photograph of the area shown in Figure 12-61, showing shear dimples in the final overstress area. Arrows indicate the directions of relative motion.

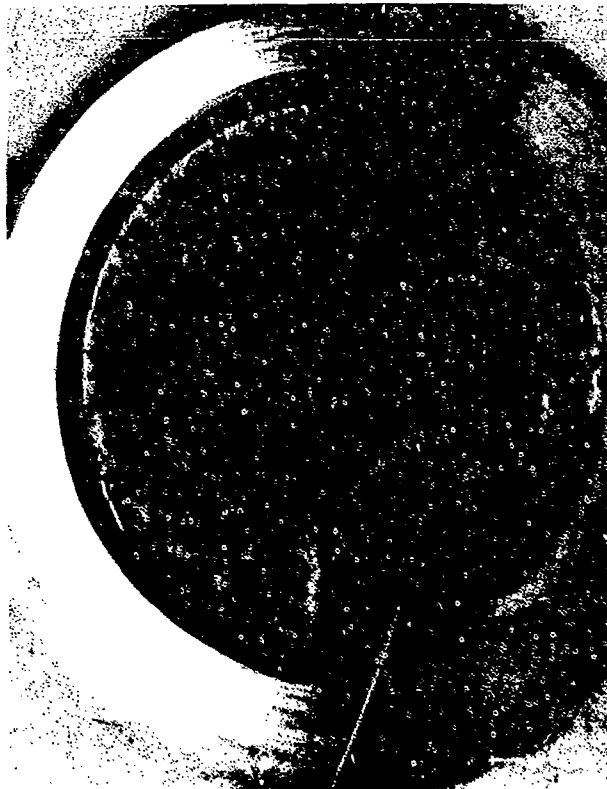
FIGURE 12-63: Test results and fractography of Ti-6-2-4-2 room temperature notched HCF test. The fatigue progression area extends over 85% of the fracture surface. The fatigue propagated from multiple surface origins (bottom of the photograph). The extent of the fatigue is shown by arrowheads.

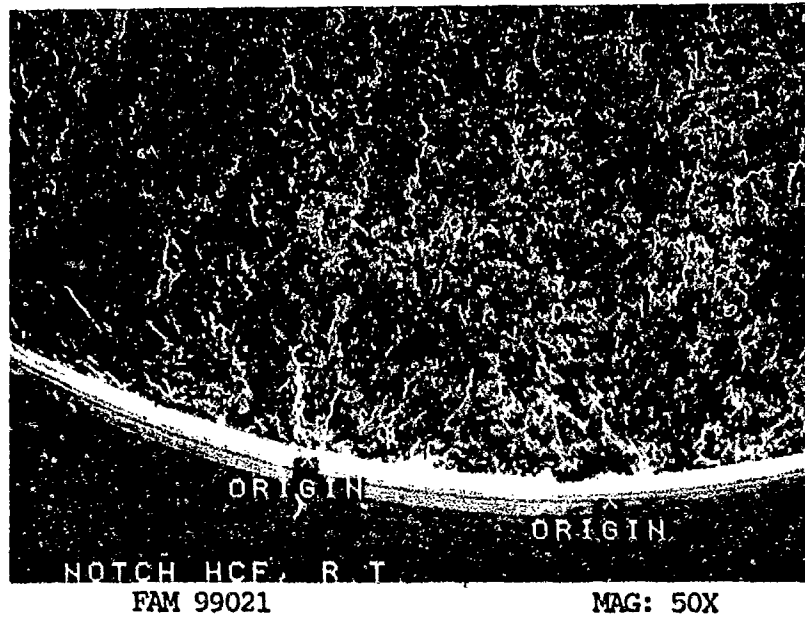
FIGURE 12-65: Low magnification view of the origin area. The specimen exhibited two surface origins. Features can be seen radiating from each origin.

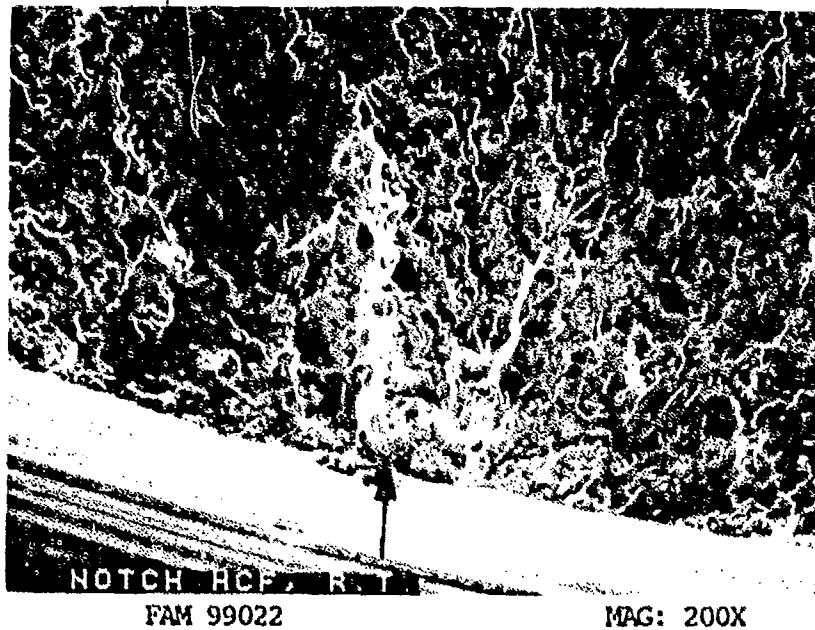
FIGURE 12-66: Higher magnification view of one of the origins (arrow). Machining marks are visible adjacent to the origin. Features can be seen radiating from the origin.

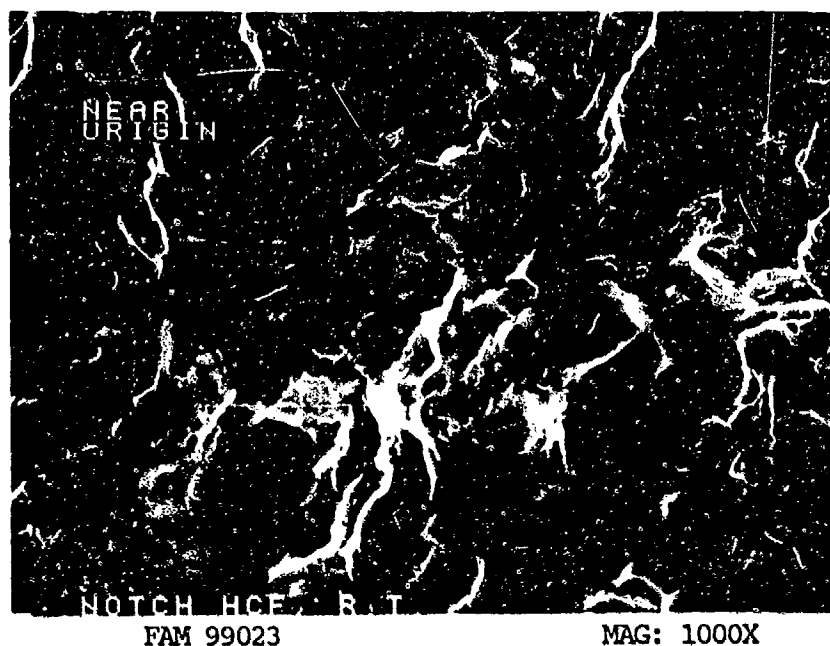
FIGURE 12-67: Remnant fatigue striations near the origin.

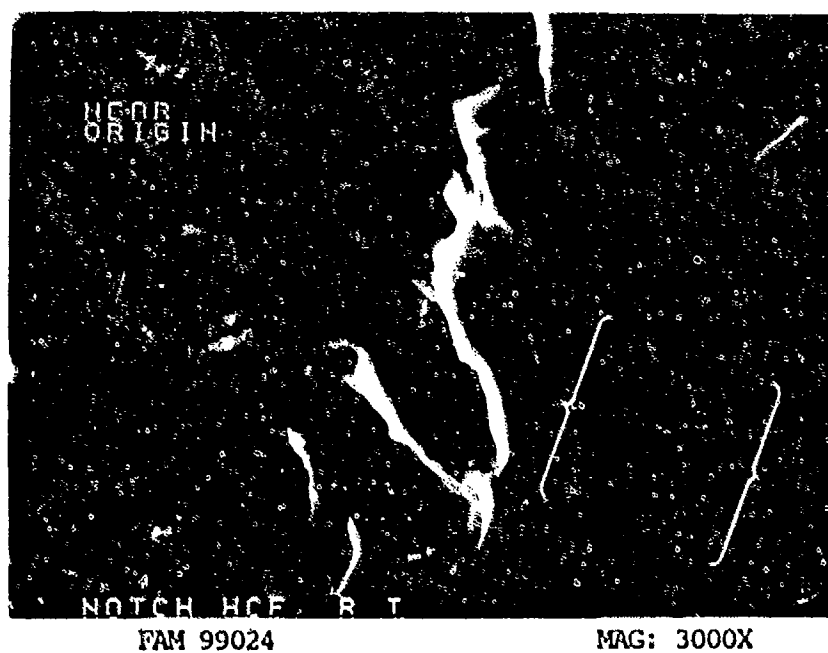
FIGURE 12-68: Higher magnification view of Figure 12-67, showing remnant fatigue striations (brackets, right) and smear features (left).

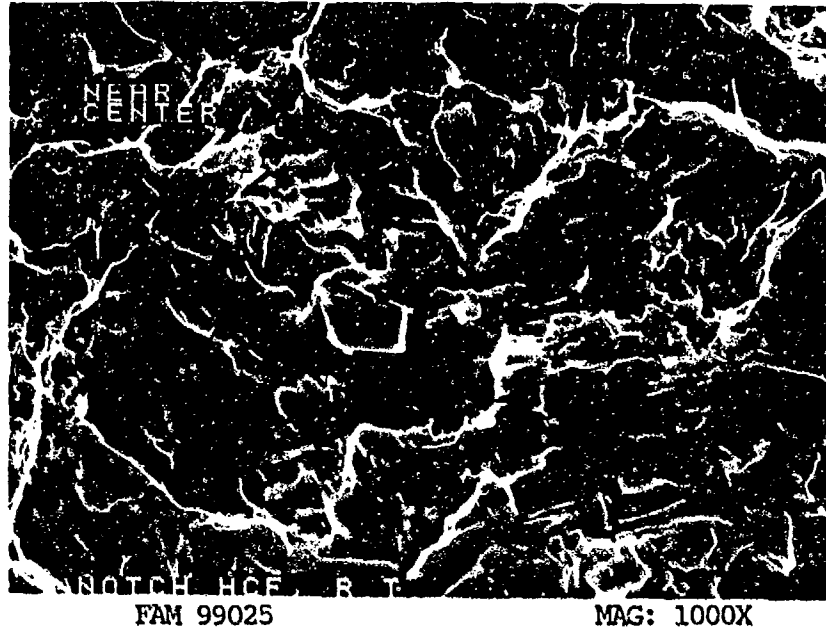
FIGURE 12-69: Mixture of fatigue striations and crack-like striations near the center of the specimen in the fatigue progression area. The fatigue is propagating from bottom to top of the photograph.

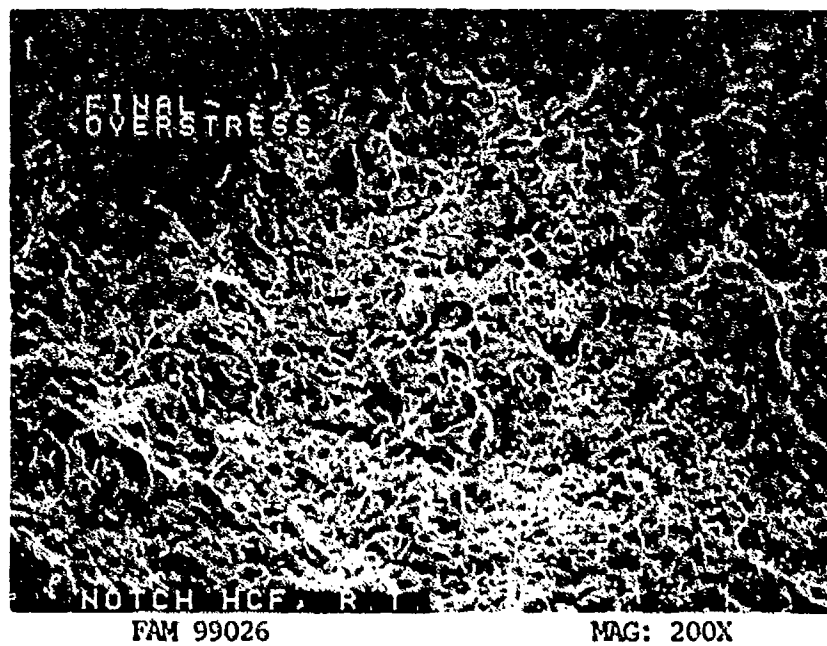
FIGURE 12-70: Final overstress area exhibiting dimpled overstress.

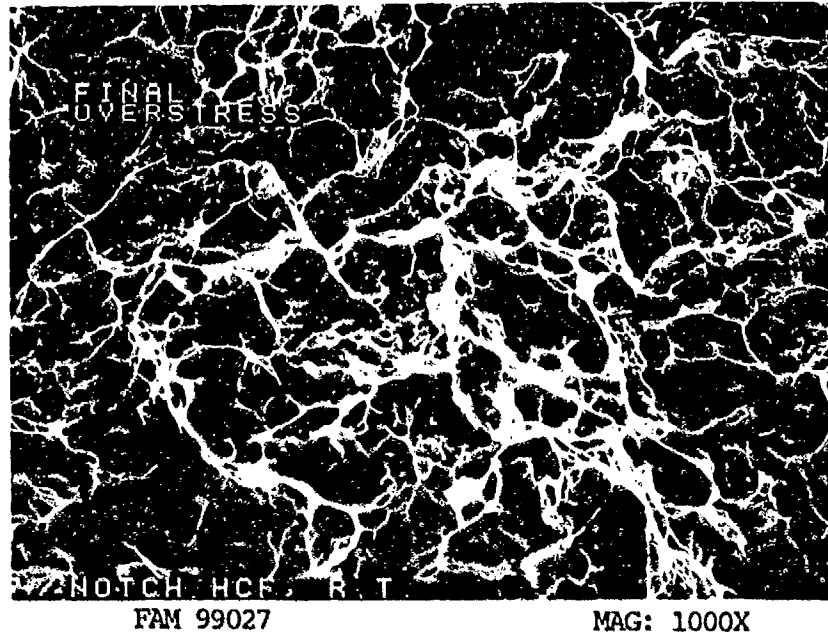
FIGURE 12-71: Higher magnification photograph of the final overstress area shown in Figure 12-70 exhibiting dimpled overstress.

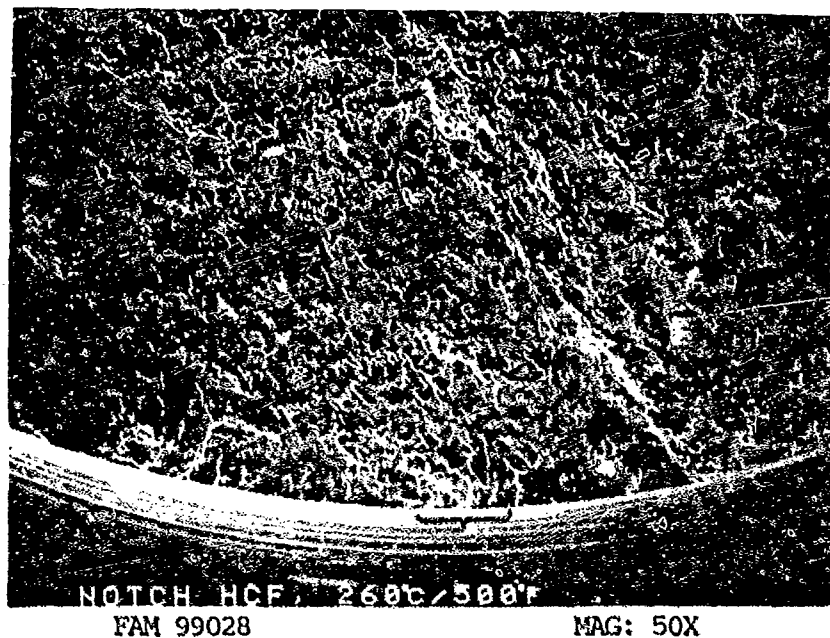
FIGURE 12-74: Low magnification view of the origin area and initial fatigue progression area. The diffuse origin area is shown by a bracket.

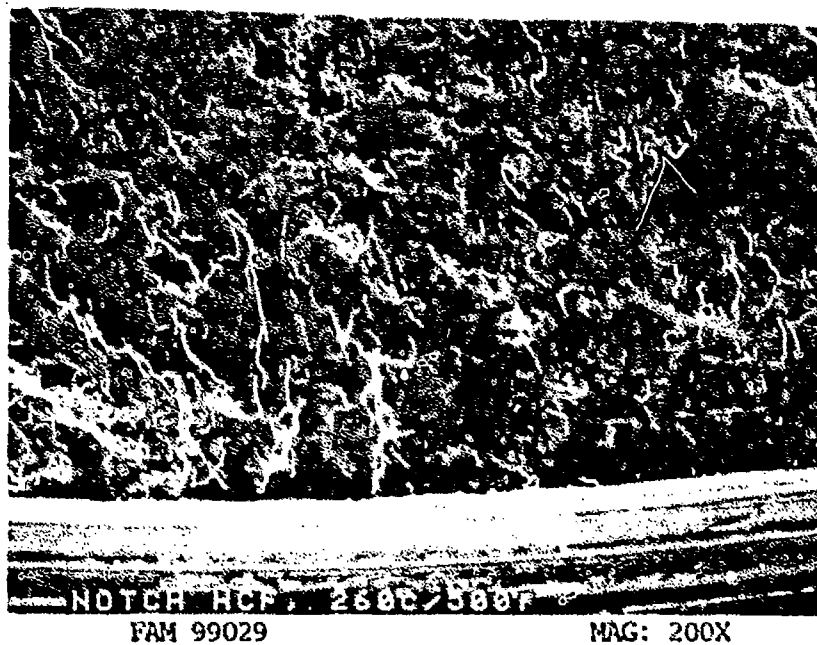
FIGURE 12-75: Higher magnification view of the origin area shown in Figure 12-74. The features are relatively flat with no localized origin discernible. Machining marks are visible adjacent to the origin area (bottom).

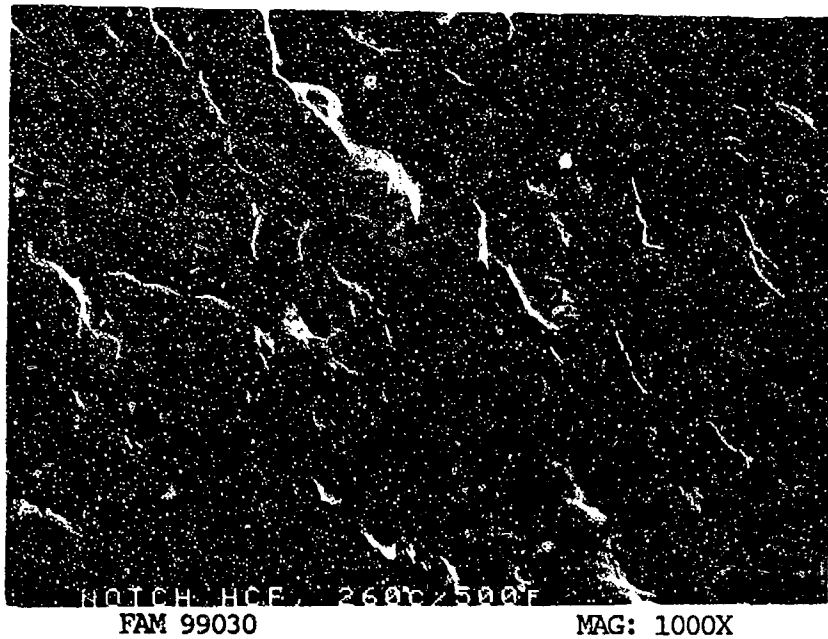
FIGURE 12-76: Remnant fatigue features near the origin area. The fracture propagated from bottom to top of the photograph.

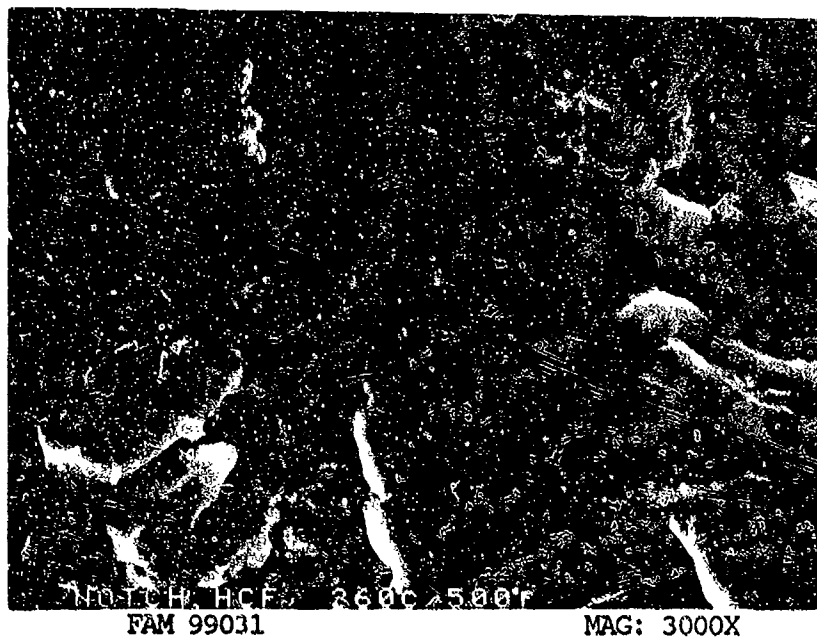
FIGURE 12-77: Higher magnification photograph of the area shown in Figure 12-76, showing remnant fatigue striations near the origin area. The direction of propagation is from bottom to top of the photograph.

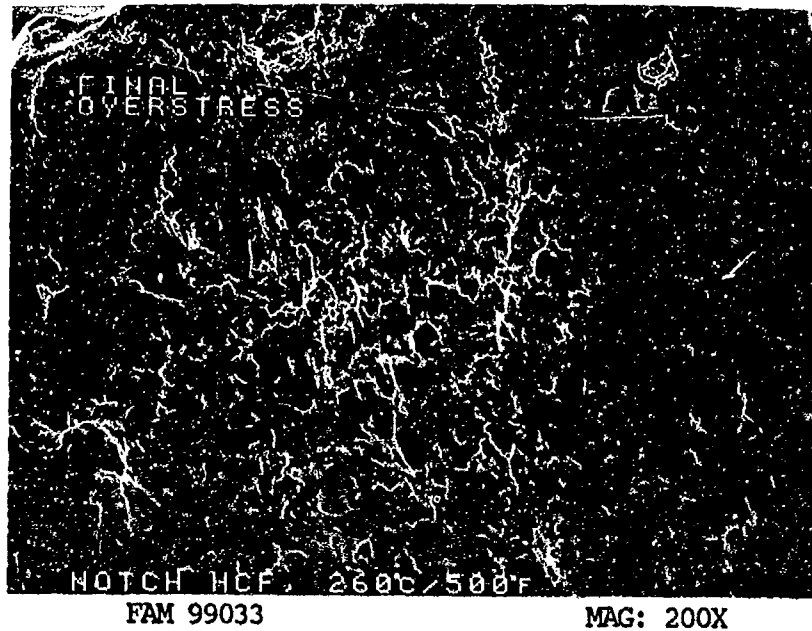
FIGURE 12-78: Mixture of overstress and smear features in the final overstress area.

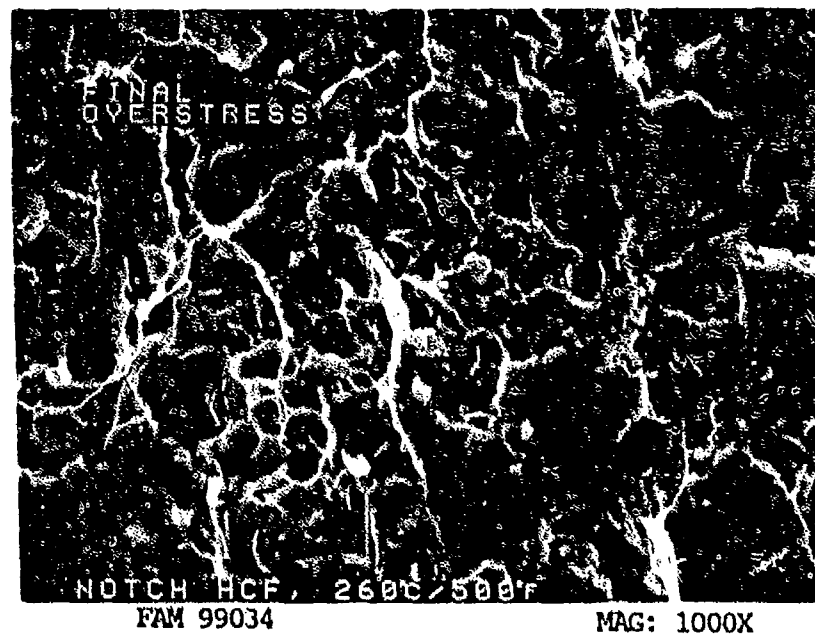
FIGURE 12-79: Higher magnification photograph showing equiaxed dimples and smear features in the final overstress area (Figure 12-78).

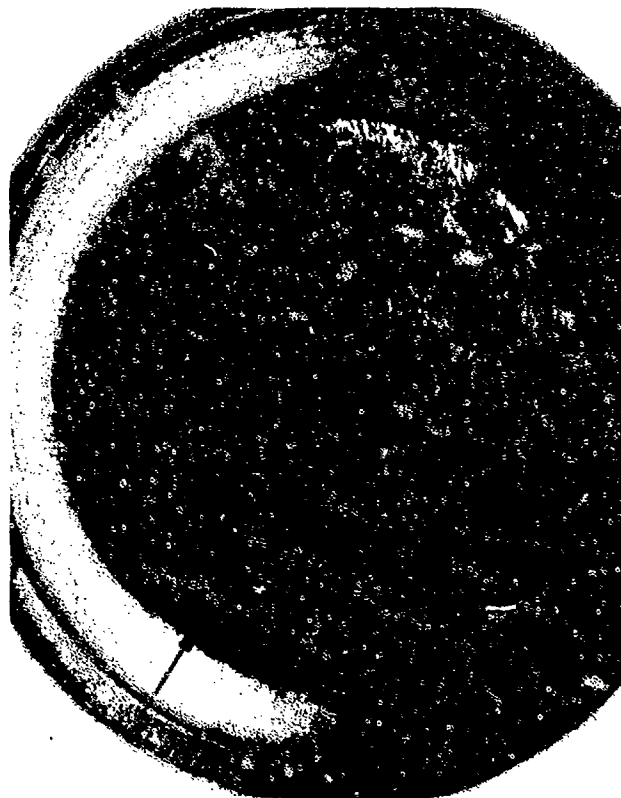
FAL 93819

FIGURE 12-80: Test results and fractography of Ti-6-2-4-2 538°C (1000°F) notched HCF test. The extent of the fatigue is shown by a bracket. A fatigue step (arrow) separates two origins.

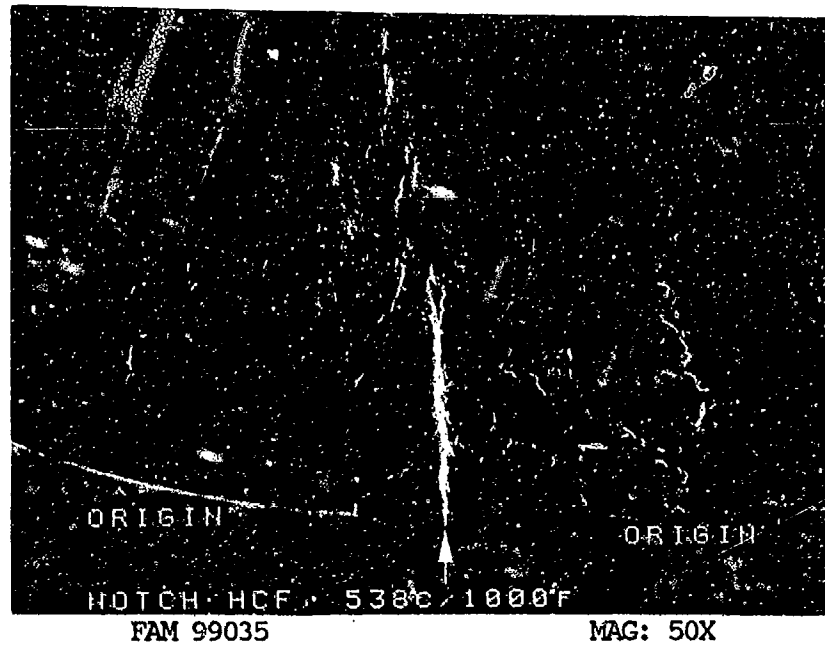
FIGURE 12-82: Low magnification view of the origin area and initial fatigue progression area. Two origins are clearly visible separated by a fatigue step (arrow).

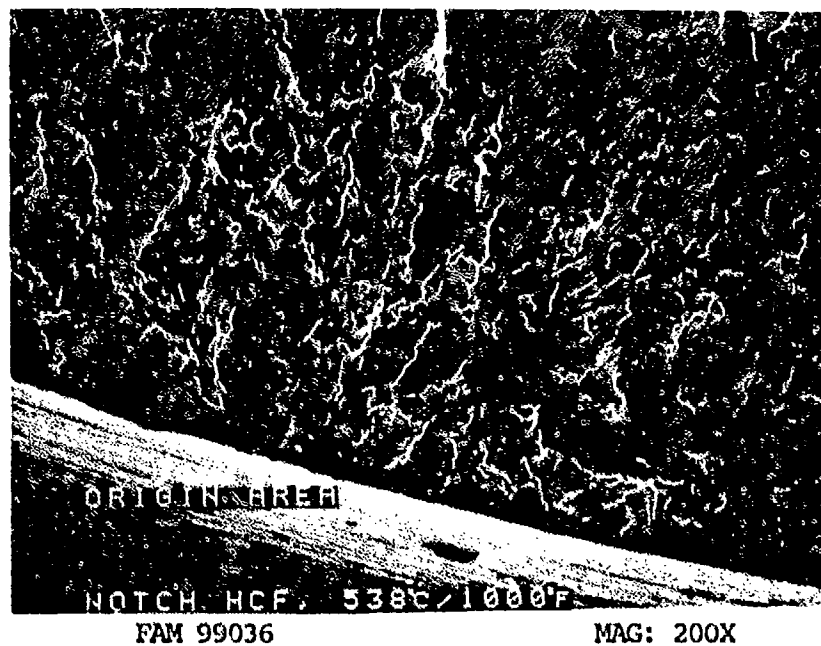
FIGURE 12-83: Higher magnification view of one origin area. Fatigue features can be seen radiating from the origin. Machining marks are visible on the specimen surface adjacent to the origin. These probably did not contribute to the fracture.

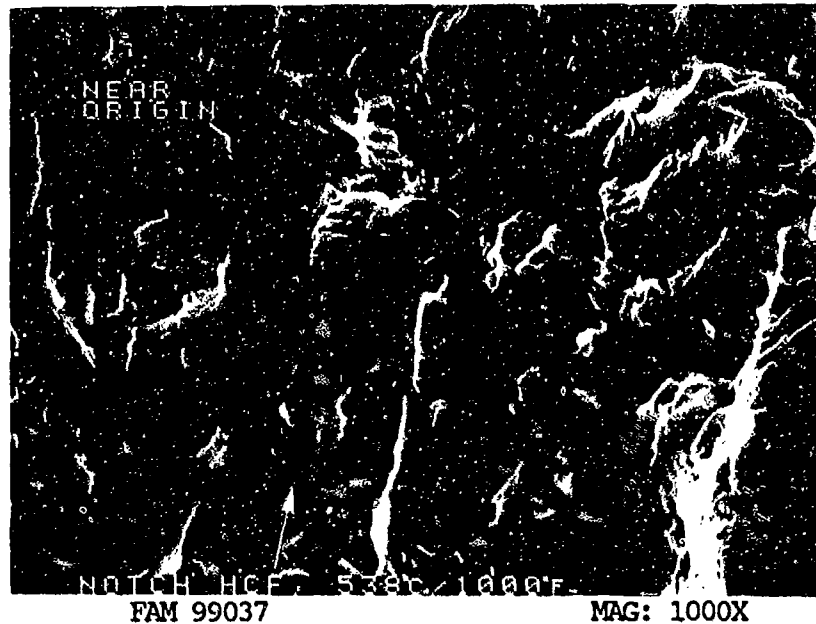
FIGURE 12-84: Fine fatigue striations near the origin. The fracture propagated from bottom to top of the photograph. Arrow indicates a patch of remnant striations.

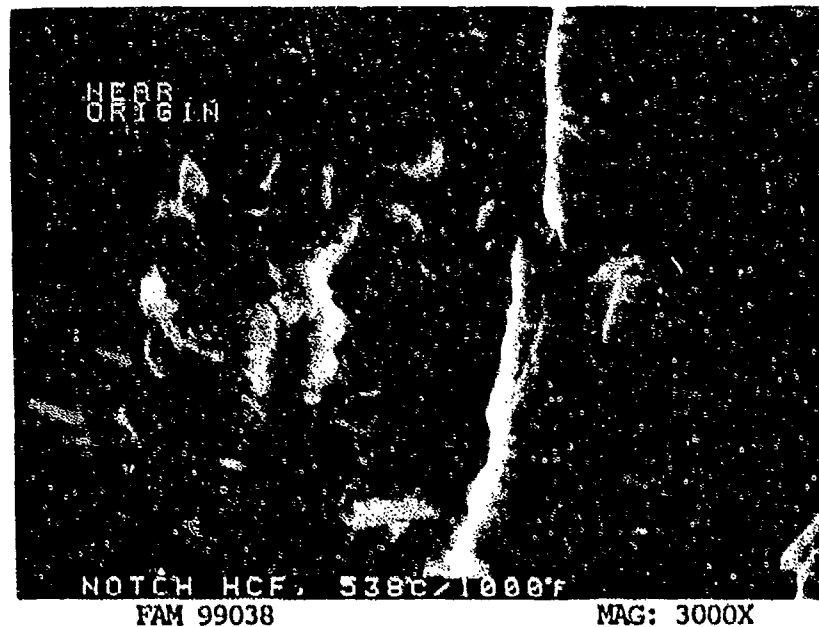
FIGURE 12-85: High magnification view of the fine striations shown in Figure 12-84. Individual striations are barely resolvable. Bracket contains five striations.

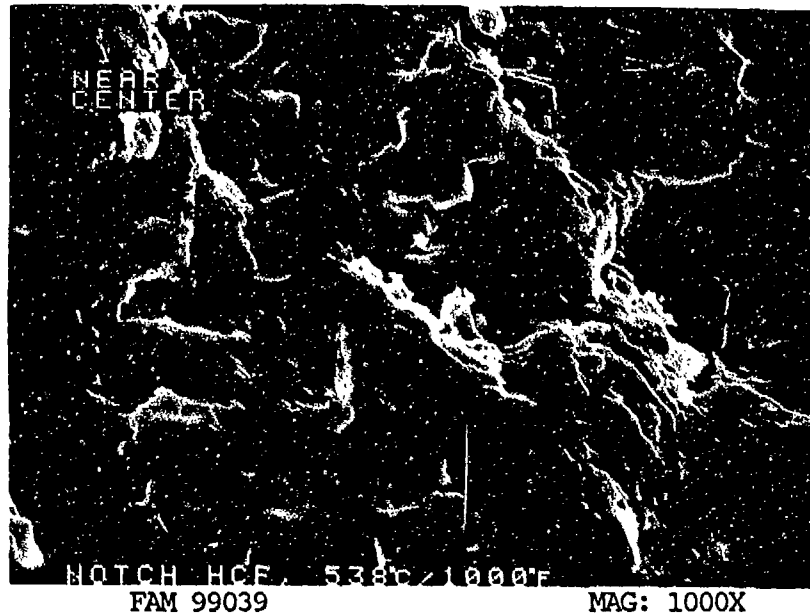
FIGURE 12-86: Oxidized striations near the center of the specimen (end of thumbnail). The striations are slightly coarser than near the origin. The direction of propagation is from the bottom to top of the photograph.

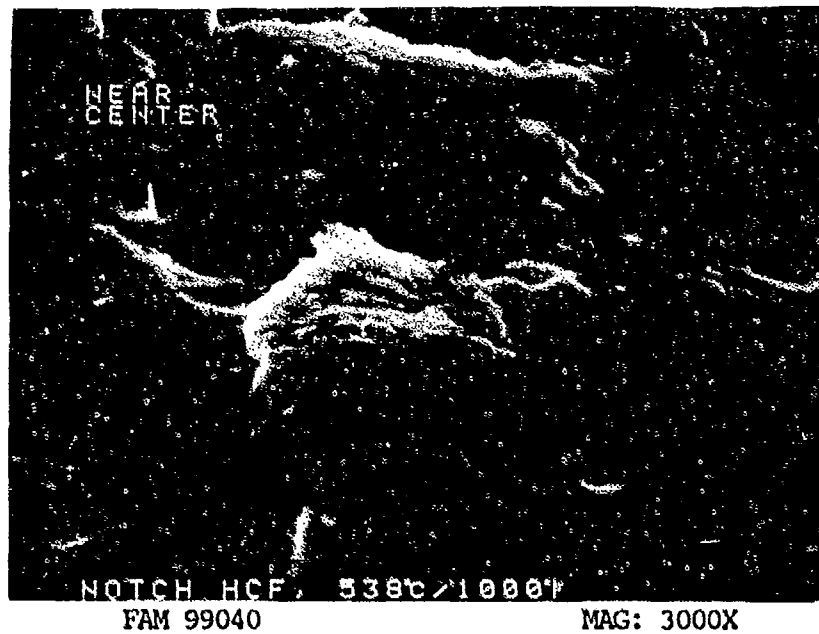
FIGURE 12-87: Higher magnification view of the oxidized striations shown in Figure 12-84.

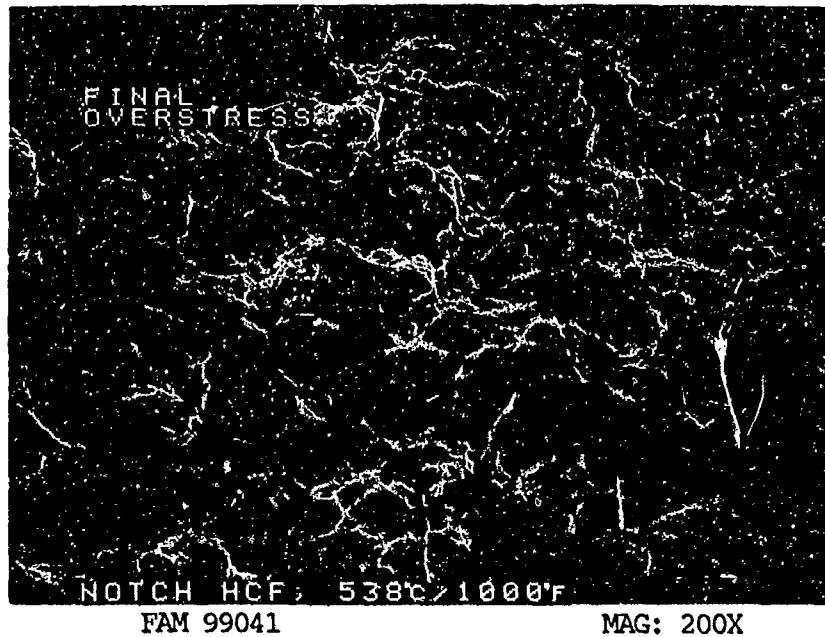
FIGURE 12-88: Dimpled overstress features in the final overstress area.

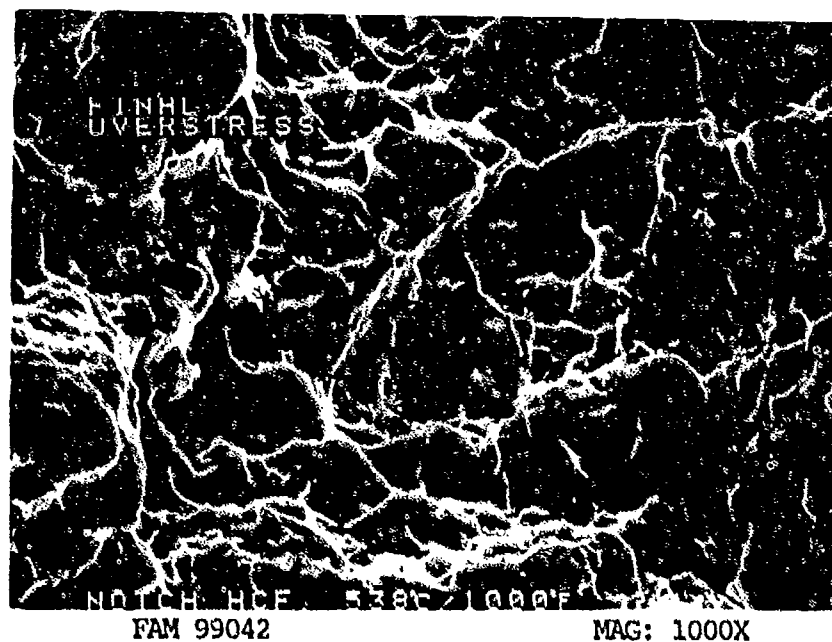
FIGURE 12-89: Higher magnification photograph of a portion of Figure 12-86, showing dimples and other ductile features in the final overstress area.

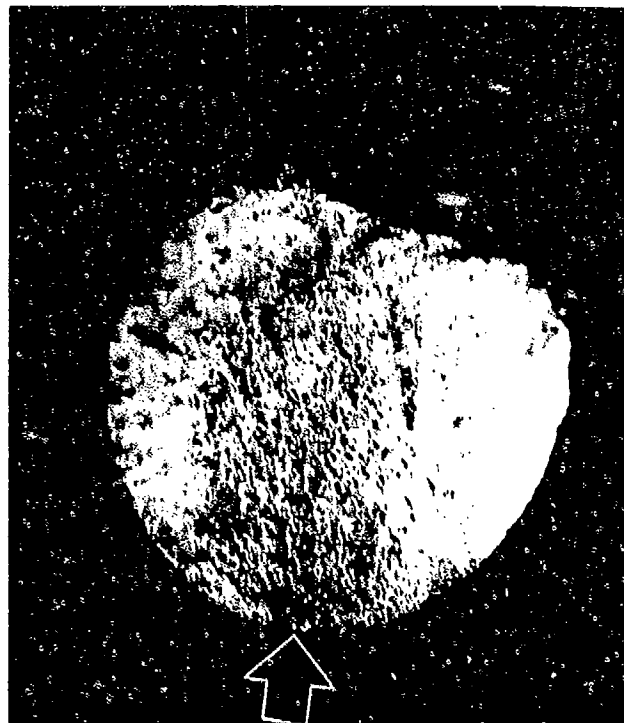
FAL 93235

FIGURE 12-90: Test results and fractography of Ti-6-2-4-2 260°C (500°F) smooth LCF test. The origin area is indicated by an arrow. The fatigue progression area covers less than 30% of the fracture surface.

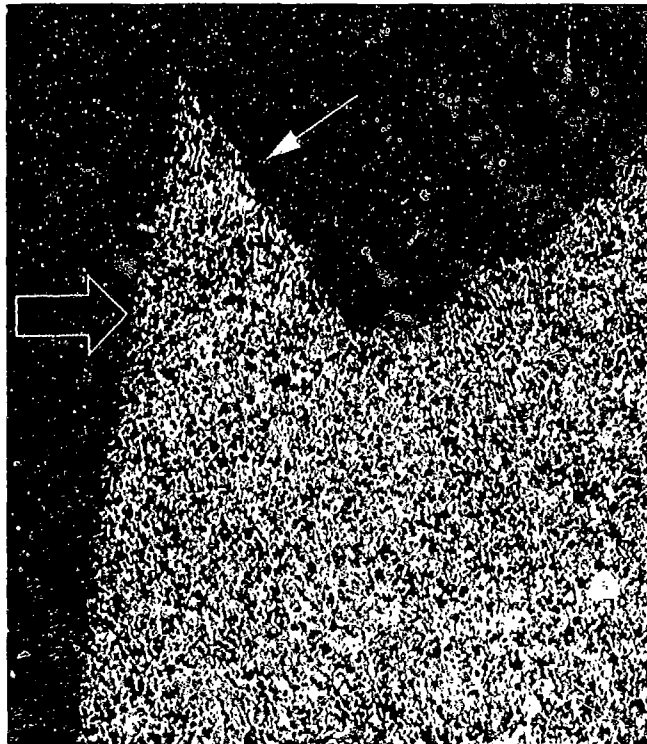
FIGURE 12-91: Optical photomicrographs showing necking (hollow arrow) and a well defined shear lip (arrow) in the final overstress area (top) and the fatigue progression area (bottom). No grain deformation is visible in the fatigue progression area.

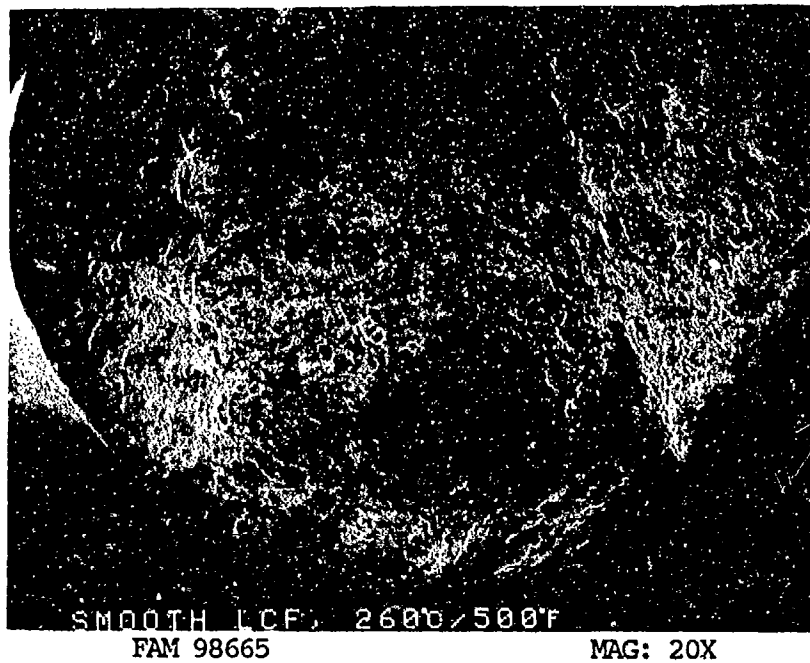
FIGURE 12-92: Overall photograph showing fatigue area on a plane perpendicular to the stress axis.

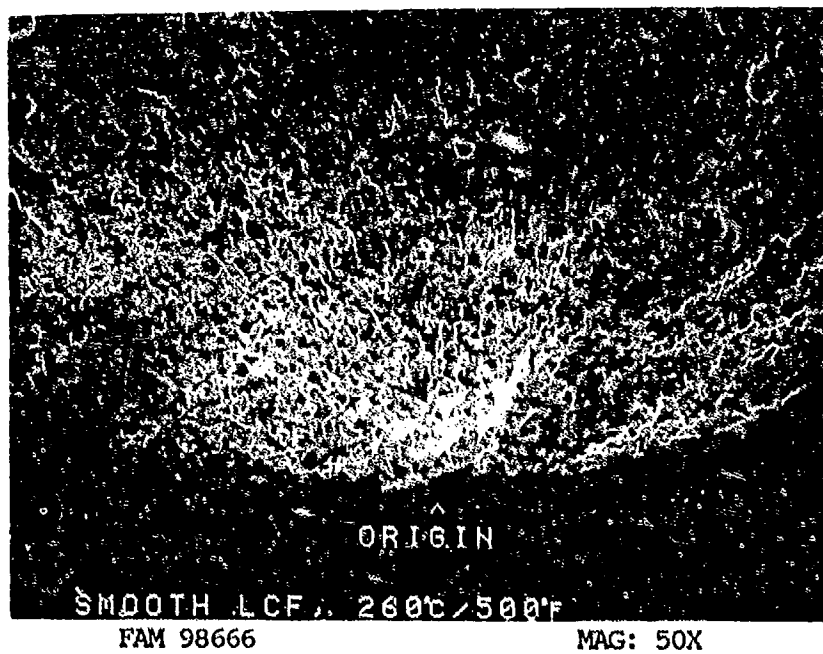
FIGURE 12-93: Fracture features can be seen radiating from the fatigue origin.

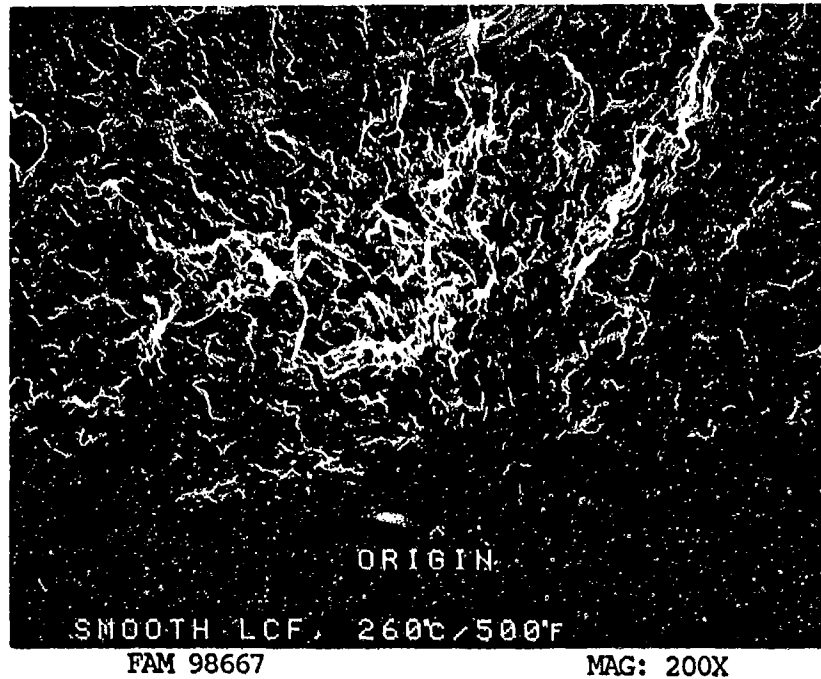
FIGURE 12-94: Higher magnification photograph of the origin area shown in Figure 12-92. Features can be seen radiating from the origin.

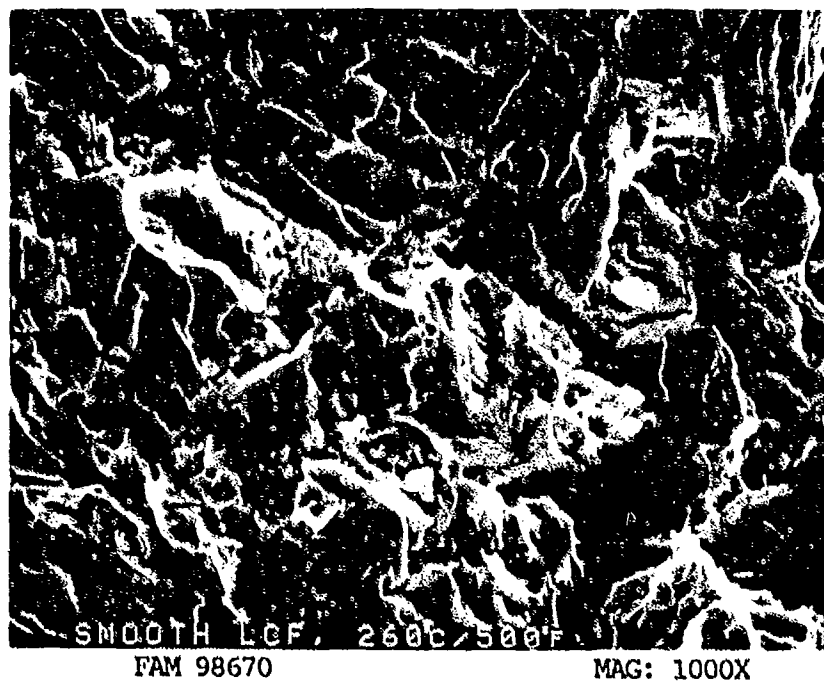
FIGURE 12-95: Remnant fatigue striations in the fatigue thumbnail region. An arrow indicates one patch. The direction of local propagation varies from one patch to another.

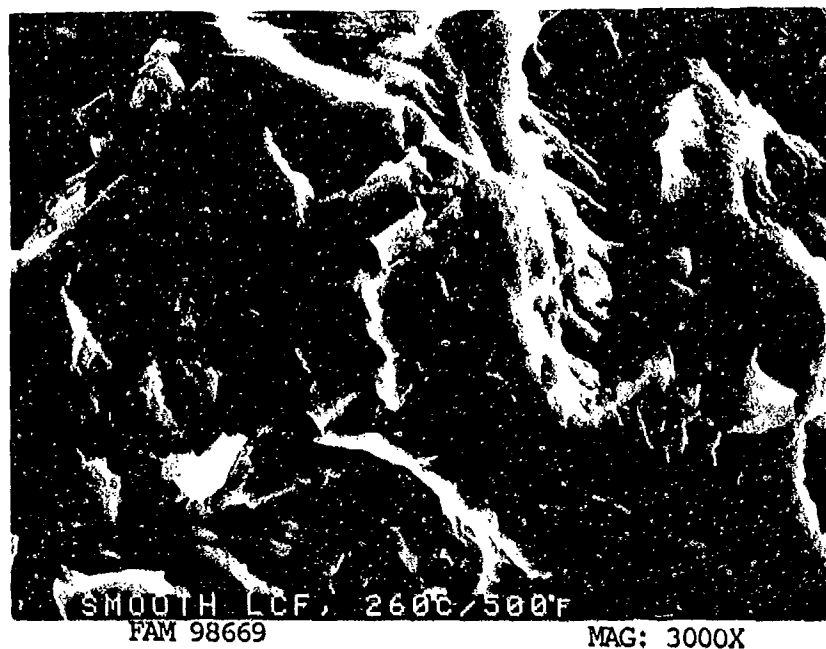
FIGURE 12-96: Higher magnification photograph of the area shown in Figure 12-94, showing remnant fatigue features.

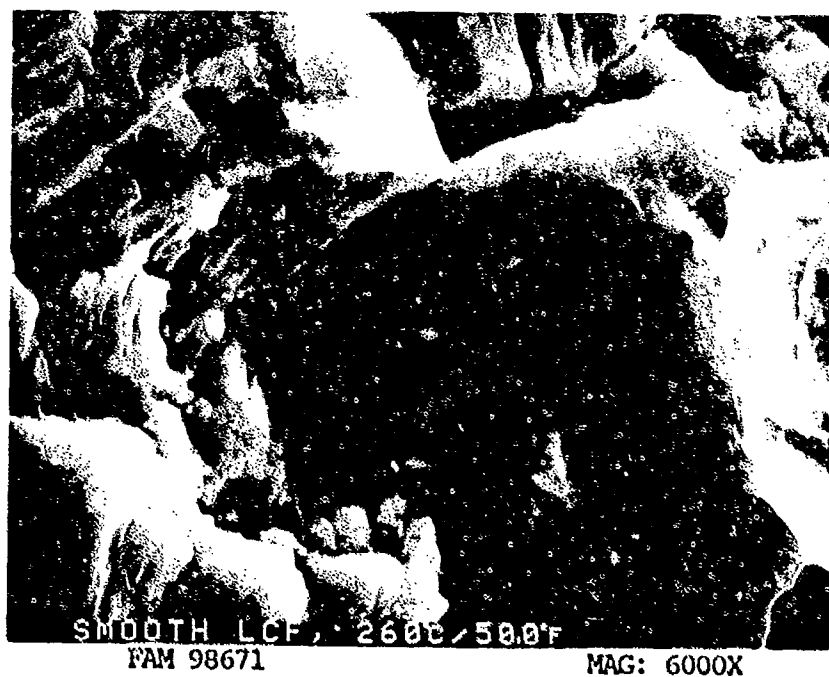
FIGURE 12-97: High magnification photograph showing remnant fatigue striations. The direction of propagation is shown by an arrow.
