FAILURE ANALYSIS HANDBOOK

C. R. Walker, K. K. Starr

Pratt & Whitney
P.O. Box 109600
West Palm Beach, FL 33410-9600

August 1989

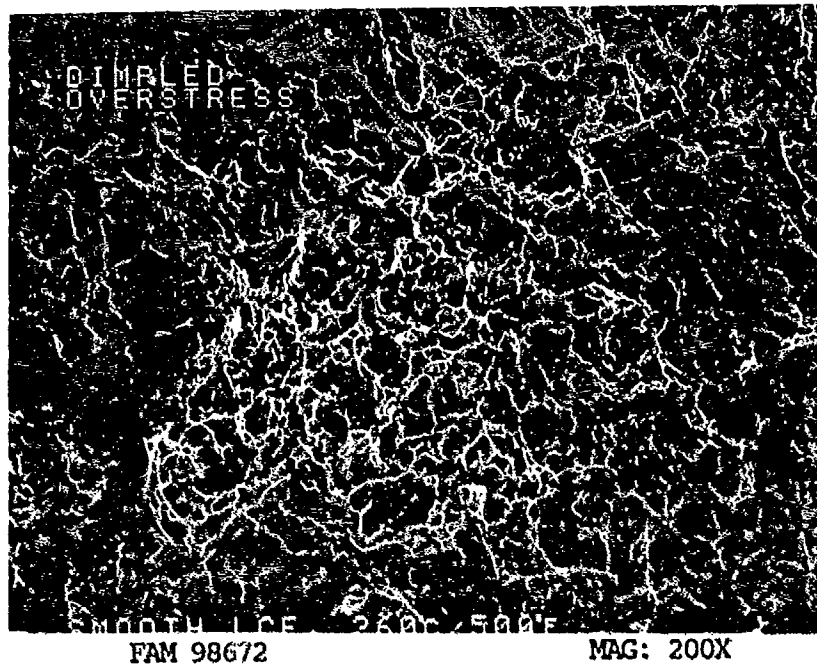
FIGURE 12-98: Equiaxed dimpled overstress in the final overstress area.

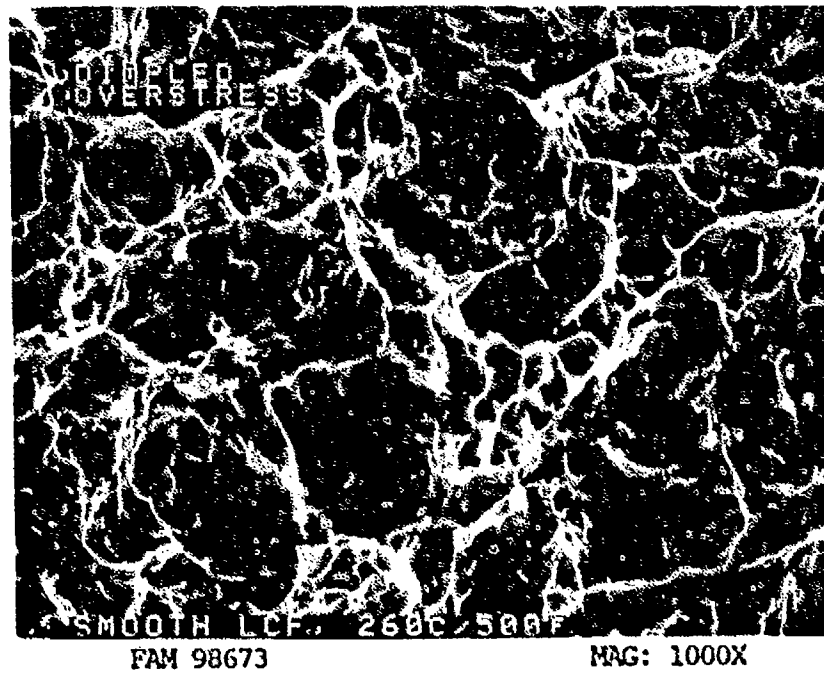
FIGURE 12-99: Higher magnification photograph showing equiaxed dimpled overstress in the final overstress area.

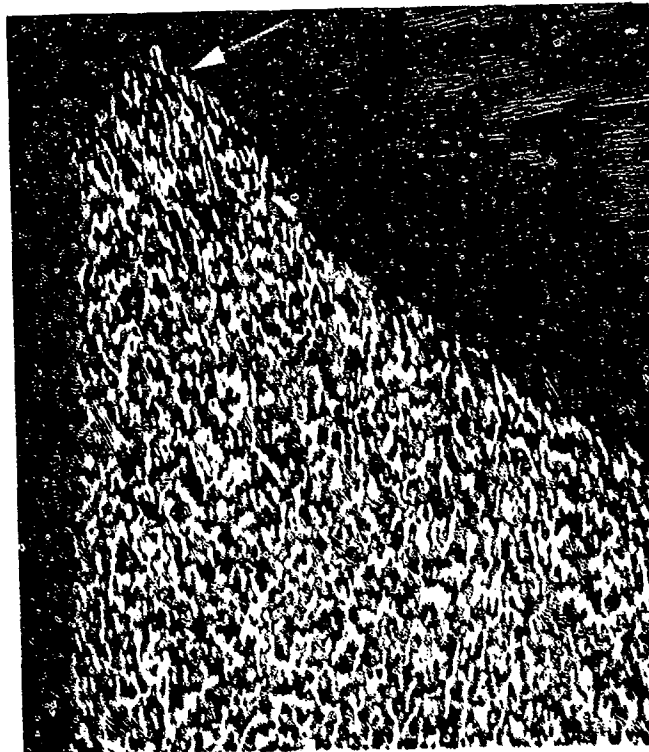
FIGURE 12-101: Optical photomicrographs showing the fatigue progression area (top) and the shear lip in the final overstress area (bottom). Grain deformation is visible in the final overstress area (arrow).

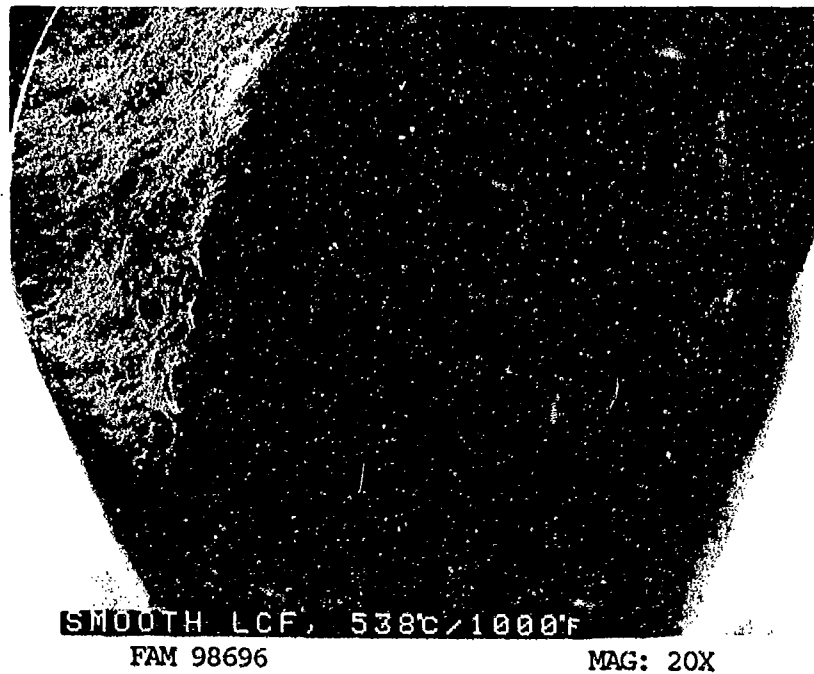
FIGURE 12-102: Overall photograph showing the origin area and fatigue thumbnail (brackets). The fatigue progression area is on a plane perpendicular to the stress axis.

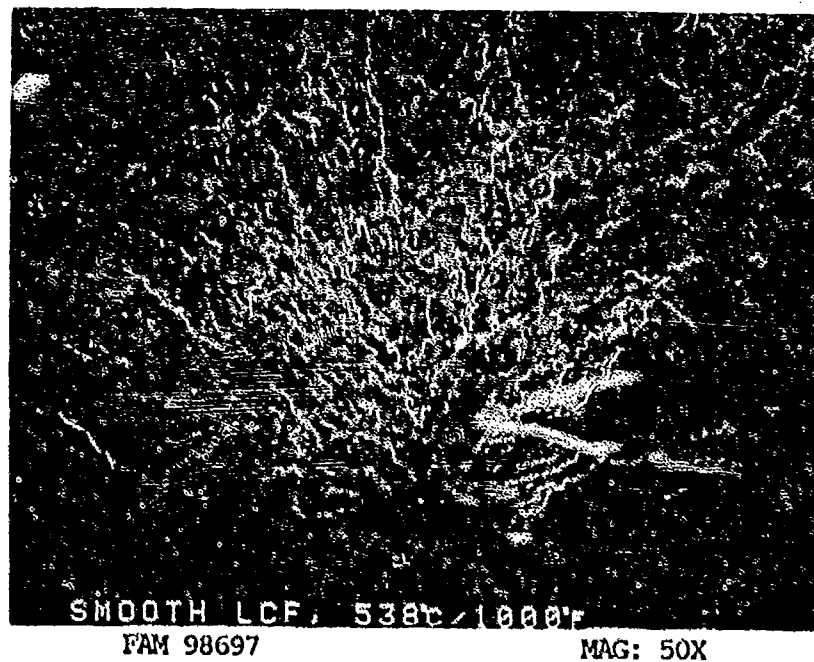
FIGURE 12-103: Fracture features can be seen radiating from the origin (arrow).

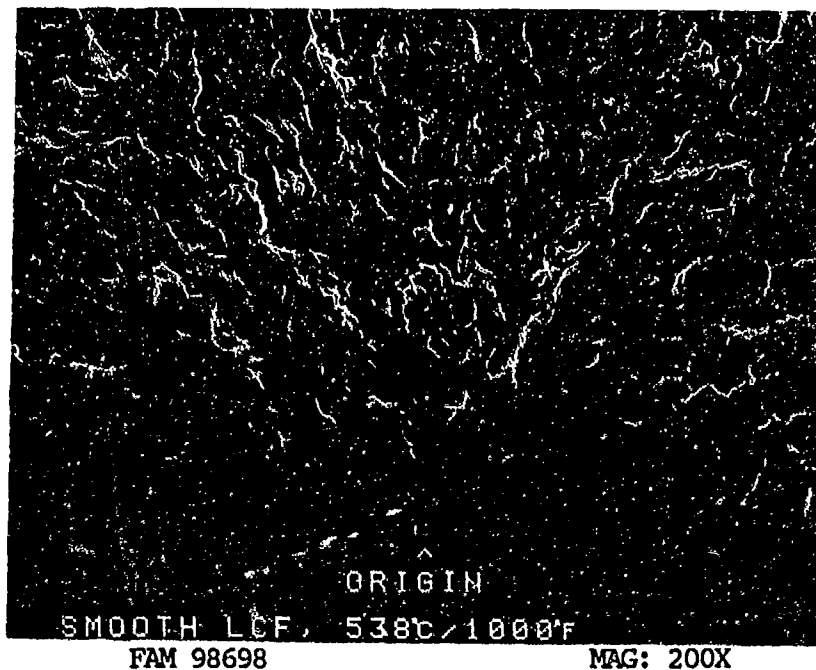
FIGURE 12-104: Close-up photograph of the origin (arrow). Features radiate from the localized origin.

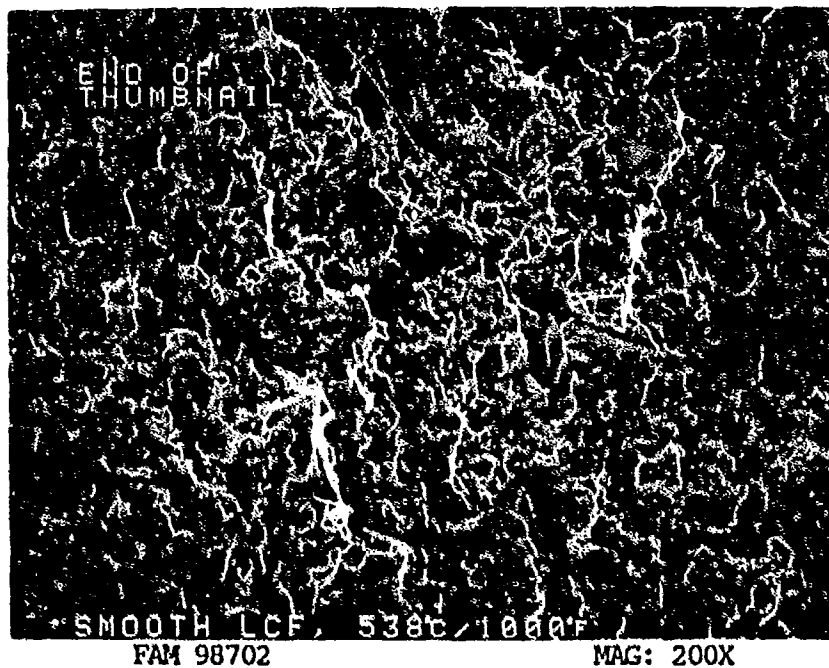
FIGURE 12-105: End of the fatigue thumbnail exhibits striations and crack-like striations.

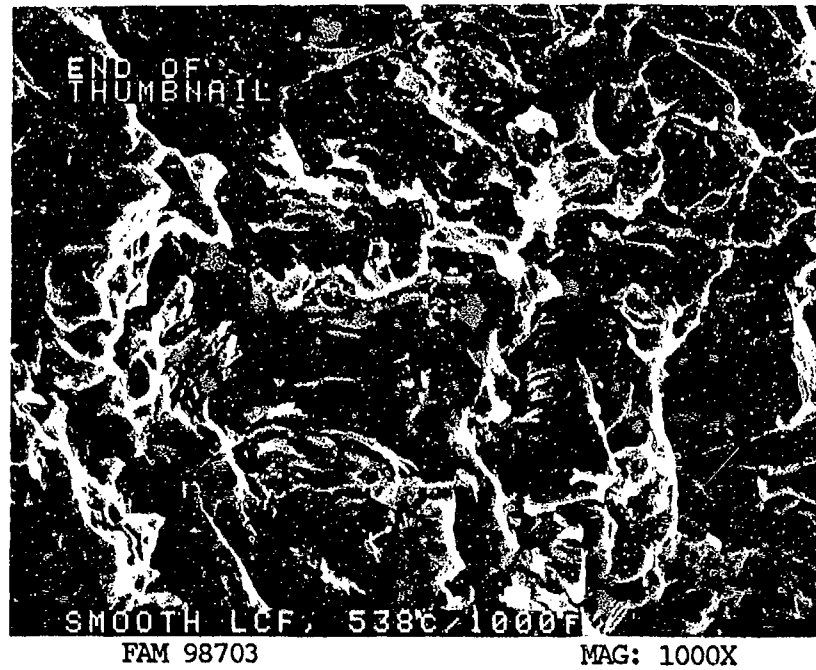
FIGURE 12-106: Crack-like striations near the end of the fatigue thumbnail. The direction of propagation is from bottom to top of the photograph.

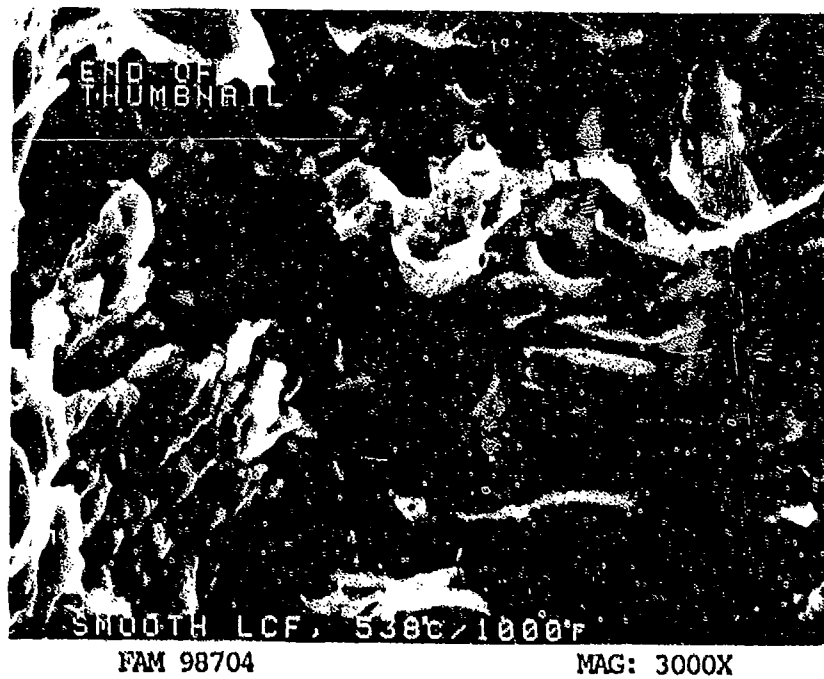
FIGURE 12-107: Higher magnification photograph of the area shown in Figure 12-106, showing crack-like striations with some secondary cracking.

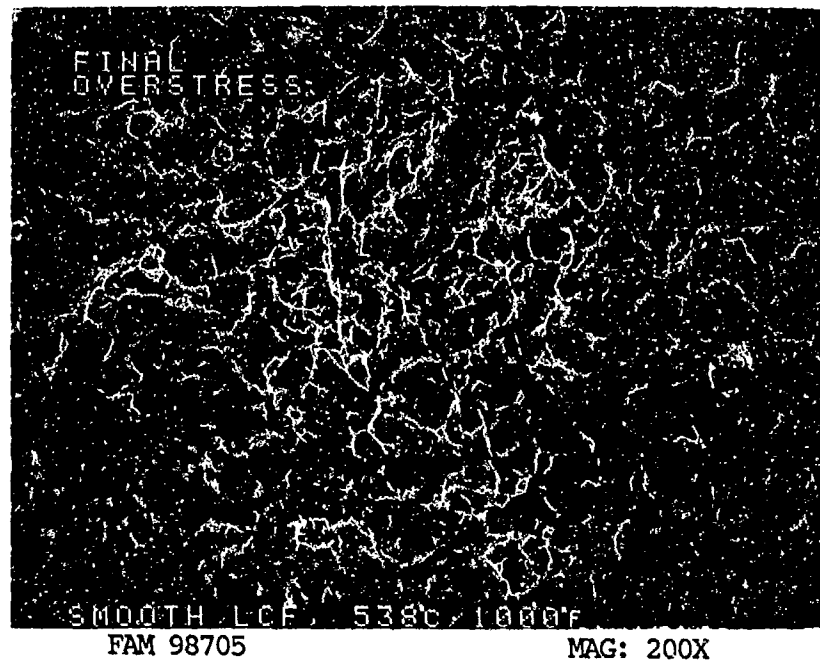
FIGURE 12-108: Equiaxed dimpled overstress in the final fracture area.

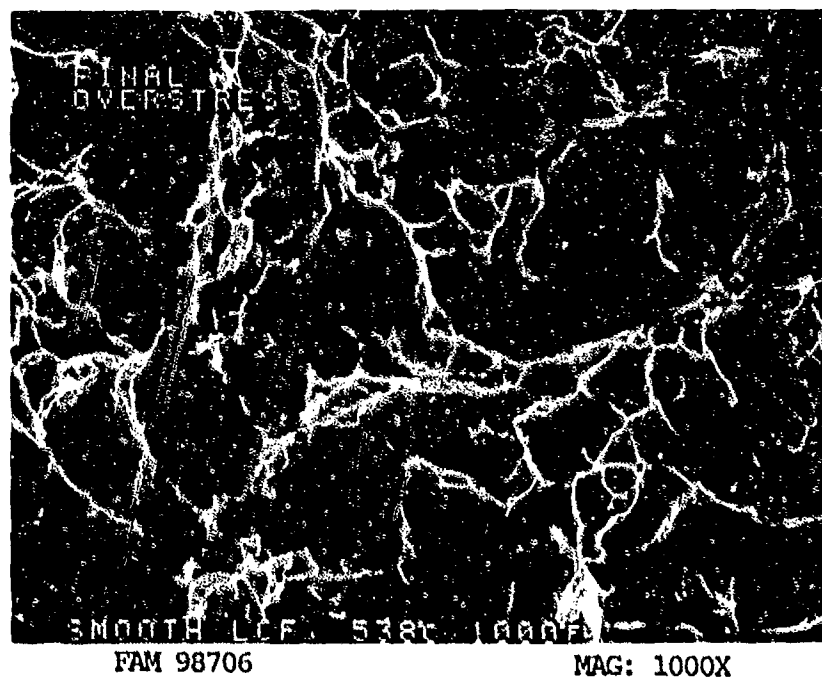
FIGURE 12-109: Higher magnification photograph showing equiaxed dimpled overstress in the final fracture area (Figure 12-108).

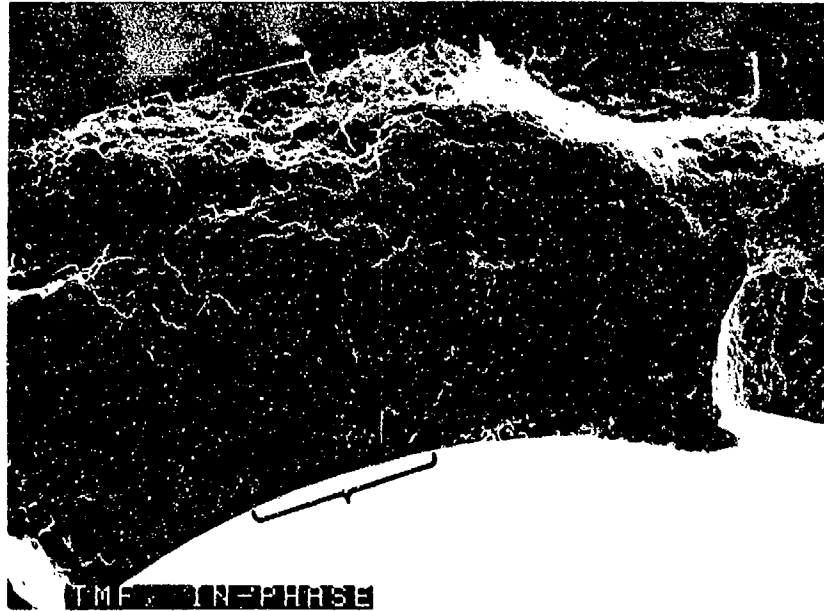
FIGURE 12-112: Low magnification photograph showing an origin area on the inside surface of the specimen (bracket) and the associated fatigue thumbnail.

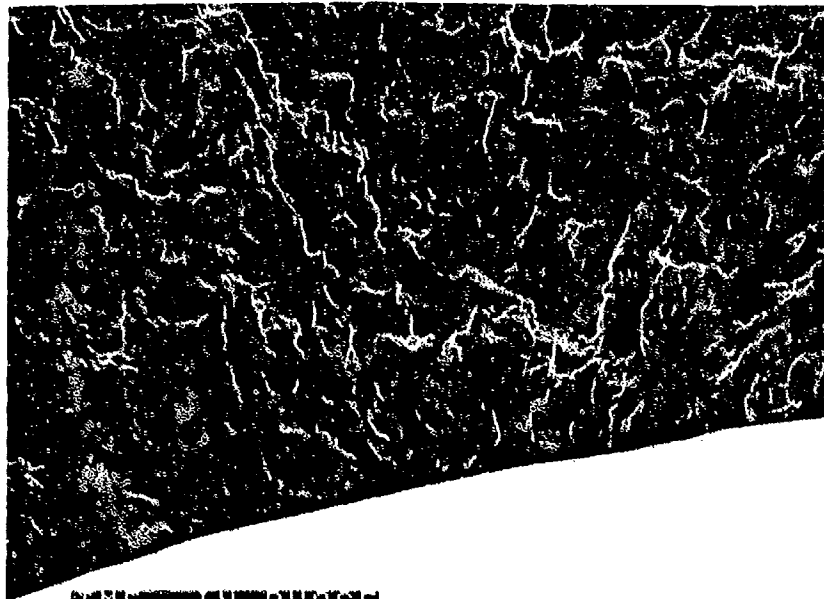
FIGURE 12-113: No localized origin can be identified in the origin area.

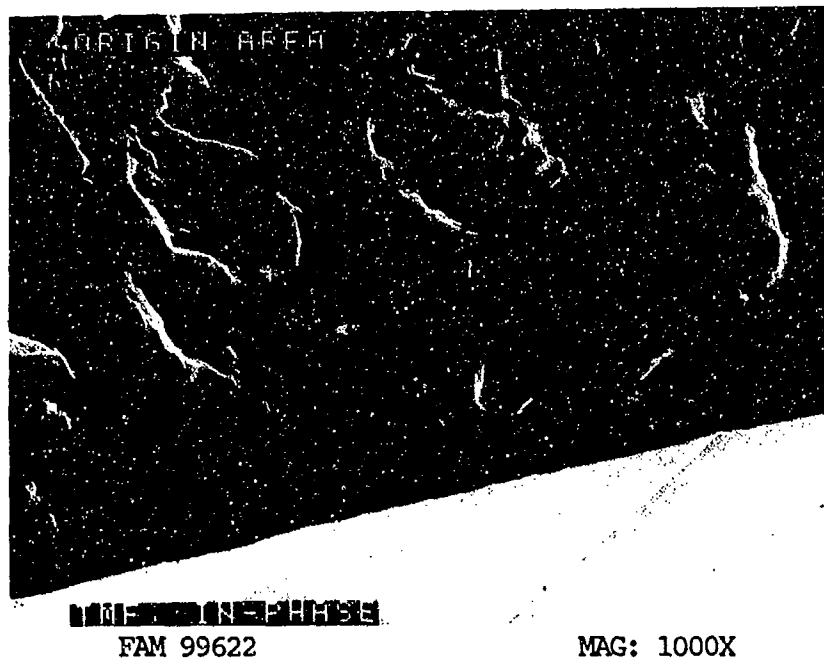
FIGURE 12-114: Close-up photograph of the origin area shown in Figure 12-113.

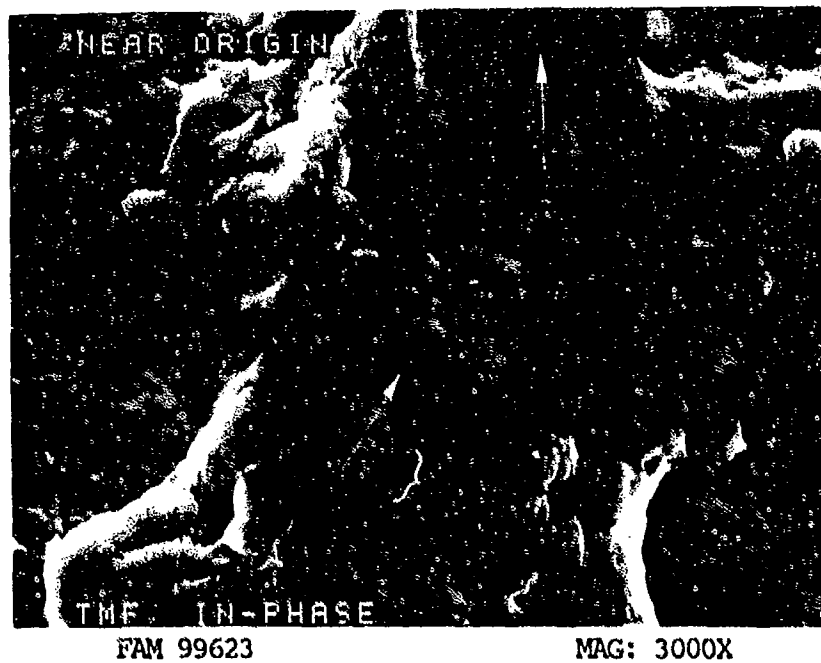
FIGURE 12-115: Fatigue striations near the origin area. The direction of propagation is shown by an arrow. Bracket contains five striations.

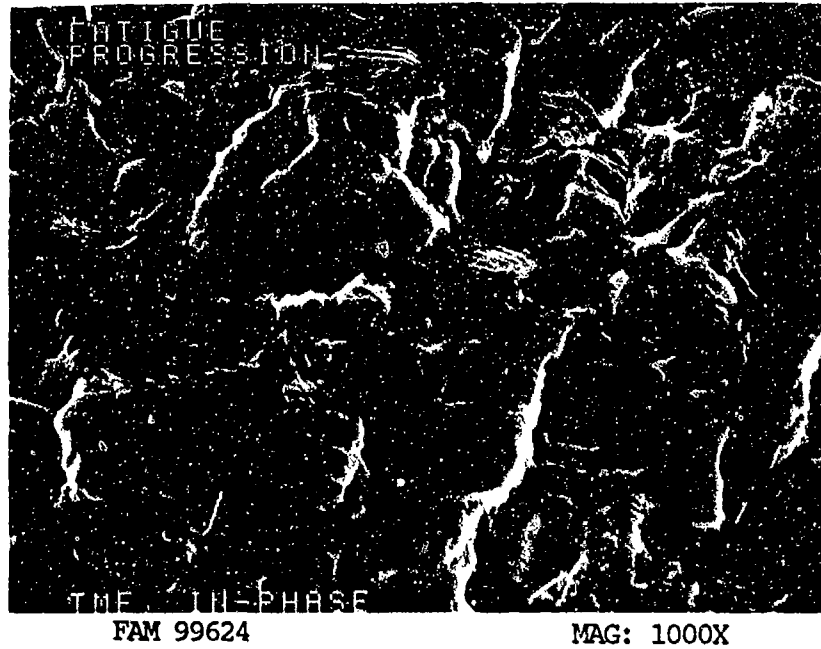
FIGURE 12-116: Oxidized striations in the fatigue progression zone. Compare these with the striations in Figure 12-115.

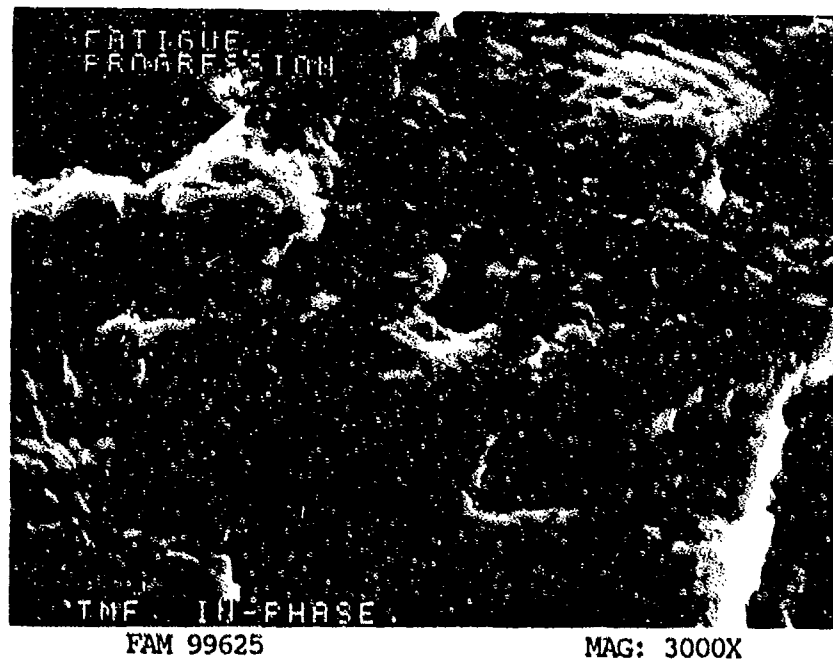
FIGURE 12-117: Higher magnification photograph of a portion of the area shown in Figure 12-116, showing fatigue striations with some secondary cracking.

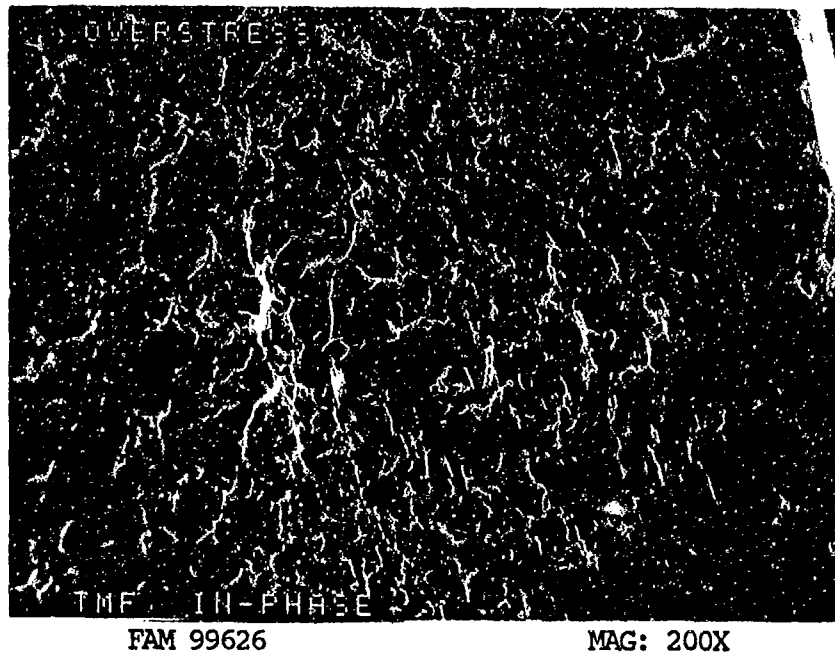
FIGURE 12-118: Dimpled overstress in the final fracture area.

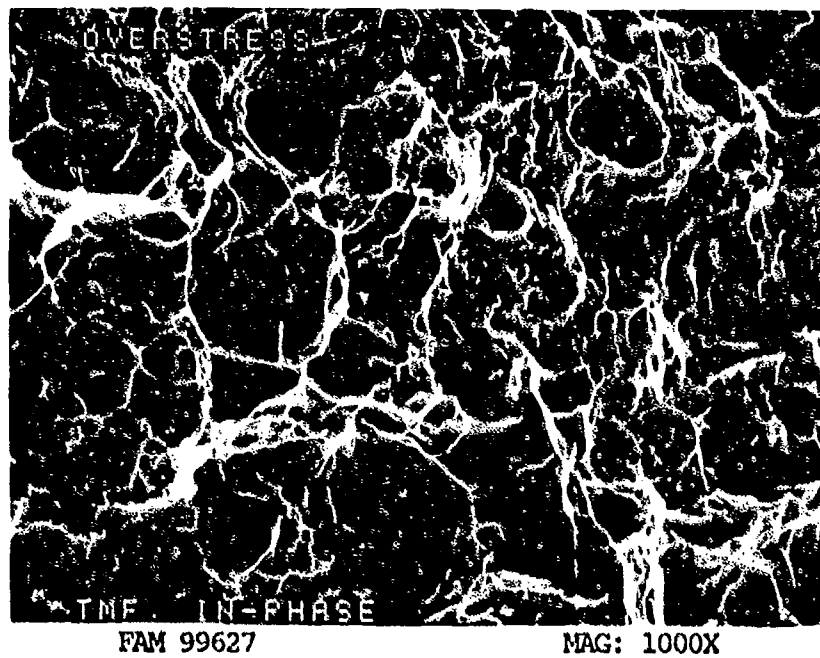
FIGURE 12-119: Higher magnification photograph showing dimpled overstress in the final fracture area. Fine dimples are contained within large ductile dimples.

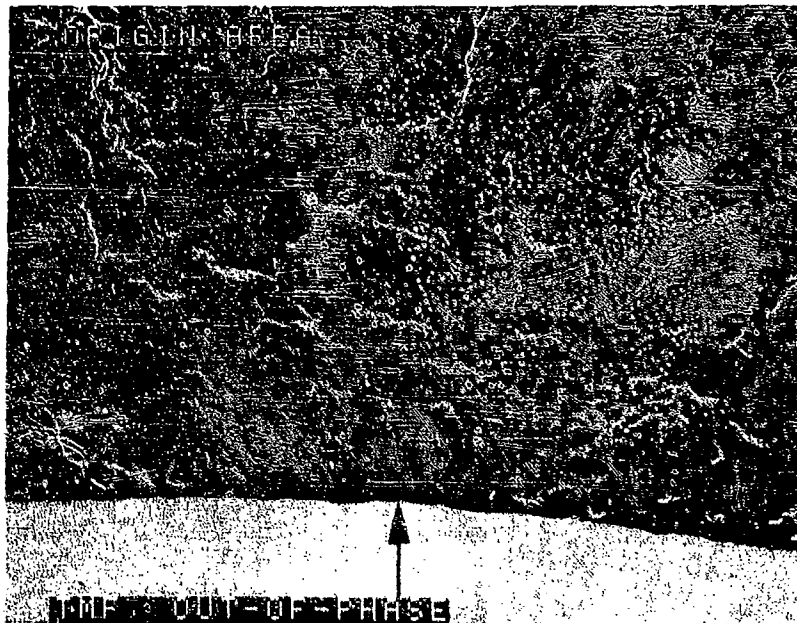
FIGURE 12-123: One of several localized origins is shown by an arrow. Machining lines are faintly visible on the inside surface adjacent to the origin.

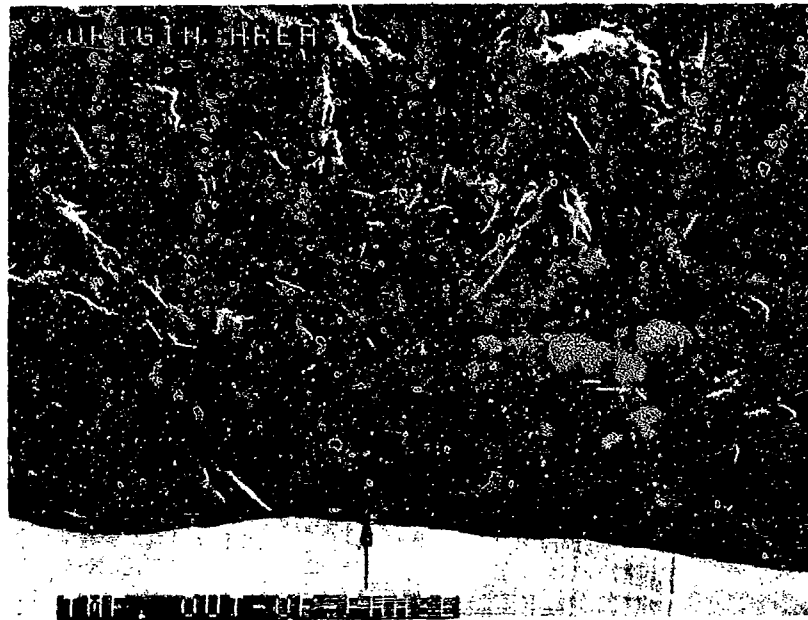
FIGURE 12-124: Close-up photograph of one localized origin area shown in Figure 12-123. Features can be seen radiating from a small fatigue facet (arrow).

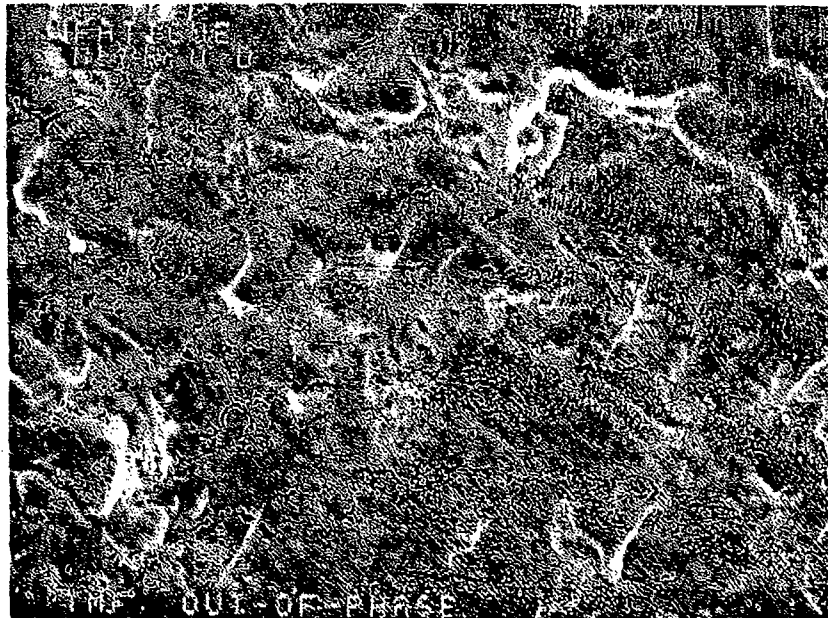
FIGURE 12-127: Striations and crack-like striations in the fatigue progression area near the O.D. of the specimen. The striation spacing has increased significantly as the crack has progressed (Figure 12-125).

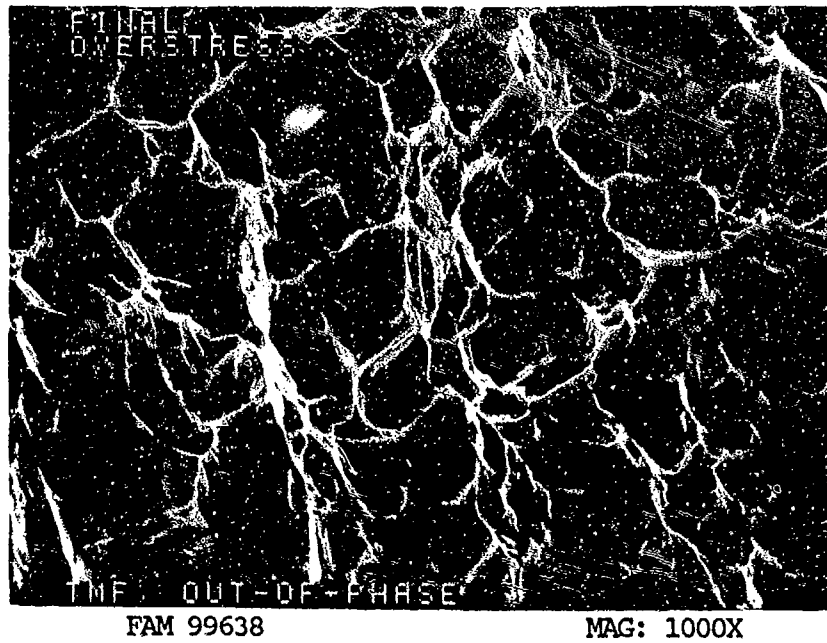
FIGURE 12-130: Higher magnification photograph showing dimpled overstress in the final fracture area.

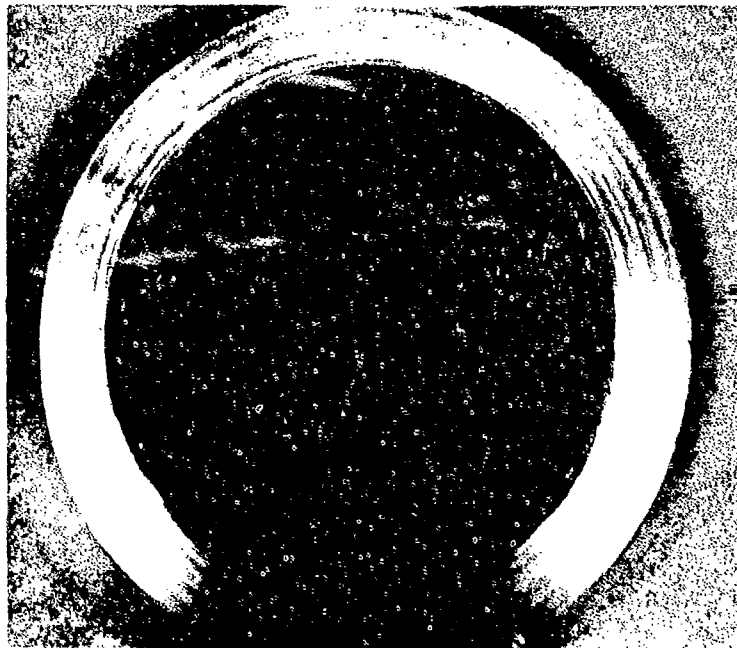
The only specimen examined was room temperature hydrogen embrittlement. The specimen exhibited equiaxed dimpled overstress with no evidence of "fluting." Some secondary cracking was observed in the base of the notch. The outermost surface of the fracture was smooth and featureless.

FIGURE 13-1: Test results and fractography of Ti-6Al-4V room temperature hydrogen embrittlement test.

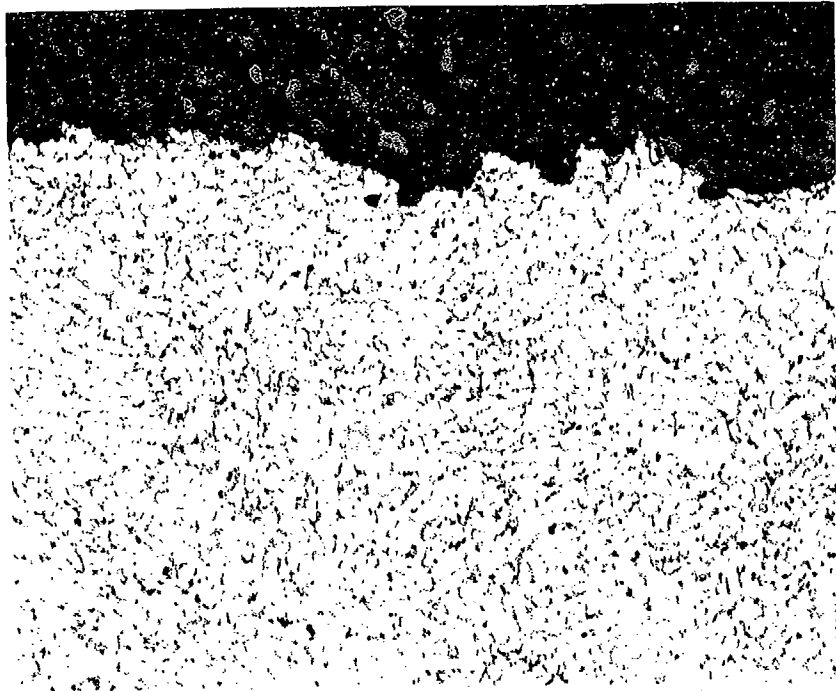
FIGURE 13-2: Optical photomicrograph showing the dimpled overstress area near the center of the specimen fracture. The specimen exhibits a mixture of transgranular and intergranular fracture.

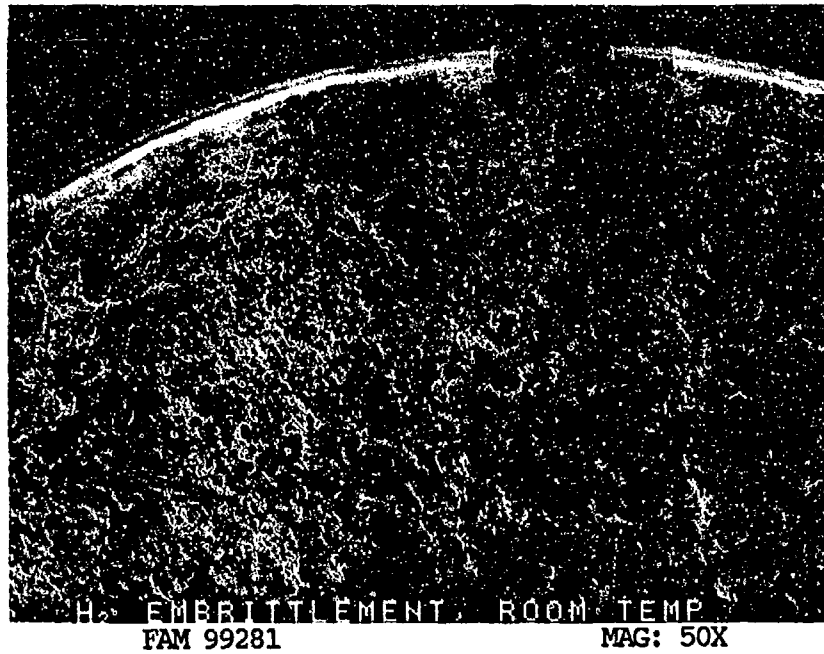
FIGURE 13-3: Low magnification photograph showing overstress features on the fracture surface.

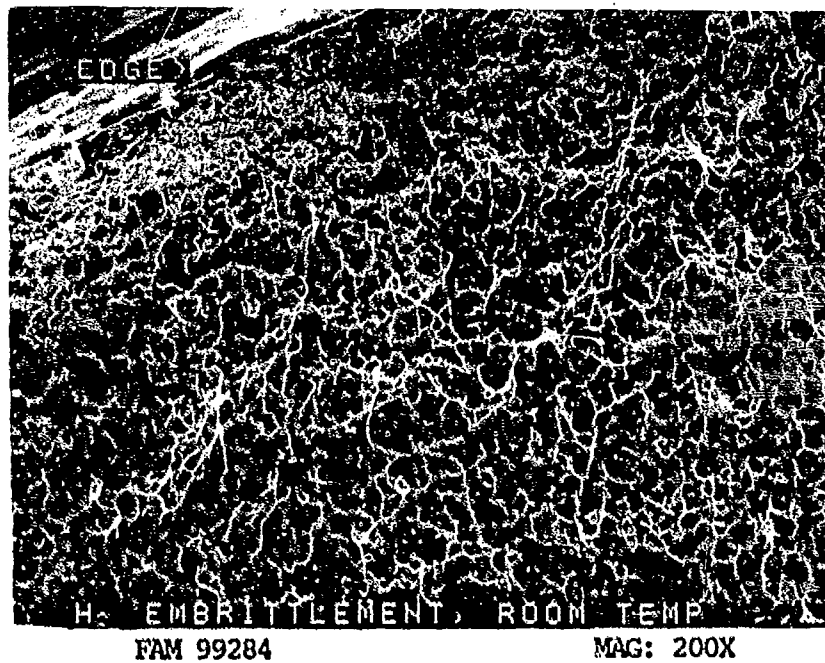
FIGURE 13-4: Higher magnification photograph of the edge of the specimen. The edge appears flat with no clear shear lip.

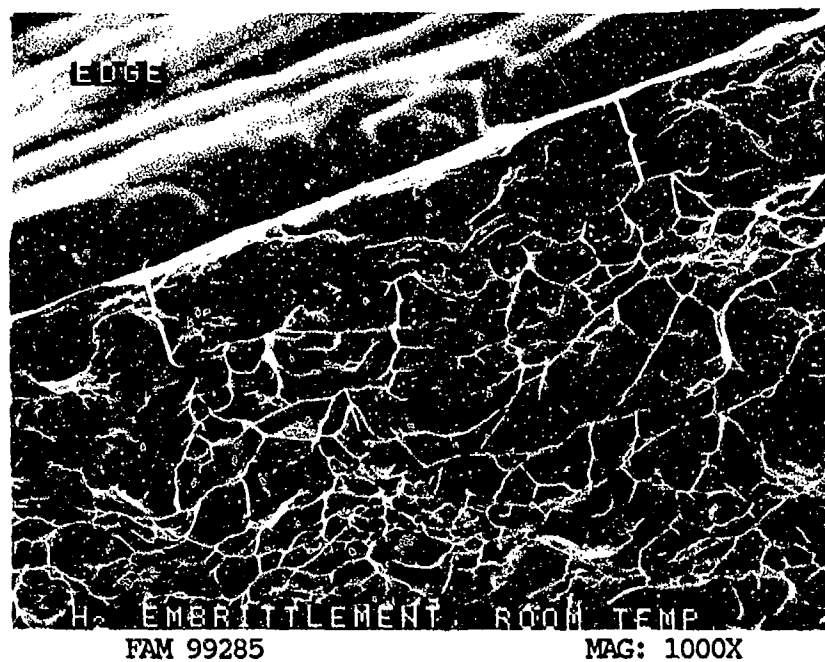
FIGURE 13-5: Tensile dimples near the edge of the specimen. The outermost fracture surface is relatively smooth and featureless (brackets).

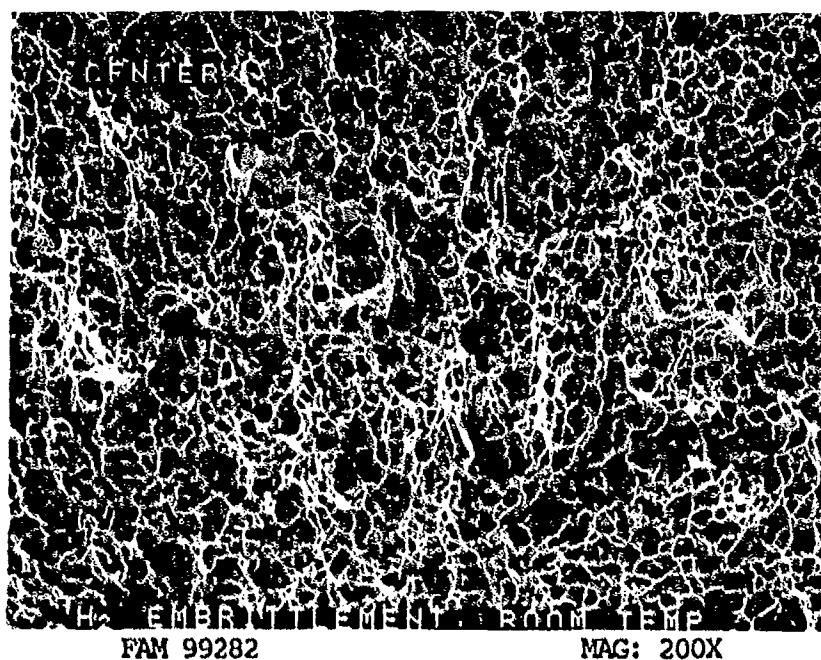
FIGURE 13-6: Equiaxed dimpled overstress near the center of the fracture surface.

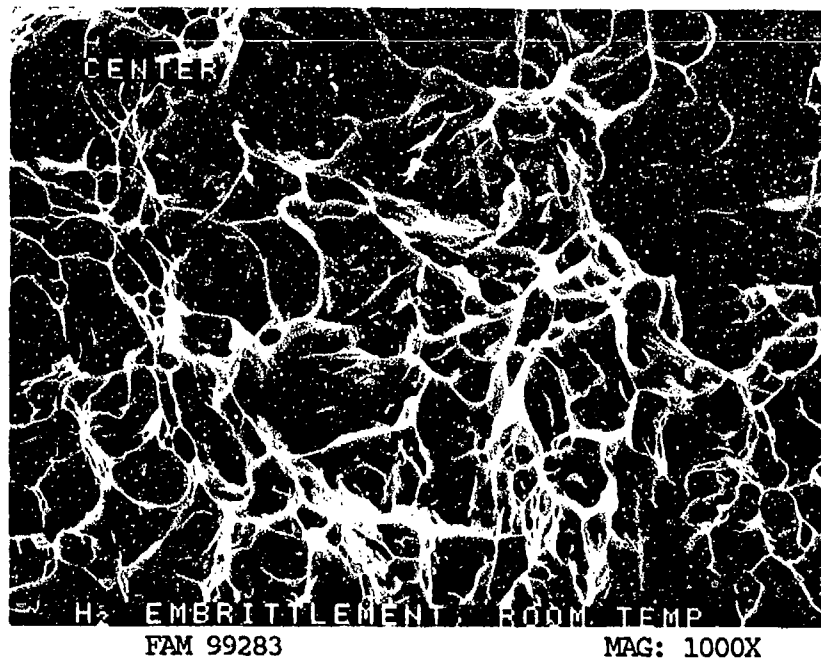
FIGURE 13-7: Dimpled overstress in the center of the fracture surface.

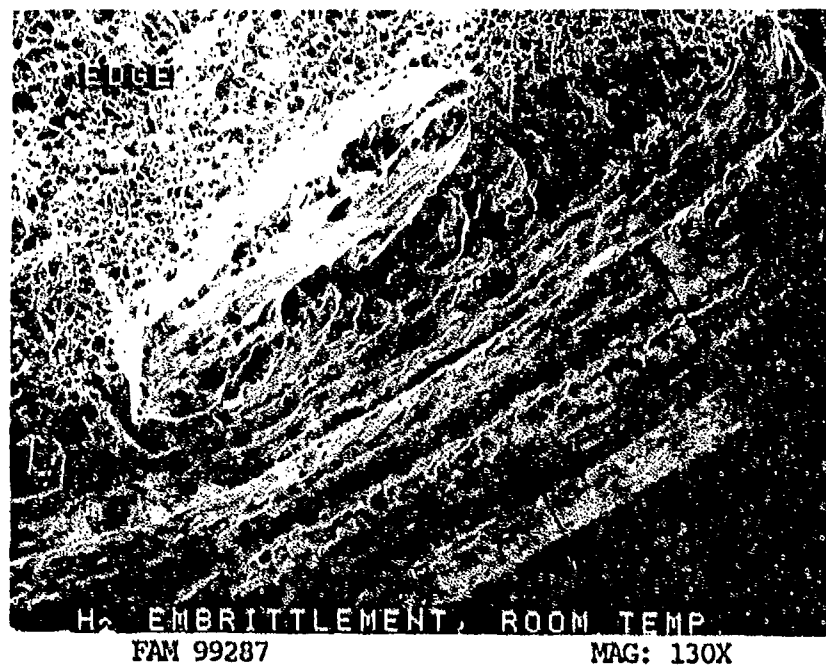
FIGURE 13-8: Secondary cracking in the notch adjacent to the primary fracture surface (arrows).

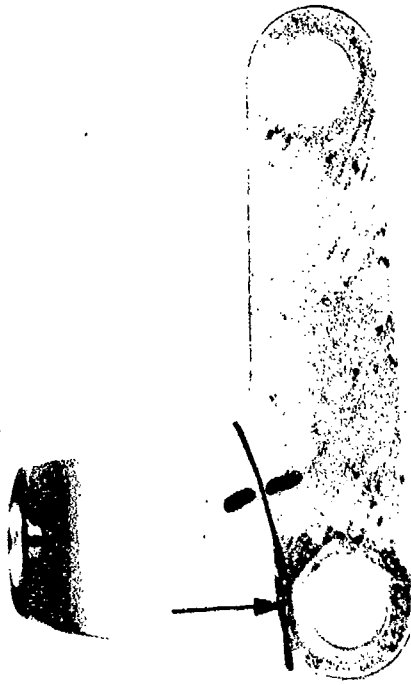
SUMMARY: The bracket fractured by fatigue (probable HCF) progressing from an origin adjacent to the bolt hole at the bolt head contact circle (fretting). The fatigue progressed approximately 0.45 inch before the final fracture occurred by overstress. This thumbnail was clearly visible. No material or microstructural defects were found.

FIGURE 13-9: Overall photograph of the reassembled loop clamp bracket. The origin area is shown by an arrow at attachment bolt head contact circle.

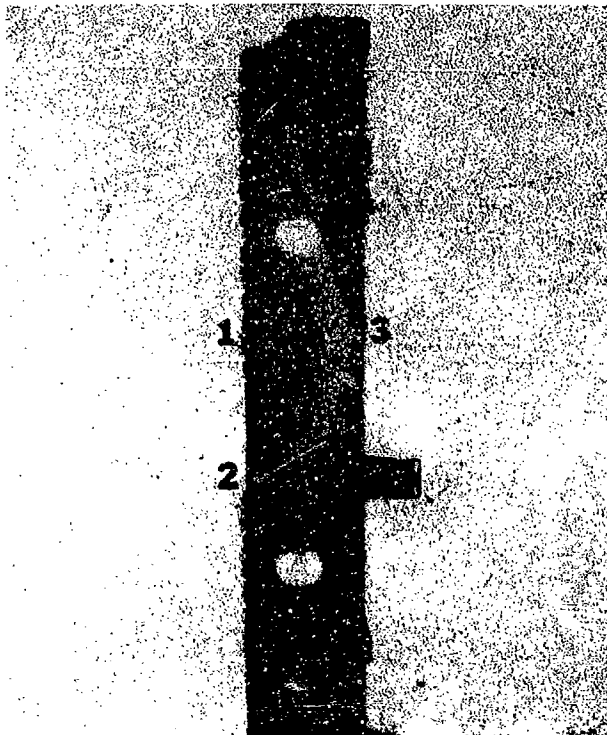
SUMMARY: Bracket fractured through the mode strut attachment due to high cycle fatigue (HCF). Transmission electron microscope (TEM) examination estimated the number of striations on fracture 2 bracket position E, to be 75,000. The smaller cross section (inboard sides) cracked first, with origins on the inside surface at the interface of the base metal and the plating. Aluminum-rich particles, probably aluminum oxide embedded during grit blasting prior to plating were found at the interface. These may have acted as origin sites. The fatigue progressed through the entire cross section of the smaller sides and through over 75% of the larger outboard sides. The most probable order of fracture is indicated in Figure 13-14.

FIGURE 13-14: Overall photograph of the mode strut bracket aft looking forward. The probable order of fracture is indicated by numbers.

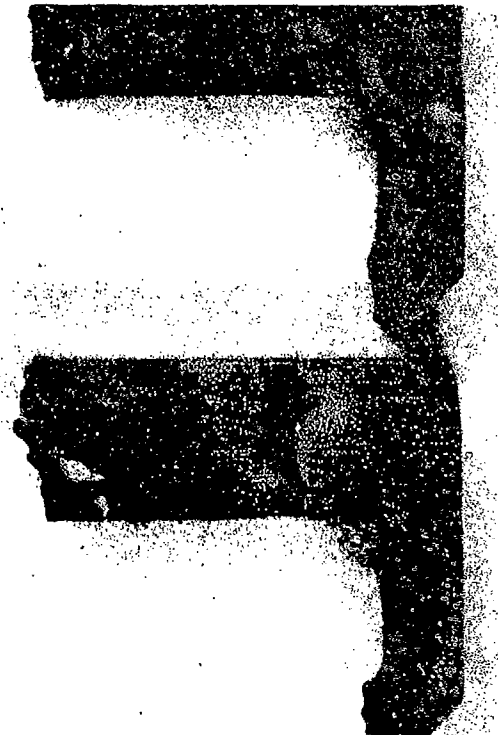
FIGURE 13-15: Side view of the fractured bracket channels.

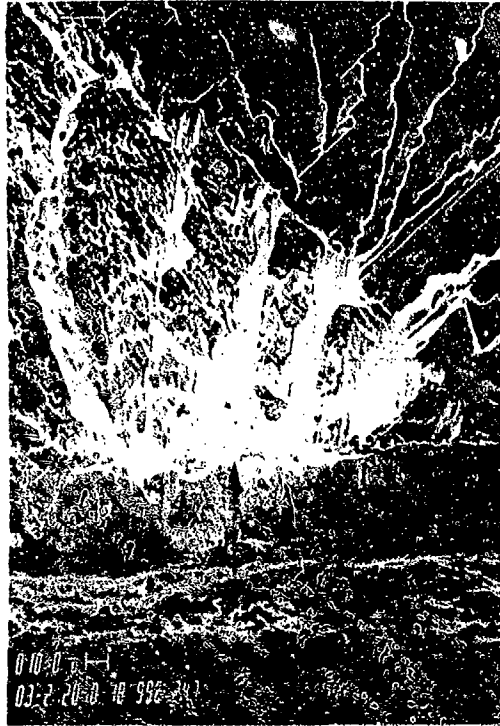
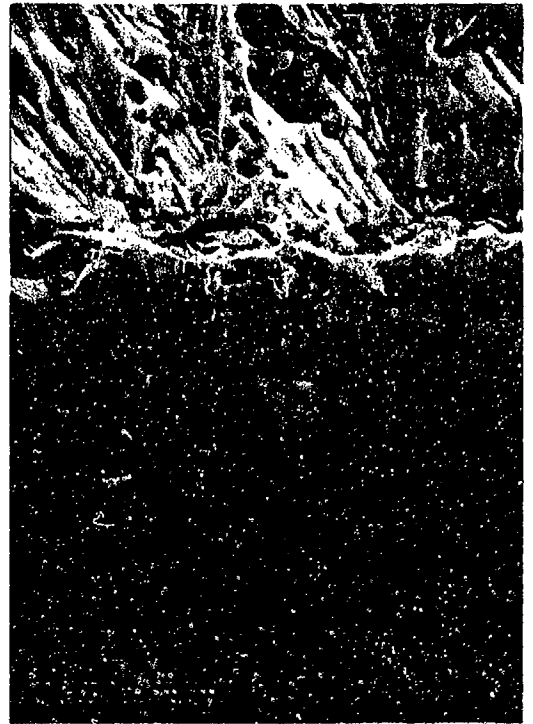
FIGURE 13-18: Feathery cleavage facets can be seen propagating in both directions from the plating base metal interface (arrows).

FIGURE 13-19: Higher magnification view of the origin area.
