REPAIR, EVALUATION, MAINTENANCE, AND
REHABILITATION RESEARCH PROGRAM

TECHNICAL REPORT REMR-CS-30

IN SITU REPAIR OF DETERIORATED CONCRETE
IN HYDRAULIC STRUCTURES: EPOXY INJECTION
REPAIR OF A BRIDGE PIER

R. P. Webster, L. E. Kukacka, D. Elling

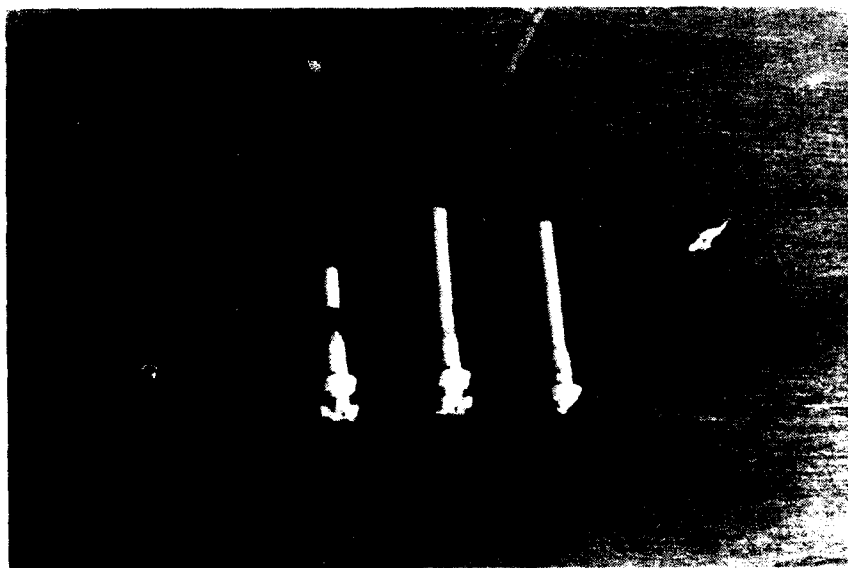
Figure 2. Lily Corporation's Injecti-Port nozzle

18. Two of the ports were molded polyethylene ports obtained from Dural International, Inc., and are designed for surface mounting, Figure 1. The other injection port evaluated was Lily Corporation's Injecti-port nozzle, Figure 2, which is a one-piece, molded polyethylene port designed for either surface mounting or for insertion into a drilled port hole. A tapered collar on the injection port allows it to fit tightly into holes 1/2- to 57/100-in. in diameter.

59. The injection ports used in the repair were manufactured by the Lily Corporation, Aurora, Il., and are marketed under the name of Lily Injecti-port nozzles (see Figure 2 on page 9). The ports are a one-piece, molded polyethylene port designed for either surface mounting or for insertion into a drilled port hole. All work done on this project utilized ports inserted into a drilled port hole.

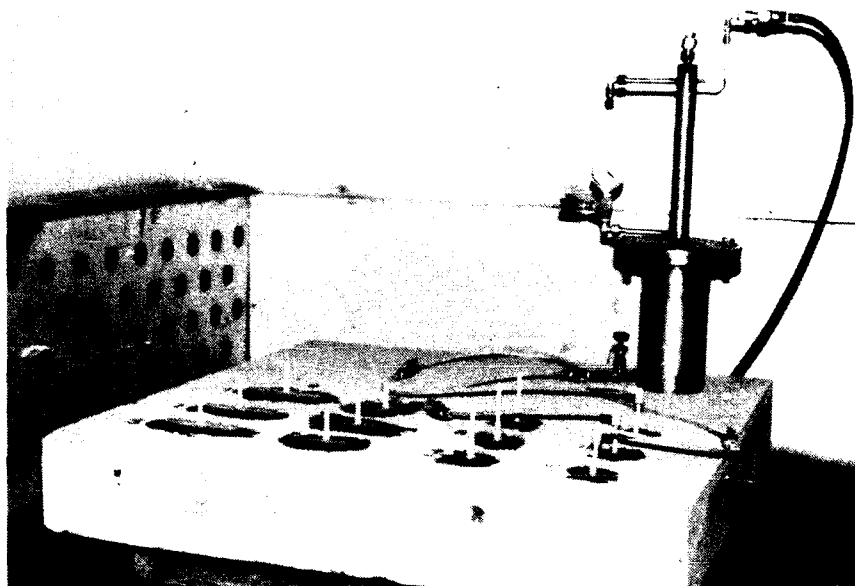
Figure 4. Hydrostatic test set-up used to test injection ports

22. The injection ports were hydrostatically tested using a stainless steel vessel pressurized with a compressed air bottle, Figure 4. Each set of ports was simultaneously tested at each pressure level for 15 min, after which the pressure was increased to the next level. Once a port failed, the pressure line to that port was closed and the test was continued. The results are summarized in Table 1.

23. In general, all of the failures resulted from leaks developing around the parameter of the injection port and propagating through the interface of the epoxy seal coat and the injection port. This problem was primarily due to the inability of the epoxy to securely bond to the polyethylene. In no instance did the injection ports physically fail. The results indicate that surface-mounted ports will withstand lower injection pressures than ports mechanically mounted in a drilled port hole. The Lily Injecti-port withstood pressures of 200 to 275 psig when inserted within a drilled port hole, but only 150 psig when surface-mounted. Also, the ability of a surface-mounted port to withstand injection pressures seems to be related to the surface area of the port in contact with the concrete; ports with a larger surface area were able to withstand the least amount of pressure. The surface-mounted Lily Injecti-port withstood the greatest test pressure, 150 psig, while having the least contact surface area, 0.8 cm^2 . The Type B (refer to Figure 1) surface-mounted port had the greatest contact surface area and withstood the least amount of pressure.

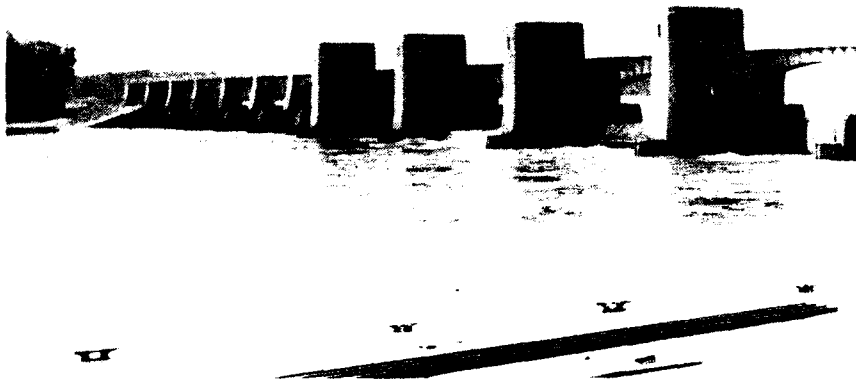
Figure 6. Lock and Dam 13. Pier No. 13 is the second bridge pier from the left.

45. After completing the laboratory work, a large-scale field test was performed on Pier No. 13, Lock and Dam 13, Fulton, Il., (Figure 6) during 15-31 August, 1988. Lock and Dam 13, which was placed into service in 1939, is one of 12 navigation structures operated by the Rock Island District, US Army Corps of Engineers as part of the Nine-Foot Channel Navigation Project. It is located at Upper Mississippi River (UMR) Mile 522.5, 2.2 miles upstream from the town of Fulton, Il. Pier No. 13 is located in the storage yard situated on the Iowa side of the Mississippi River.

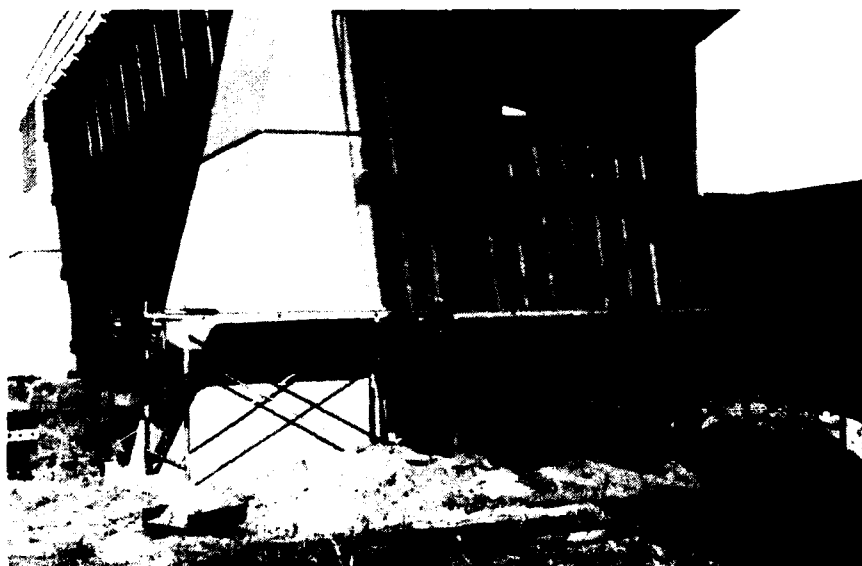
Figure 12. Construction scaffolding in place around pier

53. Five-foot high sections of construction scaffolding were erected along the Iowa and Illinois faces of the pier to provide access to the upper half of the base of the pier (Figure 12). Access to the upstream and downstream faces was provided by planks laid between the scaffolding framework.

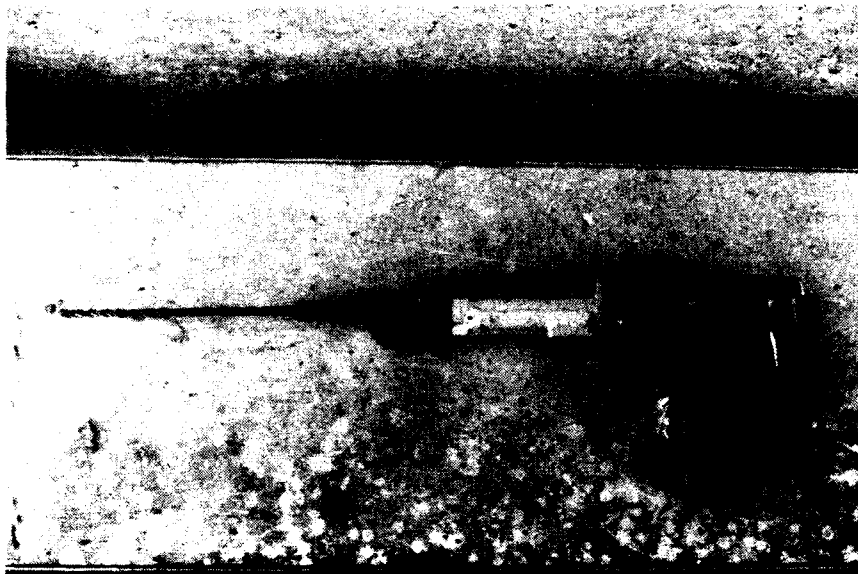
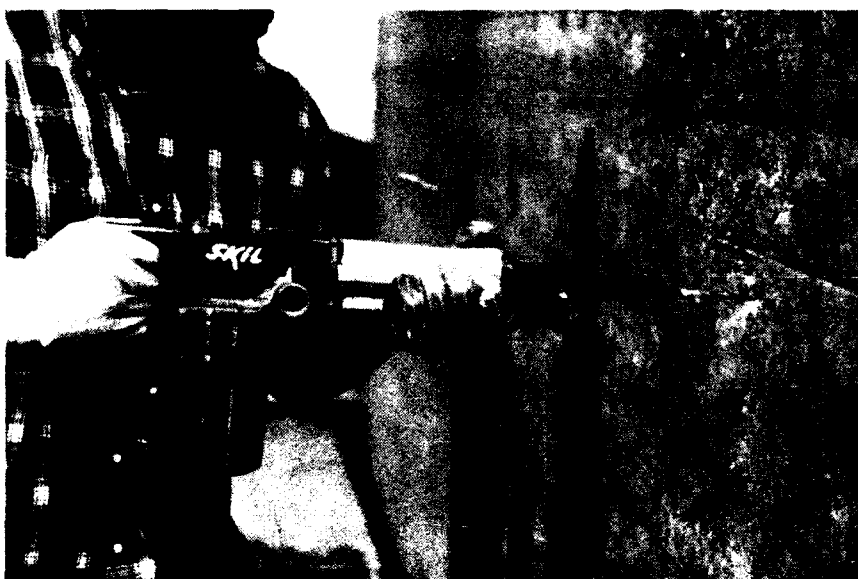
Figure 18. Skil 728 heavy duty electric roto-hammer

Figure 19. Predrilling of port holes

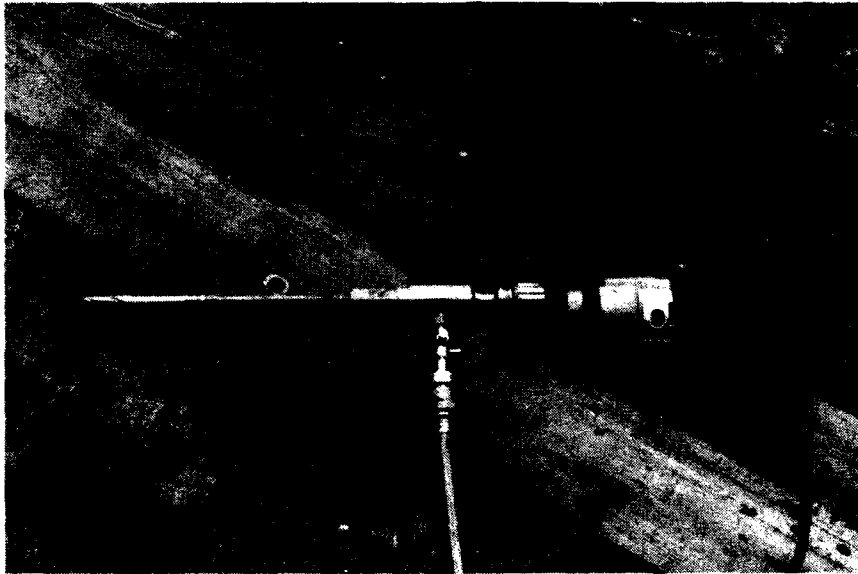
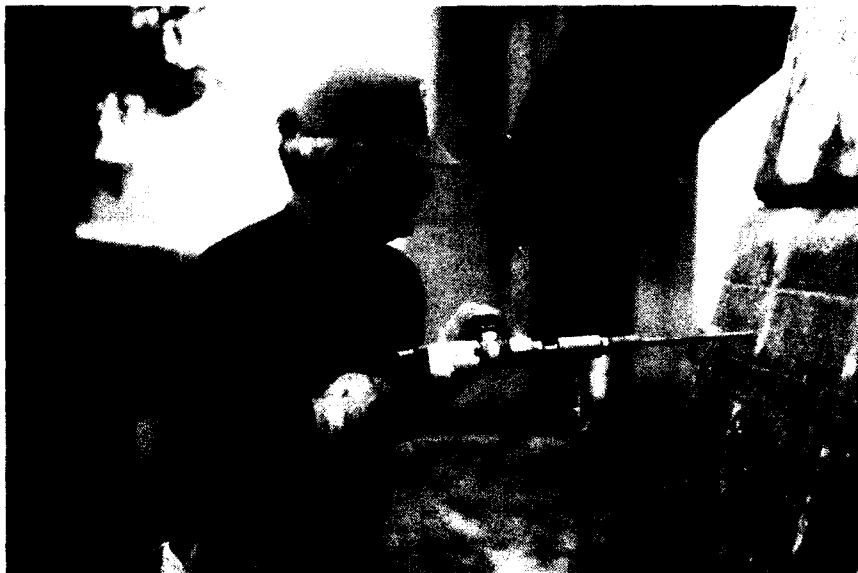
Figure 20. Milwaukee Magnum electric hammer-drill with attachment for wet drilling

Figure 21. Wet drilling of port holes

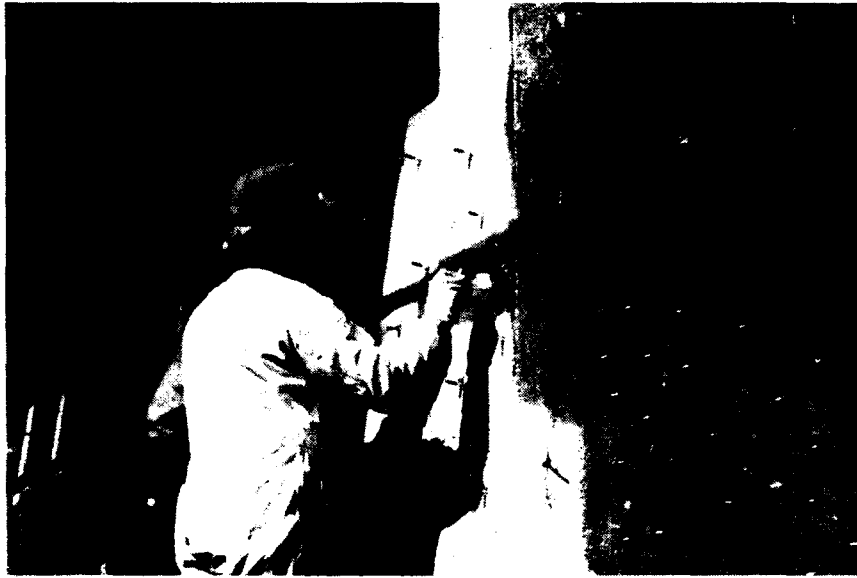
Figure 24. Application of epoxy seal coat

66. Once all the ports were inserted into the holes, the entire surface of the pier was sealed using DeNeef America, Inc.'s Deltapox VM epoxy. Deltapox VM is a two-part epoxy, containing a thixotropic agent, designed for use in vertical and overhead applications. The epoxy seal coat was applied to the surface by hand using paint brushes (Figure 24). Approximately 11-1/2-gal of epoxy was used to seal the surface of the pier and the bridge-bearing seat, at an application rate of approximately 71 sq ft/gal. The epoxy seal coat was allowed to cure for approximately 23 hr before starting epoxy injection of the pier.

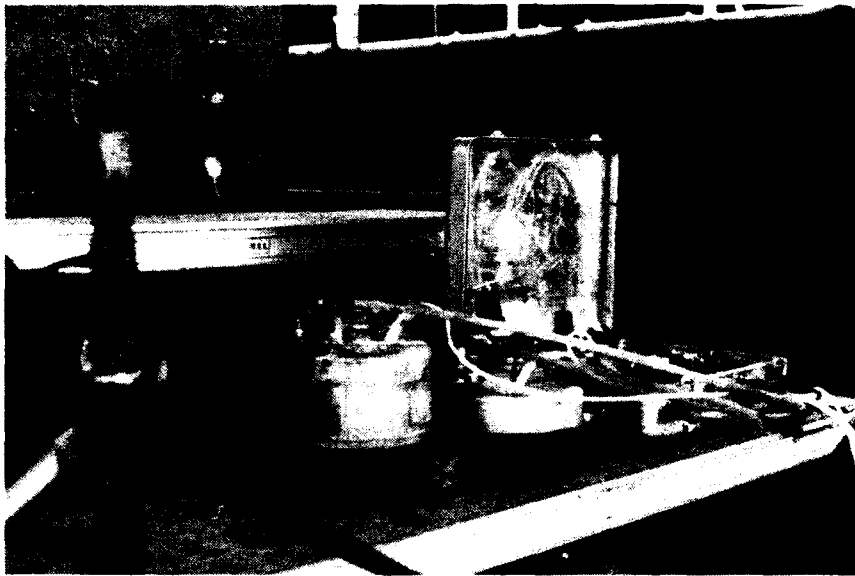
Figure 25. A3-10 epoxy injection machine

70. The resin was injected into the pier using Otto Engineering Inc.'s A3-10 epoxy injector (Figure 25). The A3-10 is a pneumatically operated, portable injection unit consisting of an aluminum suitcase, two stainless-steel resin tanks, and two 20-ft dispensing lines which are connected to a static mixing head immediately in front of the injection nozzle. The suitcase houses two positive displacement pumps, resin feed lines, and the pneumatic logic circuit which operates the unit. Mix ratios varying between 1:1 and 4:1 can be handled by the unit. The Denepox 40 has a mix ratio of 2.85:1. The unit operates at an inlet air pressure and flowrate of 85 psi and 2 cfm, respectively, and dispenses the mixed epoxy at injection pressures up to 275 psi. A 2-HP, 20-gal portable air compressor operated the injection machine in the field. Two regulator/filter/dryer units were installed on the unit to clean

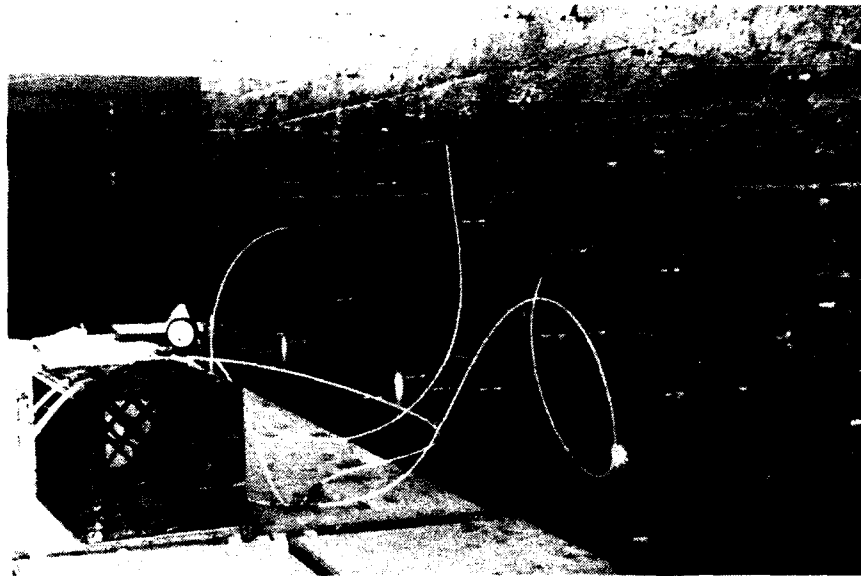
Figure 26. Manifold system used to inject three ports simultaneously

71. The epoxy was injected through a manifold system that allowed for injection into 3 injection ports at once, thereby speeding up the process (Figure 26). The manifold lines were 1/4-in.-O.D., heavy duty (maximum burst pressure of 1000 psi) nylon tubing. Push-to-connect fittings (Figure 27) attached the manifold lines to the injection ports. A pressure gauge was mounted in the junction of the manifold system to monitor injection pressures.

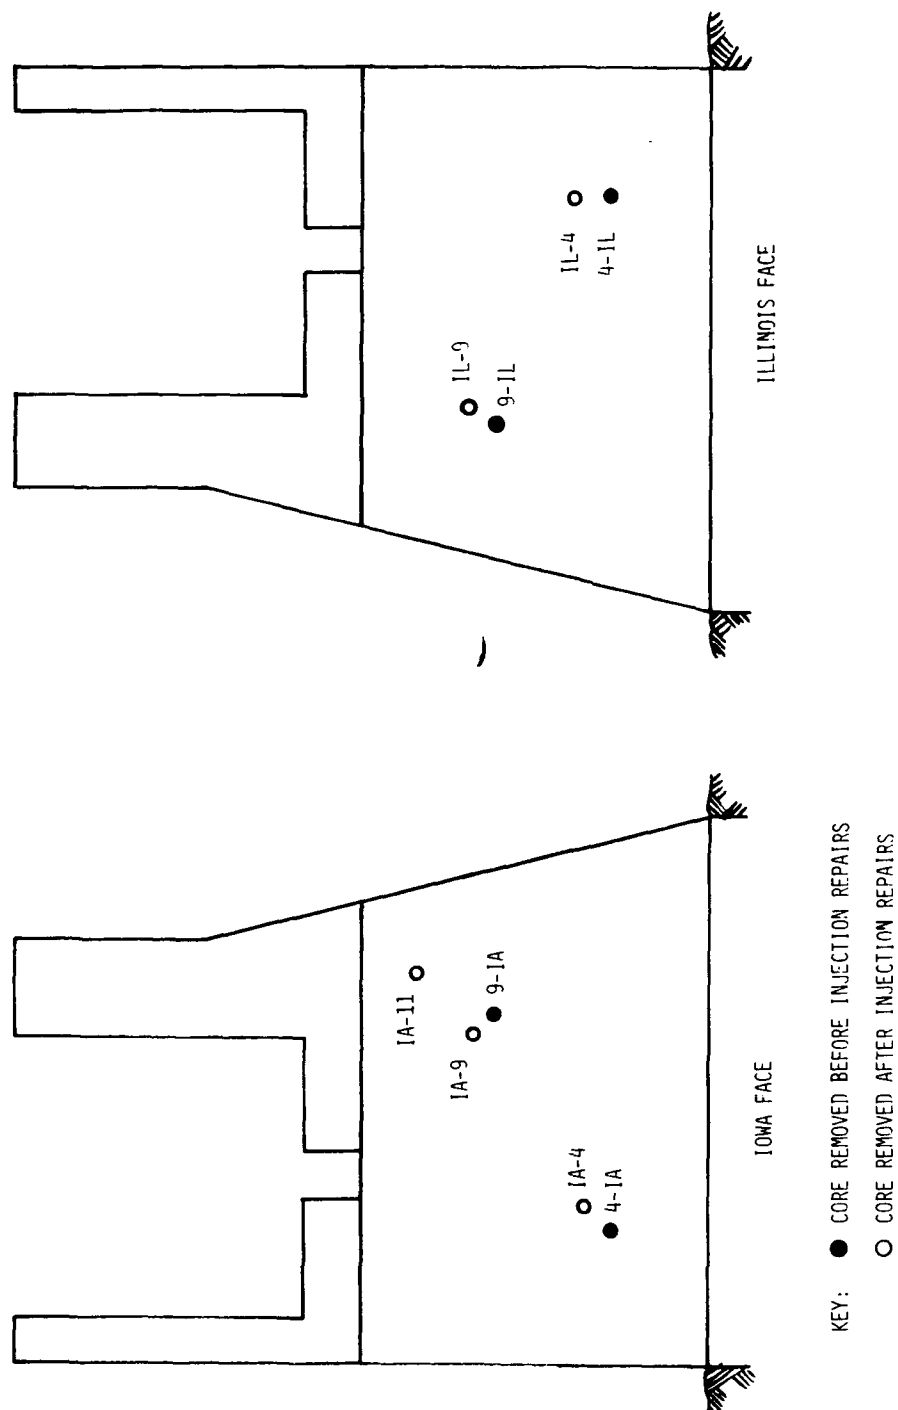
Figure 29. Location of cores taken before and after epoxy injection repair

83. Next, personnel from the Rock Island District office removed five 4-in.-diam cores from the Illinois and Iowa faces. Four of the cores were removed from areas close to where the pre-injection cores had been taken (Figure 29). A visual examination of these cores suggested that the crack network within 6 to 10 in. of the surface appears to be filled with epoxy and epoxy was visible as deep as 15 in. from the surface (Figure 30 and 31). Drilling logs are presented in Appendix C.

84. The results of the ultrasonic pulse velocity tests and the visual examination of the postinjection cores indicates that the crack network within the top 6 to 10 in. was repaired by the epoxy injection, which appeared to have
