THE DESIGN, DEVELOPMENT AND FABRICATION  
OF AN ORGANIC COMPOSITE SHIPPING CONTAINER  
FOR THE FULL UP POWER PACK (FUPP) (U)

CONTRACT DAAE07-88-C-R049

APRIL 1990

Carl H. Luther  
General Dynamics  
Land Systems Division  
P.O. Box 2094  
Warren, MI 48090

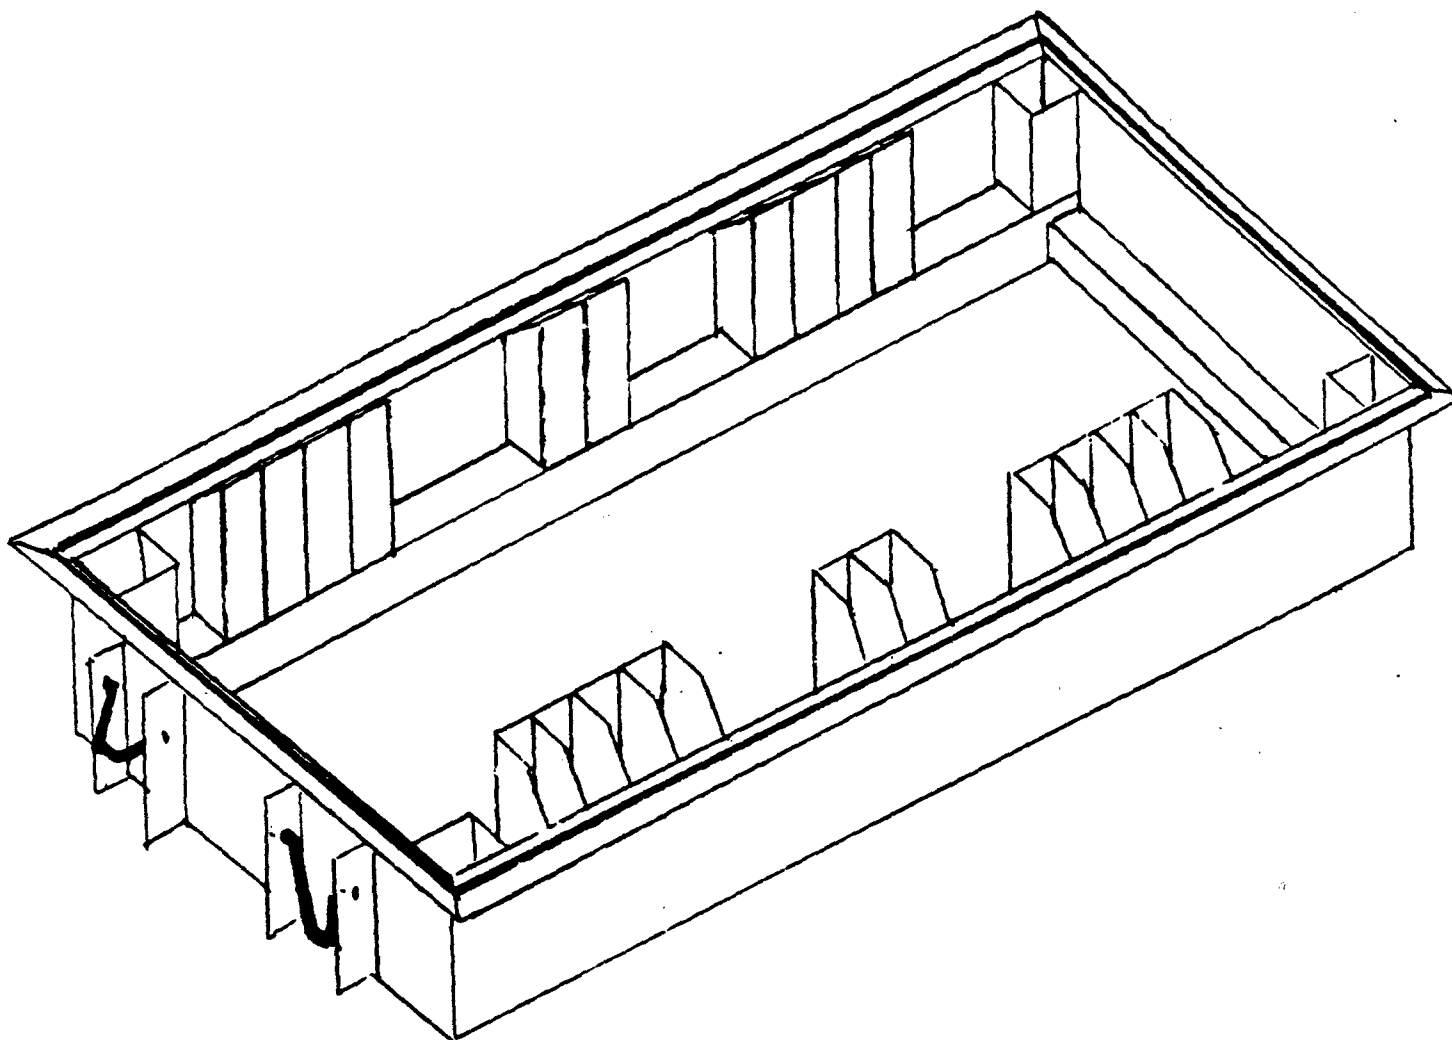
Figure 3-1. Composite Tub With Aluminum Outer Frame

The final design of the lightweight container has reduced its weight by 2,000 lbs. This represents a 40% weight reduction compared to the current steel unit. Areas of the initial design which required redesign were locations on the lower tub which were subject to concentrated loads. These typically required metallic reinforcement to "spread" the load over a greater area of composite. The lower tub is shown in Figure 3-1.

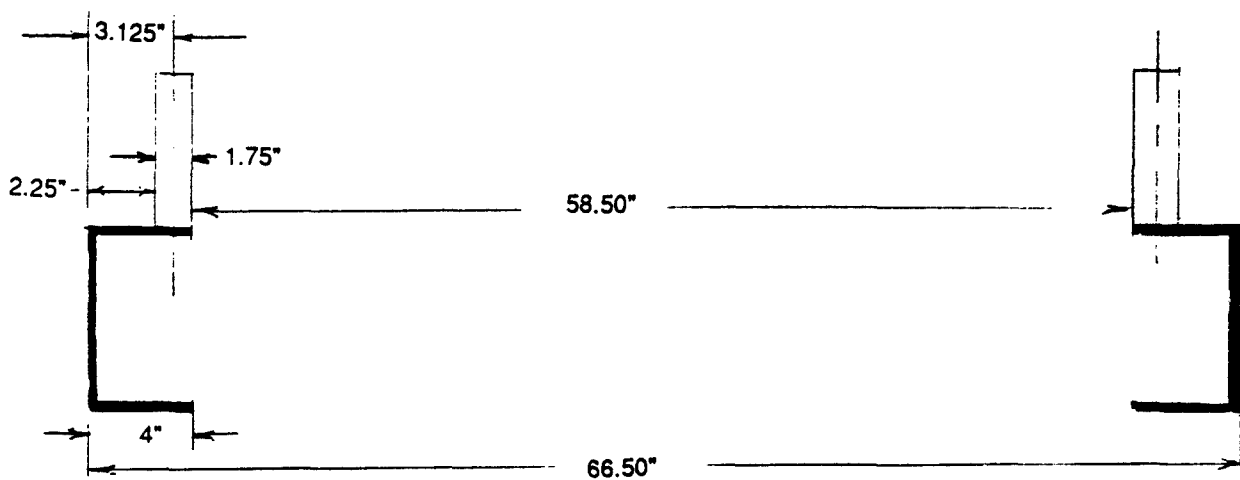
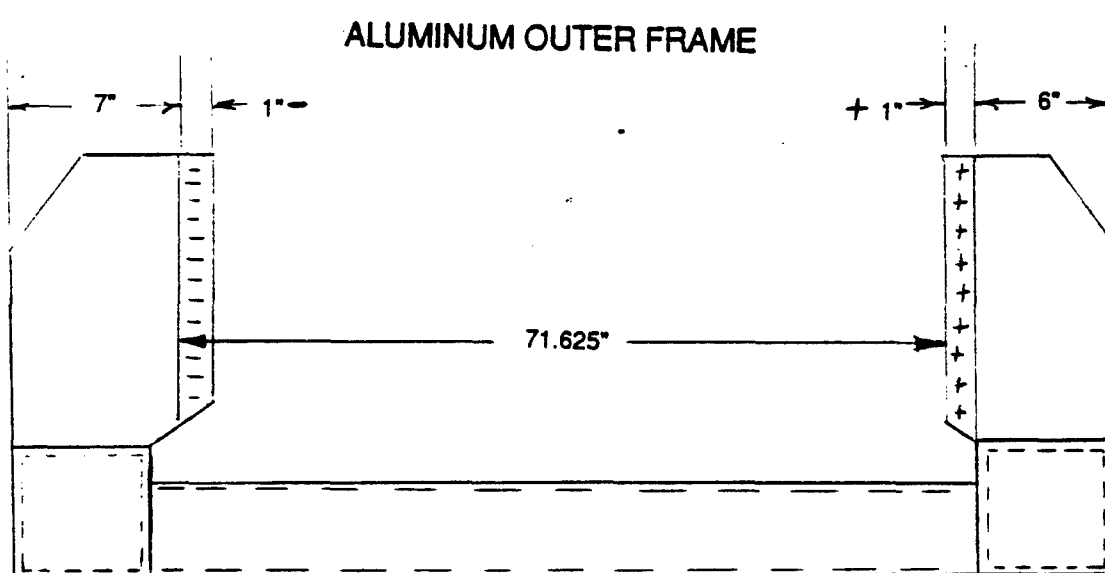
Figure 4-1. Aluminum Inner and Outer Frame

NOW : 3.125" TO RIGHT      WAS: 2.175" TO RIGHT      DELTA : 0.950"

Viewing the container from the engine end, shift aluminum shear mounts 1.0 in. to the right to adjust for changes due to aluminum vs. composite inner frame. This makes both shear mount supports 7 in. deep. See Figure 4-1.

∴ REDUCE DEPTH OF LEFT SHEAR MOUNT BY 1" AND INCREASE RIGHT BY 1"

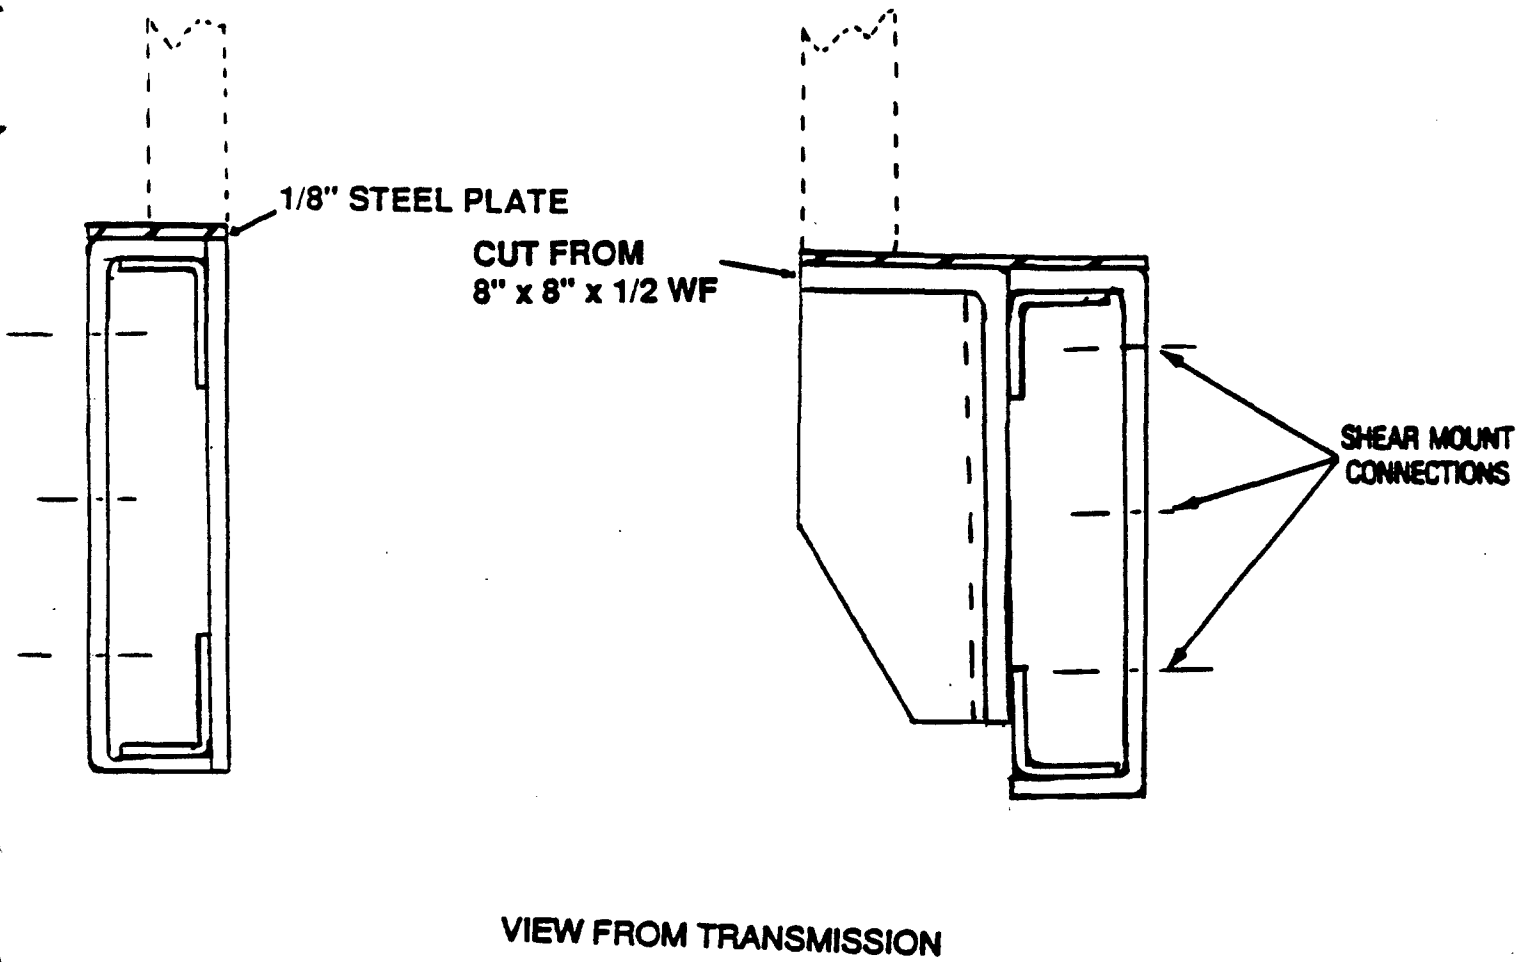
Figure 6-1. Inner Frame Pultruded Joint Design

Initial design of the inner isolation frame utilized pultruded E-glass/polyester channels. During drop testing, there was a joint failure which was traced to excessive flange bending. The inner frame was redesigned out of 6061-T6 aluminum and has successfully passed all tests.

The initial design utilized pultruded E-glass/polyester and E-glass/vinylester beams. A typical cross section is shown in Figure 6-1. These beams were selected based on their longitudinal bending capabilities being equal to or greater than the steel beams used in the existing metallic container. During drop testing, the inner frame failed. Failure analysis showed the cause to be excessive flange bending at the intersection of the I cross beam and longitudinal channel beam as shown in Figure 6-2. A redesign of this composite joint detail was attempted, but due to the necessary offset or "drop" of the engine crossbeam, it was impossible to achieve a satisfactory web-to-web bolted shear connection (which would have eliminated flange bending). It was, therefore, decided to construct the entire inner frame out of 6061-T6 aluminum. It is shown in Figure 6-3. A welded joint was designed to transfer load without high flange bending. The resulting inner frame was a much cleaner design which survived all testing. The aluminum frame weighed 23 lbs. more than the pultruded composite design, and shifted the FUPP 1.0 inch to the right, but clearances were still adequately maintained. Stress analysis indicates that 4-inch diameter lightening holes could be cut into the beam webs resulting in an 8 lb. reduction, which would bring the net weight increase to 15 lb. over composite.

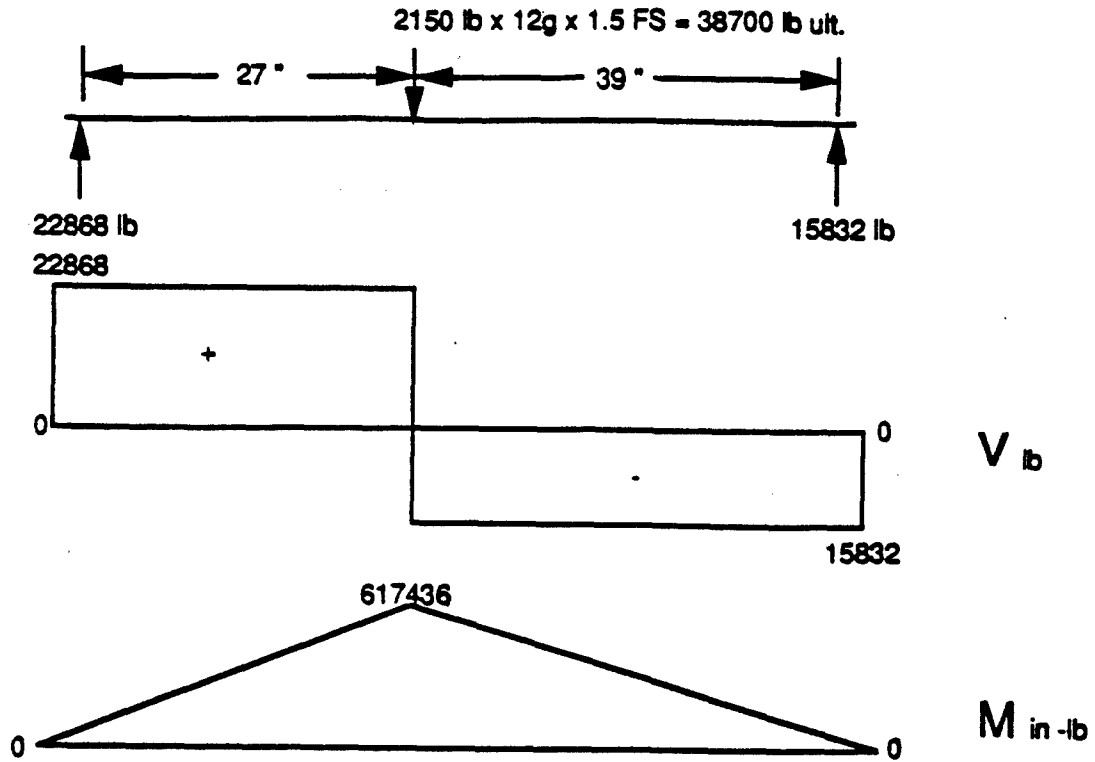
Figure 7-2. Inner Frame Cross Beam Stress Analysis

The engine cross beam is critical in bending due to the concentrated 38,700 lb. ultimate load applied at 44% span. The resulting Margin of Safety is + .80. Loading on the inner frame is as shown in Figure 7-1. Analysis is presented in Figure 7-2.

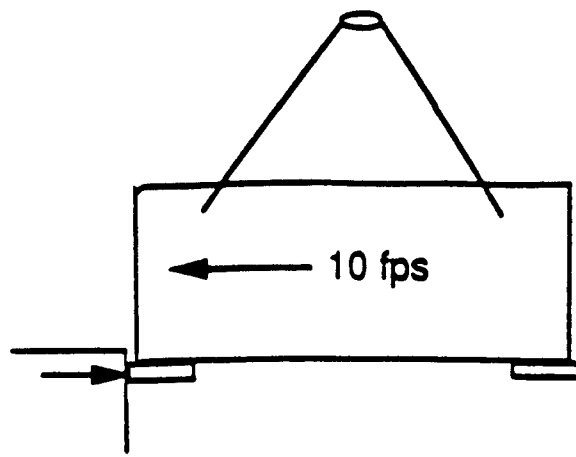
Figure 7-3. Skid Mount Stress Analysis

The bottom tub is subject to drop and pendulum impact testing, the most severe condition being pendulum impact. The critical region for this condition is the skid mount attachment. This area was beefed up after failure of the initial concept. All Margins of Safety are now positive. Stress analysis is presented in Figure 7-3.

PENDULUM  
IMPACT

The redesign of the skid mount attachment region required adding in a 2" x 3" x 1/4" 6061-T6 aluminum angle to the inside of the composite tub at each of the four corners. This is shown in Figure 6-5. In addition, ten 1/2 in. steel bolts were used at each corner to react the impact load from the skid directly into the tub reinforcement tubes. Pliogrip adhesive was also used at the interface. This attachment minimized loading on the thin (2/10 in.) composite floor. There were no failures in subsequent testing.

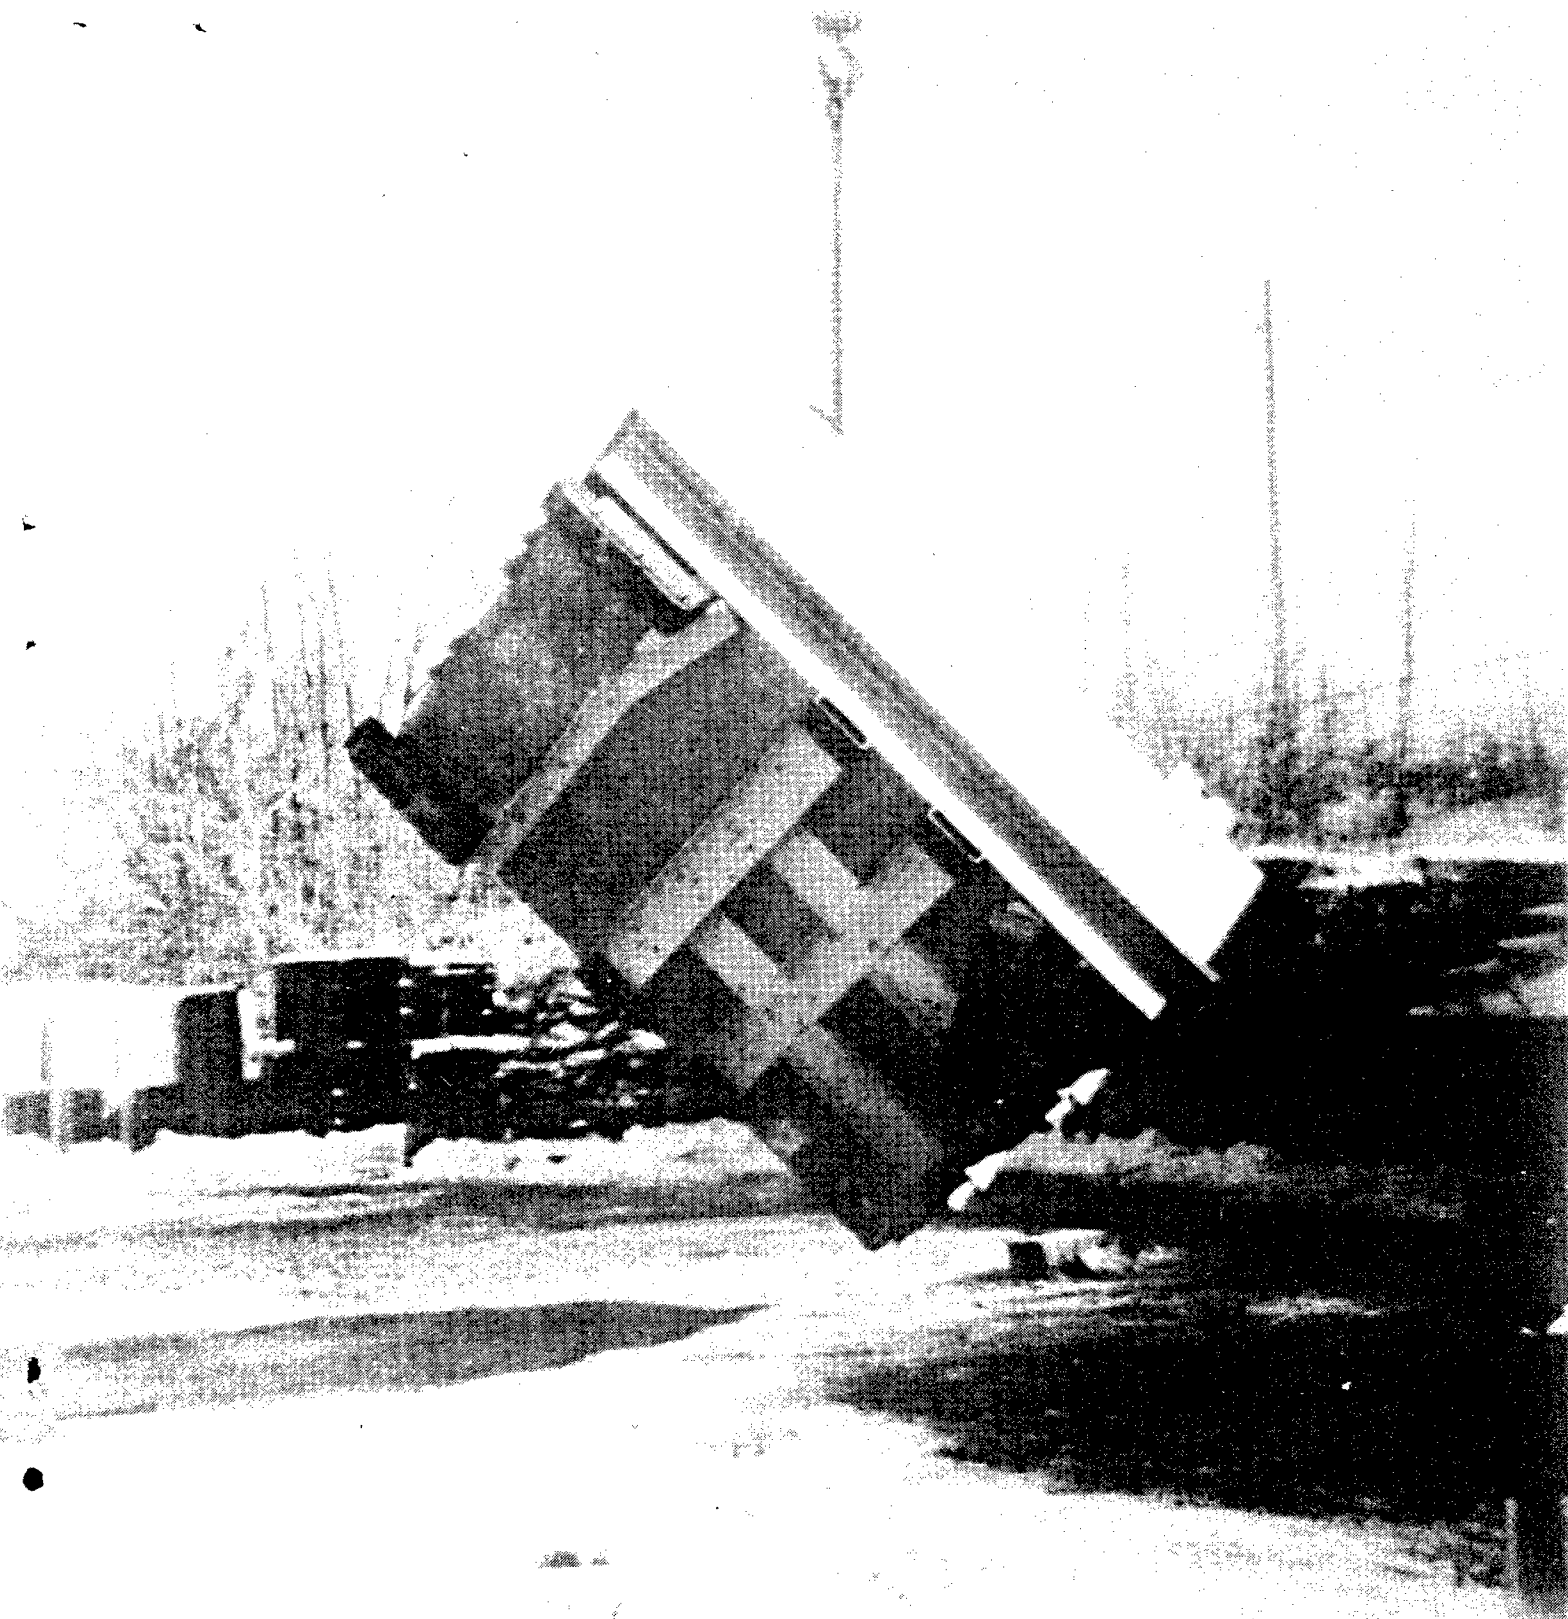
**C-5**

No deformation at the hoisting brackets was observed.

**HOISING TEST**
