MTL TR 90-53

FAILURE ANALYSIS OF THE LAU-7/A LAUNCHER RETENTION BAND ASSEMBLY

VICTOR K. CHAMPAGNE, Jr. and GARY WECHSLER
MATERIALS TESTING AND EVALUATION BRANCH

November 1990

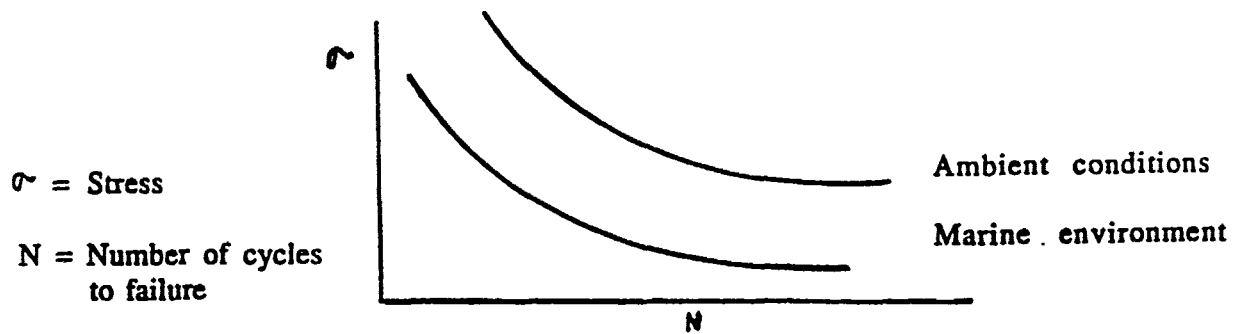
3. If fatigue failures continue to occur after 1 and 2 above are implemented, this may indicate that the spot welds do not have adequate strength to withstand the service conditions and may not be the proper welding process for this application. In addition, corrosion within sites previously identified may be initiating fatigue cracks. The LAU-7/A series of launchers have been installed on the F/A-18 wingtips, since the early 1980's, which is a more damaging location. The launchers are exposed directly to the environment and are subjected to an increased amount of mechanical vibration and shock loading. These factors can decrease the fatigue life of the spot welds, especially if corrosion becomes involved in the mechanism of failure, as shown in Figure 37.

Figure 37. Graph showing the detrimental effects of corrosion on the fatigue life of a material.
