AD-A231 442 SSC-337 (PART 1)

SHIP FRACTURE MECHANISMS INVESTIGATION

SHIP STRUCTURE COMMITTEE

1990

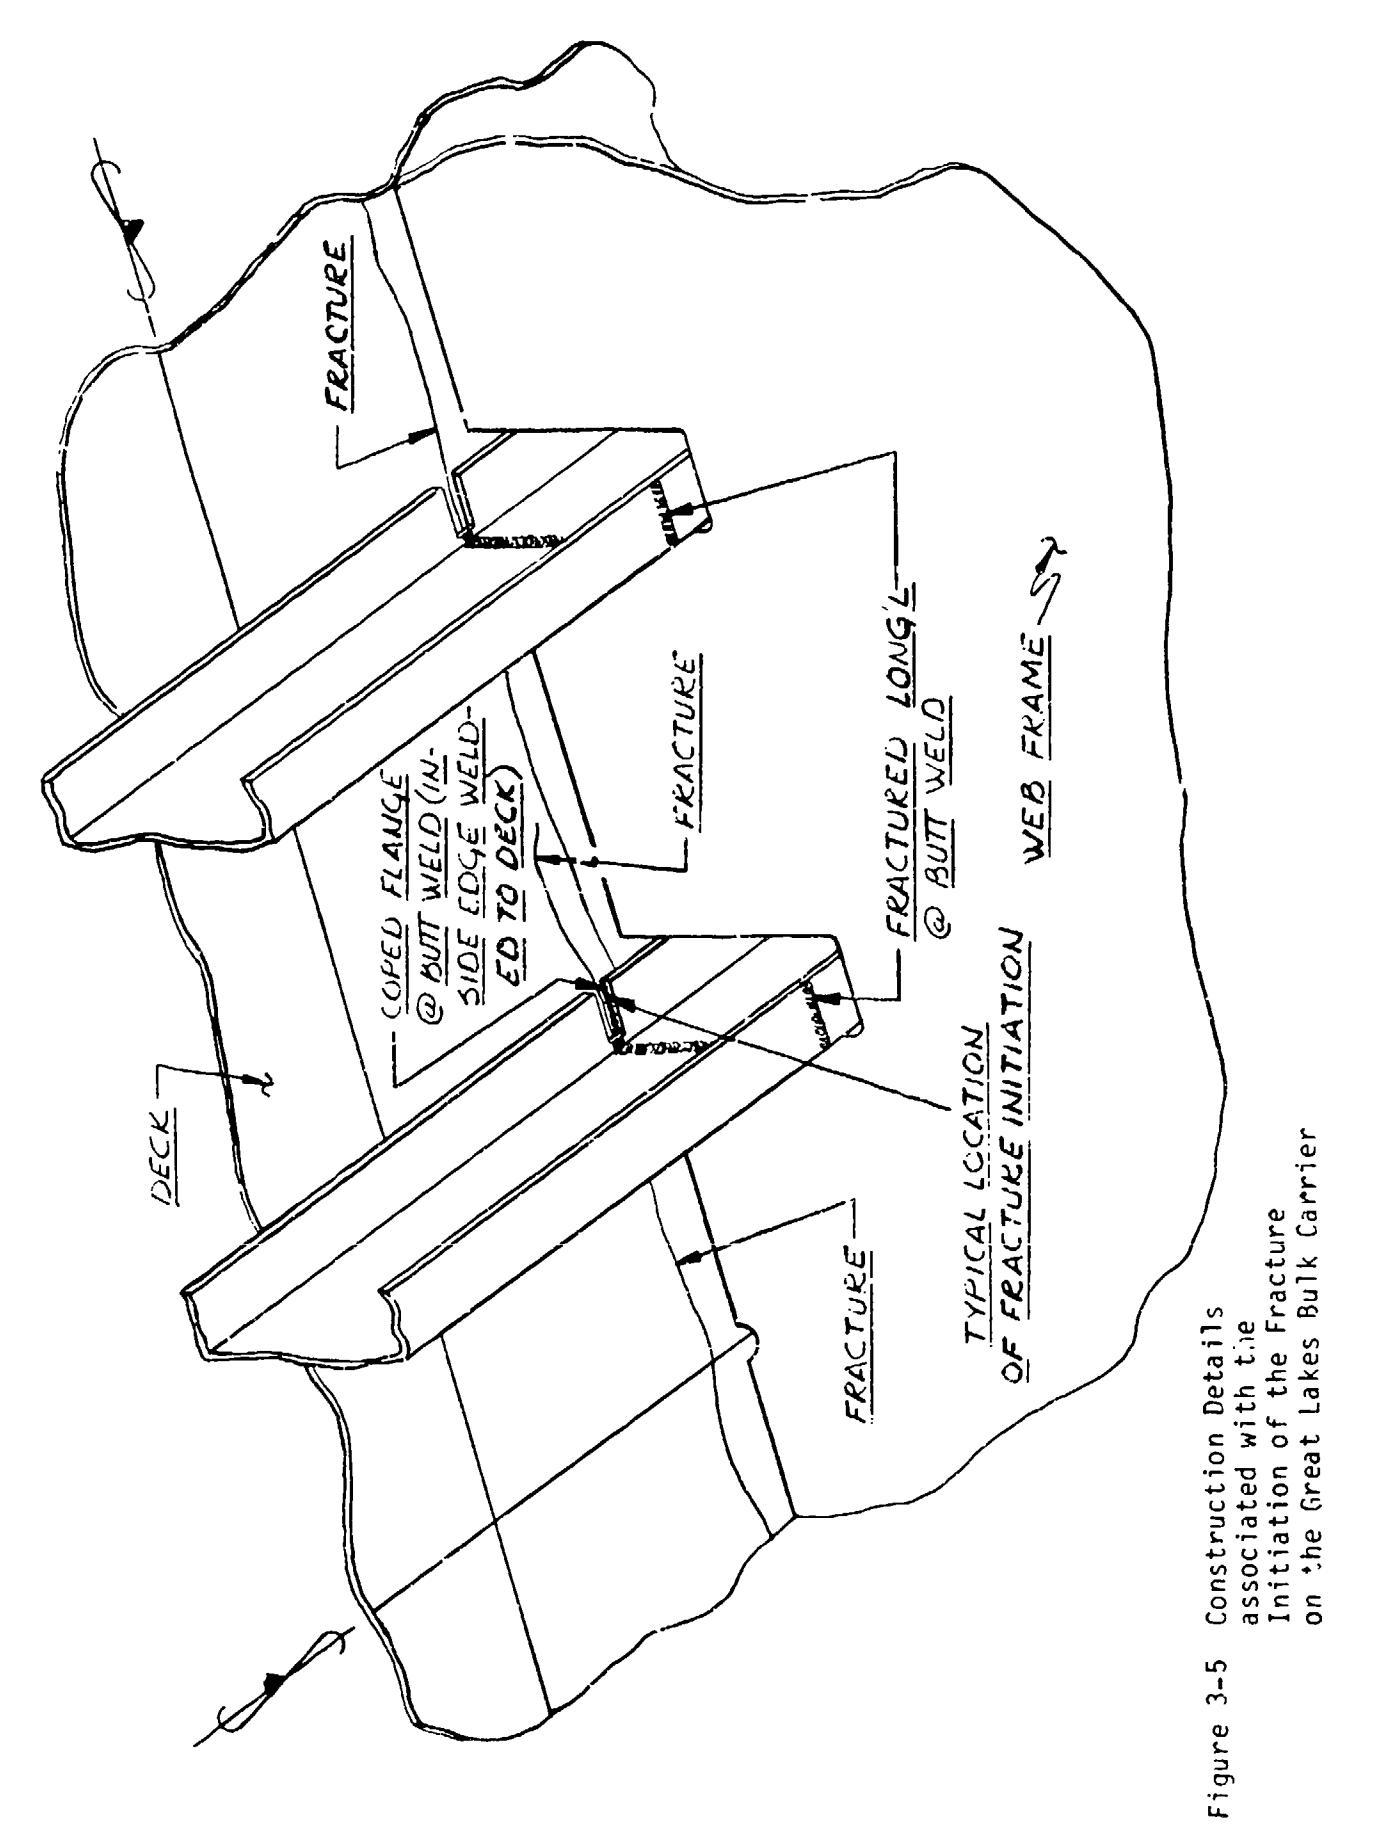
The fractures were examined January 13, 1985 by the project investigators. The fractures were located on the starboard side of the spar deck. There where three separate fractures crossing the spar deck where the ship had been joined during the lengthening process. Two of the fractures occurred in the original ship and one in the new midbody section. Upon examination below the spar deck the reason for the separate fractures became apparent. A number of poor fabrication details were used in lengthening the vessel and included plug welded rivet holes, mismatched structural members, weld used as filler for mismatched areas and notched longitudinals. The longitudinals under the spar deck consisted of channels with the flange welded to the underside of the deck at the toe and heel. The flange welded to the underside of the deck was coped out at the plate butt and the weld passed around the end of the coped flange, as shown in Figure 3-5. The chree outboard longitudinals all fractured at this same location. The fracture path in the spar deck plate ran through the notches created at the longitudinal buth welds and into the longitudinal bulkhead. The fracture surface visible in the longitudinal bulkhead during the on-site examination exhibited the classic chevron markings indicative of a brittle fracture.

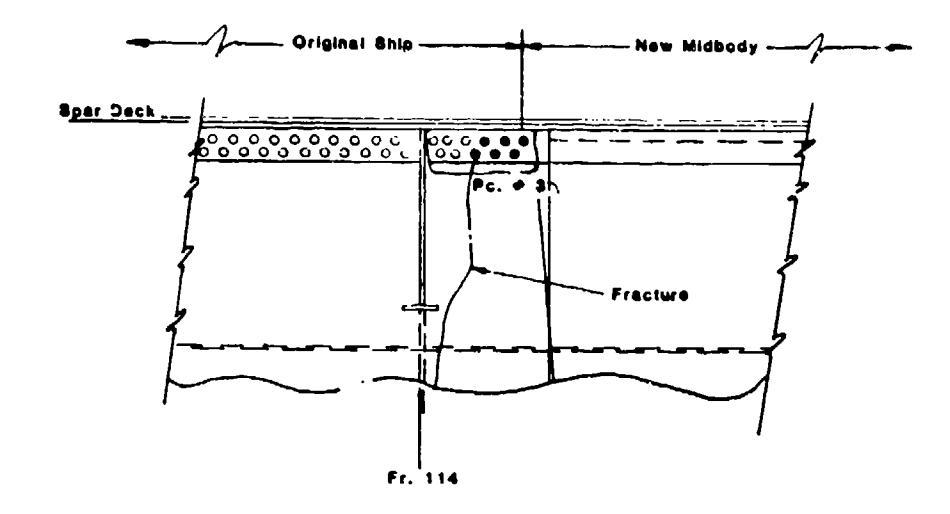
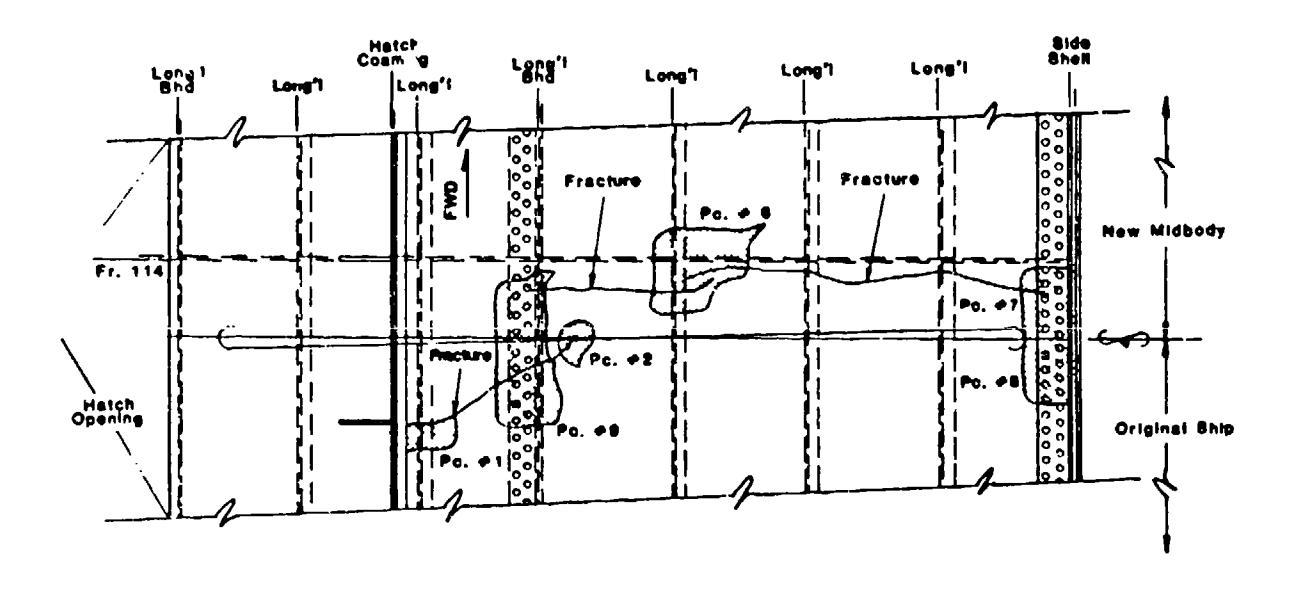
Figure 3-6 Location of Plating Samples from the Great Lakes Bulk Carrier

Nine samples were taken from the fractured plating and were shipped to Lehigh University for further examination of the fracture path, initiation sites, and arrest sites. The locations of these pieces in the spar deck are shown in Figure 3-6. A detailed description of the fracture samples is presented in [3-1]* and is summarized below.

Sample No. 6 contains two separate fractures, both of which appeared to either terminate or initiate in the sample. Cutting the sample to reveal the fracture surfaces showed that the crack extending toward the longitudinal bulkhead at the toe of a weld at the cutout in the longitudinal channel initiated in sample No. 6; see Figure 3-9. From this point the fracture ran both inboard and outboard. One end terminated in the plate a short distance outboard of the channel while the other end terminated at a rivet hole in sample No. 9. The growth directions of both of the fractures and the presence of the initiation was clear in the sample from the chevron markers.

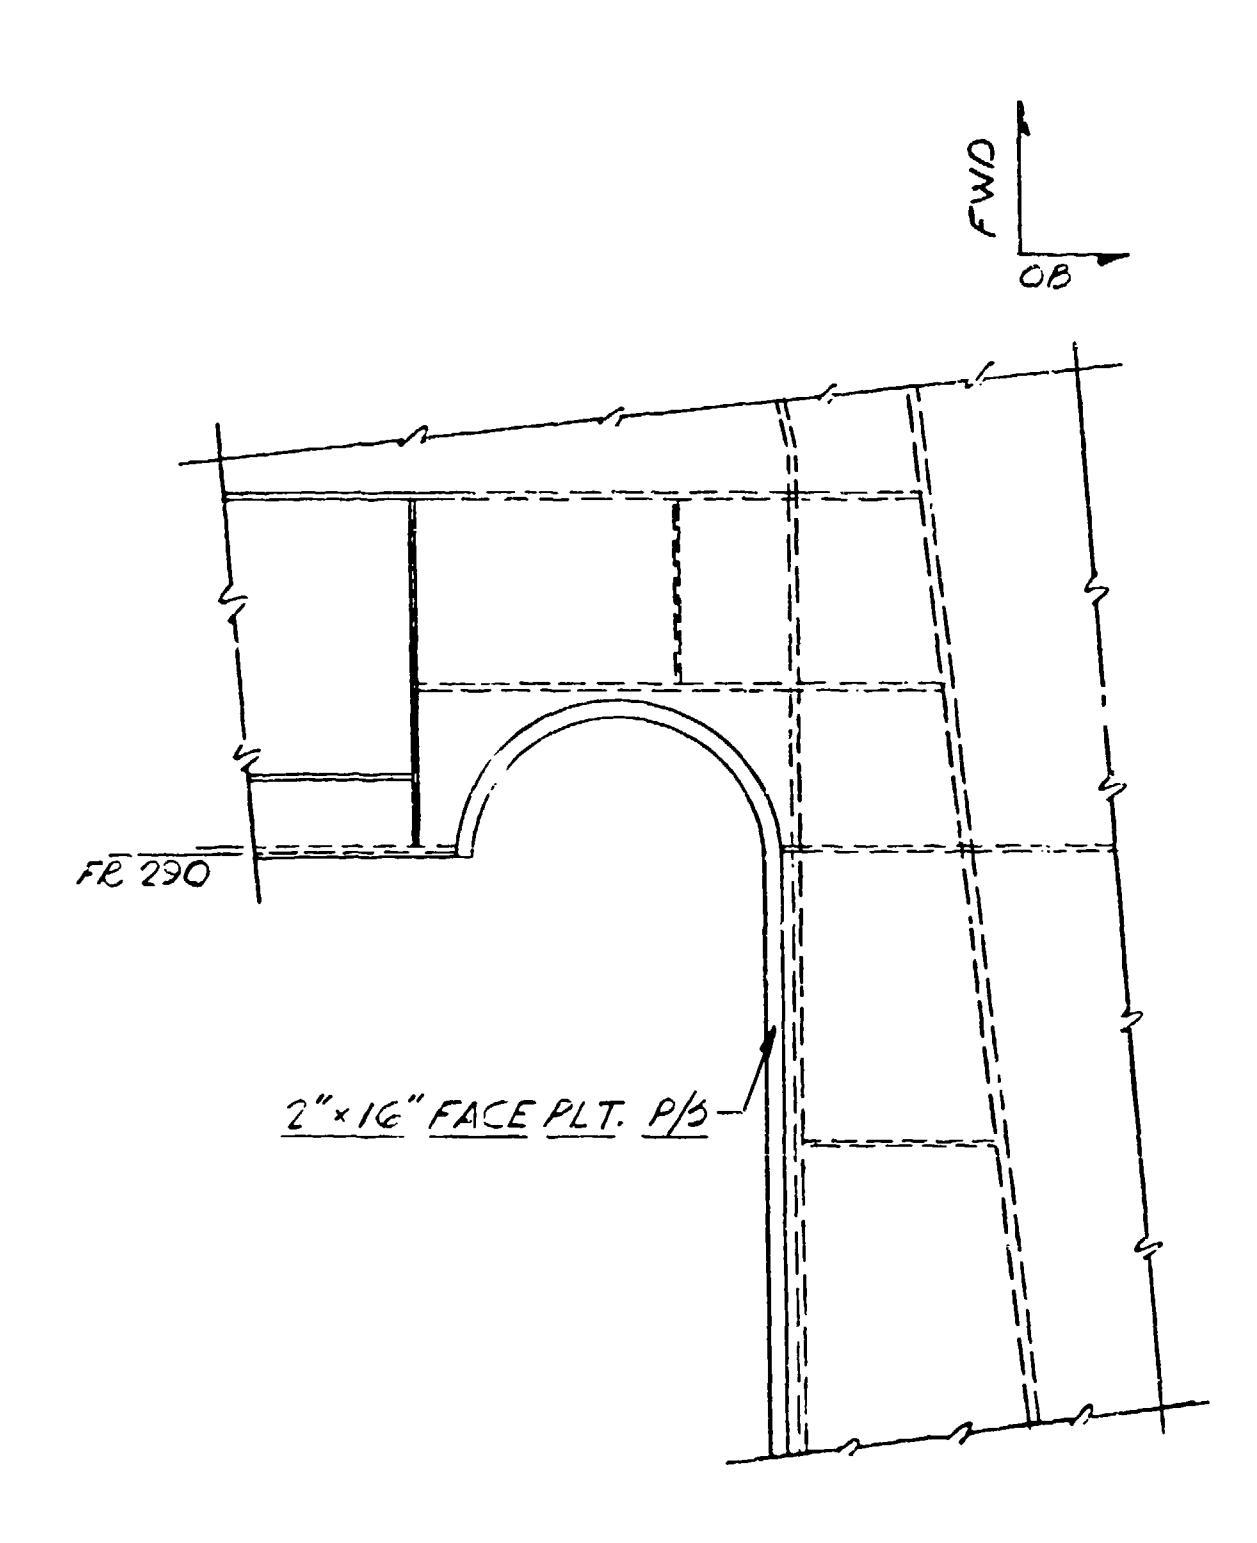
Figure 3-18 Face plate design for the forward hatch corner of the high speed containership
- Maximum stress at hull girder frequency (whipping) of 5,943 psi
- Mean stress (primarily from cargo and ballast distribution)* of 7,936 psi. hogging.

During the storm and throughout the first two operational seasons, hull girder response information was obtained in the general vicinity of the forward hatch corners. However, during the third season (after the cracks were observed) strain gauges were placed inside the hatch corner and a maximum stress (linear equivalent) of 79,000 psi was measured.

The fracture which was discovered after the storm of December 22, 1973 extended radially from the inside of the hatch corner as shown in Figure 3-16. A number of unsuccessful repair attempts were made before finally installing "CS" normalized steel doubler plate over the existing deck plate at the hatch corners. This repair fractured in the spring of 1976. The crack in the doubler plate is shown in Figure 3-17. Finally, a 2"x16" face plate was added to the inside face of the hatch cutout as shown in Figure 3-18, after which no additional fractures were reported except for an isolated weld failure.

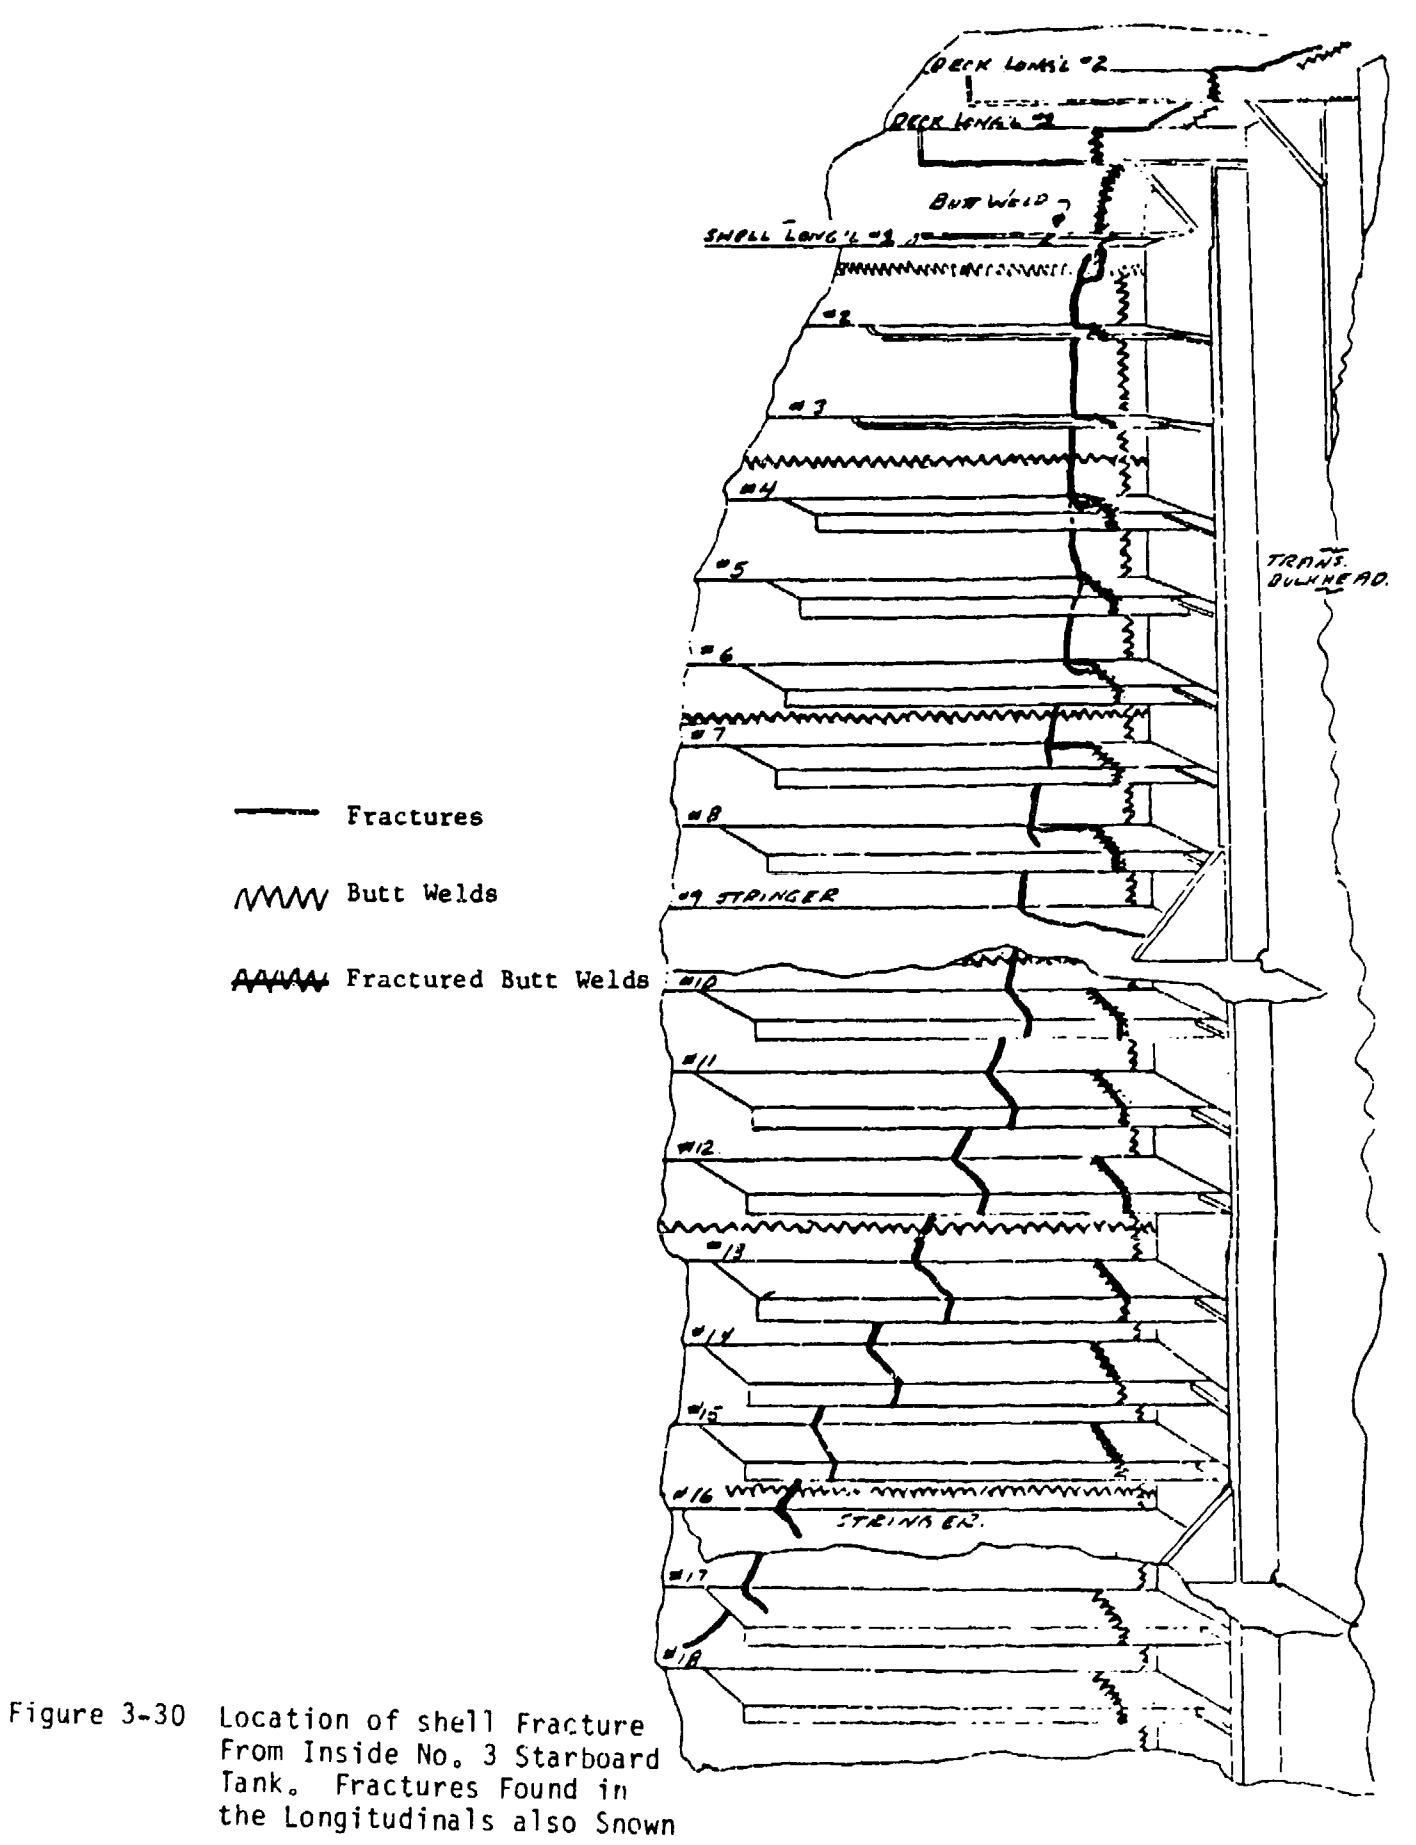
Figure 3-29 shows a sketch of the external appearance cf the fracture which occurred in the shell and deck plating of No. 3 starboard wing tank. This failure appear to be three interconnected fractures plus one separate fracture. The main fracture extends from No. 1 side shell longitudinal to No. 18 side shell longitudinal. A second fracture is in the weld of the gunwale plate and connects to the main fracture in "S" strake. The third fracture in the deck (J-strake) connects to the fracture in the gunwale plate. An independent fracture was found across the weld between "P and "O" strakes. This fracture was directed towards, but not connected to, the main fracture.

The analysis consisted of visual examination by ship owners' representatives and material property determination tests. Visual examination of this main side shell fracture showed the majority of the surfaces to be fibrous with chevrons clearly evident. These chevrons "point" to the origin of the fracture. In this case the origin was in the fillet weld of No. 5 longitudinal in line with the erection butt weld made in this longitudinal. This fracture surface is shown in Figure 3-31 with the initiating point shown in more detail in Figure 3-32.

Figure 3-29 General View of Shell Fracture No. 3 Wing Tank Starboard

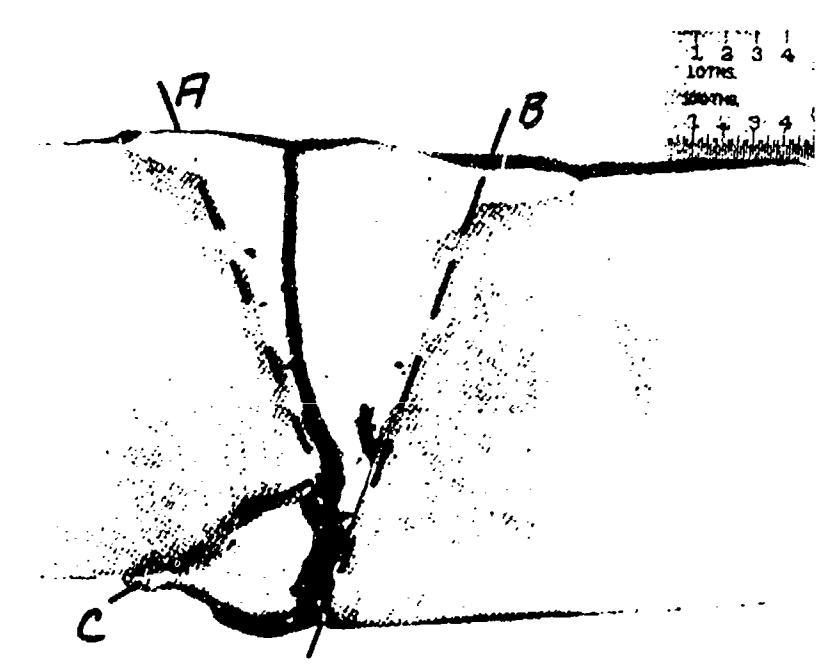
A detailed examination of the butt weld in No. 5 longitudinal showed that the weld was poorly made. Figure 3-40 is a sketch of how the weld attaching the longitudinals to the shell plate at the butt weld was supposed to be made. The butt welds in the web and face flange of longitudinal No. 5 are shown in Figure 3-41. The soundness of the web weld is good but it is obvious that the root was not back-chipped before back welding. The weld in the flange is extremely poor with effective fusion for less than half the depth. The lines "A", "B" and "C" indicate the angle of joint preparation. These welds obviously were not of the quality desired nor did they conform to the design joint of Figure 3-40.

Figure 3-41 Cross sections through the built welds in No. 5 longitudinal. Lines A, B and C indicate edge preparation prior to welding. The small beads were made from the underside or backside. Note wide cover pass. Specimen No. 3908; Etch, 4% Nital; Magn. 1.5x.

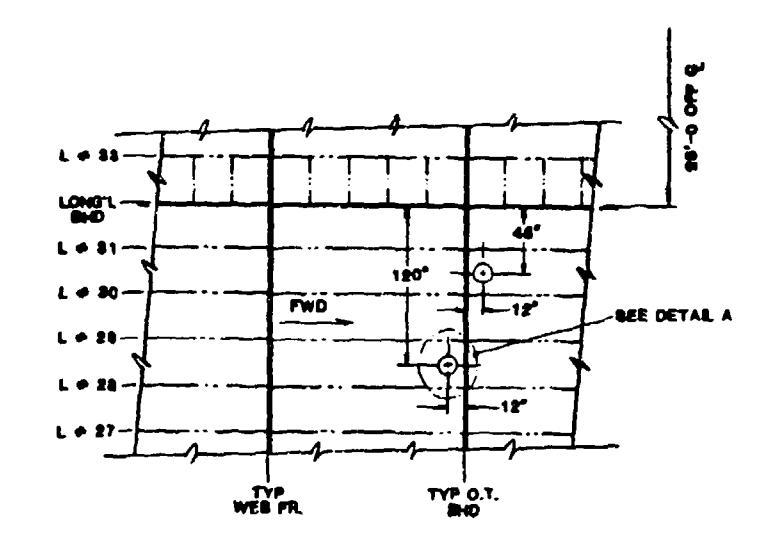
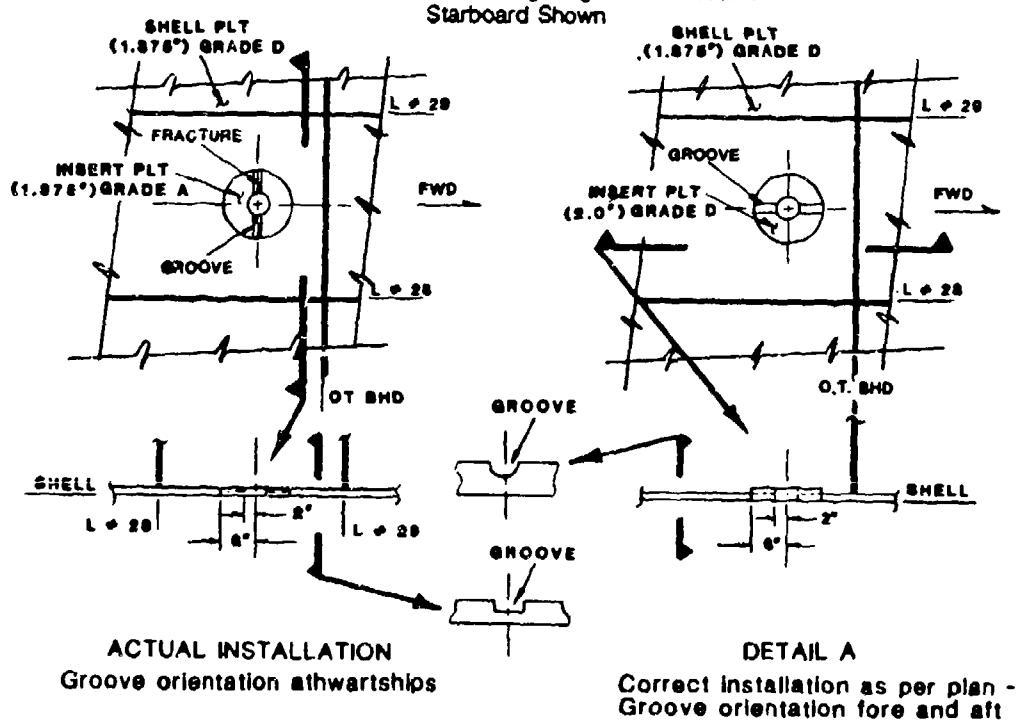
Figure 3-45 Structural Detail of the Docking Plug on the 70,000 DWT Tanker

The fracture was examined by the project investigators. The bleeder/docking plug is used for draining tank liquids in dry dock. There are usually one or two plugs per tank. These plugs are often located in insert plates as shown in Figure 3-45. These insert plates are thicker than the base shell plate to receive a threaded plug, and are often grooved to facilitate drainage. The

plans for the new forebody note that the groove should run fore and aft. The grooves in the insert plates examined on the ship were installed athwartship as shown in Figure 3-45. This tanker had two plugs per tank, all of which had grooves running athwartship. In all, four insert plates were fractured at these grooves.

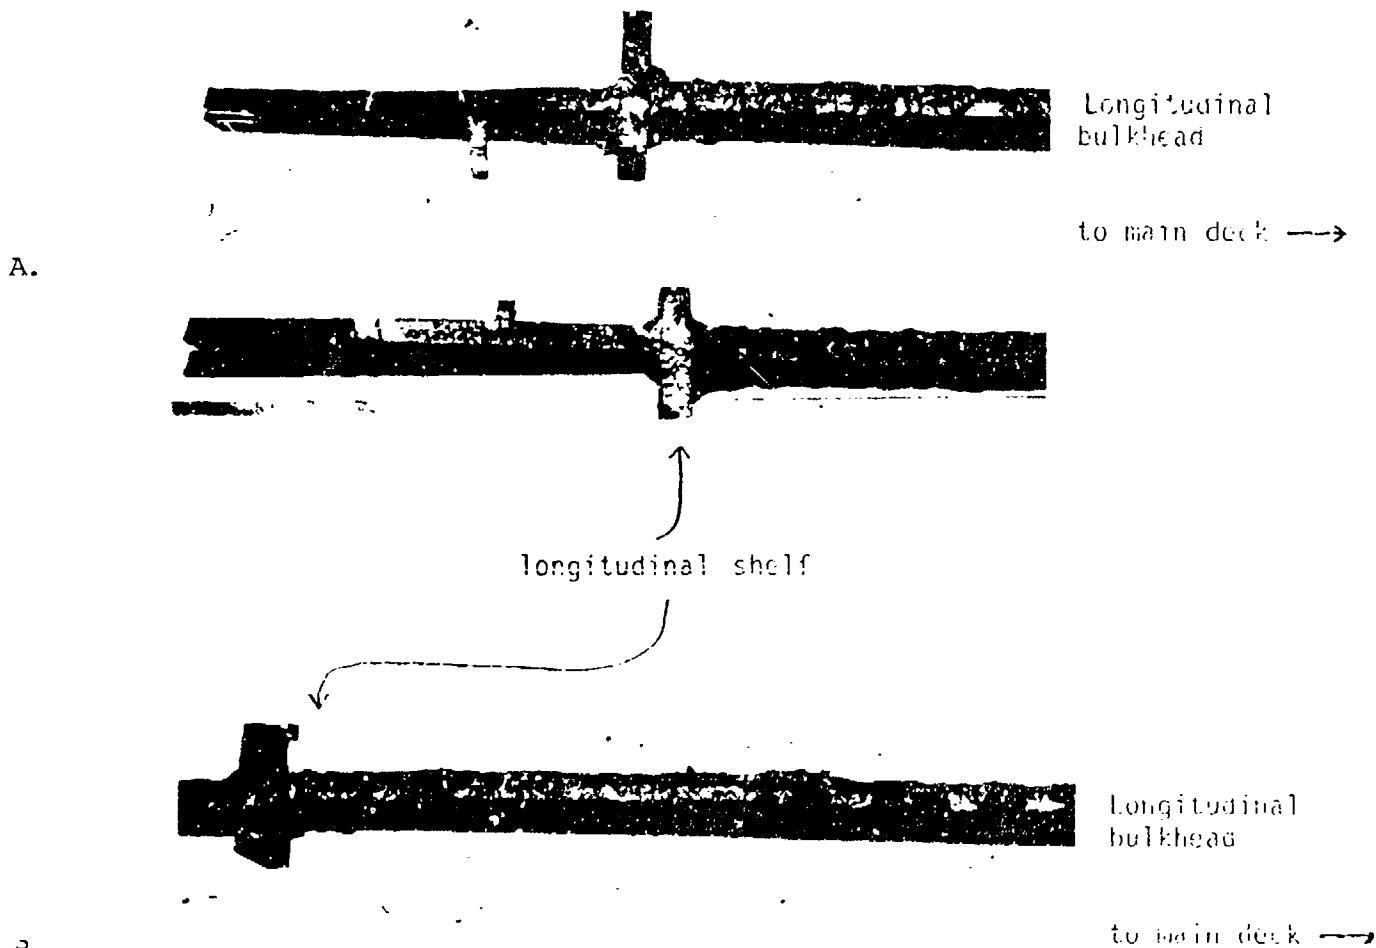
Figure 3-67 (Cont'd) Details of the 123,000 DWT Tanker Fracture Surface

There are two regions of the major fracture in the weld seam which appear to show faint chevron markers. These are seen in Figures 3-57A, 3-67B, 3-67C and 3-67D. It is the investigators' opinion that the only area that is likely to be evidence of a fast fracture is the area in Figures 3-67C and 3-67D. The chevrons in this case point upward toward the deck. This suggests that initiation was by fatigue, from some point at the toe of the seam near the deck, and the crack grew downward, mostly by fatigue. It may have had short areas of brittle crack extension. When the fatigue crack crossed the shelf plate, it extended by brittle fracture until the arrest seen in Figure 3-66.

The project investigators believe that the fracture initiated by fatigue along the toe of a butt weld in the bulkhead, probably at several places, and progressed along the seam by both fatigue and brittle fracture. A clear brittle fracture region occurs in the bulkhead below the longitudinal shelf plate. The

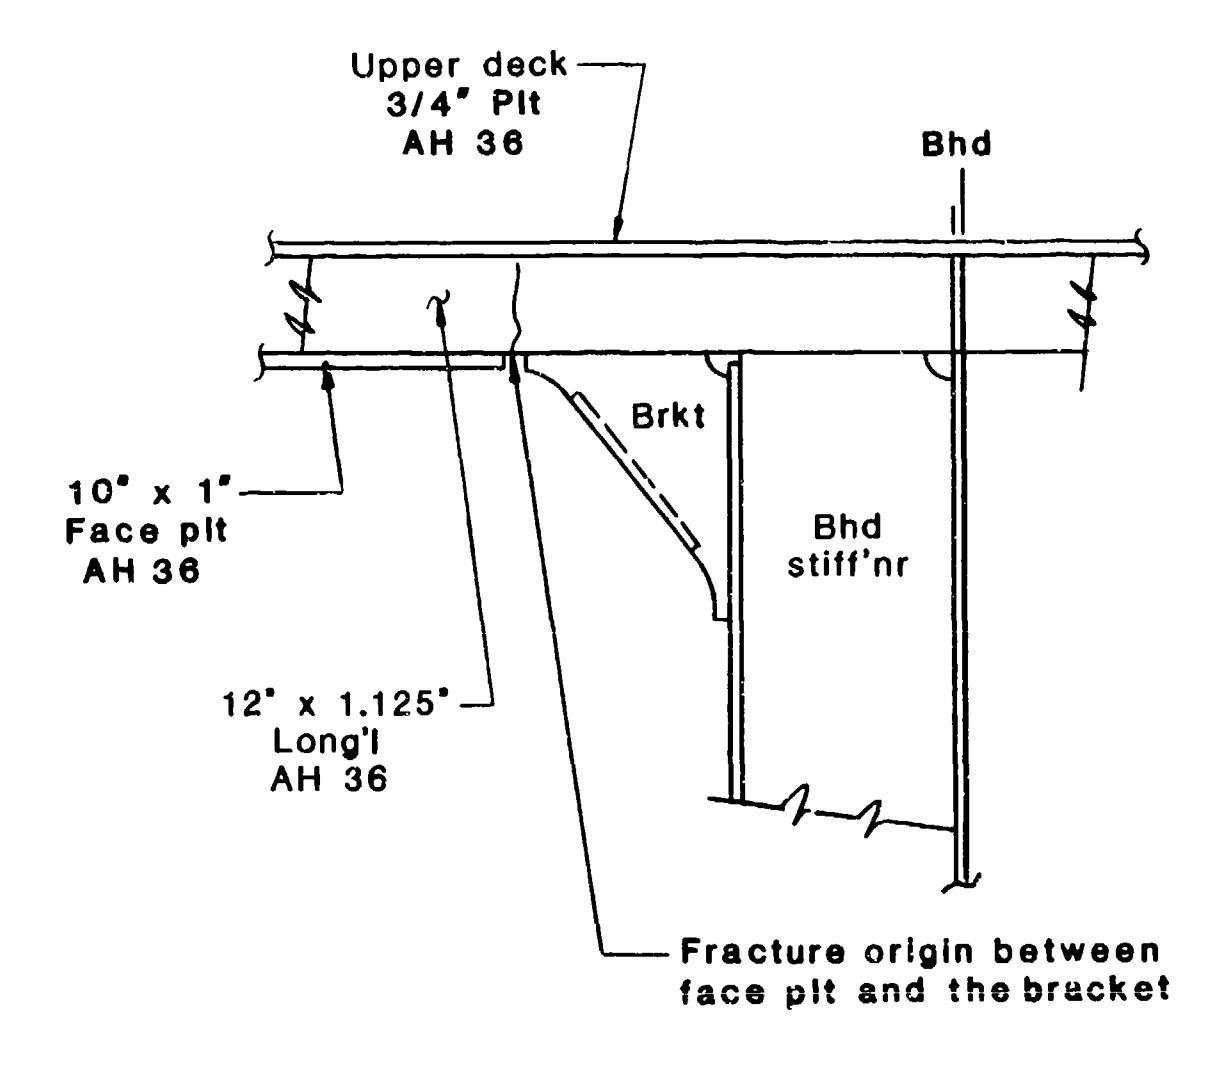
Brittle fractures occured on the starboard side of the main deck 6 in. aft of Frame 64 and 10 ft from the sheer strake, including one transverse fracture 10 ft long.

The apparent point of origin is at a notch in the underdeck longitudinals fetween the longitudinals and a bracket in the transverse web frame as shown in Figure 3-71. Fatigue propagation was observed in the longitudinal fractures.

The ship operator reported that the fracture originated at the details described above. Fatigue extension was observed in the longitudinal and for a short distance in the main deck.

Fatigue cracks propagated in the longitudinals and reached a critical length that initiated the brittle fractures.

The fracture reportedly terminated at EH Grade steel arrestor strak ϵ s .
