FAILURE ANALYSIS OF FUEL INJECTION PUMPS FROM GENERATOR SETS FUELED WITH JET A-1

INTERIM REPORT
BFLRF No. 268

Belvoir Fuels and Lubricants Research Facility (SwRI)
Southwest Research Institute
San Antonio, Texas

January 1991

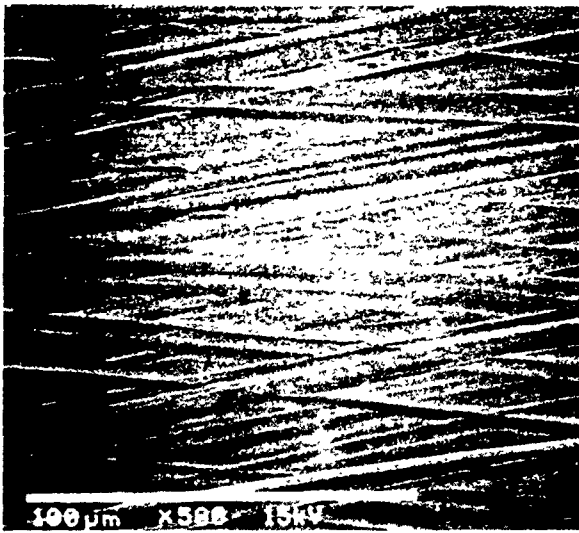
a. Bore

After completion of the pump tests, the bores from Pump Nos. 2, 3, and 4 were cut from the hydraulic heads and sectioned parallel to the axis of the valve using an electric discharge machine (EDM). Almost no material was lost during the cutting process, and the complete surface of the valve bore was then available for examination. Machining marks were visible on the surface of each bore and valve spindle, as shown in Fig. 8.

Figure 8. Representative machining marks on metering valve
