N-1826

March 1991

Technical Note

DEVELOPMENT OF A SEAWATER HYDRAULIC ROCK DRILL

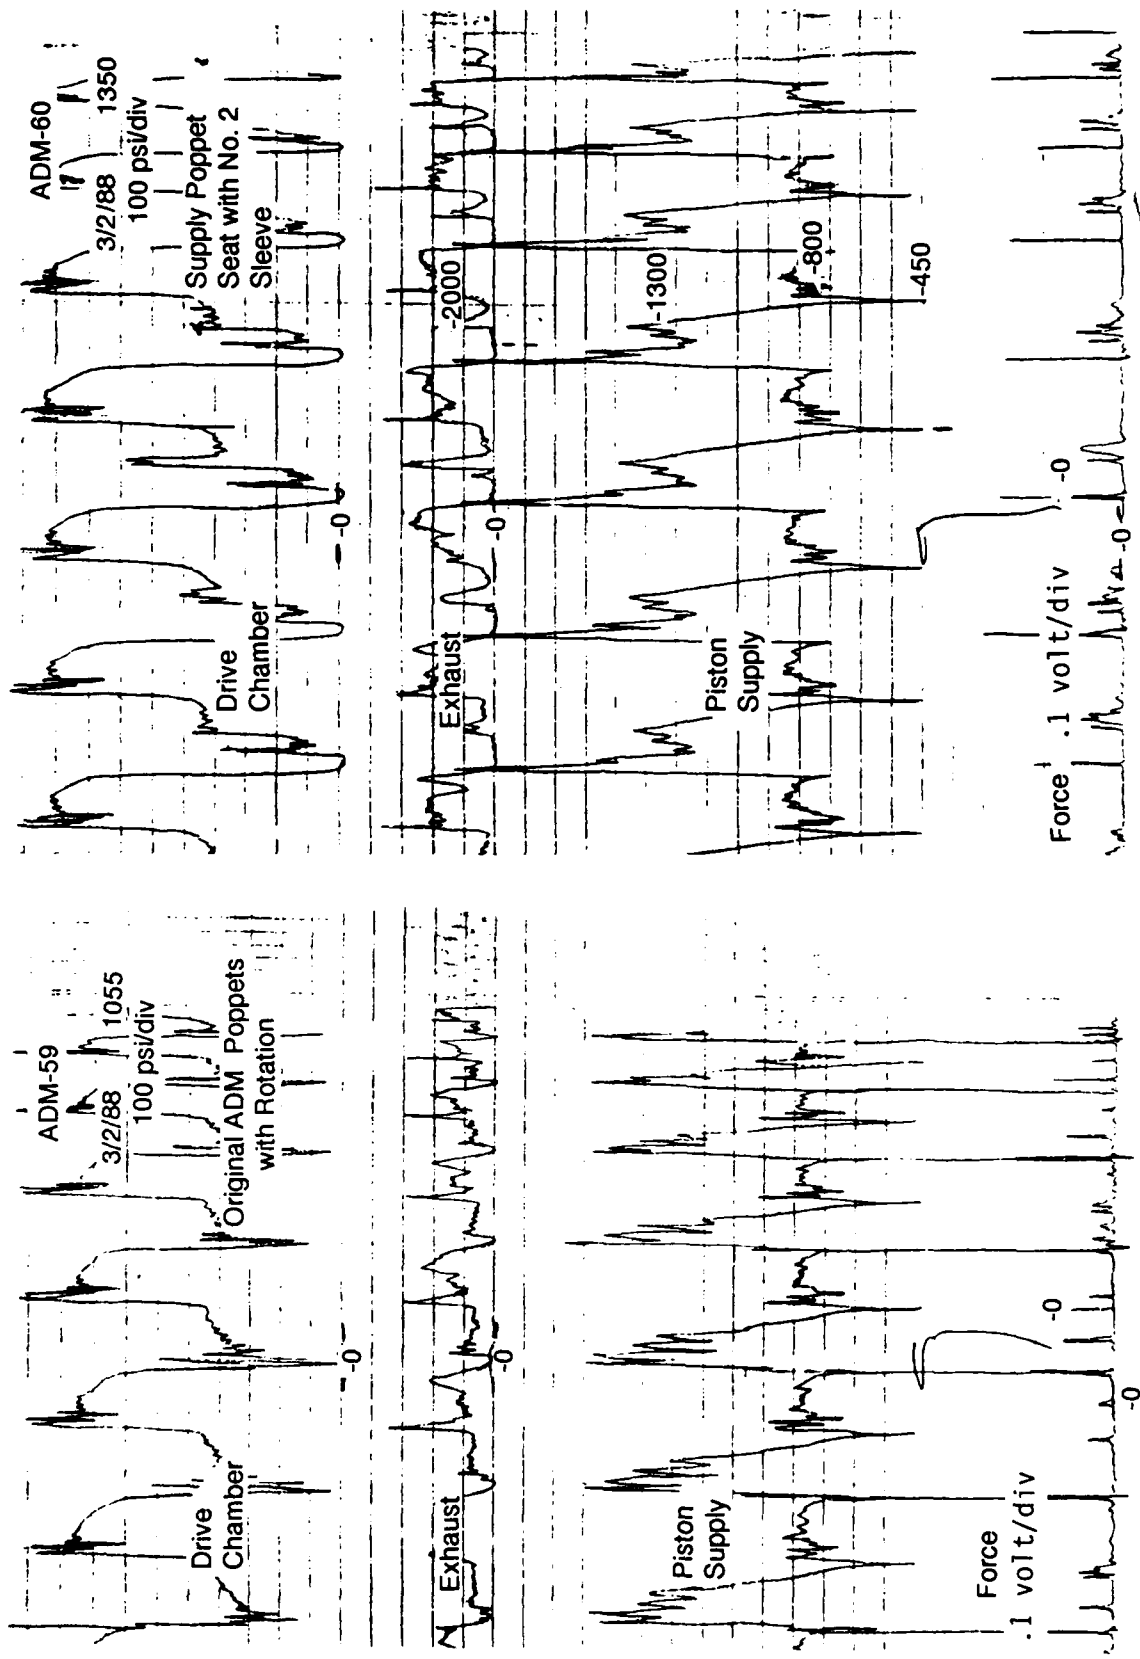
Figure 11 shows the difference in the pressure traces between the old poppet and the new poppet. The new poppet has a higher than normal, very short duration pressure spike in the piston supply line at the bottom dead center point in the cycle. After some review, it was hypothesized that this pressure pulse, the result of the rapid closure of the new supply poppet, was squeezing the piston seals to brake the piston just prior to impact against the anvil.

Figure 11. Differences between old and new poppets.

A comparison of the new and the old supply poppet assemblies showed the physical difference to be a worn-in seat area on the old poppet face, Figure 12. This worn-in area was the result of repeated poppet closures on the poppet seat. To duplicate this difference, the new poppet was lapped to approximate the profile of the groove in the original poppet, Figure 13. The grooved poppet restored impact energy. Evidently, the groove provides a cushion to attenuate the water hammer that causes the piston seals to brake the piston. The full dynamics of the seat profile are not understood, however, the desired seat profile was easily duplicated. All other poppets were subsequently lapped and matched to a seat with acceptable results.

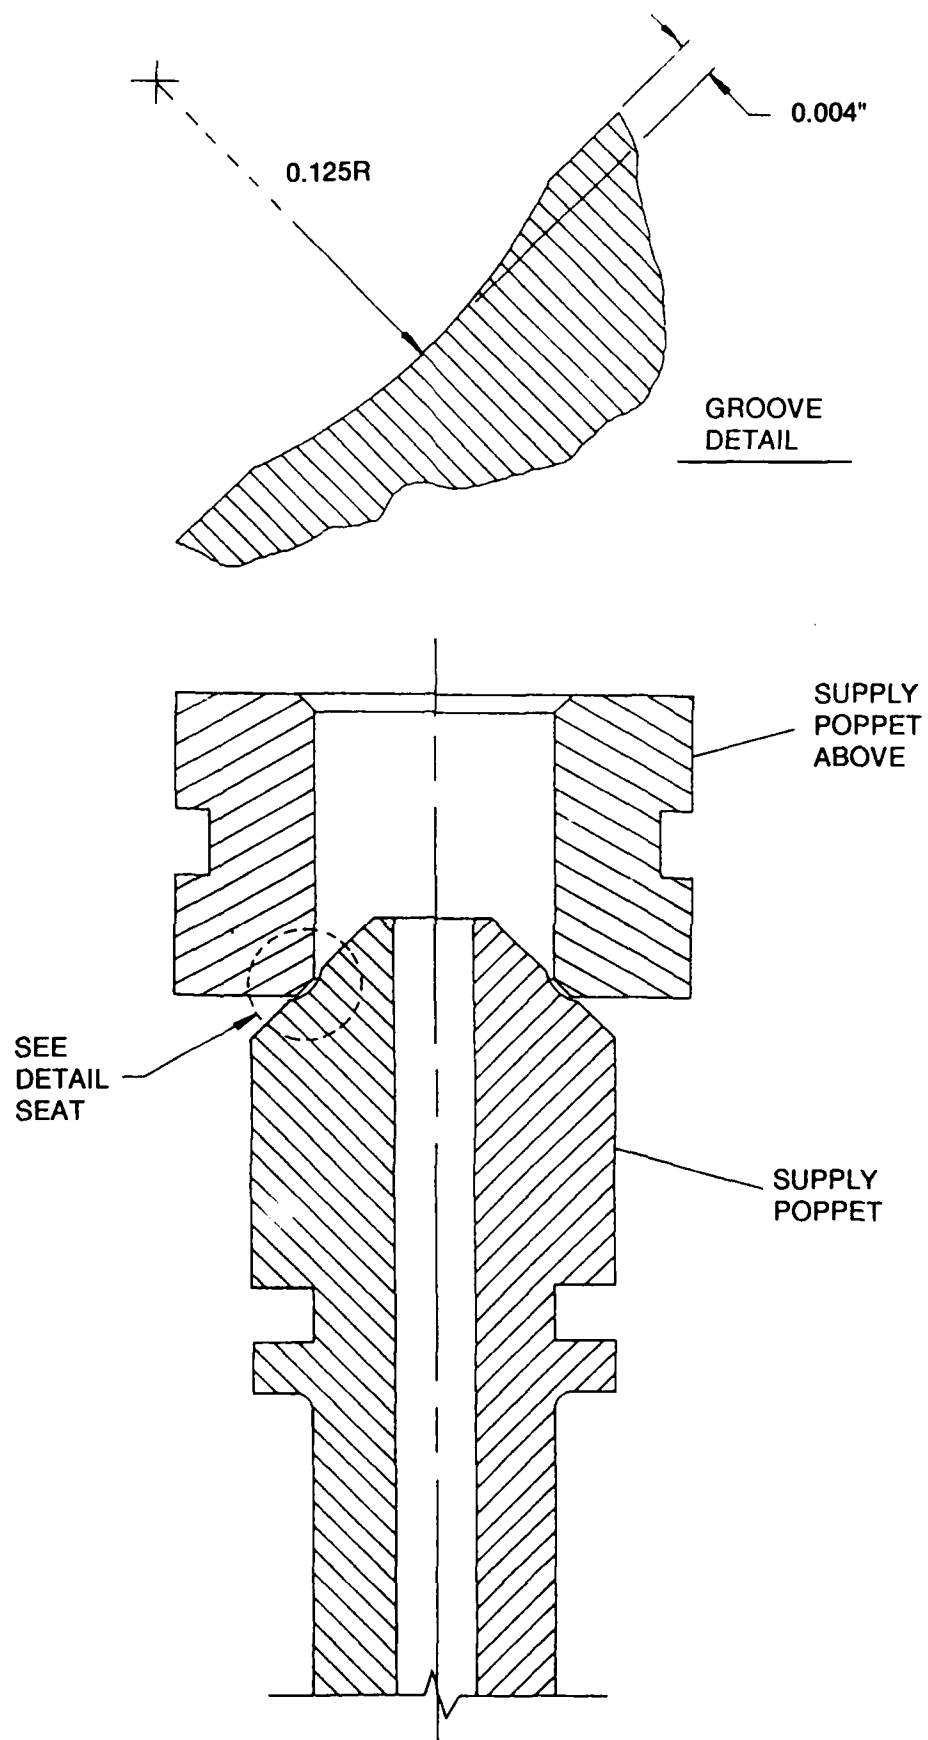
Figure 13. Supply poppet groove profile.

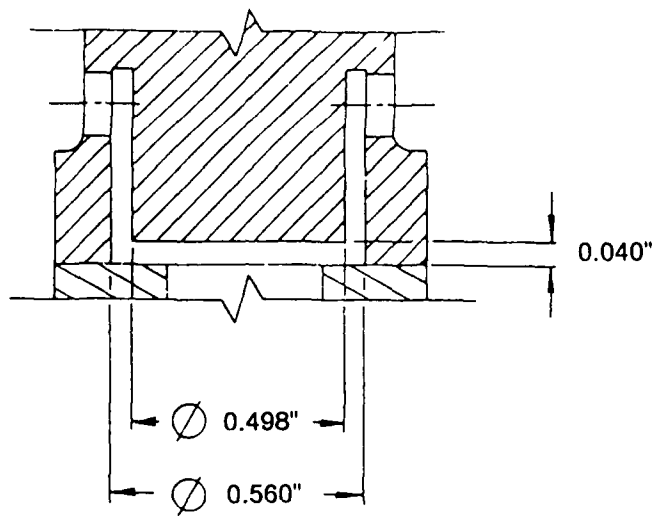
ORIFICE DETAILS

The failure of the exhaust poppet to close, as encountered during the endurance test, did not affect cycle timing. The apparent effect of the open exhaust poppet was a reduced drive chamber pressure. This resulted in a small reduction in impact energy. It was theorized that the linear impact mechanism could be simplified by replacing the exhaust poppet with an orifice. Tests were conducted with an adjustable orifice to determine an optimum orifice size that would produce a minimal decrease in drill performance. Parametric tests determined the optimum opening and a fixed insert having this configuration was made to replace the poppet assembly (see Figure 15). This simplified cycle is referred to as a single poppet-kicker port cycle.

Figure 15. Exhaust orifice design.

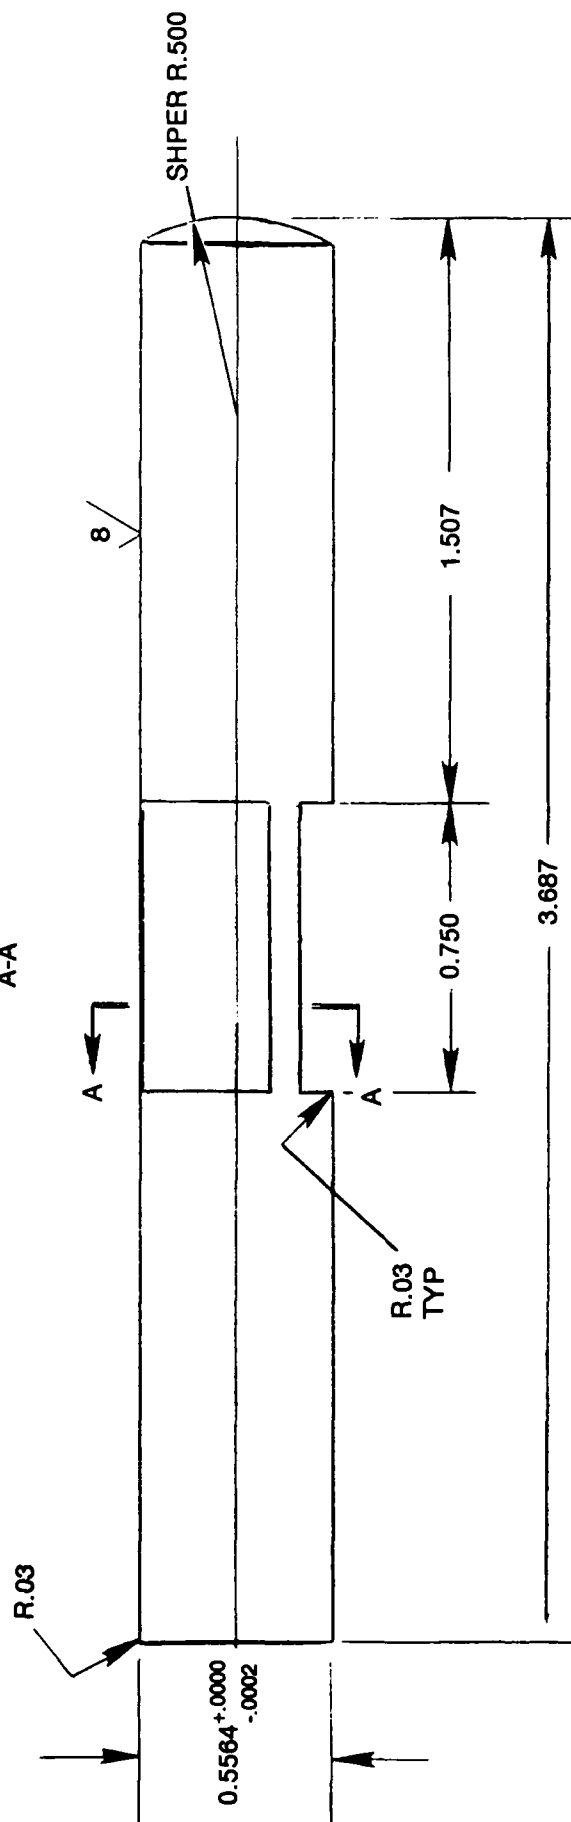
The first attempt to control sleeve alignment, using a plunger of a single diameter, was unsuccessful. The new plunger design, Figure 17, having a single diameter along its length and thin bridge sections at the porting cutout, did not maintain contact with the rear sleeve throughout the stroke. When tested, both the 440C and the MP35N plunger and sleeve pairs failed within a few cycles. The alternative solution was to control alignment with a single sleeve.

Figure 17. Single diameter drive plunger.

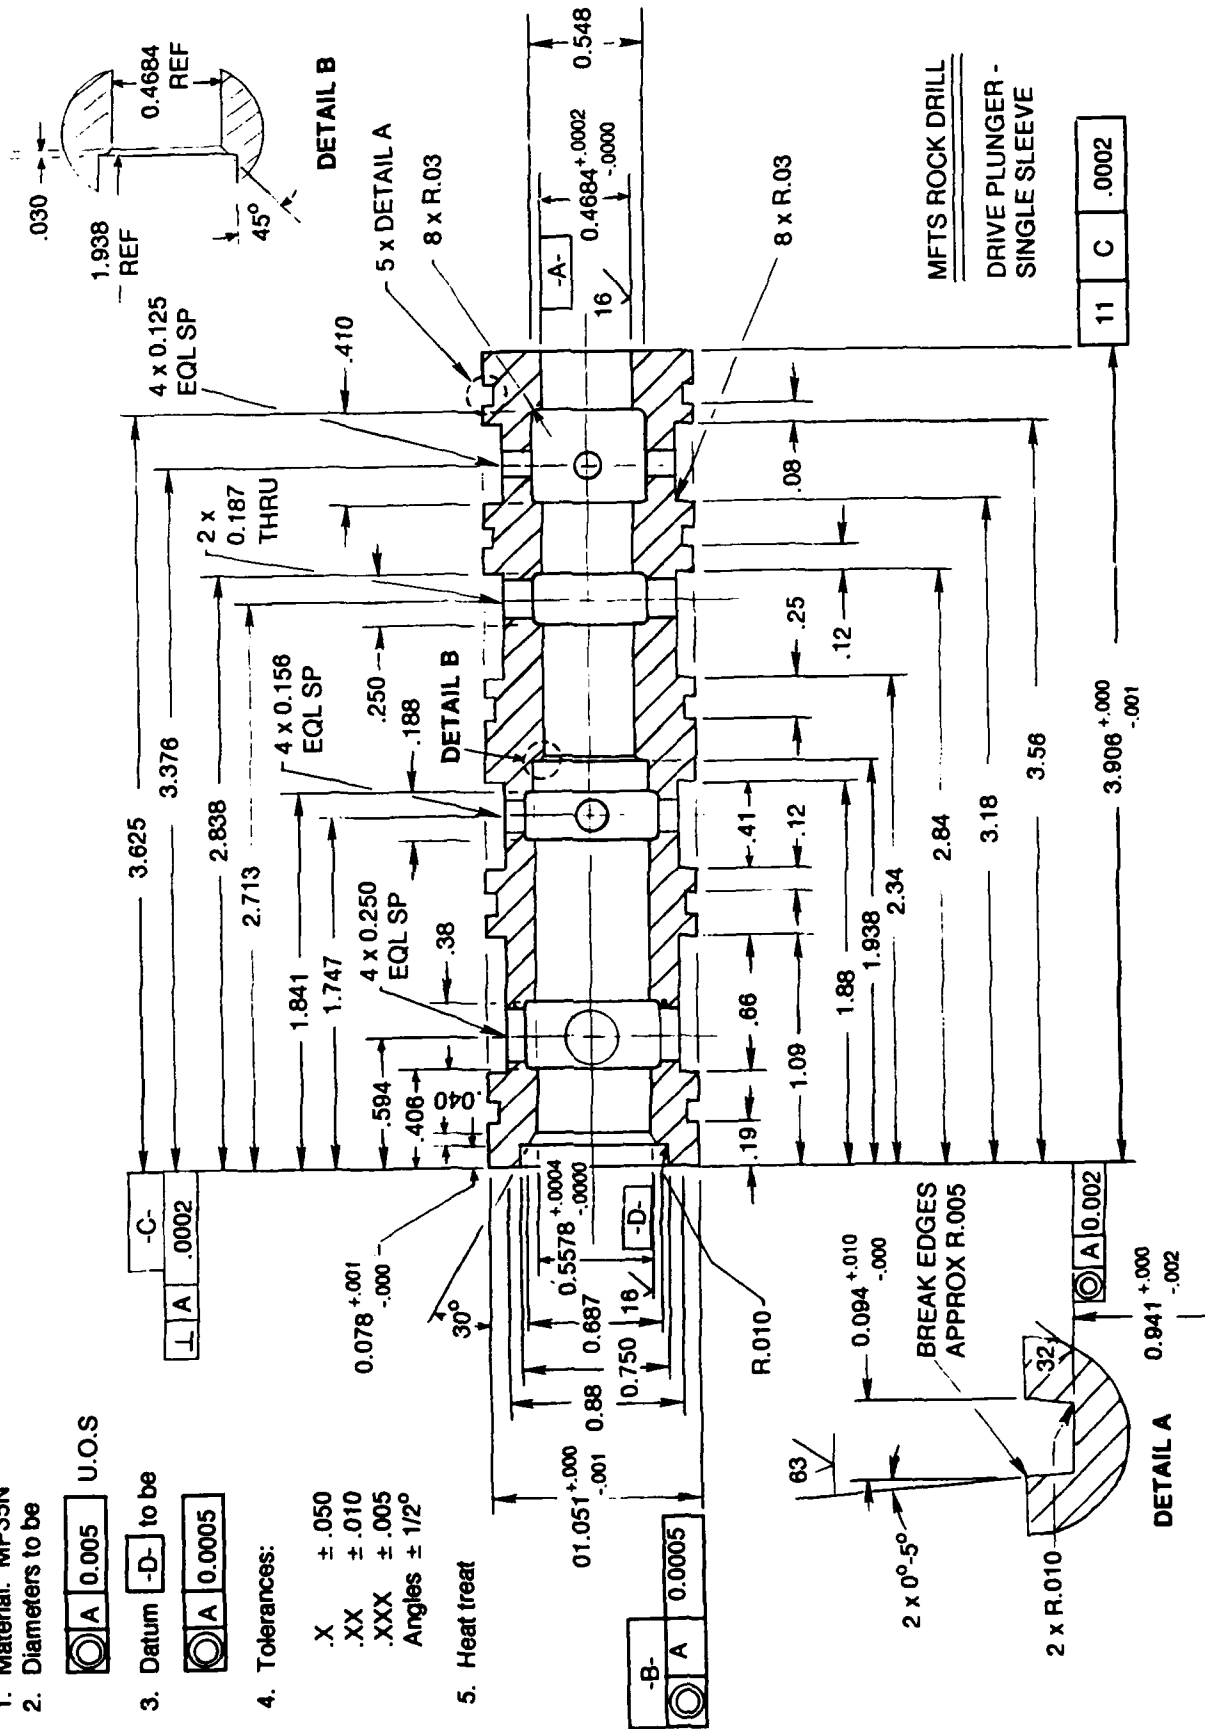
A single sleeve, Figure 18, having the original bore profile of two diameters ensured the best possible alignment. This single sleeve was made from MP35N and tested with 440C/ Nedox coated drive plungers. A marked improvement in the integrity of the Nedox coating on the plunger was observed even after 75 minutes of operation. An occasional chip to the coating was caused by the brittle Nedox coating reacting to the impact.

Figure 18. Single sleeve.
