MONITORING COMPLETED COASTAL PROJECTS PROGRAM

MISCELLANEOUS PAPER CERC-91-10

**MONITORING OF COMPLETED BREAKWATERS
AT CATTARAUGUS CREEK HARBOR, NEW YORK**

September 1991

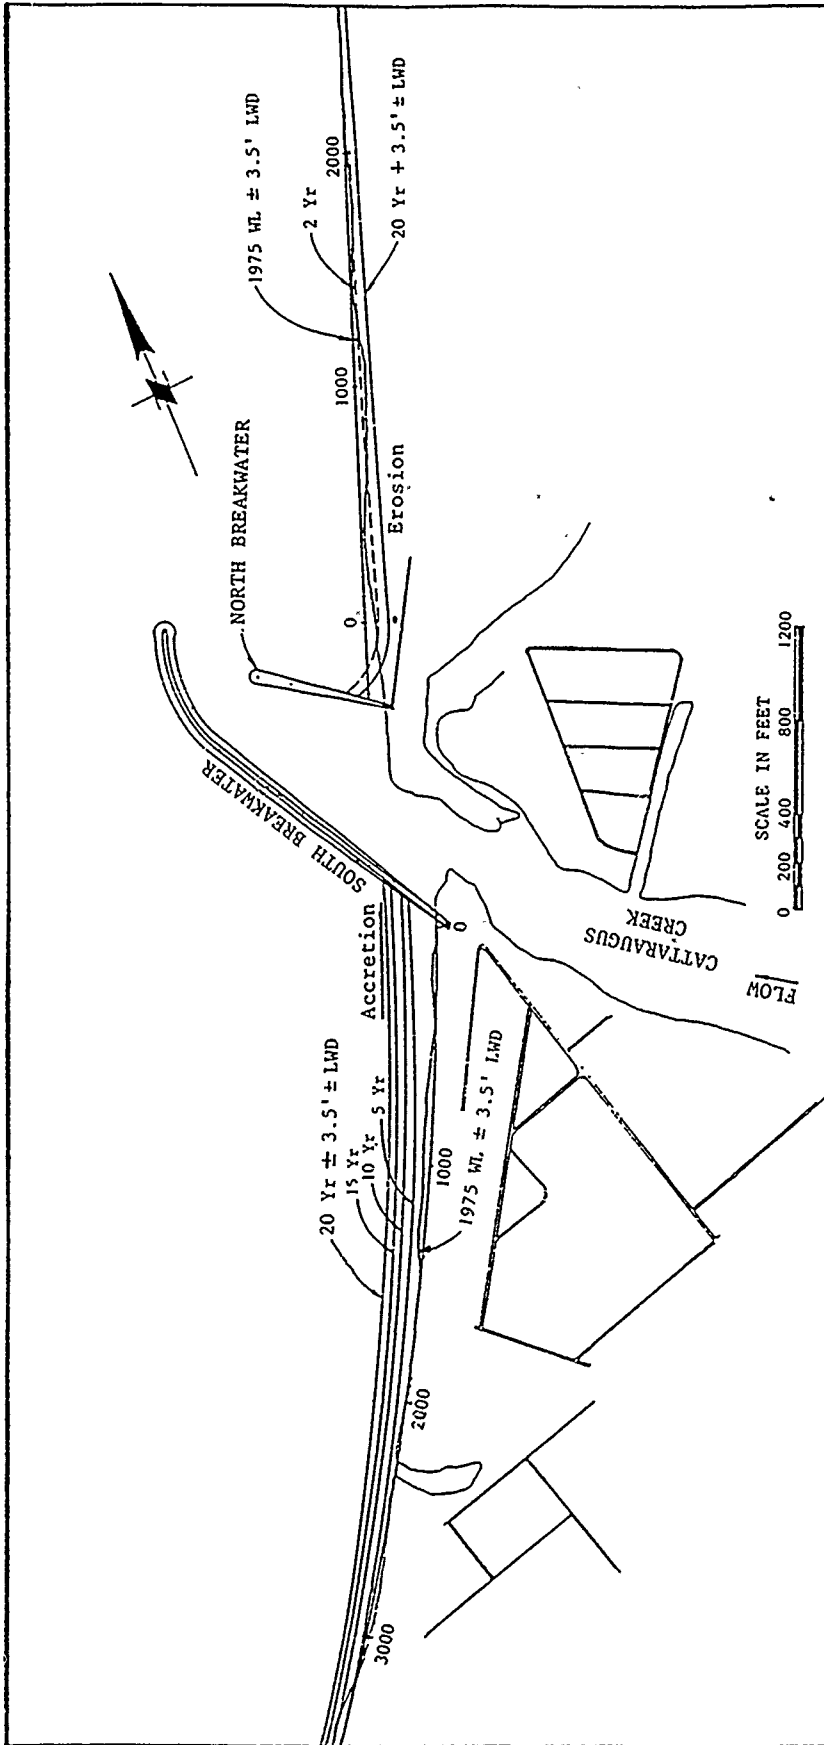
14. Based upon the littoral transport analysis, the potential effect of the harbor structures on adjacent shorelines was estimated. It was assumed that the south breakwater would act as an impermeable groin impounding littoral drift on the south beach and effectively cutting off the littoral drift supply to the downdrift beach to the northeast. Prior to construction of the breakwaters, littoral drift was supplied to the northeast beach from Cattaraugus Creek bed load and material that passed the creek mouth from sources to the south. Construction of the breakwaters would reduce this supply, and dredging of the channel would reduce the quantity of material entering the beach system from the creek. These factors would cause a net accretion and erosion of the beaches to the south and north, respectively. The breakwaters would also reduce the effect of Cattaraugus Creek as a source for the southerly beaches during reversals in littoral transport to the south. By the application of the Pelnard-Considere's method (USAED, Buffalo 1976), which predicts the configuration of the fillets impounded or eroded at a groin given the transport rate and angle of predominant wave attack, a predicted shoreline map was developed (Figure 14).

Figure 14. Predicted shoreline accretion and erosion

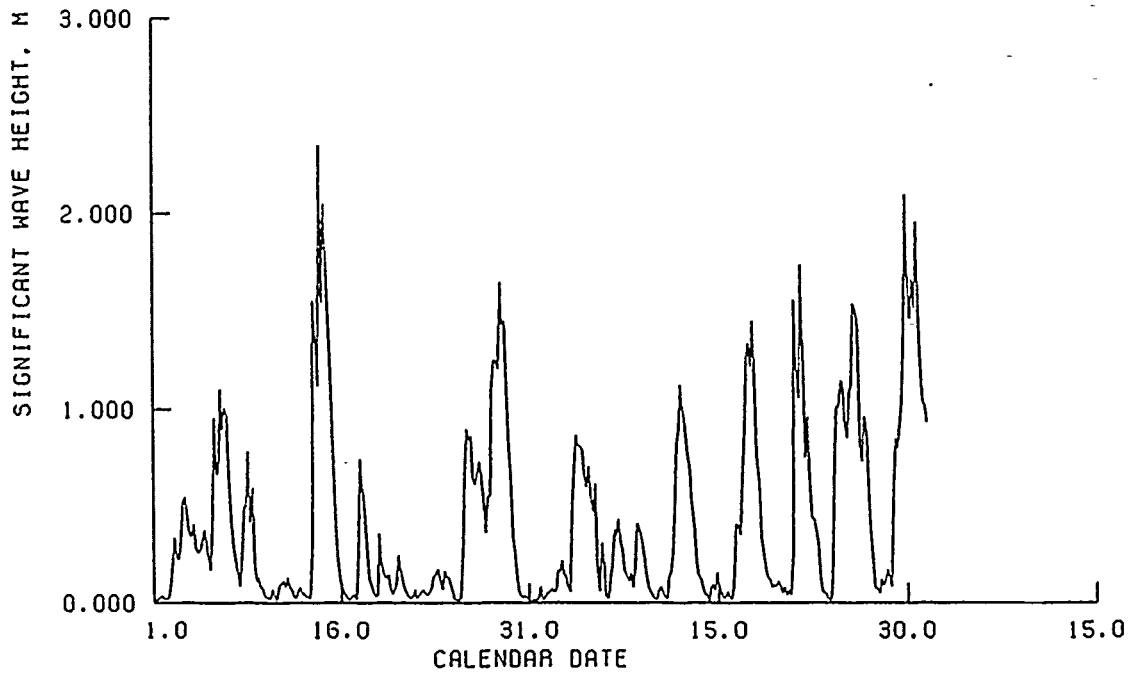
42. Figures 19 and 20 show the history of significant wave height and peak frequency, the frequency associated with the peak of the energy spectrum, for the period from 1 October 1983 until the gage was removed in December. While there were sev. ~1 storms during this period, the most significant was 13-14 October 1983. Spectra for that storm are shown in Figures 21 through 26. Prior to the 2100 data collection on 13 October, there was little energy in the spectra. The highest significant wave height calculated during the storm was 7.7 ft with a peak period of 8.26 sec. This was the highest significant wave height experienced during the wave data collection, considerably less than the incident wave height of 12.4 ft used in the design.

Figure 19. Significant wave height, October-December 1983

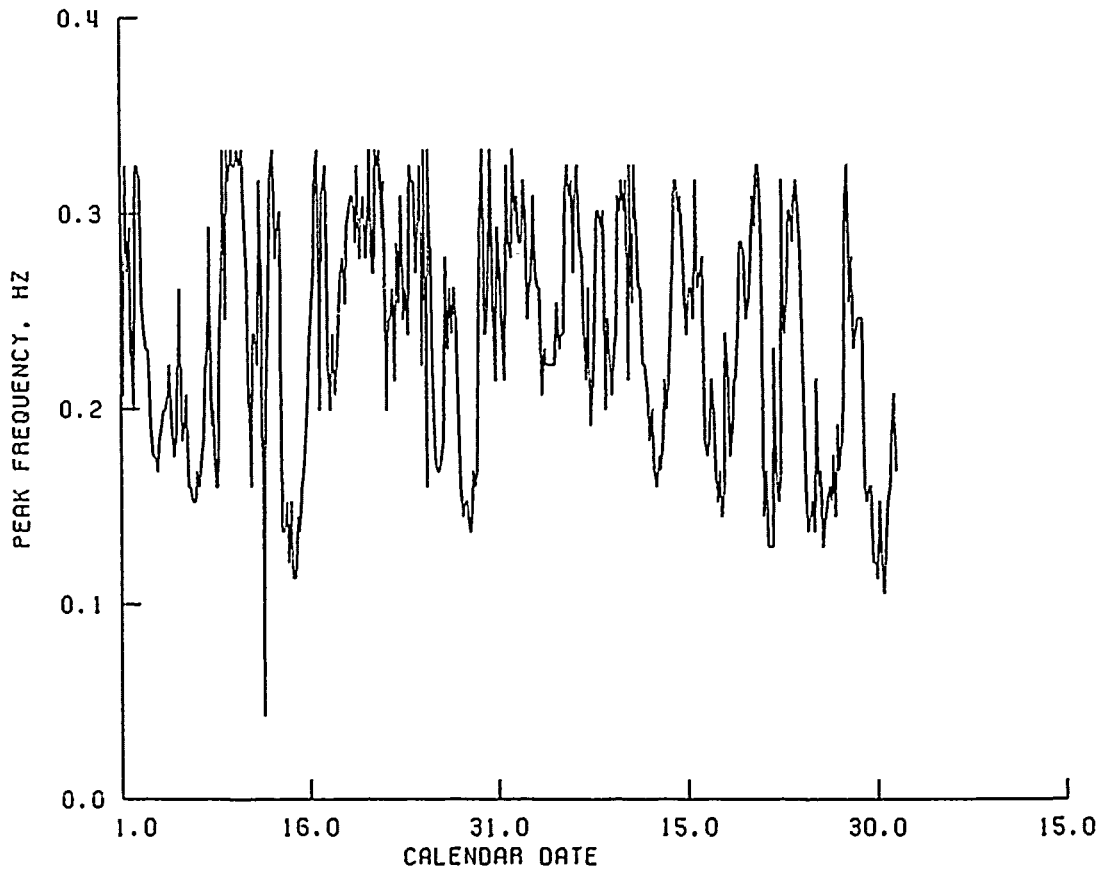
Figure 20. Peak frequency, October-December 1983

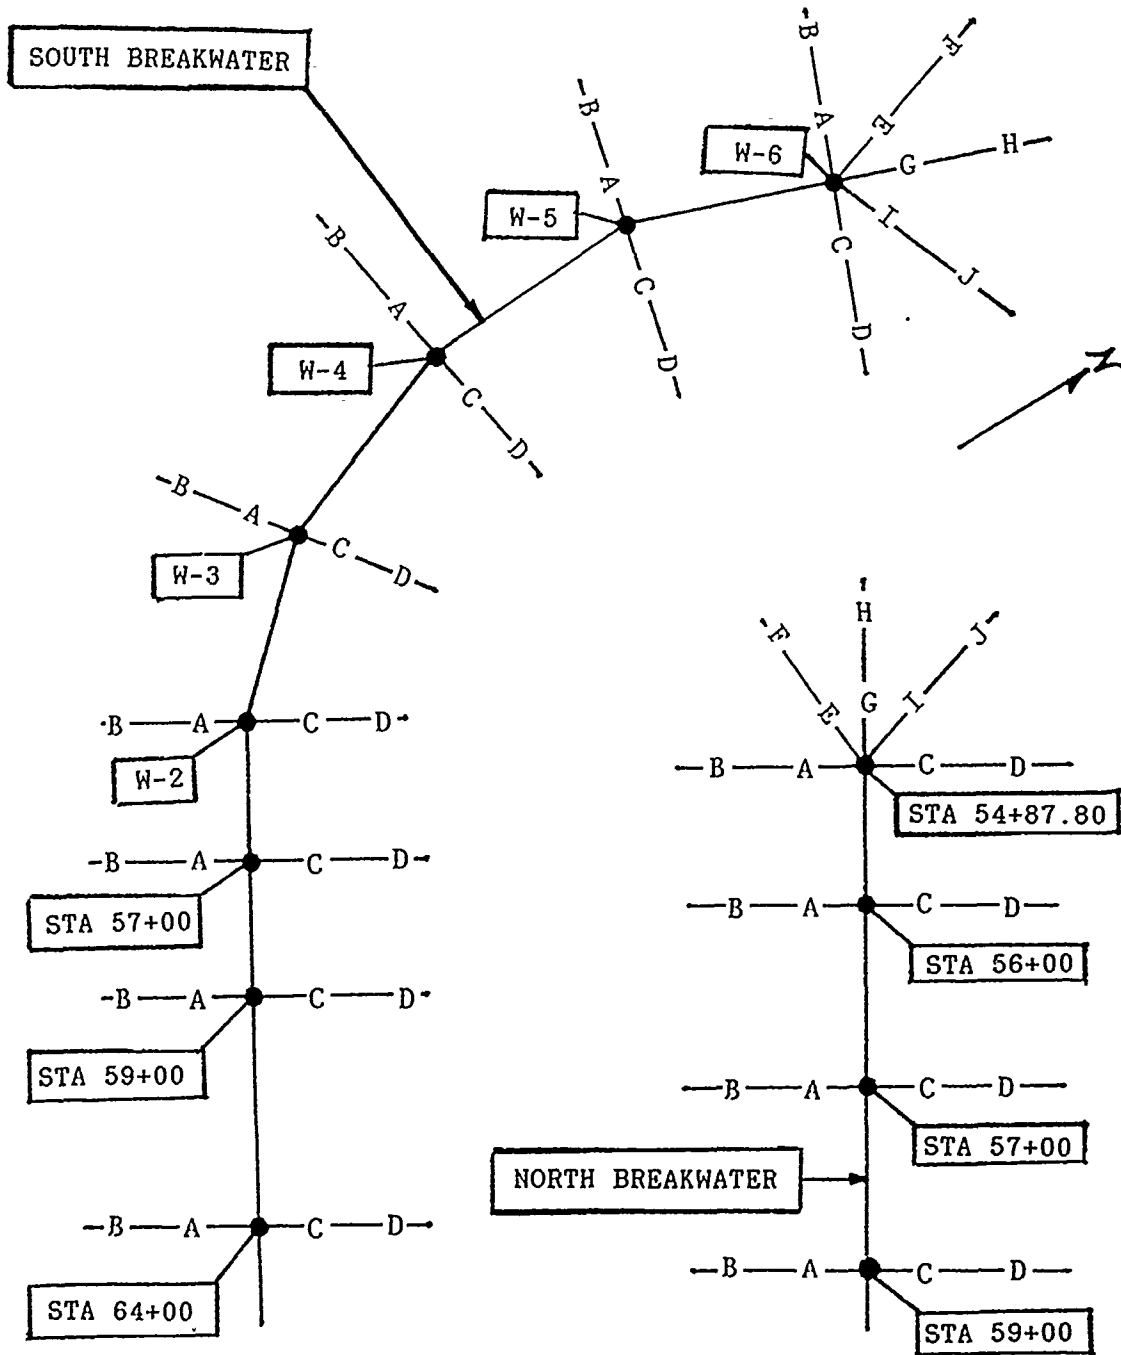
49. Stones along the lakeside of the north breakwater (C and D on Figure 27) moved perpendicular to the breakwater center line -0.01 to 0.06 ft for the period May-June 1983 to June 1985. The accompanying rotation about the target on the breakwater center line and change in elevation was -0.08 to 0.12 deg and -0.5 to 0.1 ft, respectively. The harborside stones along the trunk experienced values for (Δr , $\Delta \theta$, Δz) of -0.01 to 0.06 ft, -0.08 to 0.12 deg, and -0.1 to 0.1 ft, and the head experienced values of -0.11 to 0.06 ft, -0.08 to 0.07 deg, and -0.1 to 0.0 ft, respectively. Not included in these values for the head section is an immediate movement of stone 54+87.80 F (shown in Figure 27) inward 4.07 ft with no change in rotation or elevation and its subsequent return the following survey. It is surmised that an initial surveying positioning error explains this anomaly. These values in addition to the structure cross sections indicate negligible damage to the north breakwater, which has been confirmed during subsequent field inspections. Figures 35 and 36 present cross sections taken at the north breakwater head. The surveys indicate that some scouring near the toe has occurred but has not affected structural integrity.

Figure 27. Sketch of target and surveyed stone locations

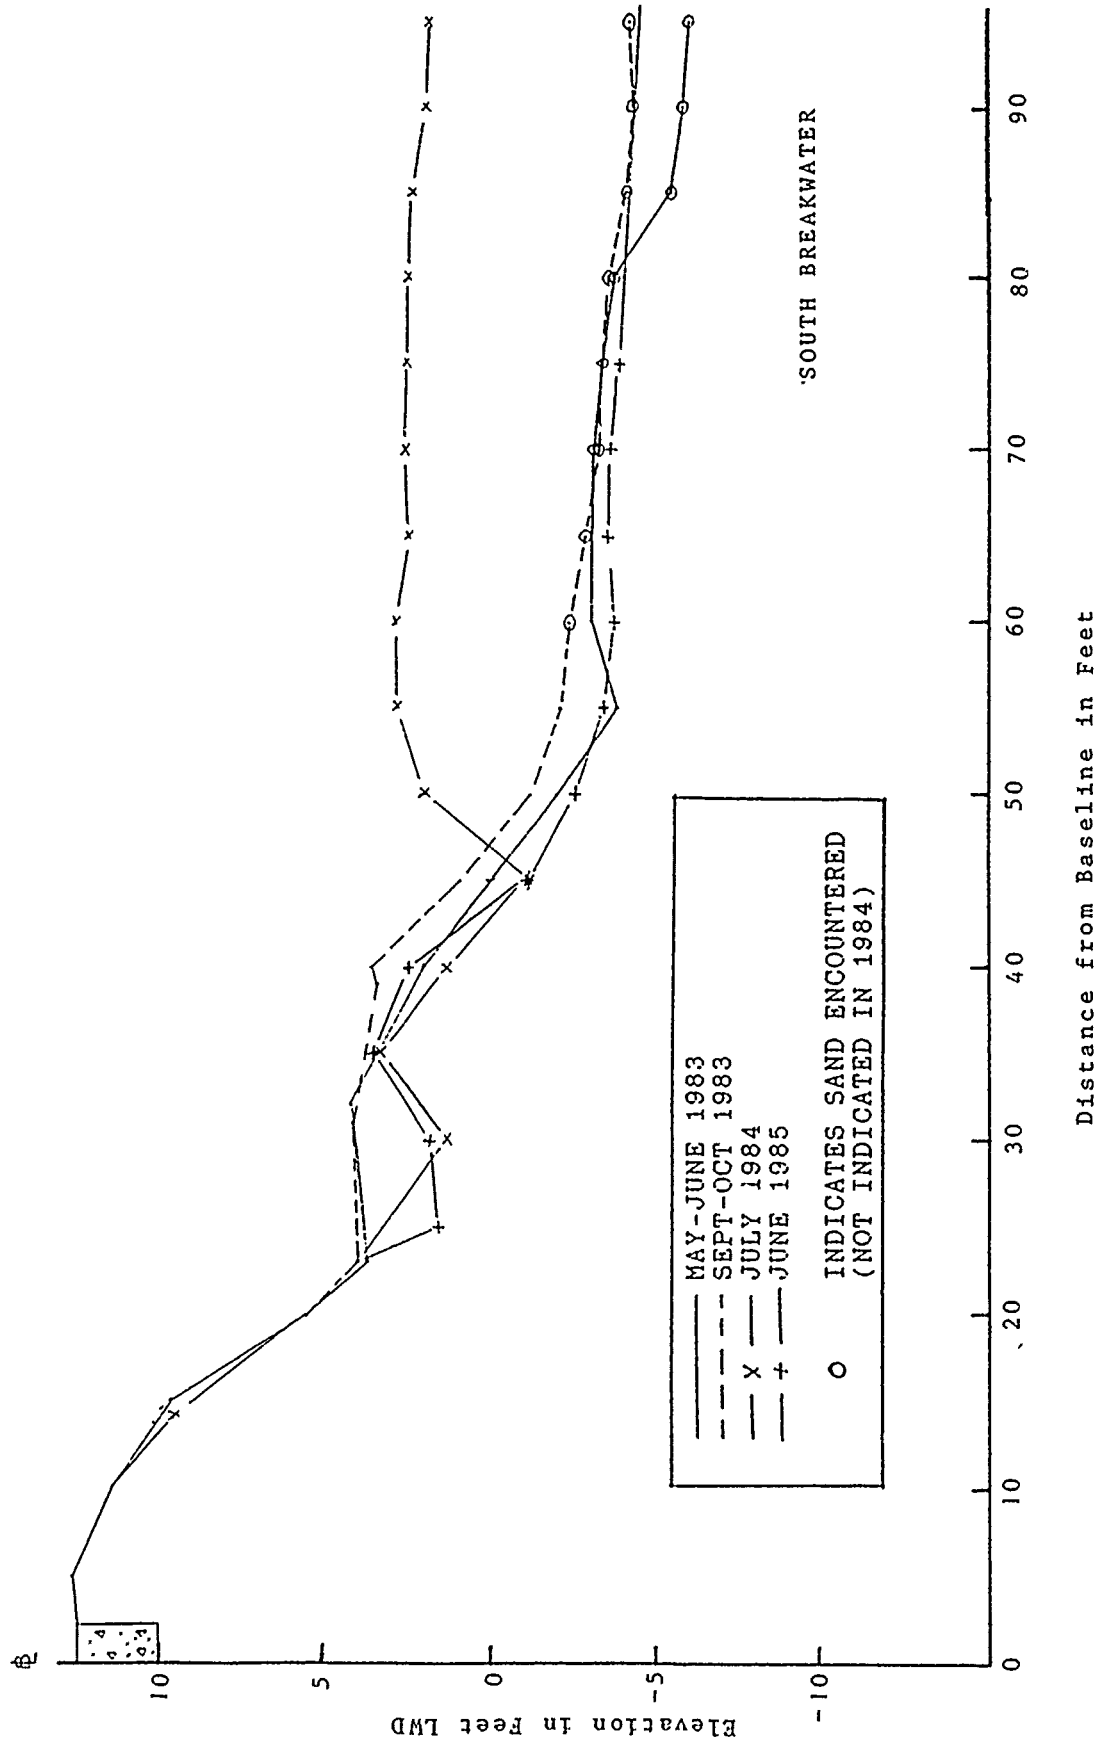
change in elevation of the target locations on the south and north breakwaters. Tables 6 and 7 present the measured stone movement. Figures 28 through 36 present structure cross sections for the south breakwater along the trunk (Sta 57+00) and the head (W-6) and the north breakwater head (Sta 54+87.8).

Figure 28. Structure cross section for Sta 57+00 (lakeside)

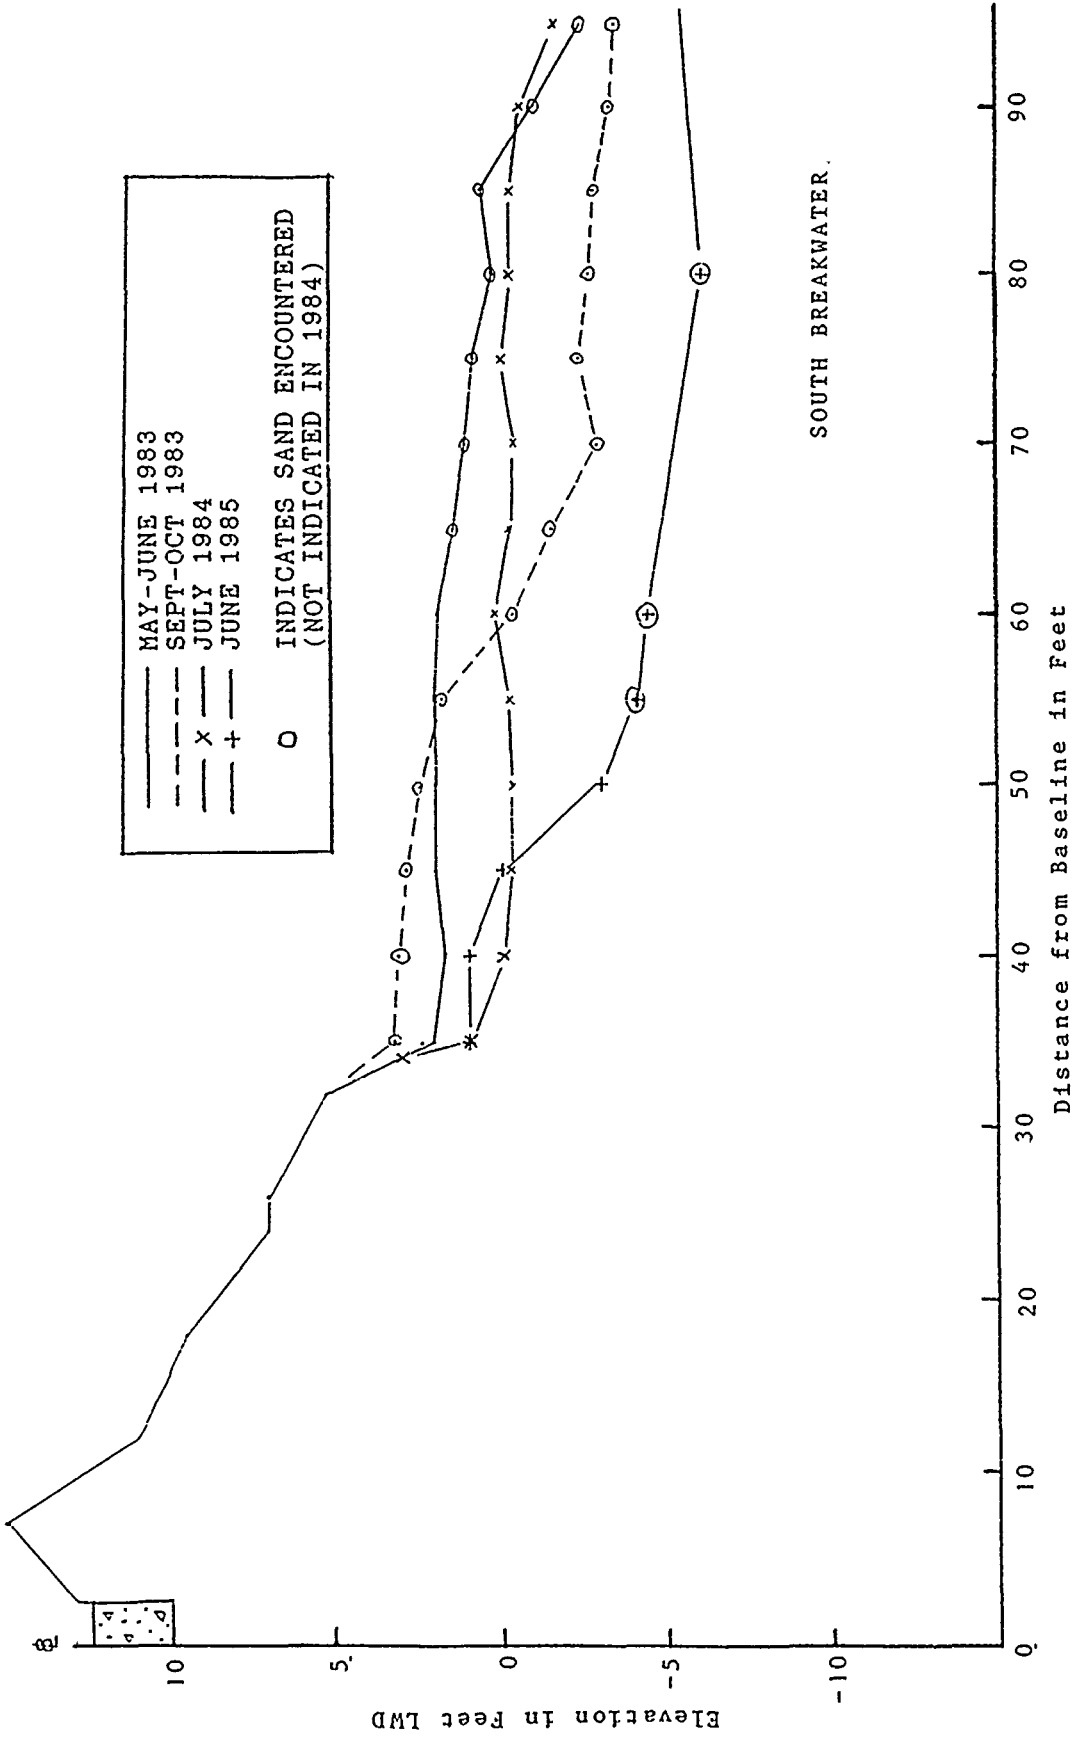
Figure 29. Structure cross section for Sta 57+00 (channelside)

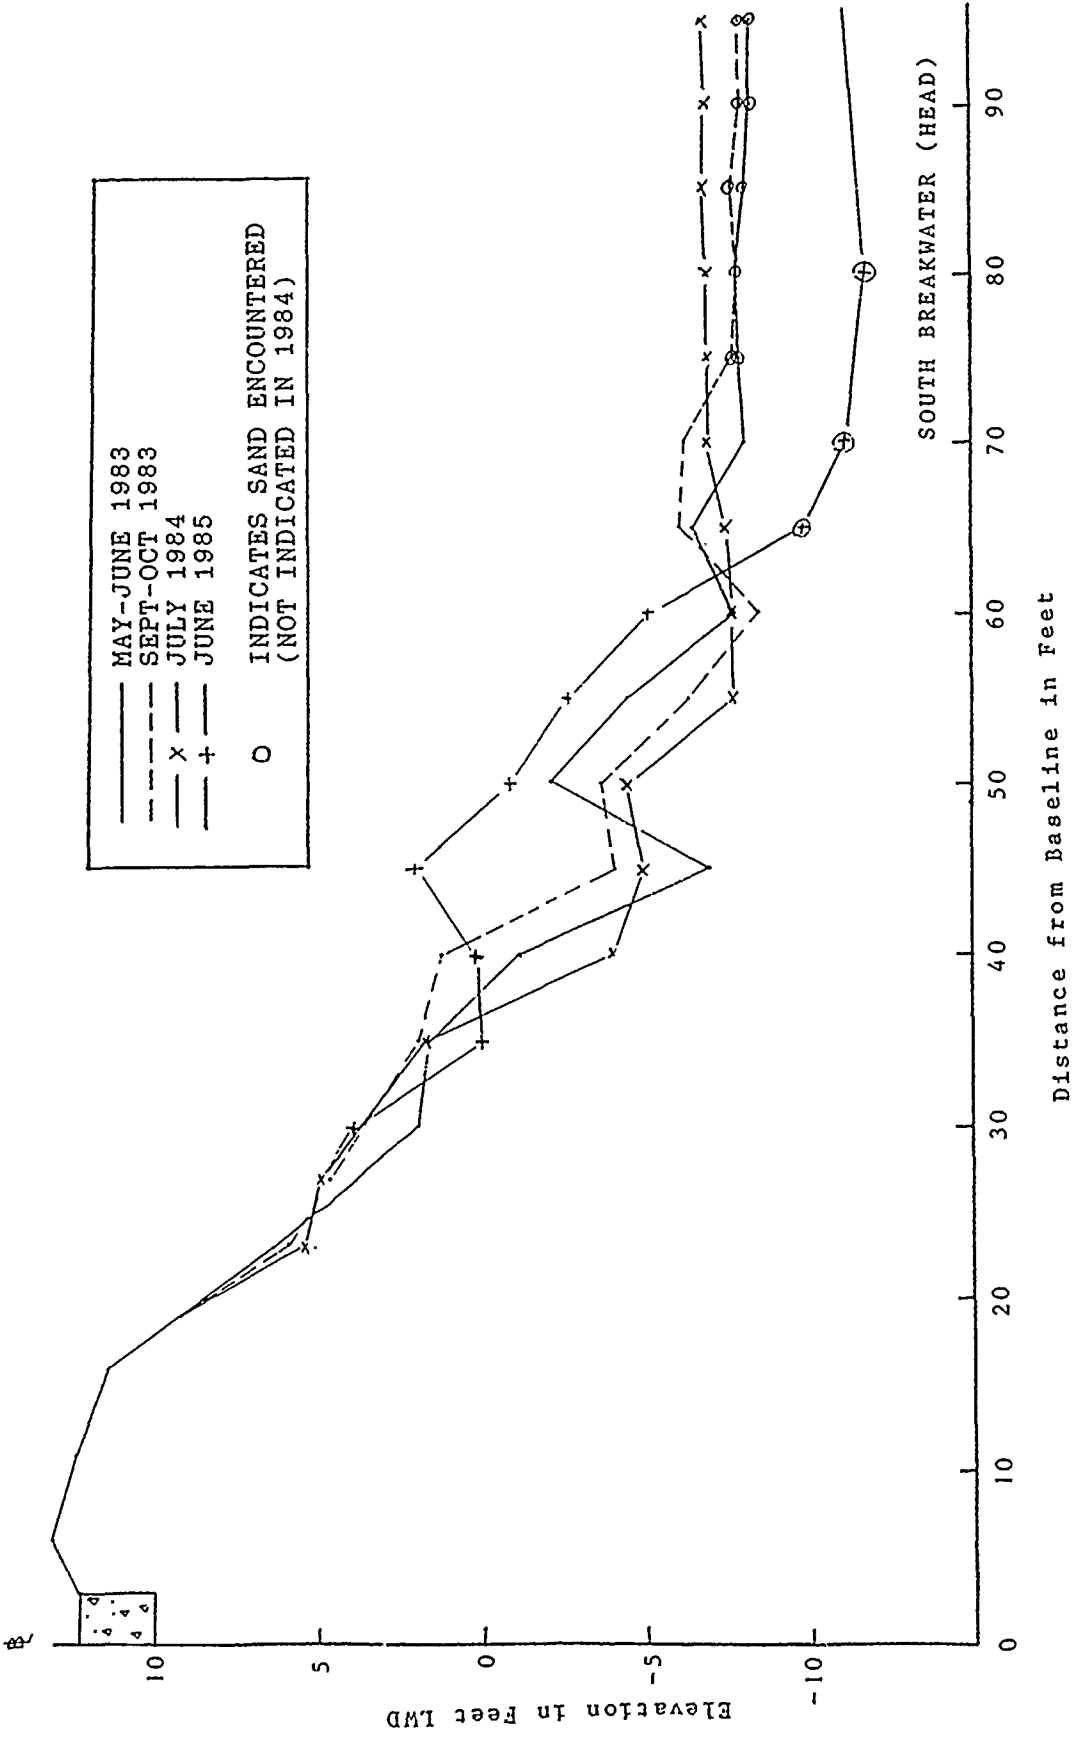
(W-6) are presented on Figures 30 through 34 and indicate minor stone steepening and scour near the toe.

Figure 30. Structure cross section for W-6 (NW)

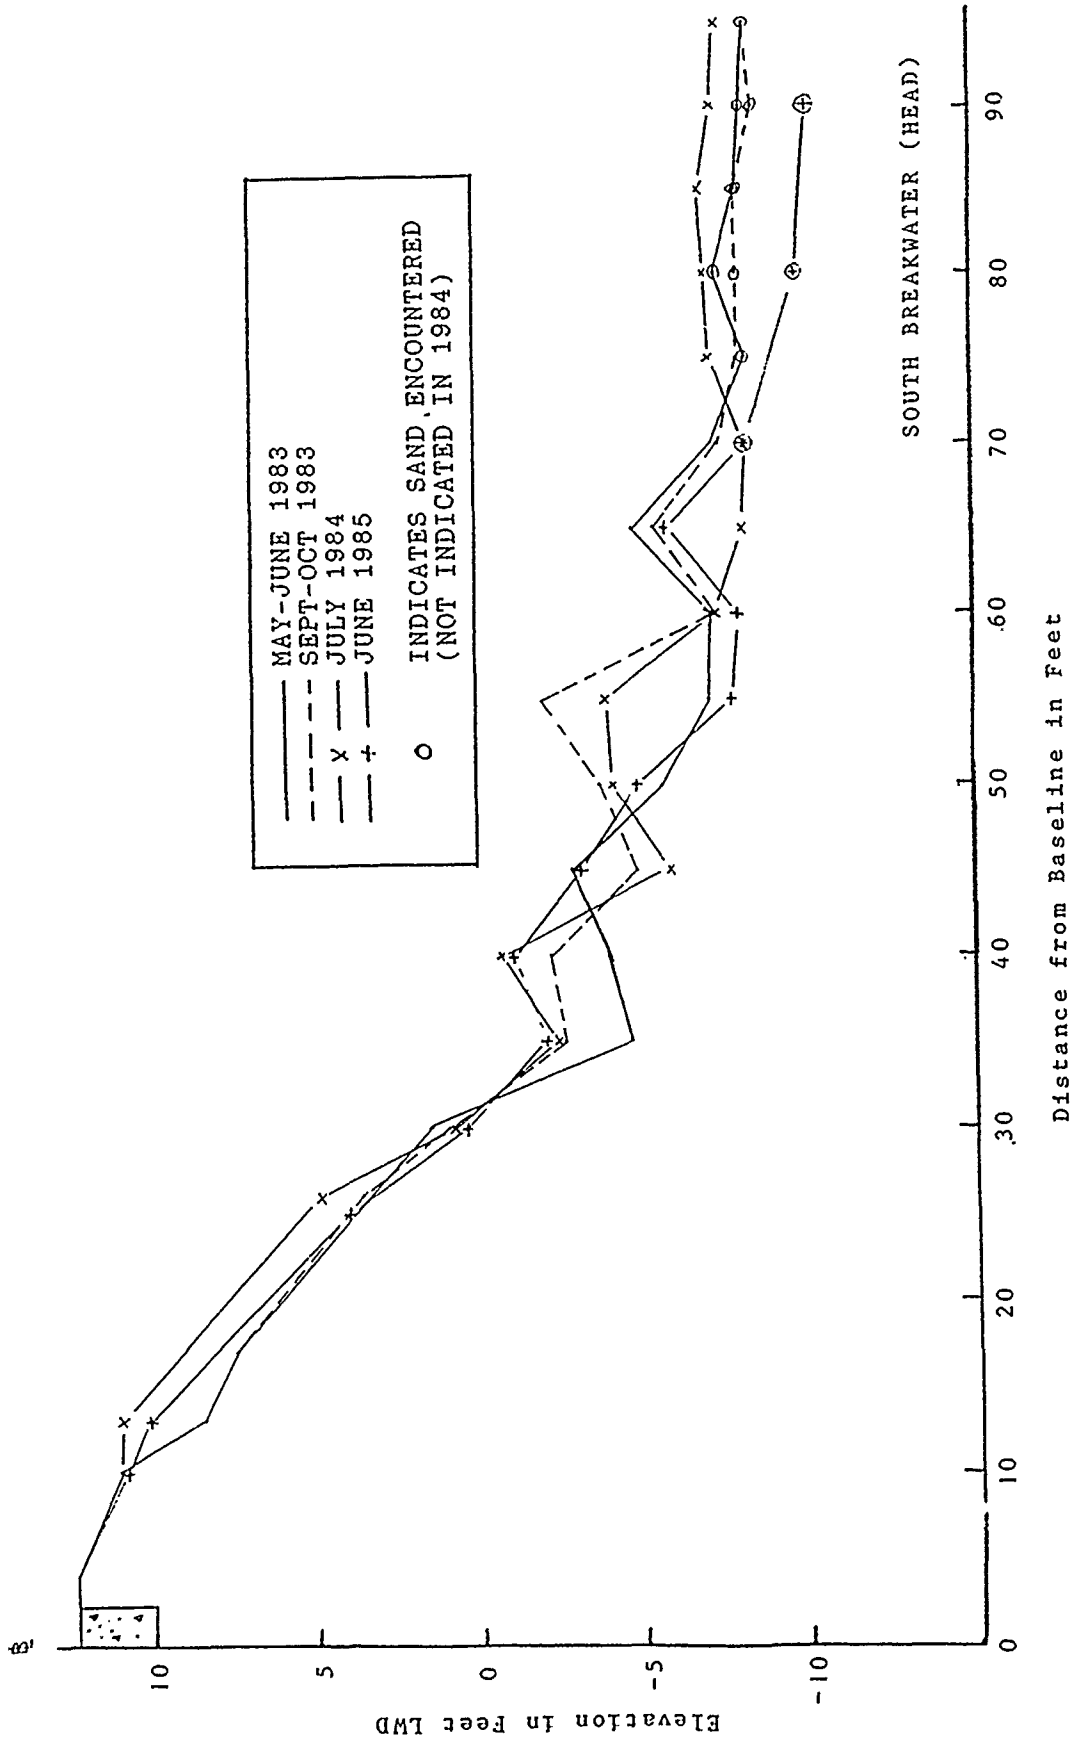
Figure 31. Structure cross section for W-6 (W)

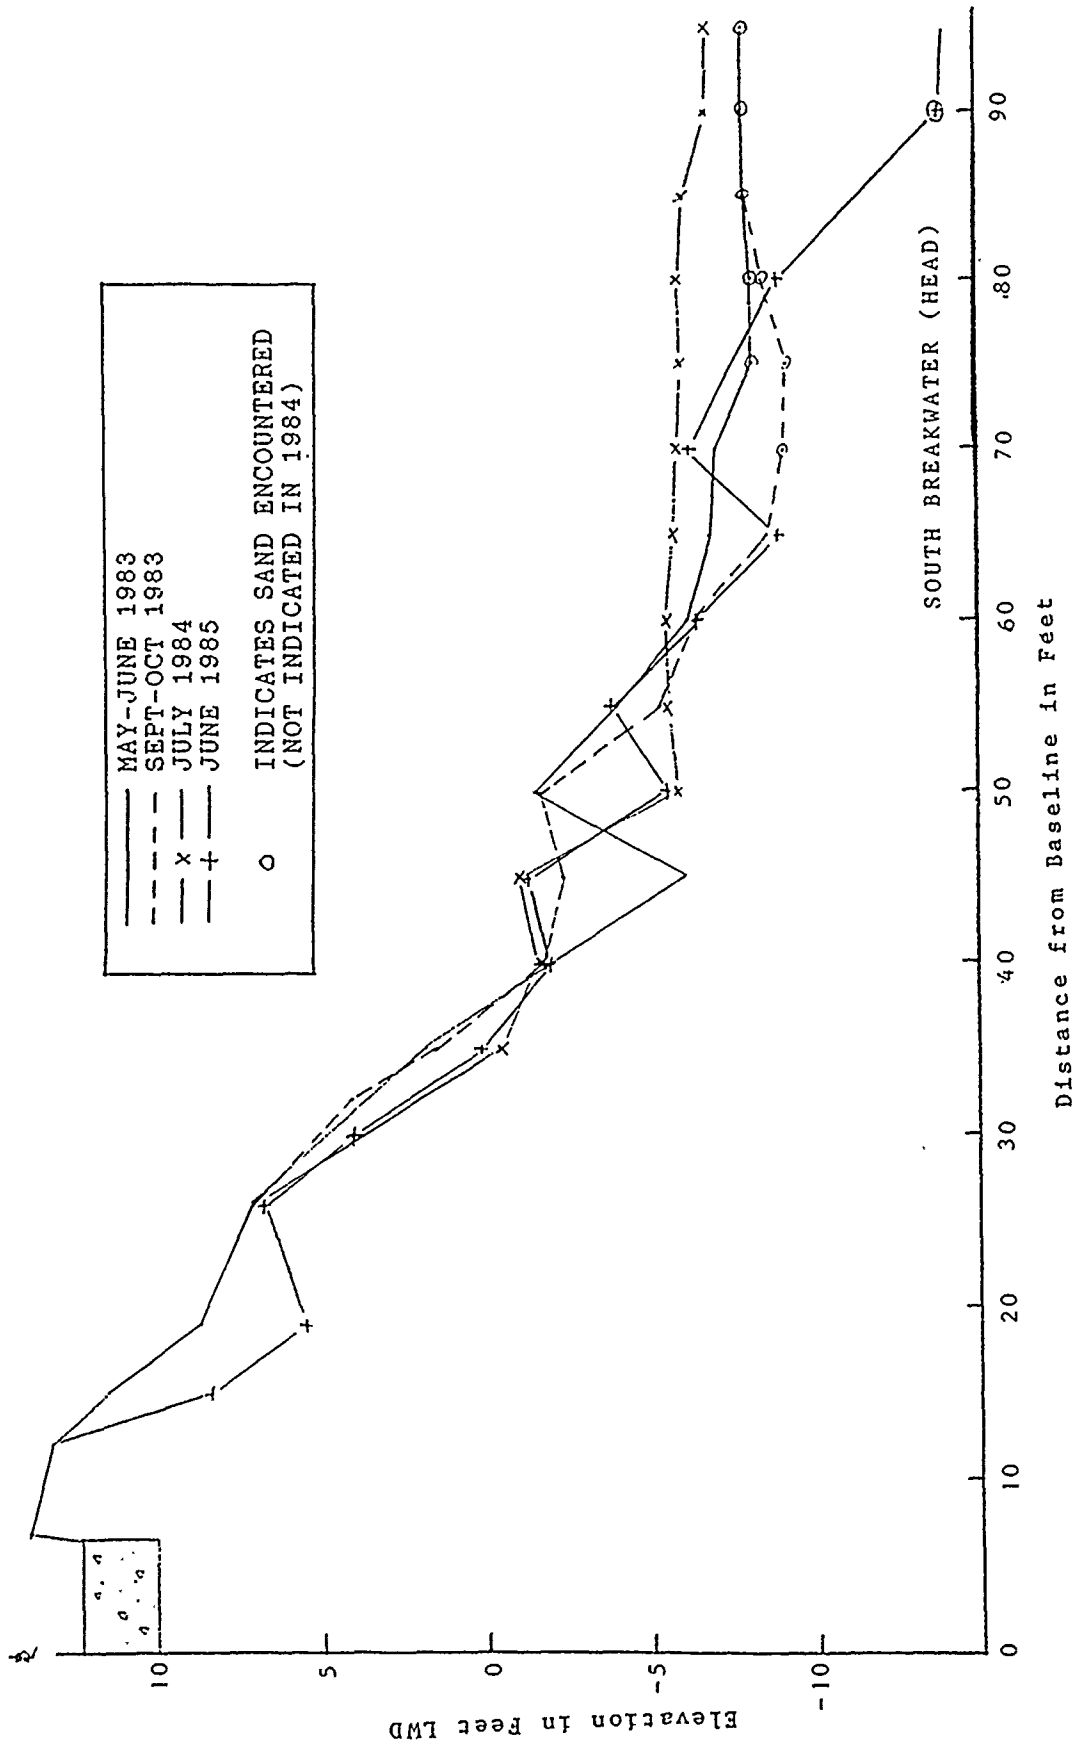
Figure 32. Structure cross section for W-6 (N)

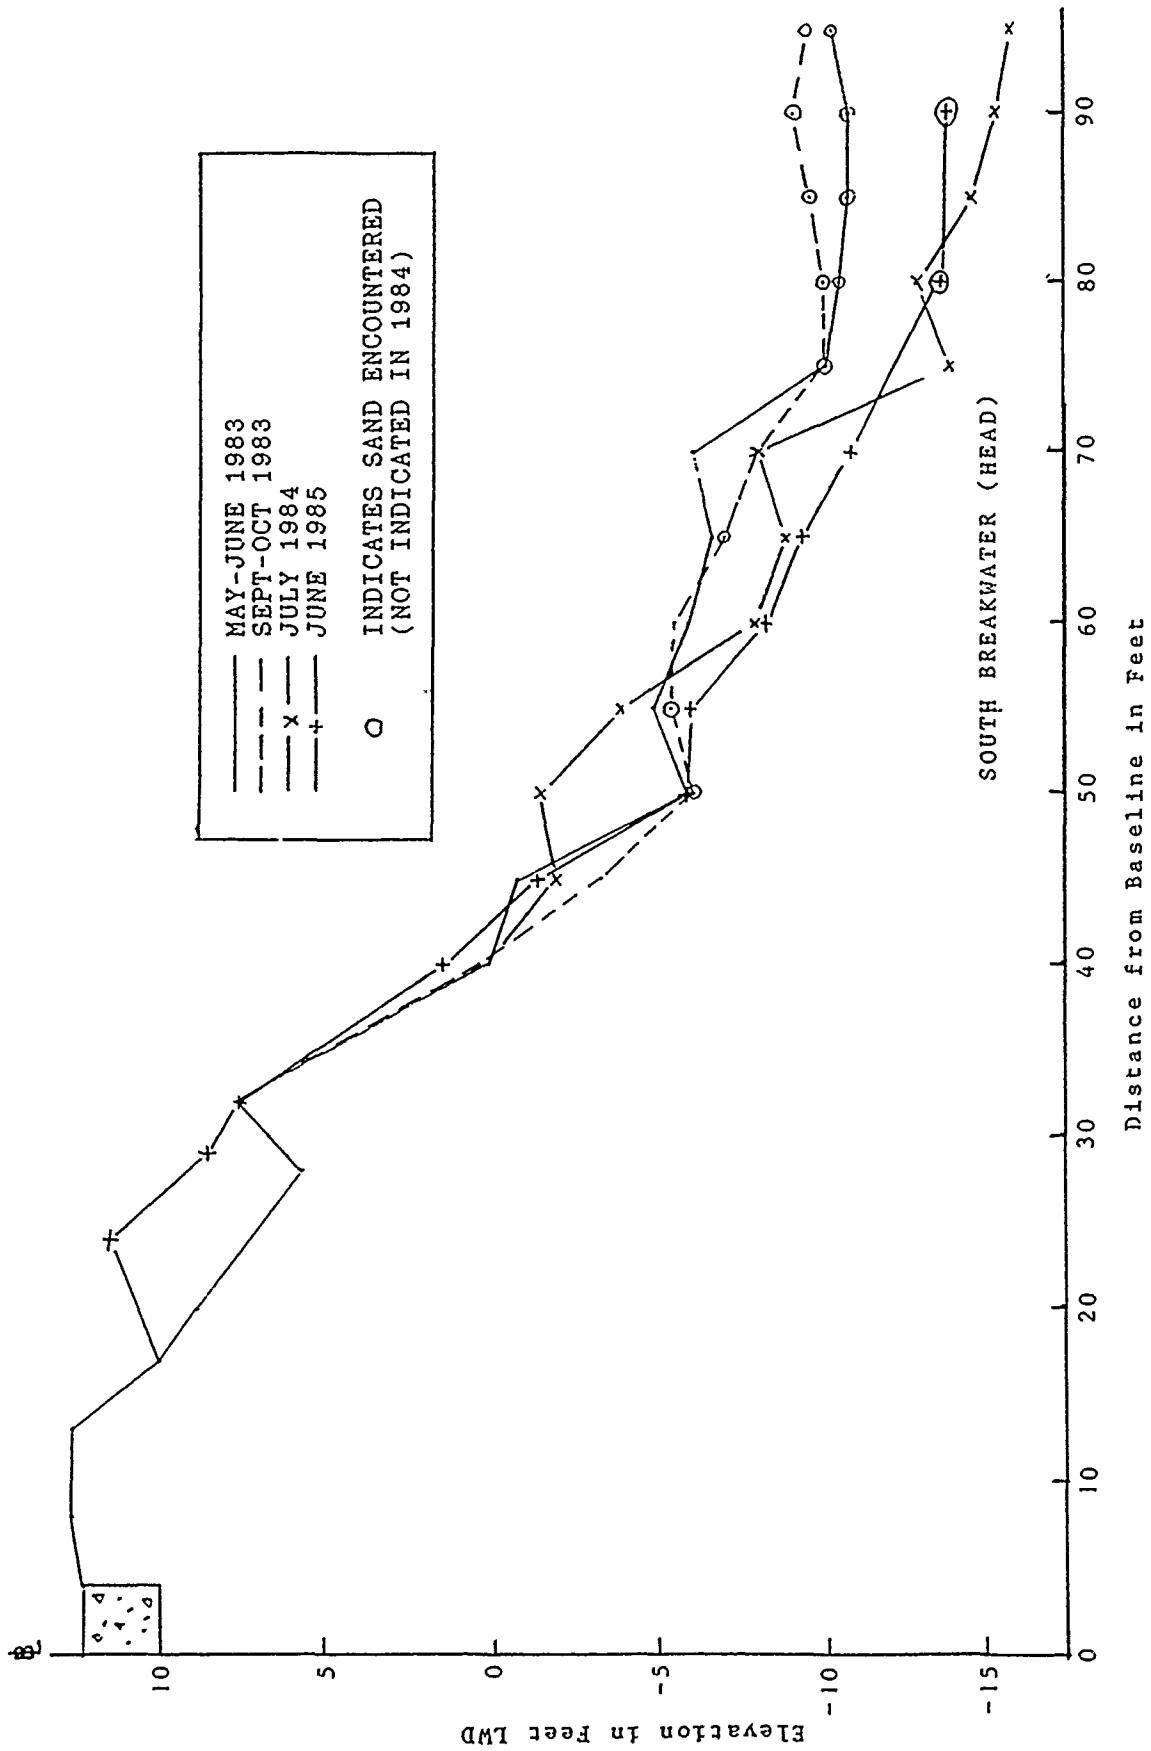
Figure 33. Structure cross section for W-6 (NE)

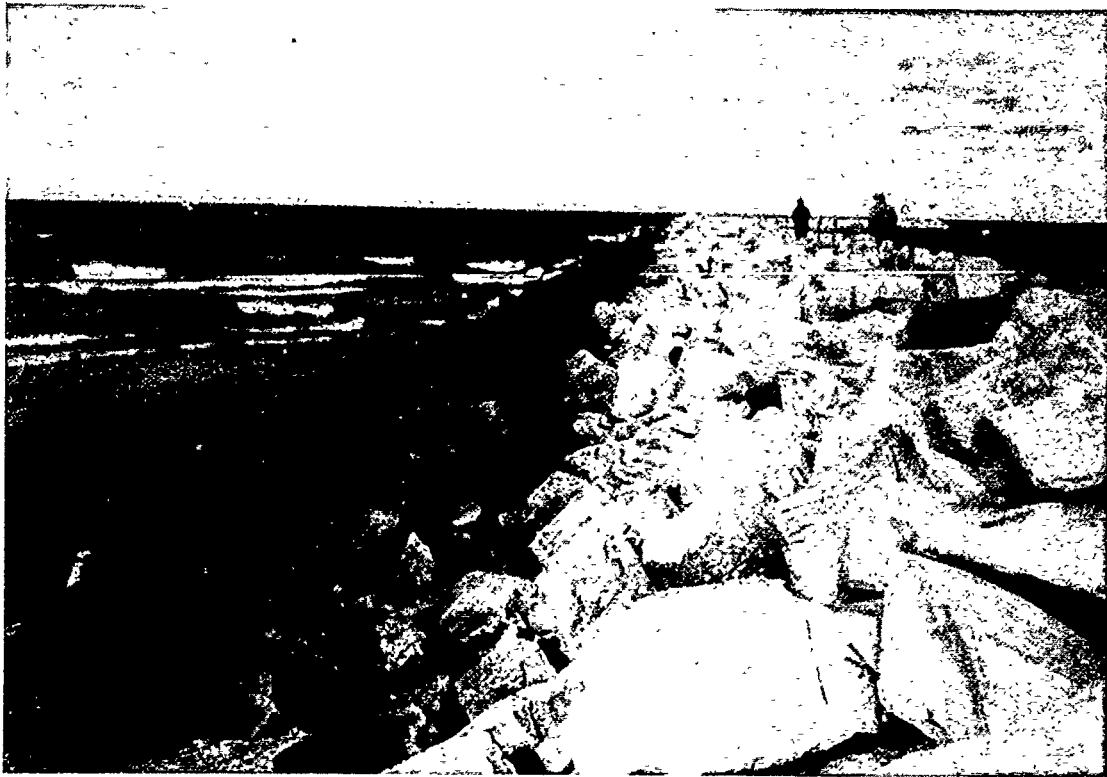
Figure 37. South breakwater, lakeside, 17 November 1988

51. To alleviate the potential detrimental effects of scour at the toe of the breakwaters, a sacrificial toe berm was constructed by placing one layer of armor over the bedding material as shown on the structure cross sections presented in Figures 16 and 17. Figures 37 and 38, taken in November 1988 of the south breakwater, show the toe berm protruding slightly above the

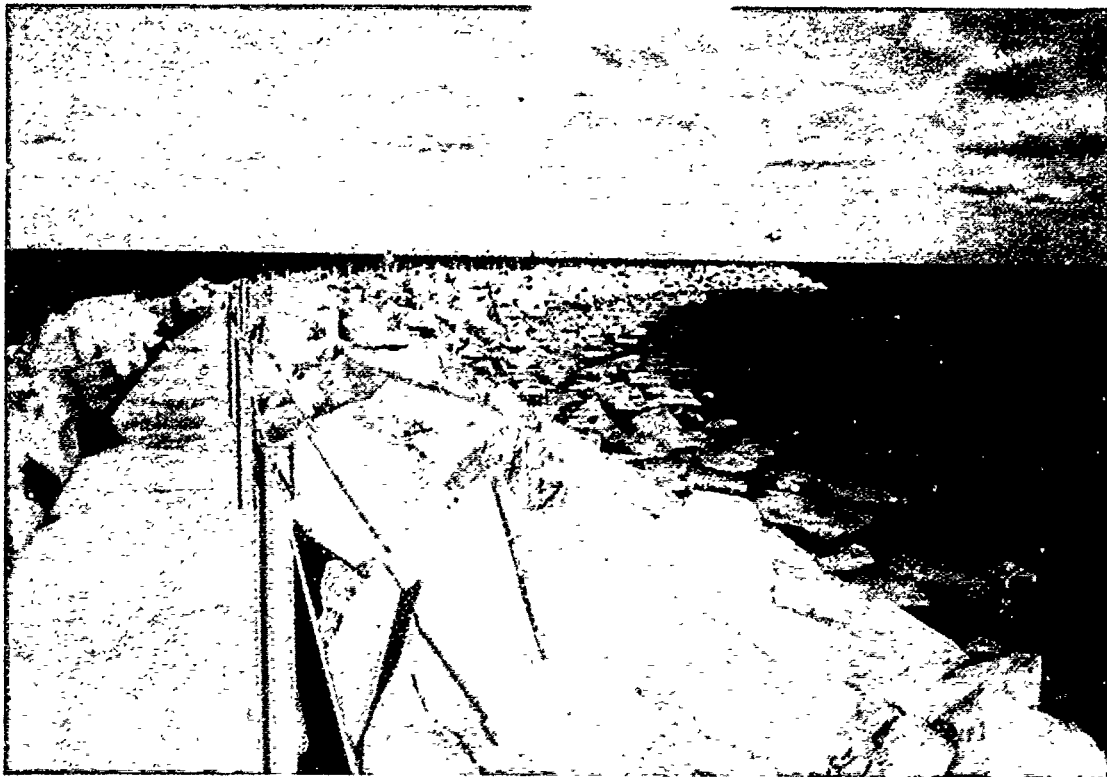
Figure 38. South breakwater, channelside, 17 November 1988

66. The south breakwater has a filter fabric sediment barrier extending through the structure 850 ft from the landward end. From field observation, it appears that sand has leaked through the structure where the barrier is absent, as seen on Figure 38. However, the growth of this deposit has been

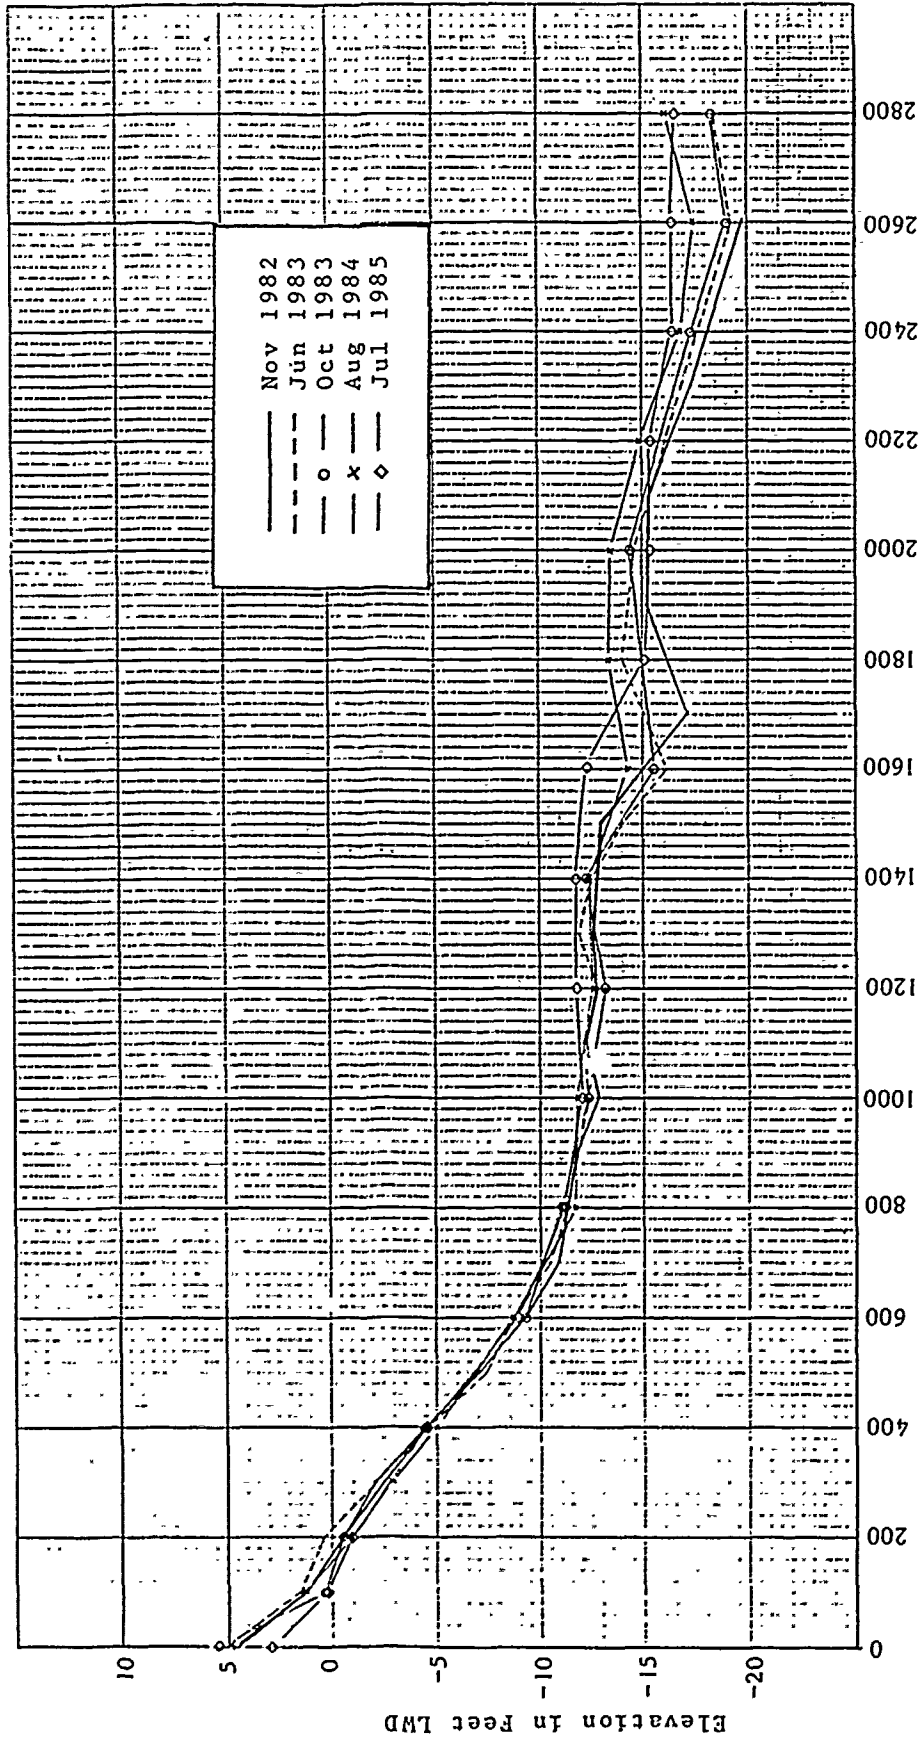
Figure 40. Profile comparisons for Sta 450+00

55. The profiling information revealed that at the south end of the beach monitoring area, Sta 450+00, minor erosion of the profile occurred above -6 ft LWD with accretion occurring below. In the central area of Sunset Bay, where the offshore contour bulge exists, little change has occurred. This is the only area where a pronounced 5-ft bar exists offshore. In the fillet area of the south breakwater, accretion has occurred above 0.0 ft LWD with 1 to 2 ft of erosion occurring farther offshore. A scour hole has appeared off the south breakwater head and is approximately 800 ft in diameter with a maximum depth 4 ft lower than the surrounding areas. This change in offshore bathymetry in the vicinity of the breakwaters is readily apparent in Figure 51. It is surmised that it is caused by increased wave activity due to reflection off the south breakwater head. It should be noted, however, that the scour hole generally filled in during the period from June 1985 to June 1989. This change will be discussed further in a subsequent section (Recent Observations).

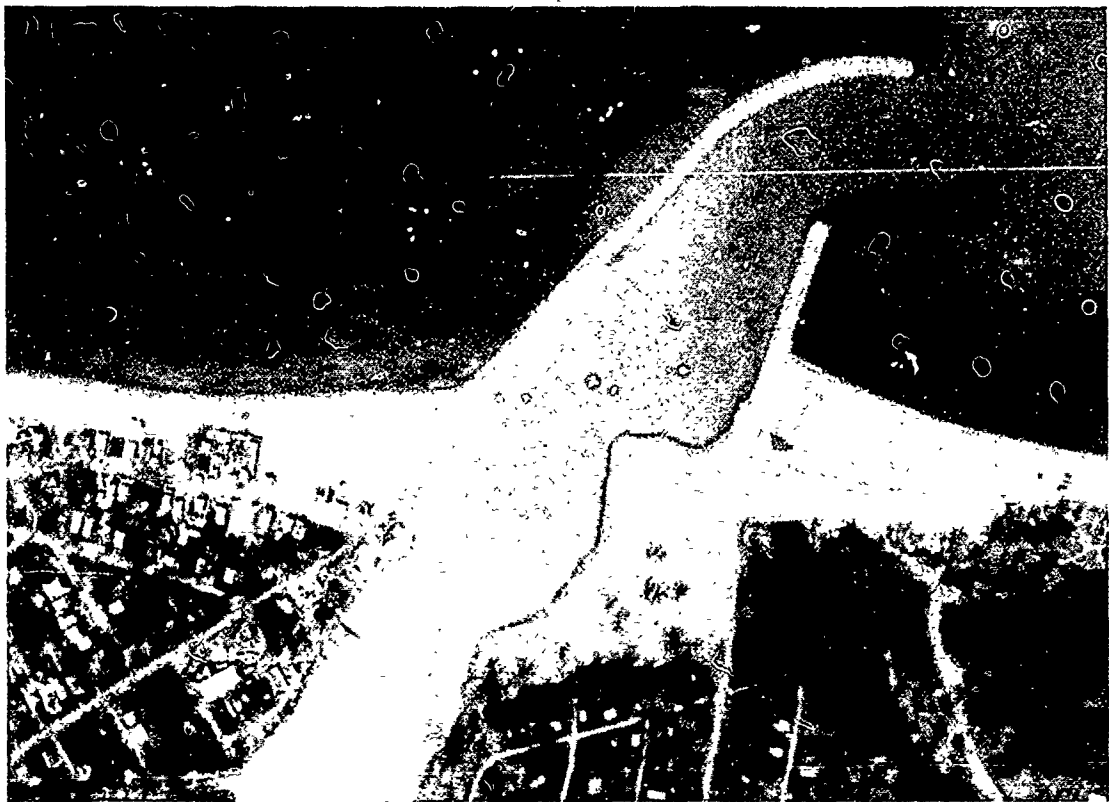
Figure 49. Cattaraugus Creek Harbor,
13 May 1983, +3.6 LWD

54. To evaluate beach response to the presence of the harbor structures, profile surveys of the project area and the adjacent shoreline were taken November 1982, October 1983, August 1984, and July 1985. Survey lines were located at 100-ft intervals from 600 ft south of the south breakwater to 600 ft north of the north breakwater and at 500-ft intervals 3,500 ft farther south and 4,500 ft farther north, resulting in coverage of 10,000 ft of shoreline. The surveys were conducted by a combination of rod and level, lead line, and Fathometer from the back beach to 0.5 mile offshore. Figures 40-48 present comparative profiles for Sta 450+00, 465+00, 485+00, 490+00, 495+00, 501+00, 505+00, 525+00, and 550+00, respectively. Figures 49 and 50 present aerial views of the area near the breakwaters on 13 May 1983 and 26 October 1985.
