MONITORING COMPLETED COASTAL PROJECTS PROGRAM

MISCELLANEOUS PAPER CERC-91-10

**MONITORING OF COMPLETED BREAKWATERS
AT CATTARAUGUS CREEK HARBOR, NEW YORK**

September 1991

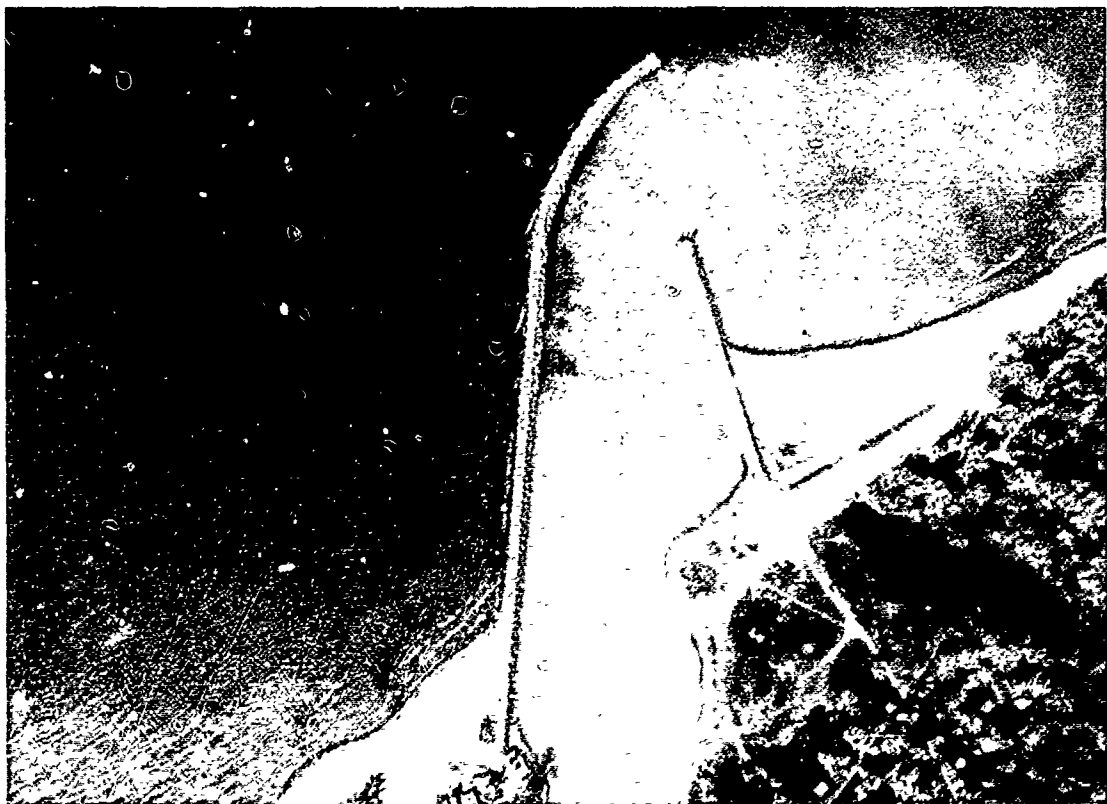
Figure 50. Cattaraugus Creek Harbor,
26 October 1985, +3.5 LWD

92. The use of filter fabric was successful, at least to date. There were obvious indications of transport through the south breakwater lakeward of where the fabric had been installed (Figures 50 and 51). Figure 50 shows conditions with waves entering the mouth of the creek and pushing more sediment-laden water through the structure. Figure 51 shows the opposite conditions, with the clearer lake water penetrating into the channel. These are indications that sediment has been prevented from penetrating the structure and reaching the channel where filter fabric has been used.

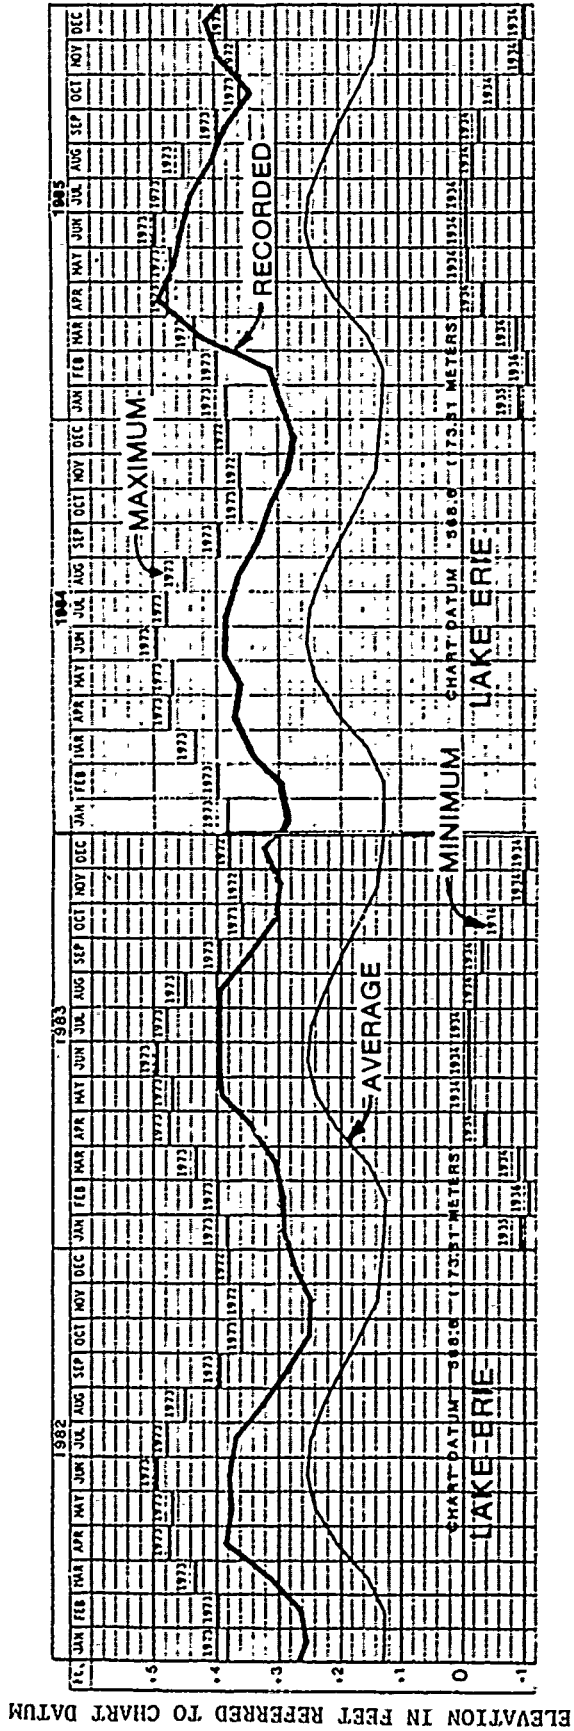
Figure 67. Monthly lake levels during monitoring program period

62. Figure 67 presents the monthly lake levels through the monitoring period (December 1982-June 1985). The Great Lakes experienced above-normal supplies (inflows) during this period resulting in levels 1.5 to 3 ft above average. Levels were increasing particularly near the end of the monitoring period and peaked the following year. The increase in water level partially explains the profile changes (i.e., erosion near and above water level with accretion farther offshore). In light of this change, it would be premature to compare the monitoring results with the predicted shoreline presented on Figure 14. Accretion immediately south of the breakwaters and erosion north of the breakwaters were predicted. The profiles south and north of the breakwaters have experienced a general net accretion, primarily occurring offshore.

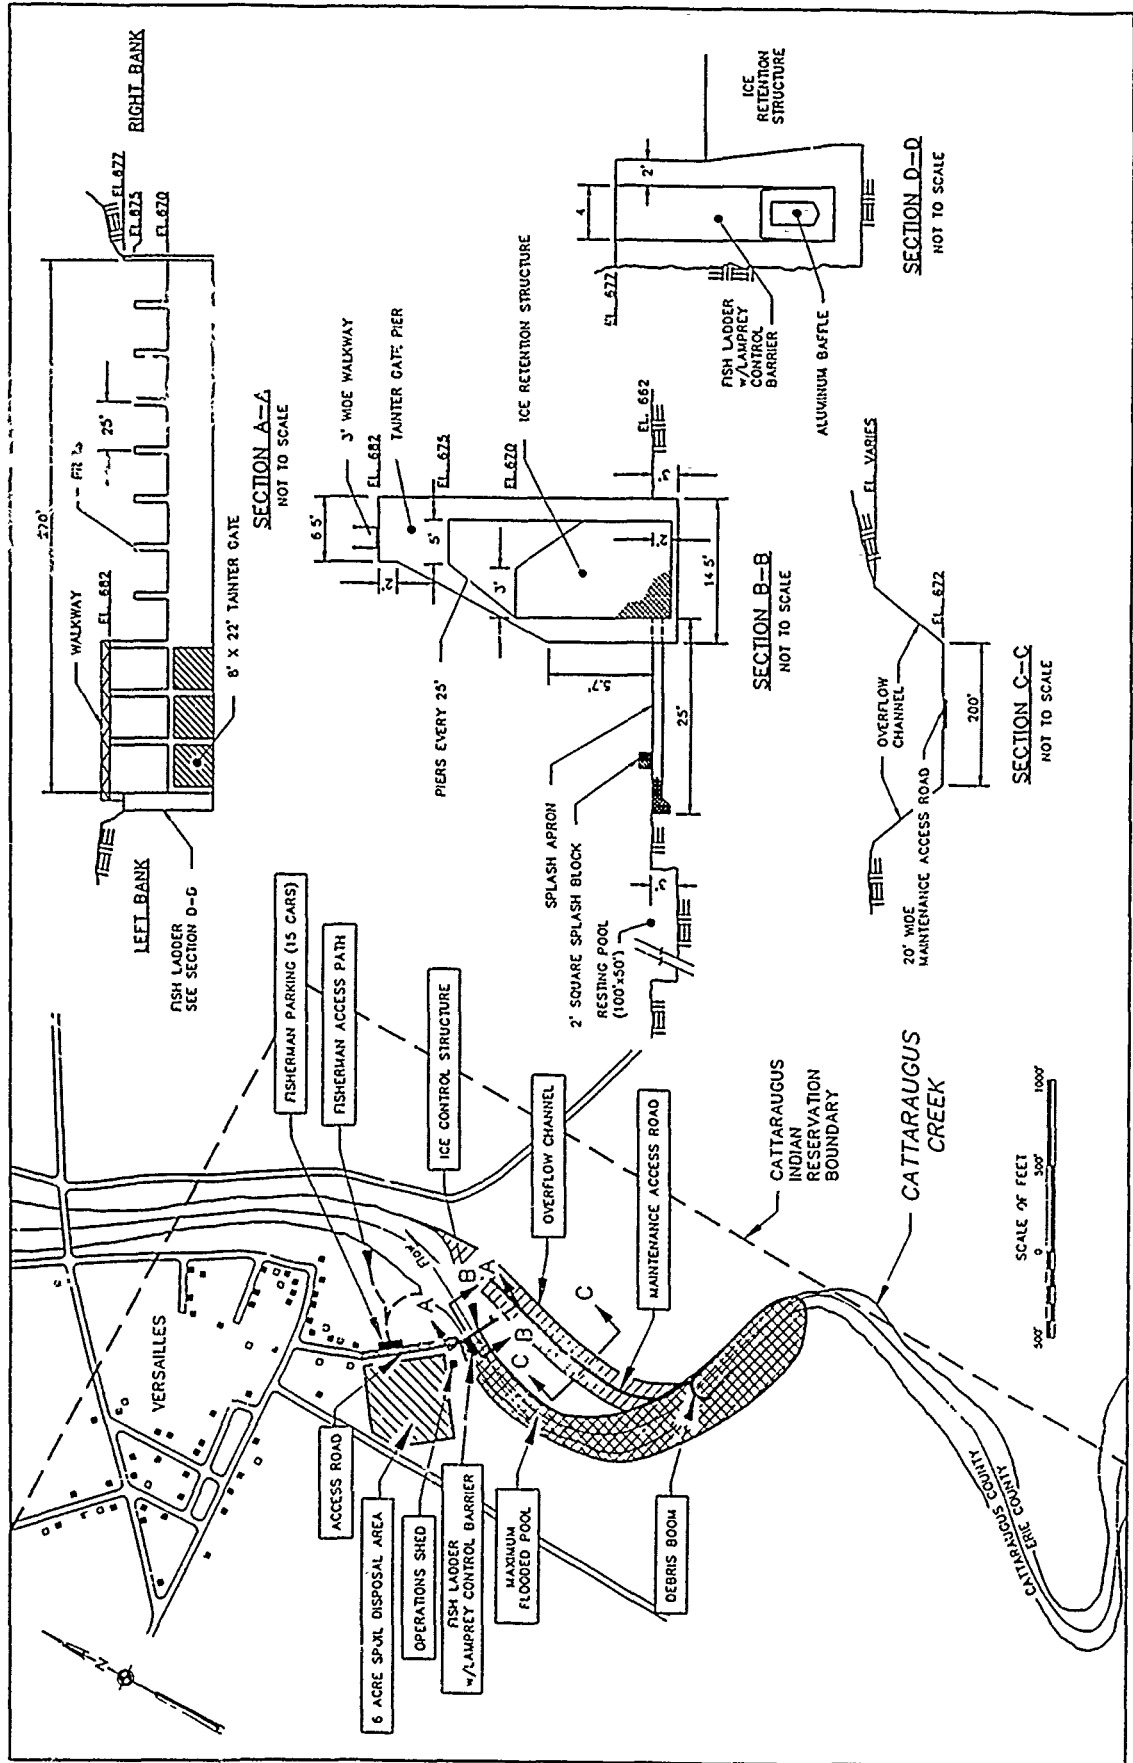
Figure 98. Alternative Plan 3A

77. Two promising plans were the construction of an overflow channel in the right overbank near the mouth and the construction of an ice retention structure upstream of the town of Versailles. Further investigation of the overflow channel showed it to be not economically feasible. The plan would have consisted of a 4,600-ft-long overflow channel, 400 ft wide, and 2 to 3 ft in depth. A protective berm would be provided adjacent to the left bank of the channel to prevent the cottages in Snow's Marina from being flooded when the channel is carrying flood flows. The access road would be lowered where it crosses the channel, and the beach area at the downstream end of the overflow channel would also be lowered to +5.0 ft LWD. Maintenance dredging at the mouth of the channel and annual loosening and breaking the windrowed ice that forms along the lakeward margin of the beach berm would be performed. Beach profile data gathered under MCCC authority were used to evaluate the maintenance dredging requirement. This plan is presented in Figure 98.

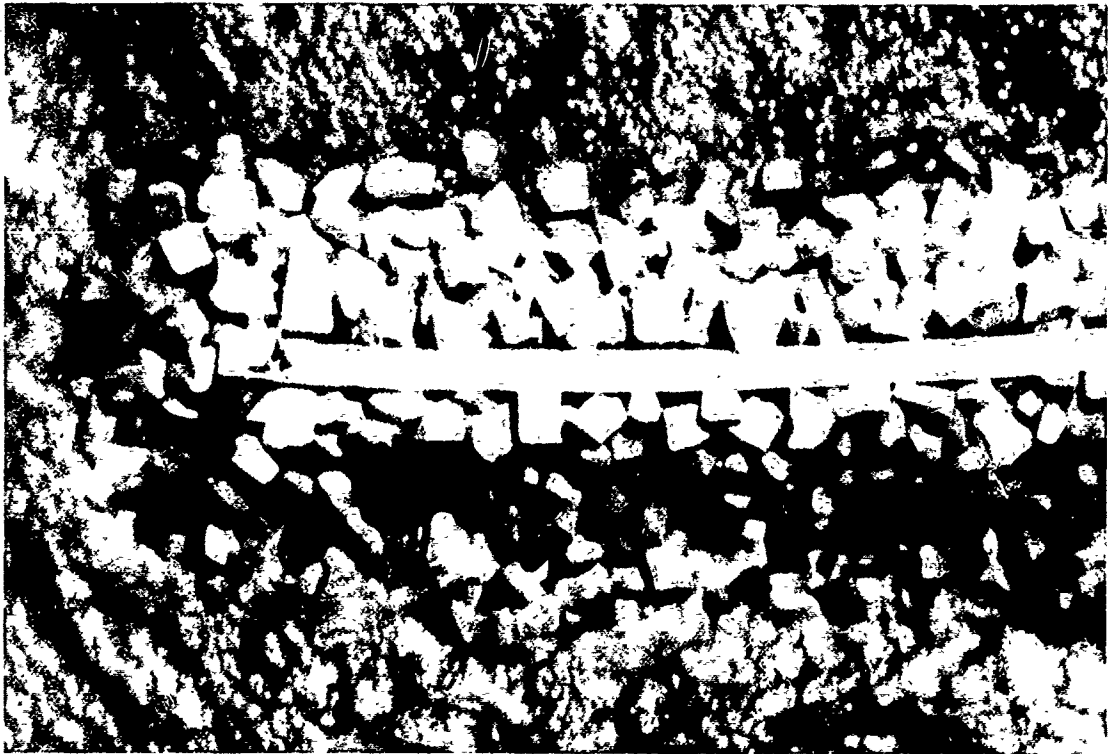
81. For comparative purposes, Figures 106 and 107 present vertical aerial views of the south breakwater head section taken 16 May 1984 and 3 June 1986, at a scale of 1 in. = 20 ft. Adjacent to the end of the concrete walkway (circular target) is the navigation light's concrete foundation. Inspection

Figure 106. South breakwater head, 16 May 1984

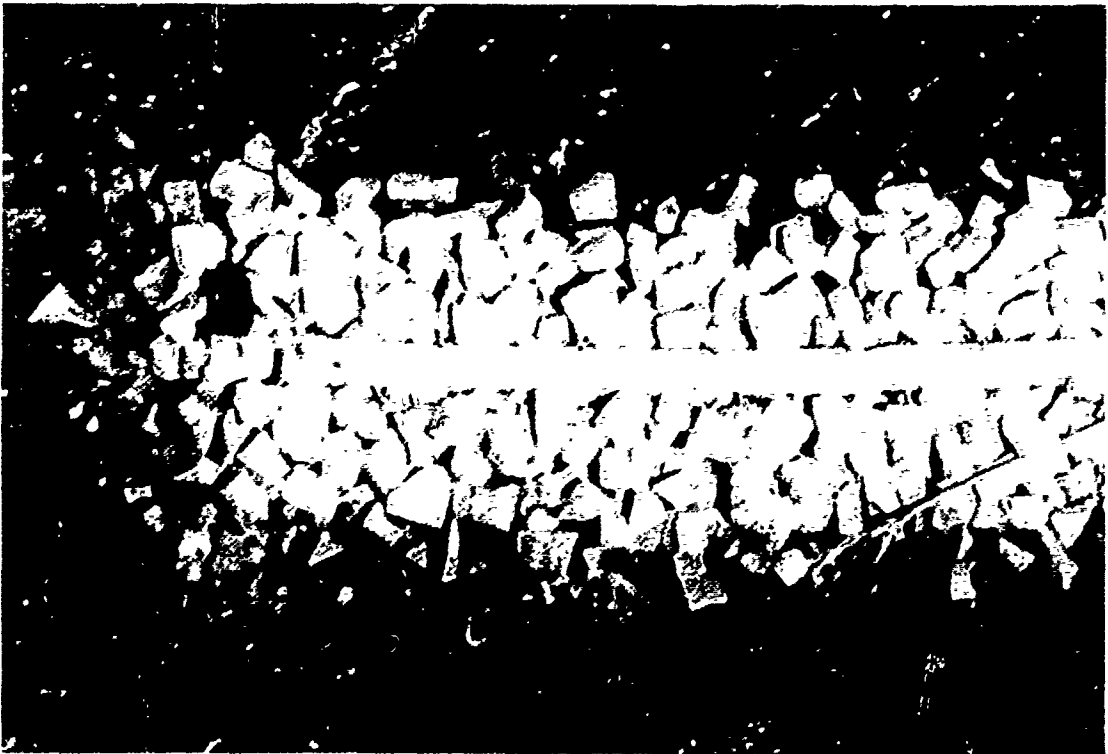
Figure 107. South breakwater head, 3 June 1986
