WHOI-91-34

## ESOM I and II Final Report

November, 1991

### Technical Report

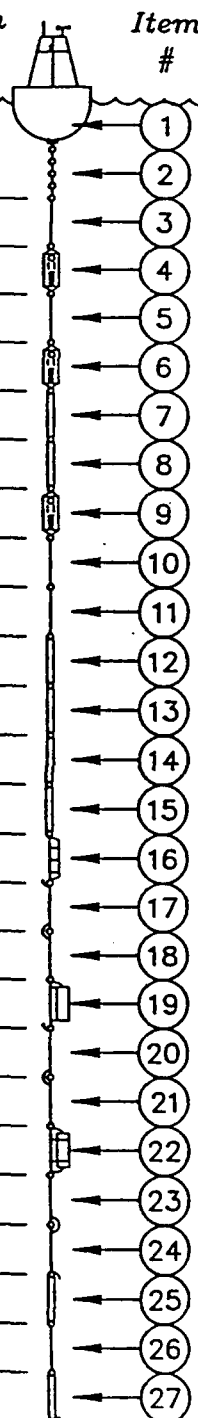
FIGURE 1: ESOM I Mooring Schematics

The two samples (Items 18, 23, Fig.1) were subsequently tested at WHOI for residual mechanical strength (Table V).

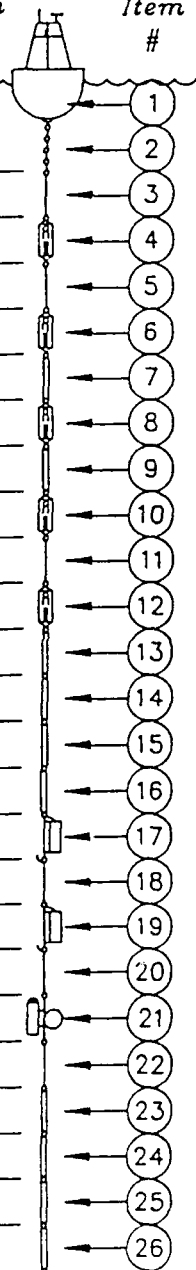
Six months after redeployment, the ESOM II mooring failed due to a mechanical break of the 3x18-7/16" EM cable section (Item 16, Fig.2) This section was carefully examined at WHOI and then sent to Al Lucht, Wire Rope Industry Consultant for microscopic examination and analysis [10]. His conclusions on the modes and causes of cable failure were:

The EM samples from ESOM II were tested at WHOI to detect shorts, open circuits and changes in leakage resistance. The failed sample (Item 16, Fig. 2), apart from the faulty termination, retained its mechanical and electrical characteristics. A second 3x18-7/16" EM cable (Item 18, Fig. 2) was found to be in excellent condition, and data from the continuity meter confirmed its proper functioning throughout the second deployment. The 3x19-3/8" EM cable sample (Item 20, Fig. 2) did not pass the electrical test. An open circuit was found in the upper pigtail section of the termination. Data from the continuity meter showed that the electrical failure occurred a few hours after the second deployment. A detailed report on this sample is presented in Appendix A.

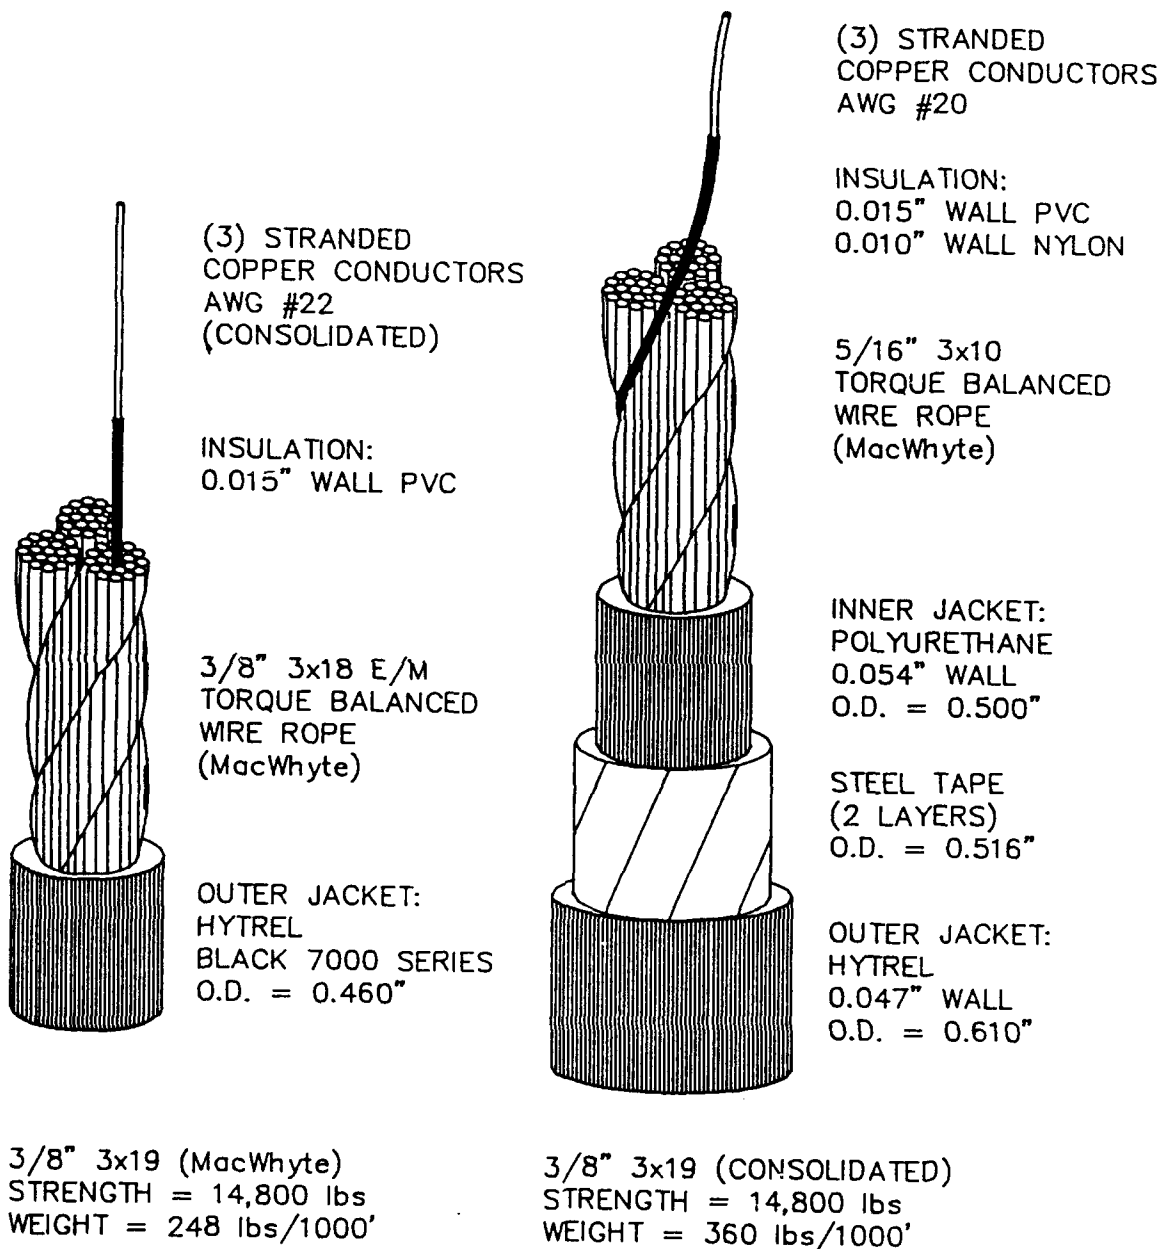
FIGURE 4: E/M cable samples

Two types of novel EM cables, using the proven 3x19 oceanographic rope construction were systematically tested (Figure 4). In the first type (MacWhyte Mfr.), the conductors are placed in the center of each strand. In the second type (Consolidated, Mfr.) the conductors are placed in the valleys between the strands [8]. Two self recording continuity meters periodically checked the EM cable electrical continuity.

During the turnaround cruise, all the EM samples were recovered, inspected and electrically tested. Data from the two continuity meters did not indicate any kind of electrical failure. The EM cable "long term" samples appeared to be in good condition, with no structural damage except for a few superficial cuts due to fishbites. The jacket damage was repaired and the three samples were redeployed for the ESOM II experiment. The "short term" samples were further tested at the BBSR and at WHOI. Item 18 (Figure 1) had a failed pigtail in the swage termination. The cable itself tested properly (continuity and leakage resistance tests).

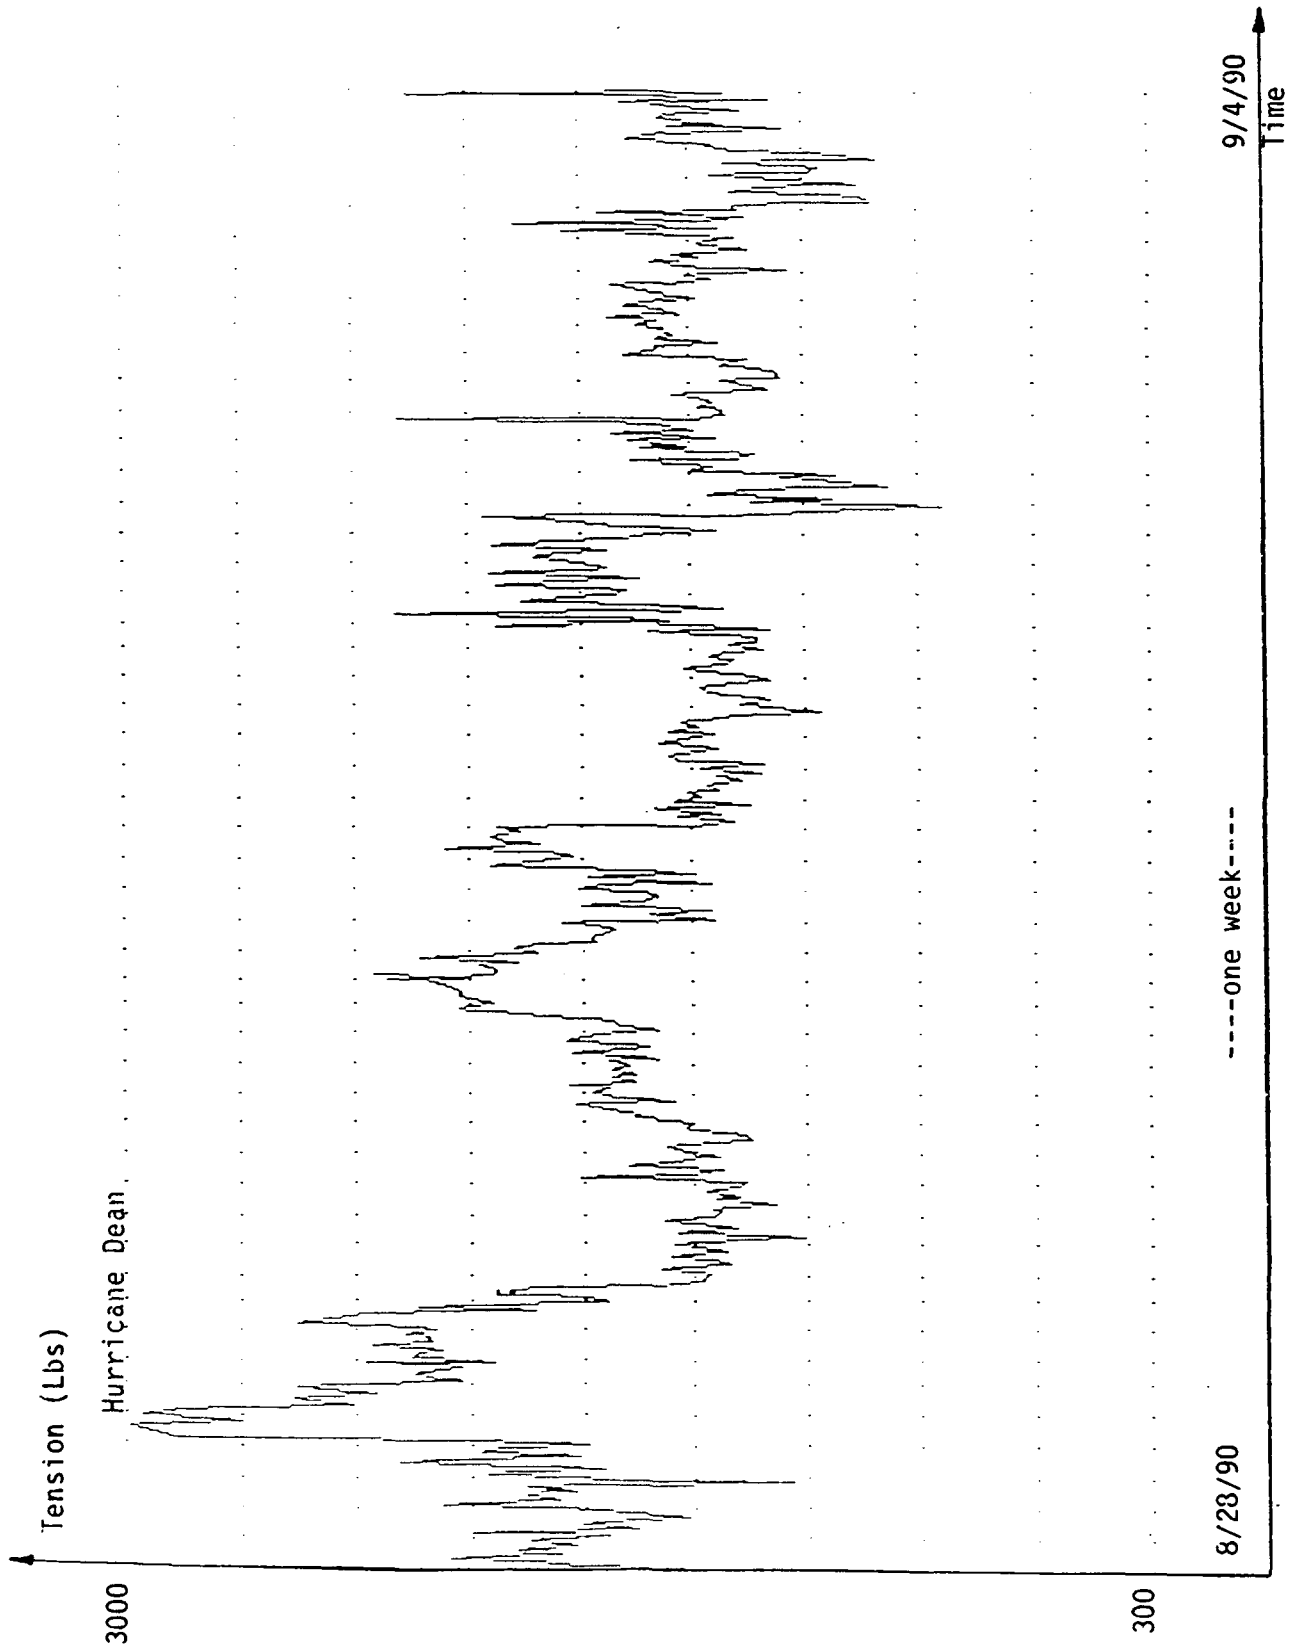
FIGURE 9: Tension cell data

A Teledyne Model 12367-20K tension cell, with a maximum capacity of 20,000 lbs, was mounted at the bottom of the surface buoy and connected through a shackle to the mooring. This sensor was carefully calibrated at WHOI prior to the deployment. Surface buoy tension data was transmitted daily to WHOI through ARGOS, to monitor buoy performance (Figure 9). When the surface buoy went adrift, the tension data clearly indicated a failure on the mooring line.

The sensor was recovered in good condition after the 18 month deployment. The underwater bulkhead connector and the pigtail going to the buoy instrument well were covered by heavy biofouling, but were otherwise undamaged.

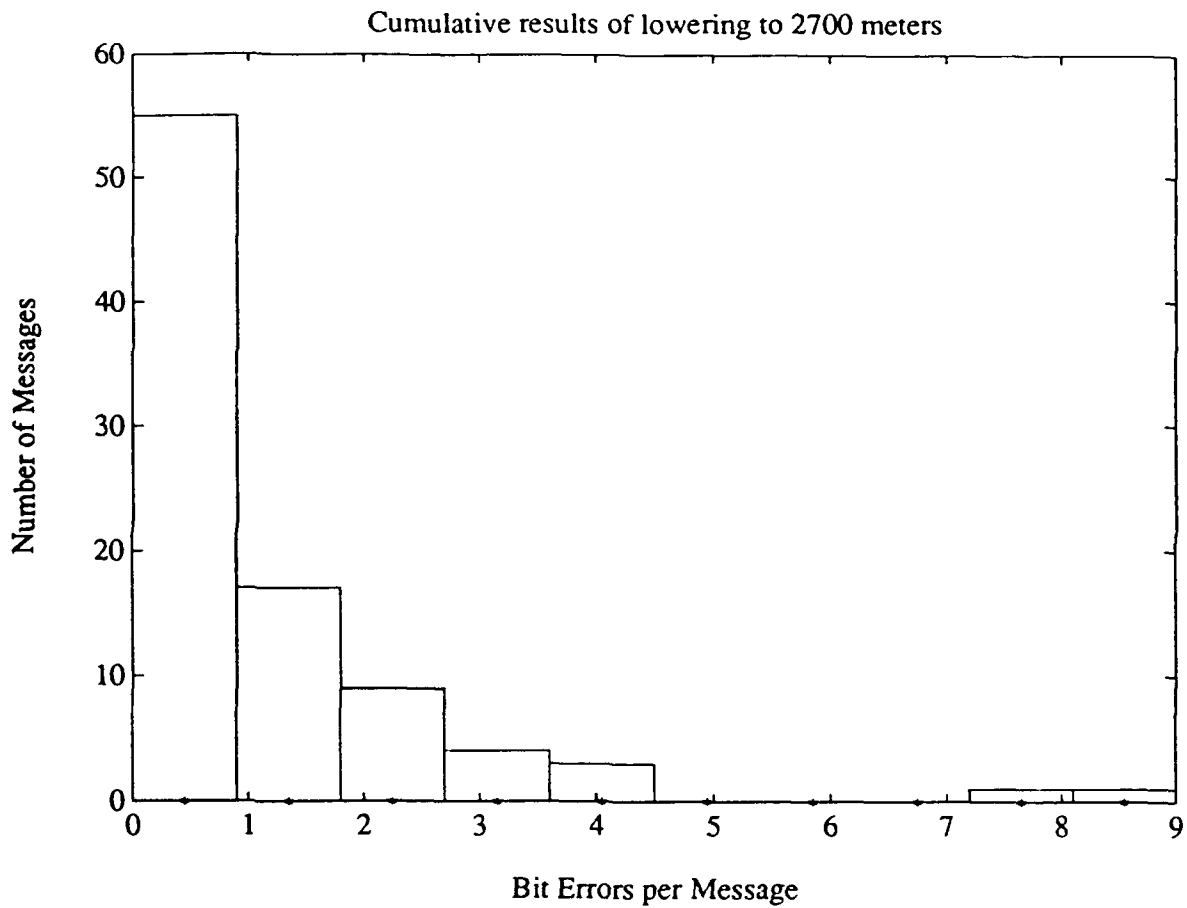
FIGURE 15: Cumulative results of lowering to 2700m

Prior to deployment of the ESOM mooring, two acoustic modems were lowered from the R/V Oceanus to 2700m depth to confirm their proper operation. Under calm sea conditions, with the receive hydrophone deployed at a depth of 6m, the average BER for both modems was about  $4 \times 10^{-4}$  (Figure 15). Only two of the data packets had more than four bit errors. BER at 2700m was only slightly higher than at 1000m and above.

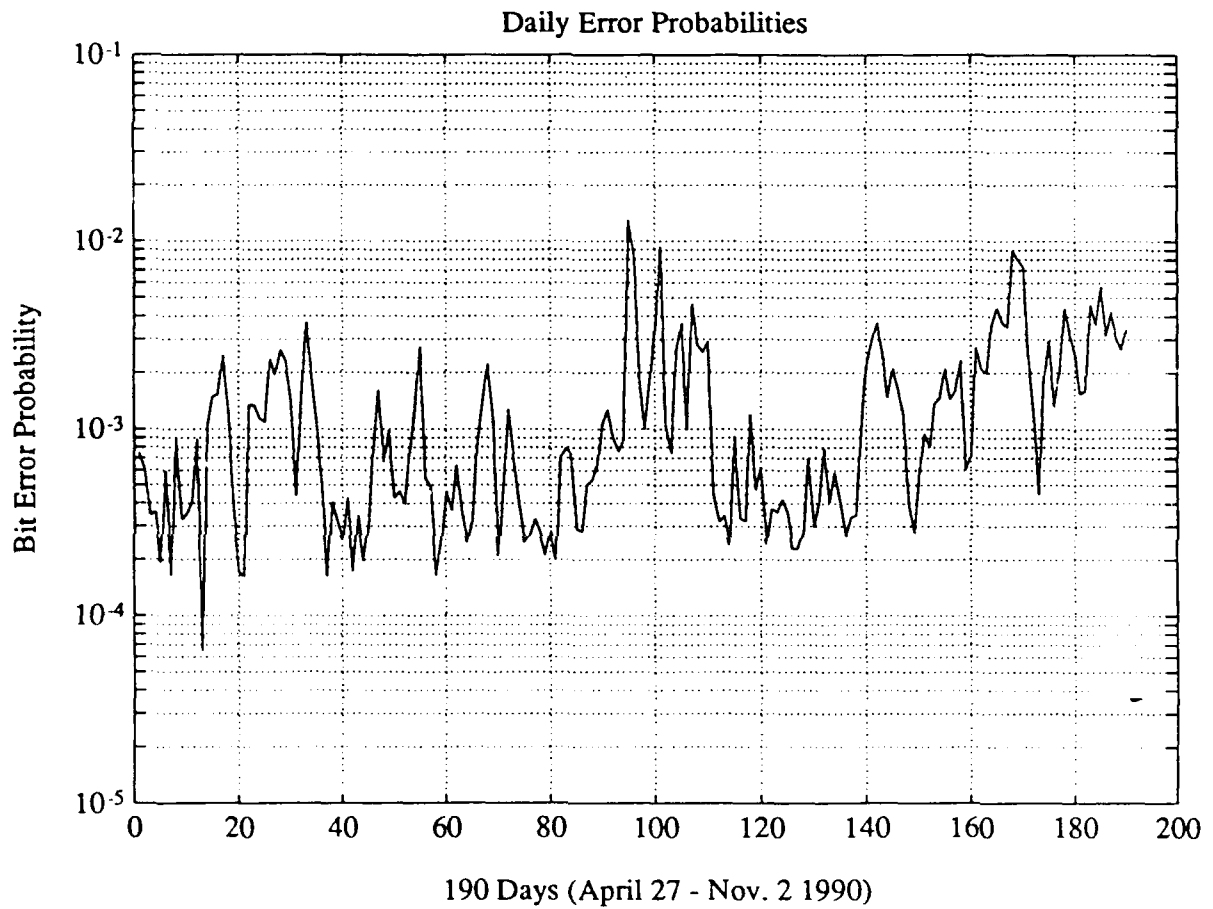
FIGURE 16: Data record from modem at 1500m

After the modem lowering, the ESOM buoy was installed and data were collected regularly over the next six months. Figure 16 (from [14]) show results from the modem deployed at 1500m. This modem operated for the full six month period and transmitted over  $20 \times 10^6$  data bits at a BER that ranged from  $1 \times 10^{-2}$  to  $1 \times 10^{-4}$  and averaged  $1.45 \times 10^{-3}$ . The other two modems operated much less consistently. The modem at 300m was damaged prior to or during deployment and suffered from a reduced transmit power level. As a result, its performance was marginal. The deep modem, deployed at 2900m failed after 32 days due to an electronic problem. During the time it operated, the average BER for its transmission exceeded 10% and its SNR was of the order of 2 dB, well below the performance level expected based on data from the shipboard lowering. Analysis of the system performance following the mooring retrieval suggests that high levels of surface-generated background noise masked the signal from the 2900m modem. Signal strength from the 1500m modem was higher and its data were seriously degraded much less frequently. Typical SNR for the 1500m modem was 10dB.

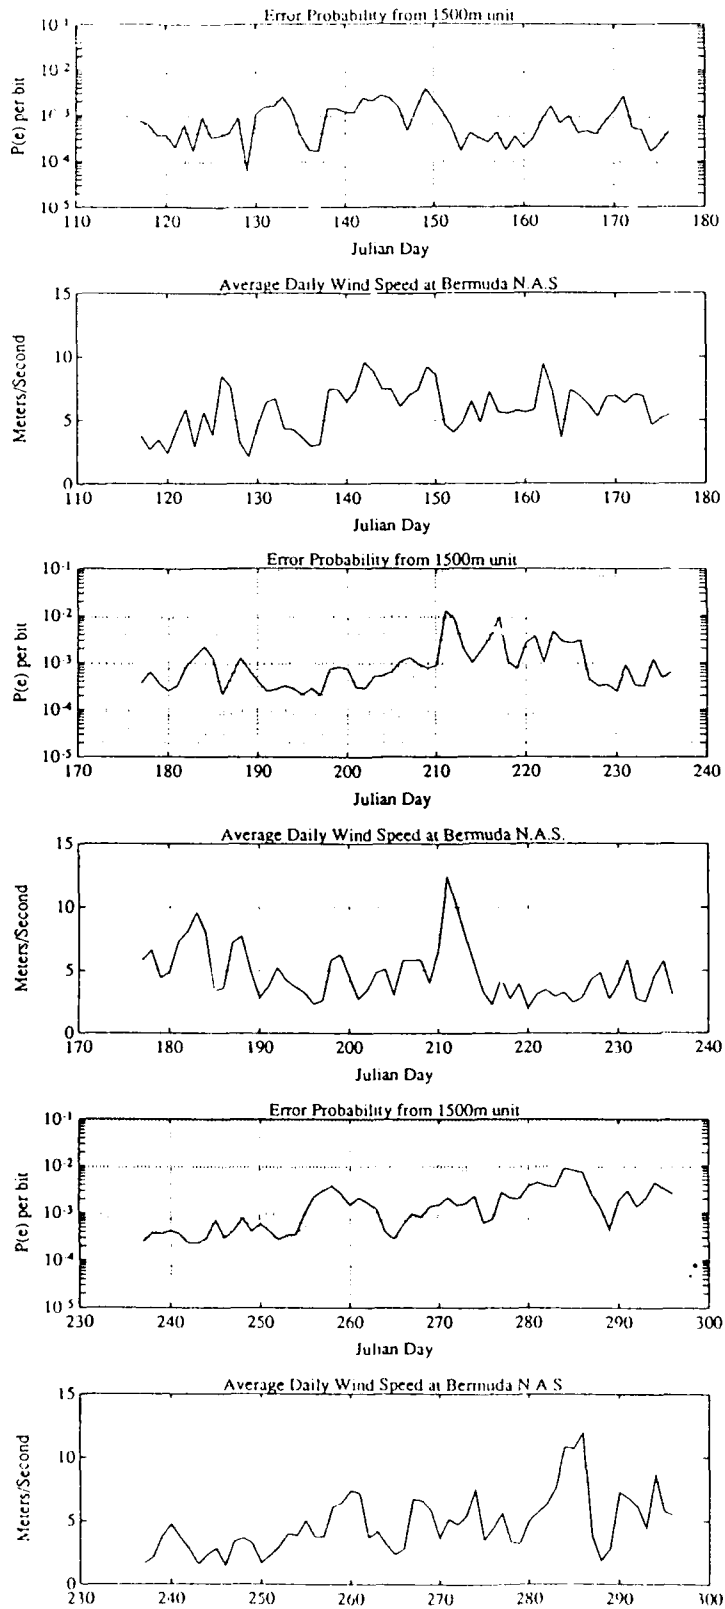
FIGURE 17: Wind speed and error probability data record

The source of the noise is believed to be surface waves and their interaction with the surface buoy and the hydrophone mounting system. This conclusion is based on data shown in Figure 17 (from [14]), which shows daily averaged wind speed at the Bermuda Naval Air Station (20km north of the mooring site) plotted above daily average BERs for the 1500m modem. A clear correlation between high average winds (and presumably high sea state) and high BER is evident.
