# Delivery Order 9 Enhanced Preliminary Assessment

FORT BENJAMIN HARRISON, INDIANA

February 1992

Roy F. Weston, Inc.  
West Chester,  
Pennsylvania 19380

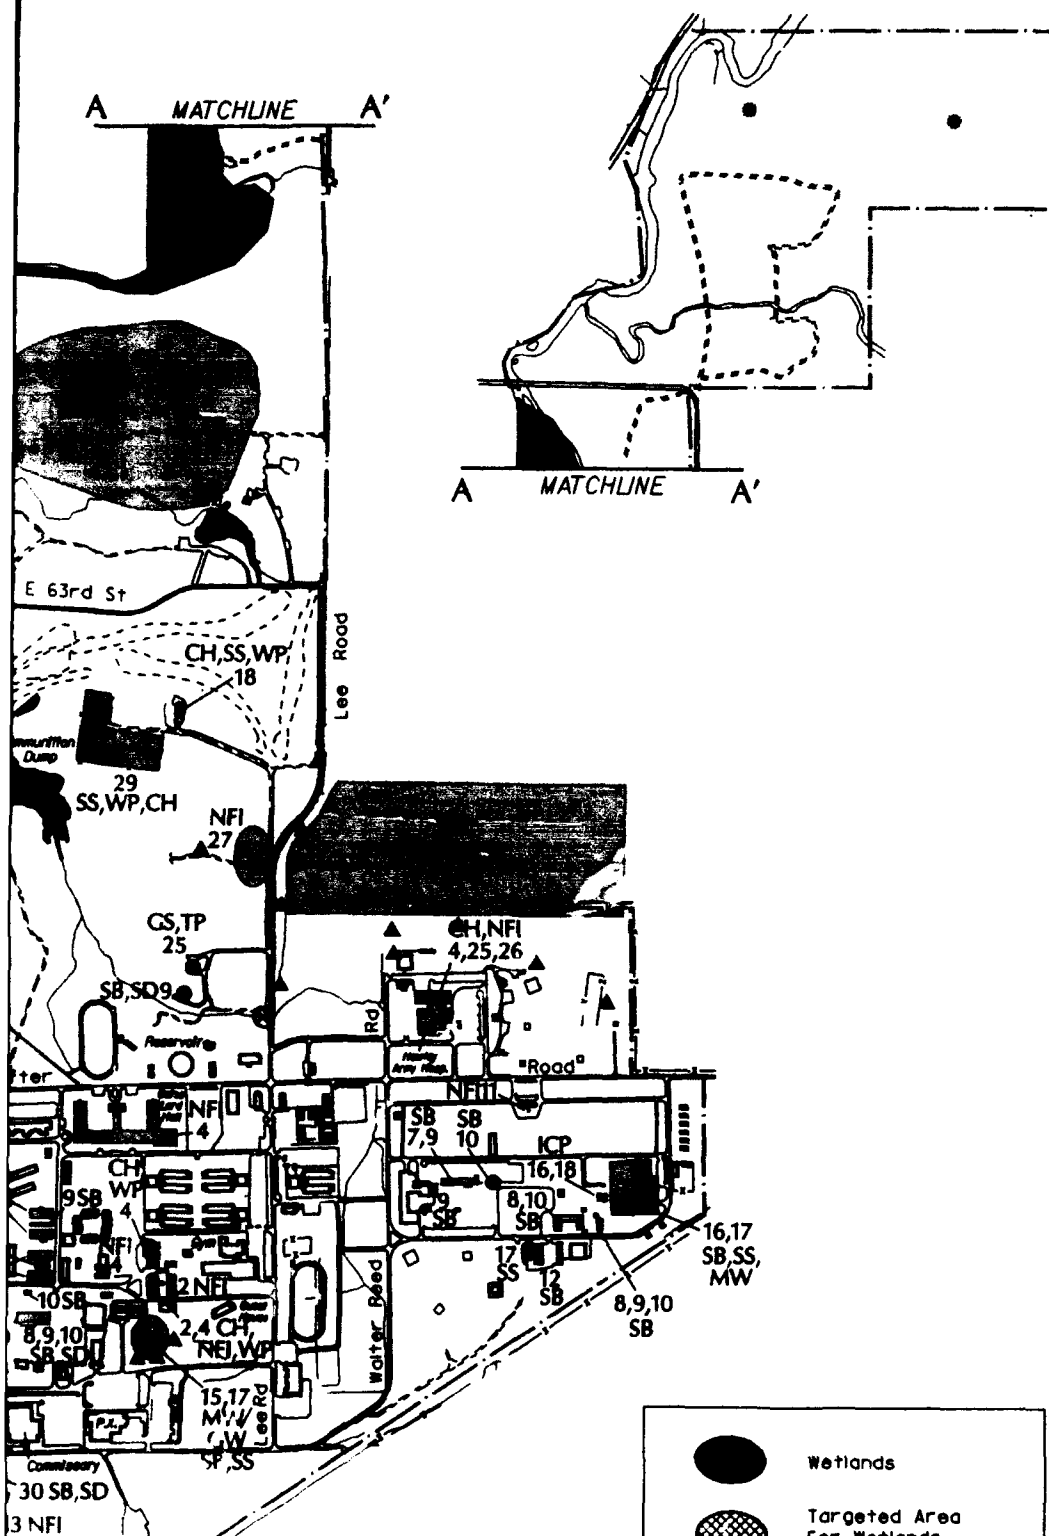
Figure ES-1  
Property Information  
Composite

Table ES-1 presents a summary of the description and findings for each AREE and the recommended activity, if any. Figure ES-1 shows recommended sampling location information for the AREES. No conditions that present an imminent threat to human health were observed on the FBH property.

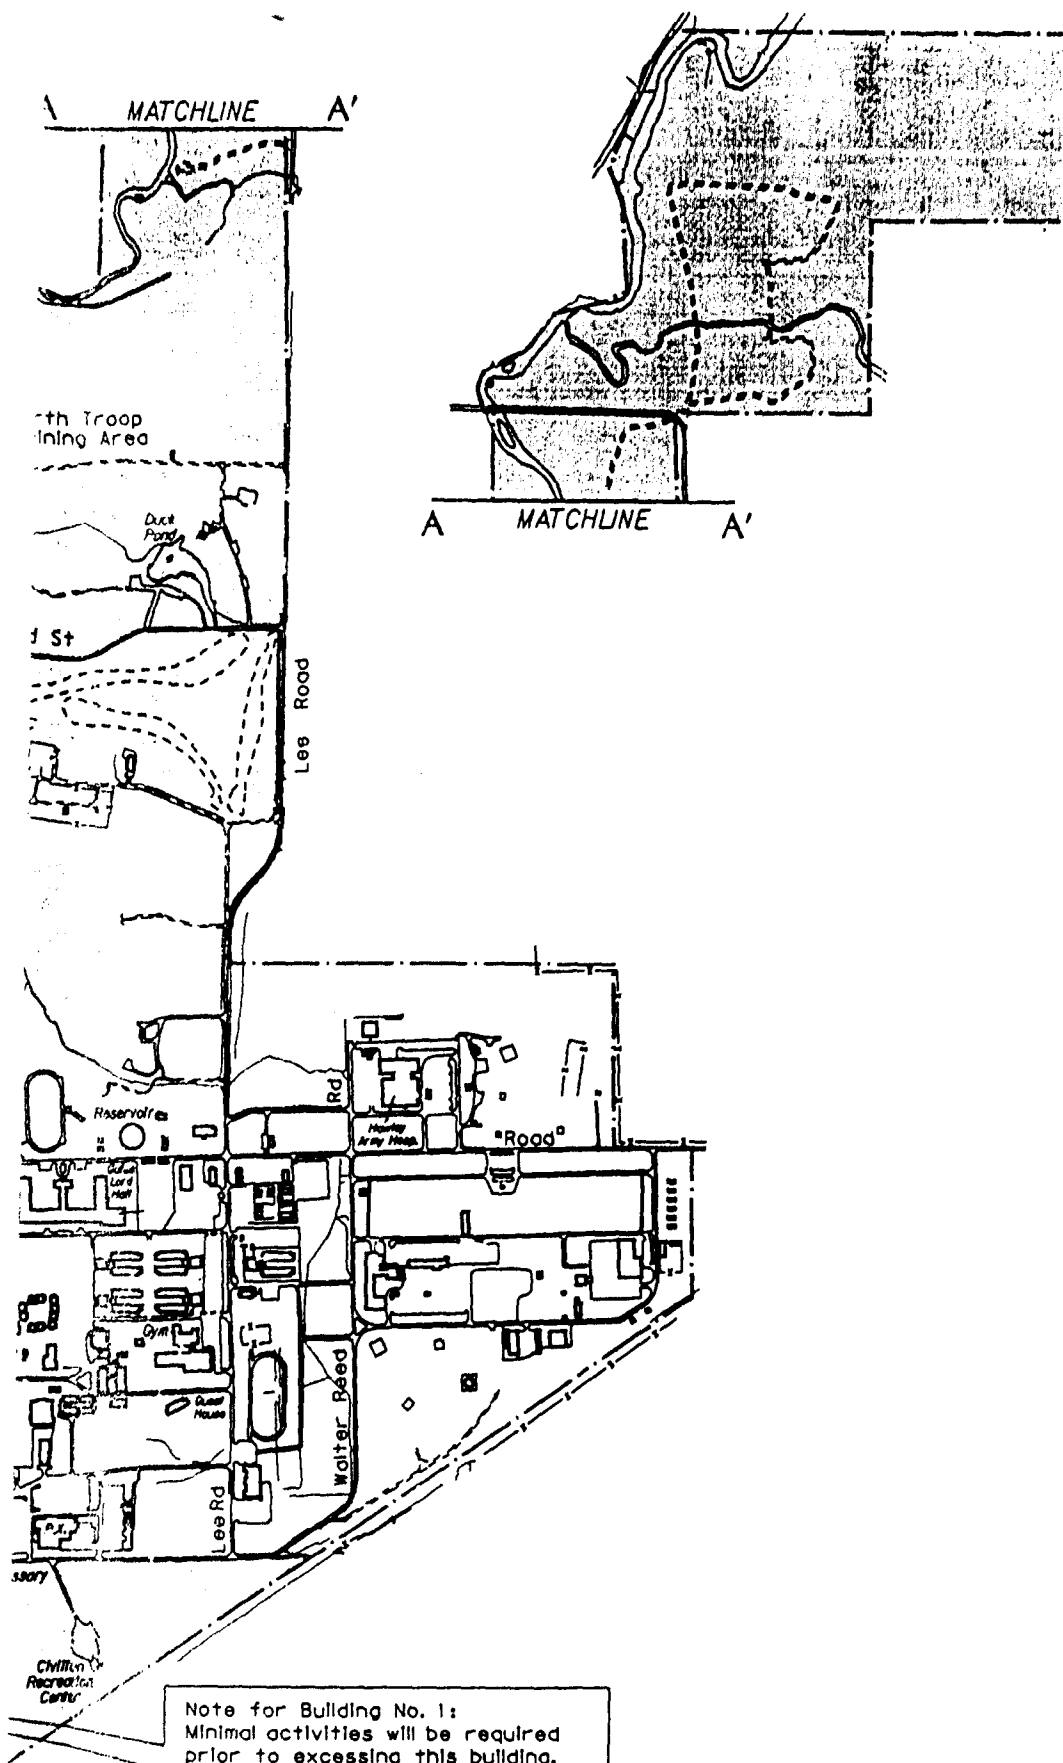
## Figure 5-2 Areas with Minimal Potential for Environmental Problems

Note: The areas with minimal potential for environmental problems, identified on this figure, may require minimal investigation, including but not limited to asbestos, radon and lead paint surveys, prior to being accessed. In addition, the presence of sensitive environments such as wetlands, endangered habitats, archaeological sites, and historically significant areas may become a factor when planning to access certain areas at Fort Benjamin Harrison. These environmentally sensitive areas are depicted on Figure 2-8.

Note for Building No. 1:  
Minimal activities will be required prior to accessing this building. These activities include removal of solvents, paints, photo processing solutions and cleaning chemicals; cleaning and sampling exposed surfaces; and performing asbestos survey to identify asbestos removal needs.
