Performance of Insulated Pavements at Newton Field, Jackman, Maine

Maureen A. Kestler and Richard L. Berg

May 1992

Prepared for
FEDERAL AVIATION ADMINISTRATION
DOT/FAA/RD-92/8

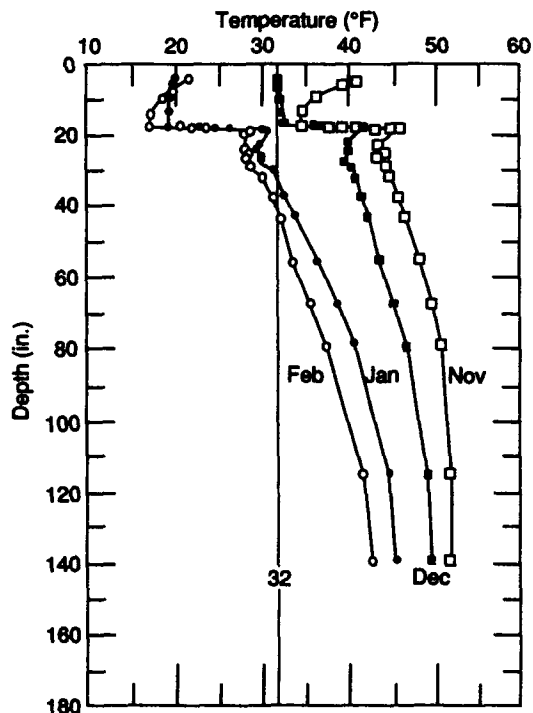
d. Subsurface temperatures at Newton Field, station 4+50, winter 1987-1988.

A distinct temperature discontinuity occurs immediately beneath the insulation on the runway (Fig. 13d). Two vertical thermocouple assemblies, one located both in and above the insulation and the second located entirely below the insulation, are separated horizontally by approximately 5 ft. It is believed that the temperature discontinuity between the thermocouple assemblies is caused either by damage to the insulation or by the horizontal separation of the insulation panels. The problem probably occurred during construction. Evidence of this problem was encountered during construction near stations 4+50 and 8+00. At both locations, trucks, bulldozers, and other construction traffic caused a large subgrade "flow" that in turn raised the insulation. Under

direction of the resident engineer, the insulation was removed, the subgrade was removed to the desired depth, and the geotextile, insulation, and base course were all replaced.

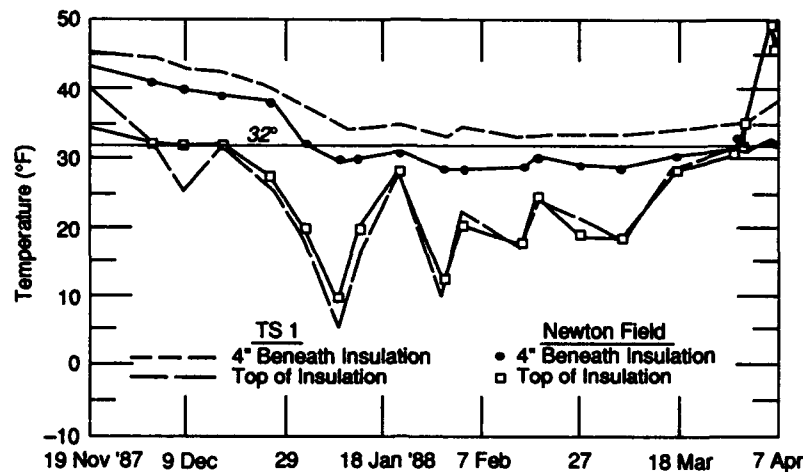
Figure 14. Comparison of temperatures above and beneath the insulation at Newton Field and in test section 1.

The difference in insulating ability of the insulation at the two pavement sites is also seen in Figure 14. Although the temperatures at the top of the insulation at each site are comparable, 4 in. beneath the insulation the temperatures differ substantially and fairly consistently over time. For winter 1987–1988, the 32°F isotherm never penetrated to this depth at the test sections, but at a comparable depth at the runway, the temperature remained below 32°F for nearly three months. This performance was the same for all three winters during which subsurface temperatures were obtained at both sites.

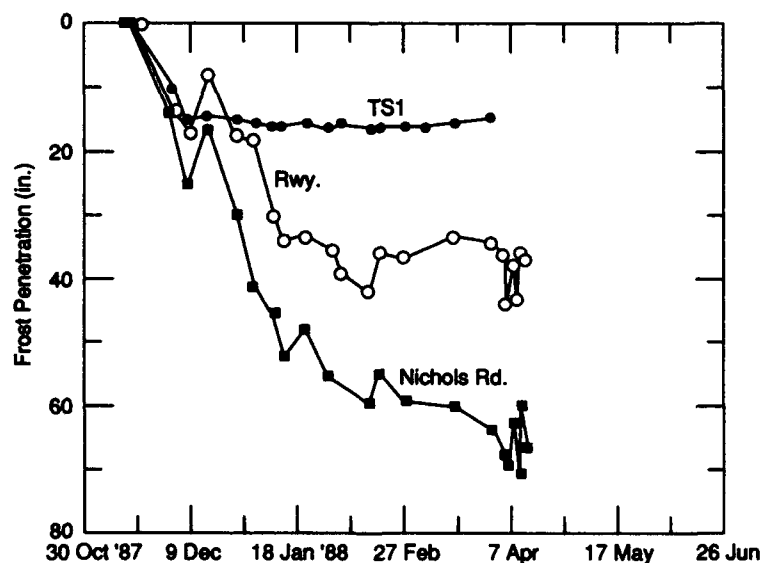
Figure 15. Progression of frost penetration with time, winter 1987–1988.

The progression of frost penetration with time is shown in Figure 15. For the 1987–1988 winter, the insulated pavement at the runway (station 4+50) allowed approximately 2 ft of frost penetration beneath the insulation. Although appreciably less than at noninsulated Nichols Road, the actual frost depth far exceeded all estimates. The unexpected frost penetration beneath the insulation on the runway during winter 1986–1987 constituted the primary reason for installation of the test sections in 1987. In contrast to the limited effectiveness of the insulation at the runway, the insulation at test section 1 prevented frost from penetrating into the subgrade. While Figure 15 is based upon 1987–1988 data, the curves are representative of each year, frost never

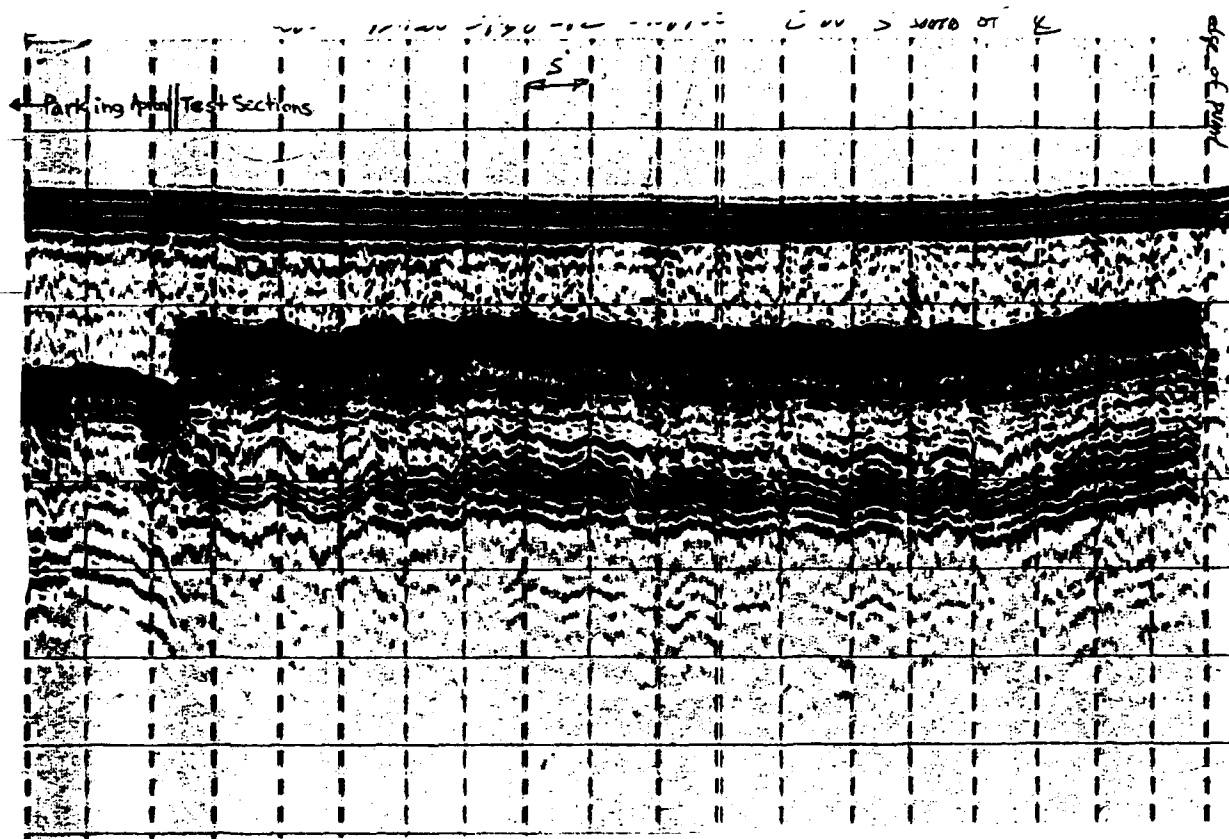
a. Centerline profile at test sections.

The transducer was pulled manually along the centerline of the test sections; the corresponding radar record is shown in Figure 22a. The unequal depths of the insulation at the parking apron and test sections are indicated by the discontinuity in the second set of dark bands.

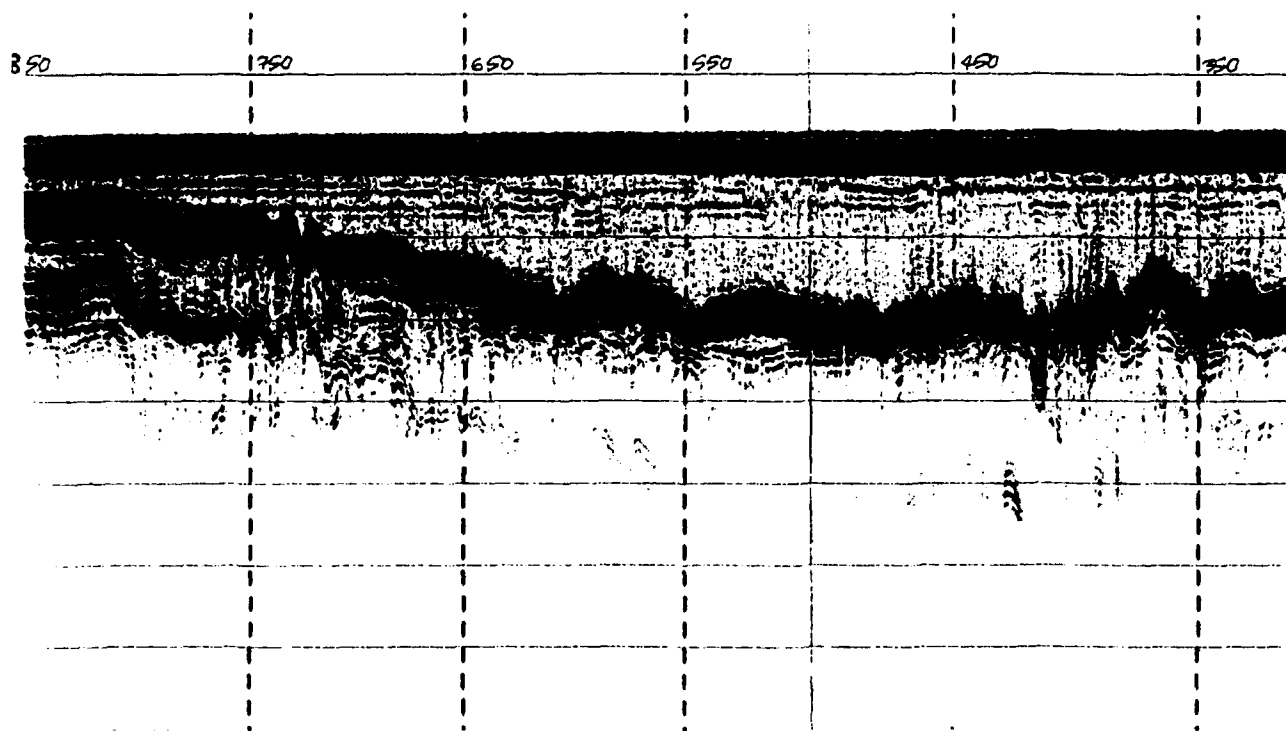
b. Centerline profile at west end of Newton Field, station 3+50 to station 8+50.

In contrast to the relatively uniform depth of the insulation panels at the test sections, Figures 22b and c show the irregular base course thickness and corresponding nonuniform depth of the insulation panels along the centerline at the two ends of the runway. For the insulation panels at shallow depths, the vertical stresses imposed by the design single-wheel load of 30 psi exceed the panels' 40 psi compressive strength. It is possible that this could lead to crushing of the insulation and ultimately lower the efficiency of the insulating layer. In Figure 22d, the individual 2-ft wide panels can be identified and are indicated on the figure.
