MTL TR 92-39

FAILURE ANALYSIS OF THE MAIN ROTOR RETENTION NUT FROM THE AH-64 HELICOPTER

MILTON LEVY, PAUL BUCKLEY, JOHN BEATTY,
RICHARD BROWN, ROBERT HUIE
U.S. ARMY MATERIALS TECHNOLOGY LABORATORY
METALS RESEARCH BRANCH

June 1992

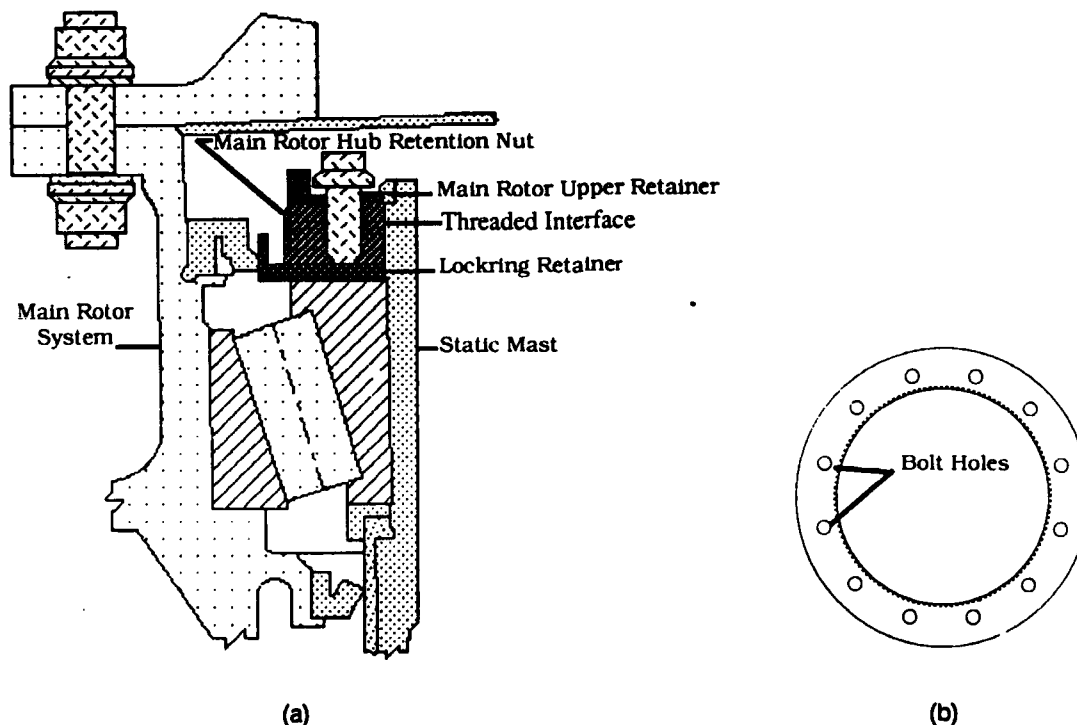
The main rotor retention nut is a flight-critical component that secures the main rotor hub and blade assemblies to the static mast. A schematic cross section is shown in Figure 1a. Figure 1b is a top view of the retention nut showing the 12 threaded bolt holes in the nut and the threaded internal diameter of the nut. The nut, which is made out of 18 Ni maraging steel C-250 grade per HMS 6-1080, is installed by screwing it down hand tight onto the static mast. The upper retainer is placed on top of the nut and 12 electroless-nickel plated (QQ-N-290) 8740 steel (MIL-S-6047) bolts are inserted and torqued according to a numbered sequence to a final level of 225 in-lbs., in order to generate compressive residual stress in the nut.

Figure 1. (a) Cross-sectional view of main rotor system, (b) Top view of main rotor hub retention nut with 12 bolt holes shown. Central hole is threaded to fit onto the threaded external diameter of the static mast.

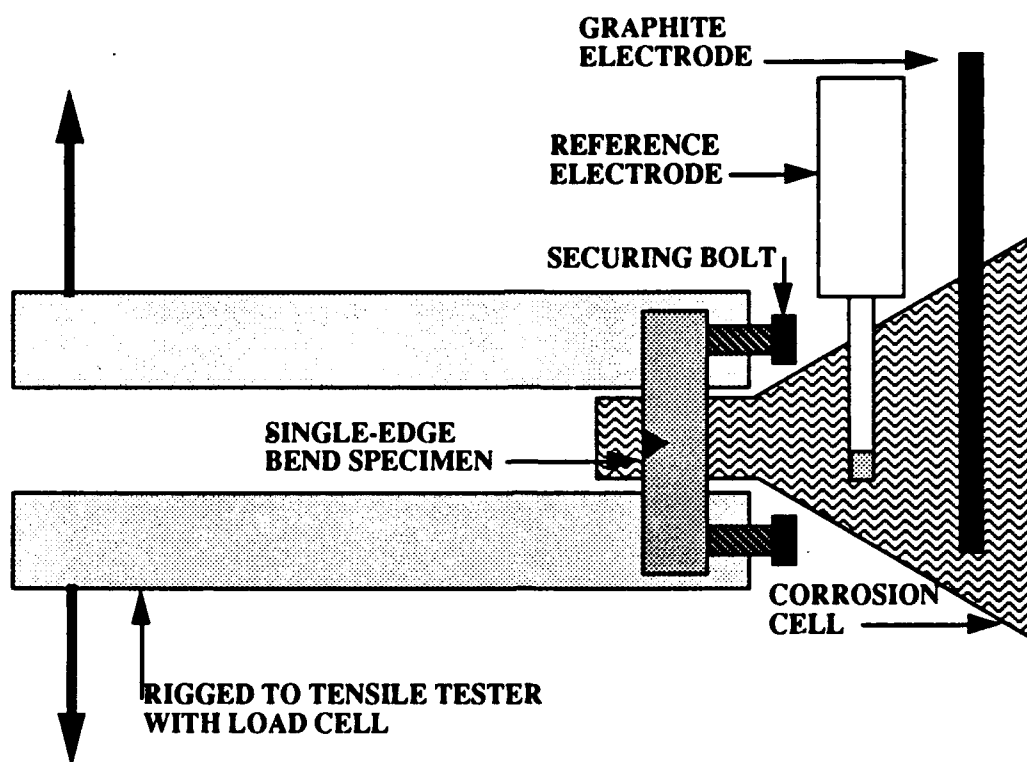
Figure 12. Constant-potential rising-step load single-edge bend test used to determine mining K_{Isc} values.
