DOT/FAA/RD-92/8

Performance of Insulated Pavements at Newton Field, Jackman, Maine

May 1992

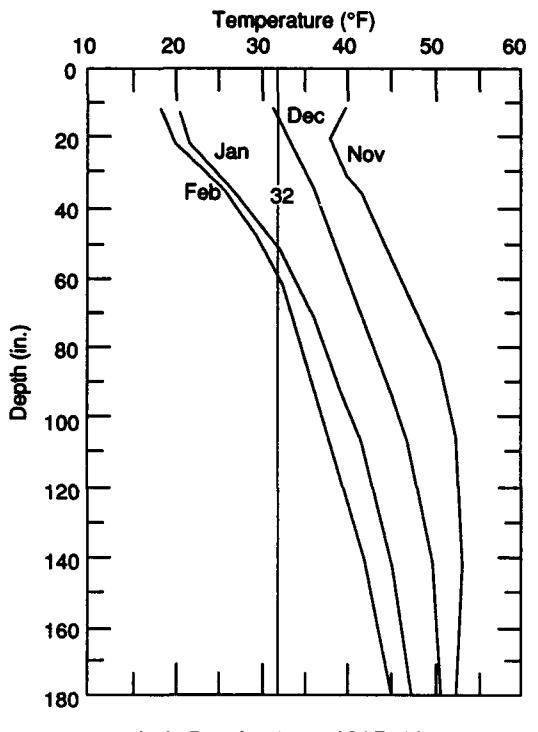
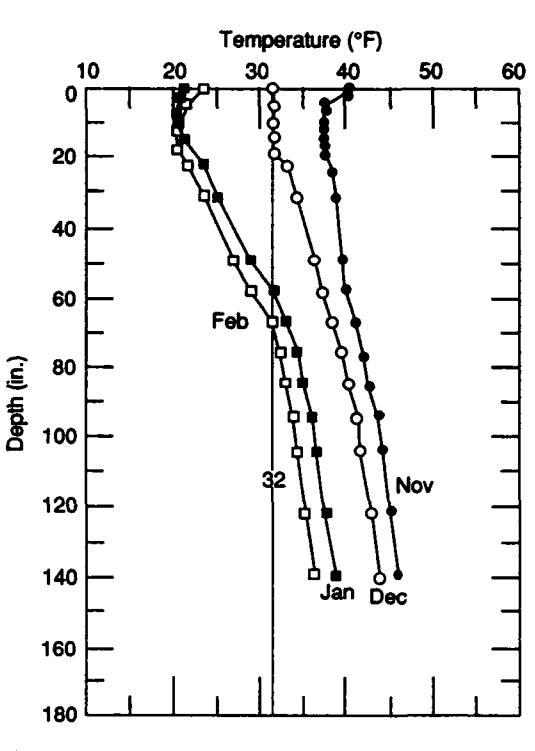
Subsurface temperatures were recorded at the test sites with thermocouples and thermistors. Figures) 3a and b show the changes in temperature with increasing depth beneath the pavement surface during winter 1987– 1988 for the noninsulated pavements at Nichols Road and the unpaved road adjacent to the test sections, respectively. For any given winter month shown, temperatures gradually increase with increasing depth beneath the pavement surface. Figures 13c and d demonstrate the effectiveness of the insulating layer for the insulated pavements at the test sections and the runway.

a. Nichols Road, winter 1987-1988.

b. Subsurface temperatures at unpaved road adjacent to test sections, winter 1987-1988.

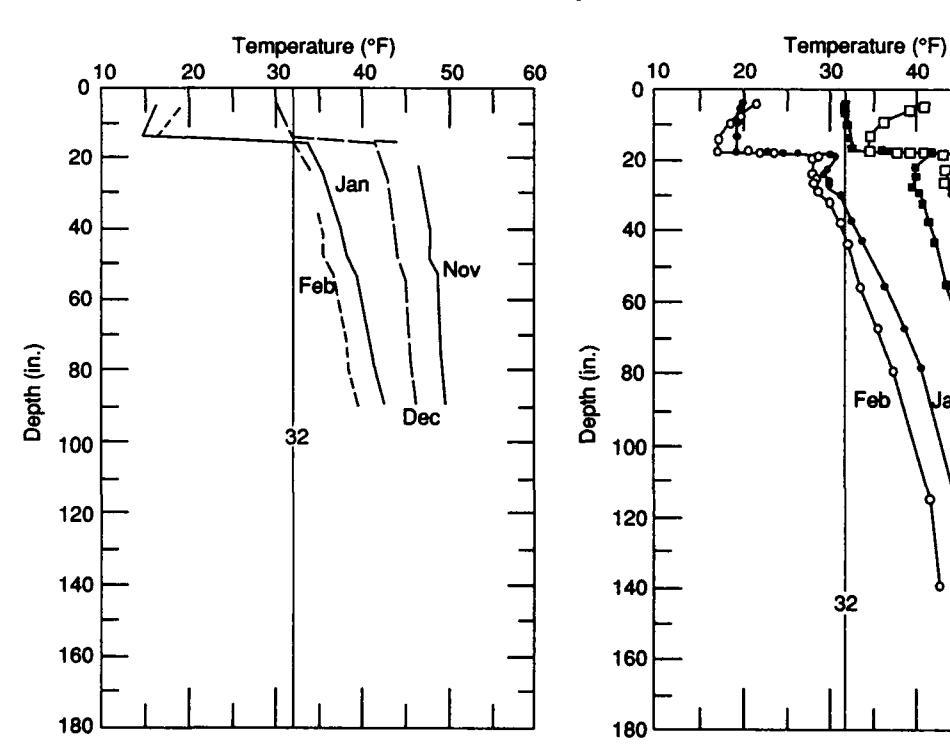
c. Subsurface temperatures at test sections, winter 1987-1988.

Figure 13. Subsurface temperatures at the study sites.

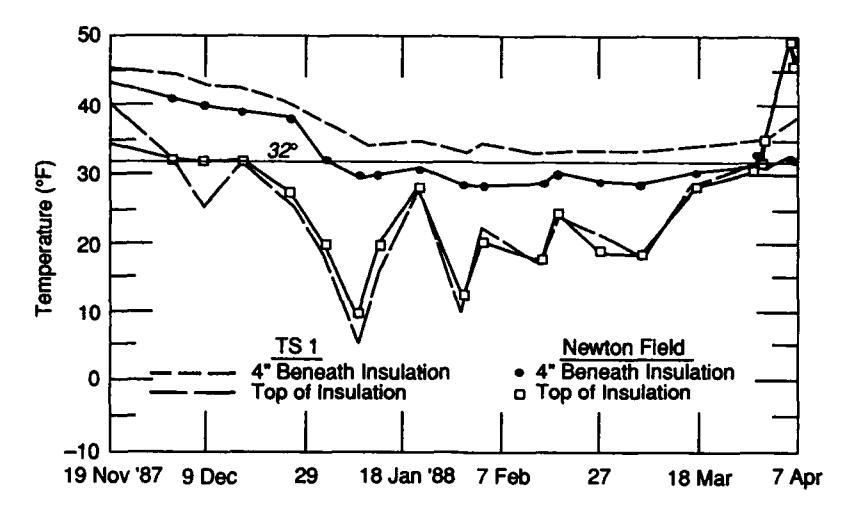
Figure 14. Comparison of temperatures above and beneath the insulation at Newton Field and in test section 1.

The difference in insulating ability of the insulation at the two pavement sites is also seen in Figure 14. Although the temperatures at the top of the insulation at each site are comparable, 4 in. beneath the insulation the temperatures differ substantially and fairly consistently over time. For winter 1987–1988, the 32°F isotherm never penetrated to this depth at the test sections, but at a comparable depth at the runway, the temperature remained below 32°F for nearly three months. This performance was the same for all three winters during which subsurface temperatures were obtained at both sites.

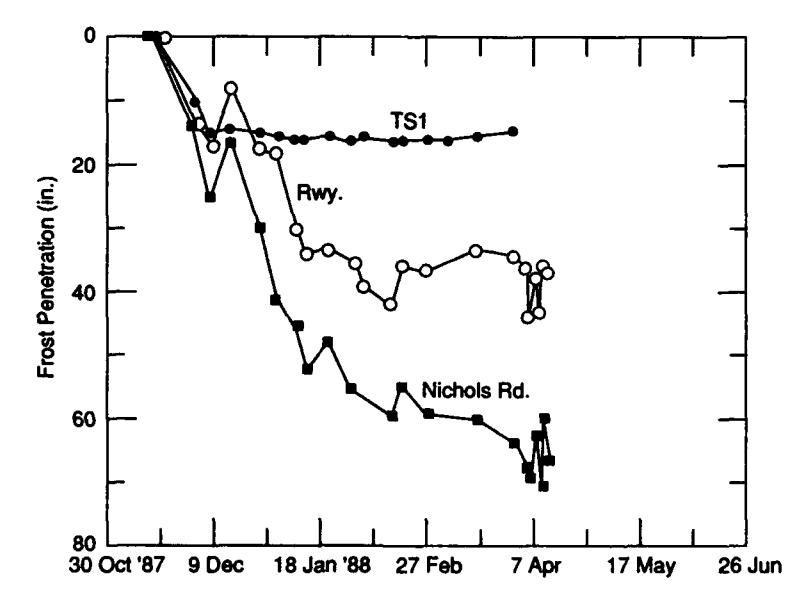
Figure 15. Progression of frost penetration with time, winter 1987-1988.

The progression of frost penetration with time is shown in Figure 15. For the 1987–1988 winter, the insulated pavement at the runway (station 4+50) allowed approximately 2 ft of frost penetration beneath the insulation. Although appreciably less than at noninsulated Nichols Road, the actual frost depth far exceeded all estimates. The unexpected frost penetration beneath the insulation on the runway during winter 1986–1987 constituted the primary reason for installation of the test sections in 1987. In contrast to the limited effectiveness of the insulation at the runway, the insulation at test section 1 prevented frost from penetrating into the subgrade. While Figure 15 is based upon 1987–1988 data, the curves are representative of each year; frost never

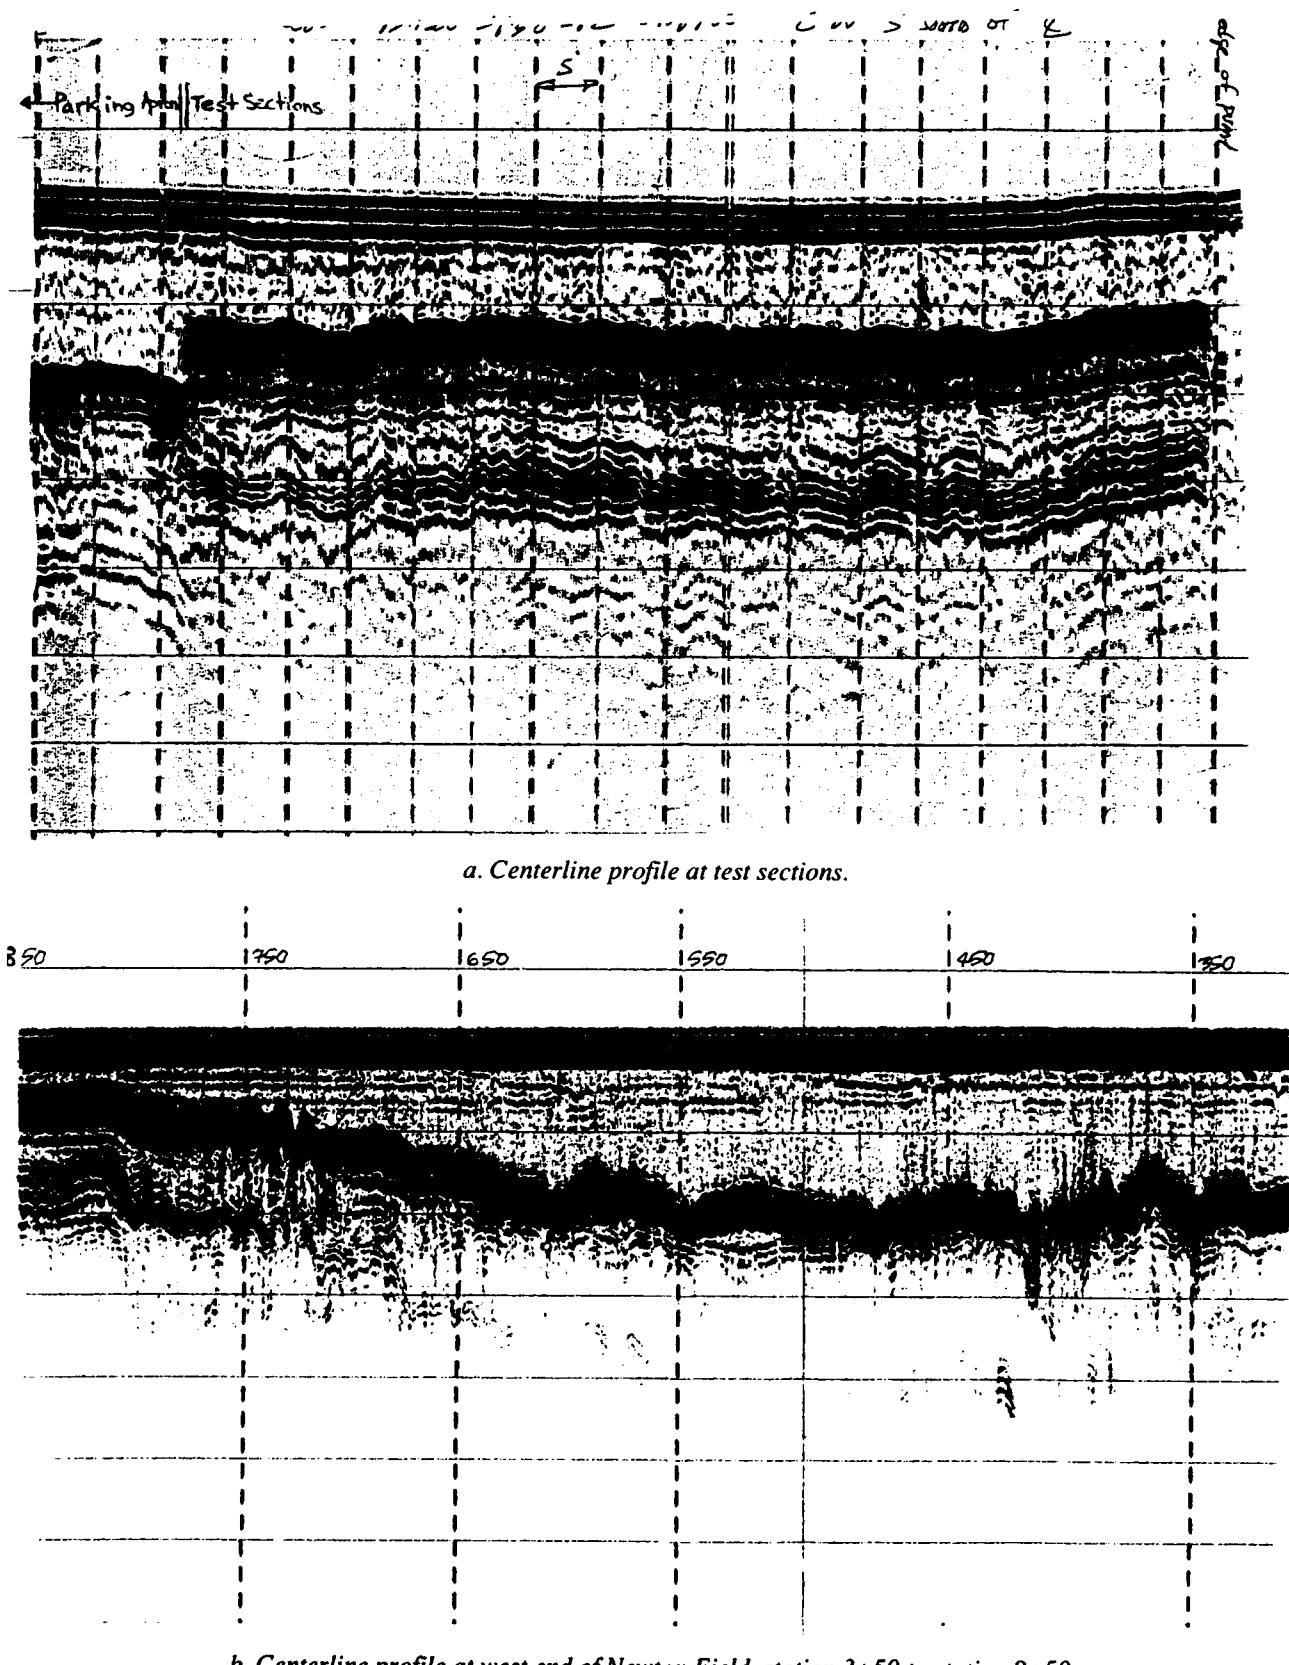
b. Centerline profile at west end of Newton Field, station 3+50 to station 8+50. Figure 22. Ground-penetrating radar profiles.

Assuming the gravel base course between the insulation and the asphalt concrete is of relatively uniform water content, approximate depths from the pavement surface to the bottom of the insulation can be determined from the graphic radar records, which resemble subsurface profiles (Fig. 22). Typically, the uppermost set of dark bands represents the antenna direct coupling; the next series of bands represents the interface between the insulation panels and the subbase (i.e., the bottom of the insulation); and the third, less distinct set is simply a multiple of the above insulation/subbase interface bands.

The transducer was pulled manually along the centerline of the test sections; the corresponding radar record is shown in Figure 22a. The unequal depths of the insulation at the parking apron and test sections are indicated by the discontinuity in the second set of dark bands. In contrast to the relatively uniform depth of the insulation panels at the test sections, Figures 22b and c show the irregular base course thickness and corresponding nonuniform depth of the insulation panels along the centerline at the two ends of the runway. For the insulation panels at shallow depths, the vertical stresses imposed by the design single-wheel load of 30 psi exceed the panels' 40 psi compressive strength. It is possible that this could lead to crushing of the insulation and ultimately lower the efficiency of the insulating layer. In Figure 22d, the individual 2-ft wide panels can be identified and are indicated on the figure.

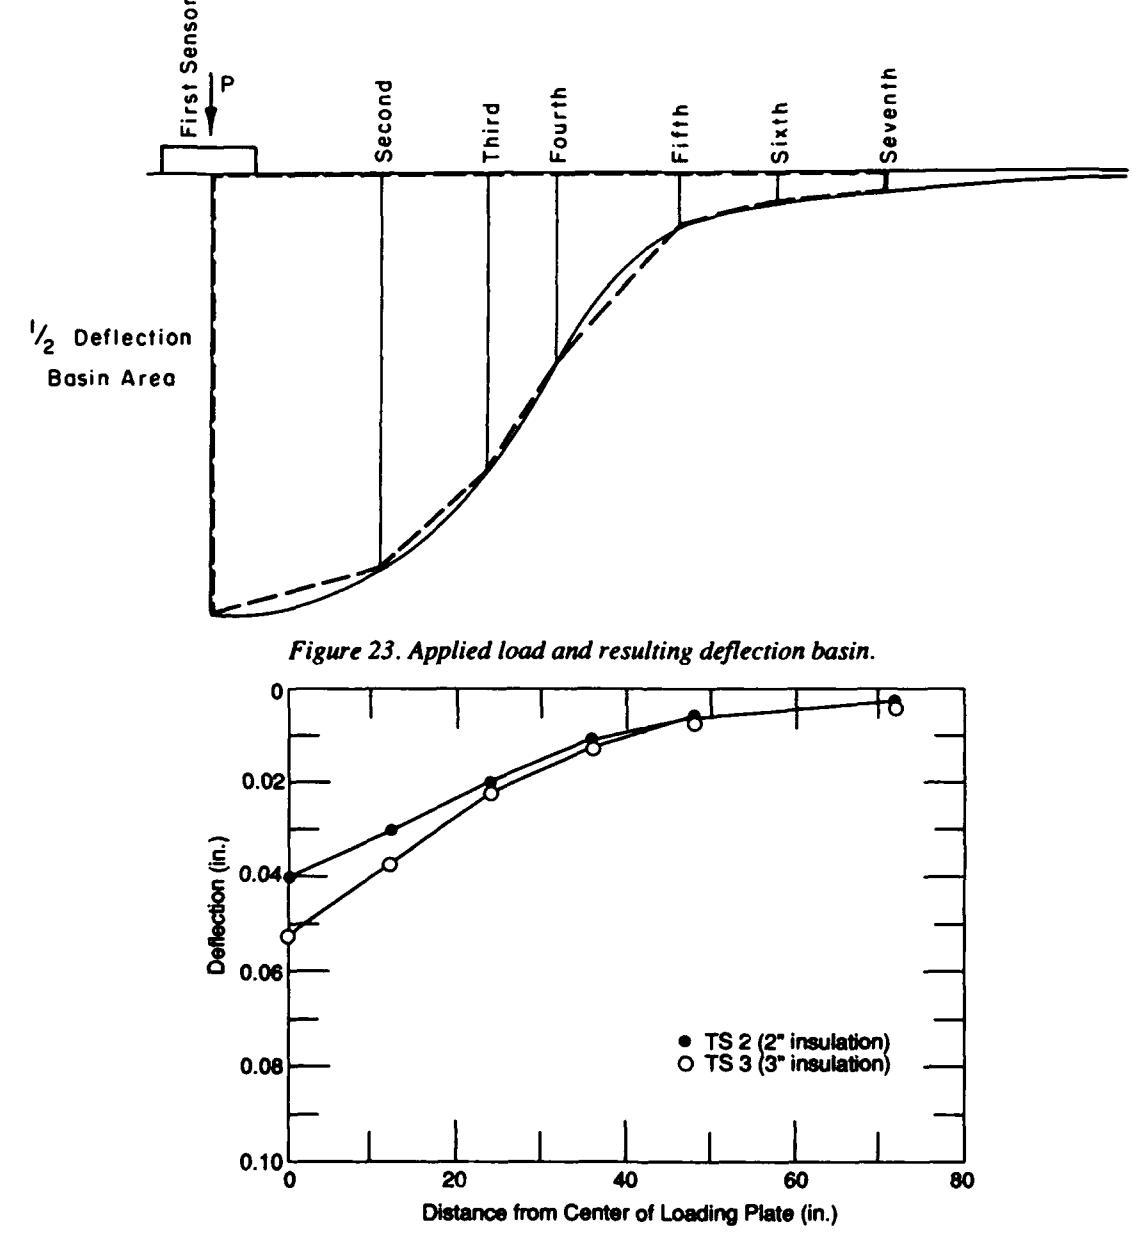
Figure 24. Typical deflection basins, test sections 2 and 3, spring 1989.

With the exception of the thickness of the insulating layer, the cross sections for test sections 2 and 3 are identical. Consequently, differences in the shape and area of the deflection basins in Figure 24 are attributed primarily to the additional 1-in. thickness of insulation in test section 3.
