WL-TR-92-3069

ADD-ON DAMPING TREATMENT
FOR THE F-15 UPPER-OUTER
WING SKIN

JULY 1992

FINAL TECHNICAL REPORT FOR PERIOD 1 JANUARY 1989 TO 28 FEBRUARY 1991

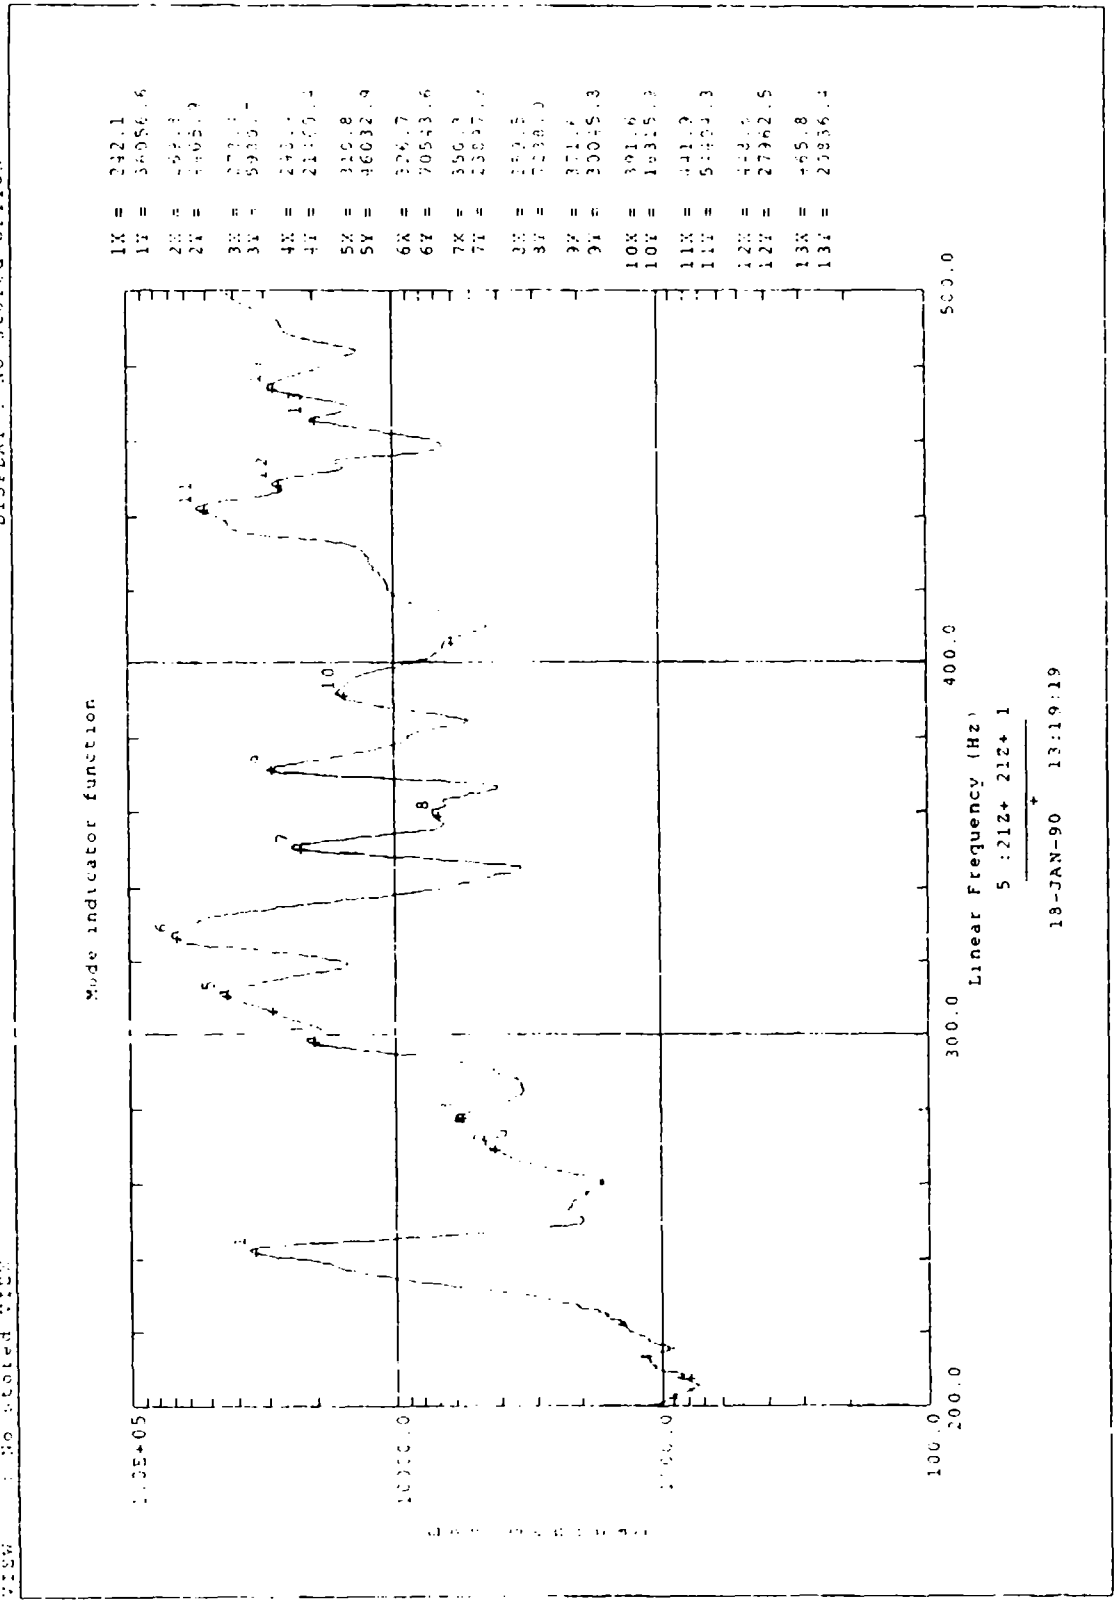
Figure 27. Modal Indicator Function for Stiffener Response

Mode shapes and other modal parameters were obtained from the transfer functions gathered during the modal surveys on the skin and stiffeners. Figures 26 and 27 contain modal indicator functions for the skin test data and the stiffener test data, respectively. The modal indicator function represents the relative strength of each mode plotted on a logarithmic scale. Figures 26 and 27 showed that a number of resonant frequencies were shared by the skin and stiffeners. This was expected because the skin and stiffeners are one structure. Mode shapes were generated of the skin by itself, the stiffeners by themselves, and the skin and stiffeners combined. Figures 28 through 34 show some of the skin and stiffener modes. The strong correlation between the stiffener and the skin motion led to a damping design applied to both the skin and stiffeners which yielded the necessary increase in the service life of the wing skin. The damping treatments developed are discussed in the next section.
