WL-TR-92-4017

X-RAY COMPUTED TOMOGRAPHY FOR FAILURE ANALYSIS

Boeing Defense & Space Group
P.O. Box 3999
Seattle, WA 98124

Interim Report for Period May 1991 to January 1992

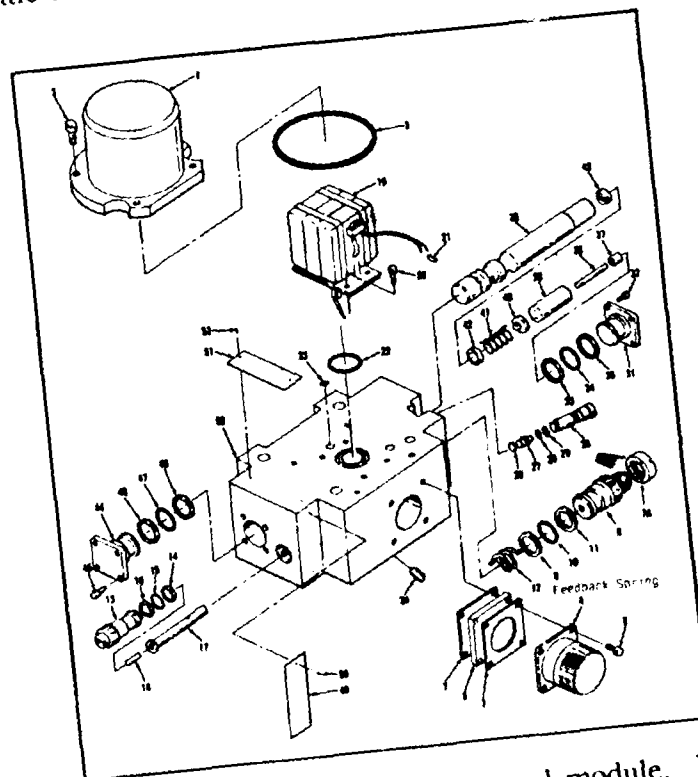
Figure 3.1-3 Breakout drawing of the autobrake control module. Item #12 is the feedback spring.

Computed tomography evaluation of the autobrake control module was performed on a medium resolution (~1 line-pair/mm) system. CT slice heights were selected to inspect the suspect pressure control servovalve and other regions of interest such as orifices, valves and moving parts. Figure 3.1-3 shows a breakout drawing of the module. The first CT slice, was taken to inspect the feedback spring, no. 12, in Figure 3.1-3, that seats in detent holes on items no. 8 and no. 17. The CT image shown in Figure 3.1-4, with an enlargement of the spring shown in Figure 3.1-5, clearly indicate that the feedback spring of the pressure control servovalve had jumped out of the detents. This was the cause of the out-of-specification hydraulic pressure response. When the spring is not properly centered in the hole, this leads to rubbing, binding, and scratching as observed in past failure analysis investigations of this unit. Subsequent CT slices, not shown here, demonstrated the capability to adequately evaluate the other areas of interest in the assembly.

CT specifically provided the analyst direct evidence the spring was clearly not in the detent. This cannot be determined with certainty from any other nondestructive technique. Because disassembly causes the spring to float free when the end of the servovalve portion of the unit is removed, even disassembly of the unit would force the analyst to rely on the indirect evidence of scratches and rub marks.

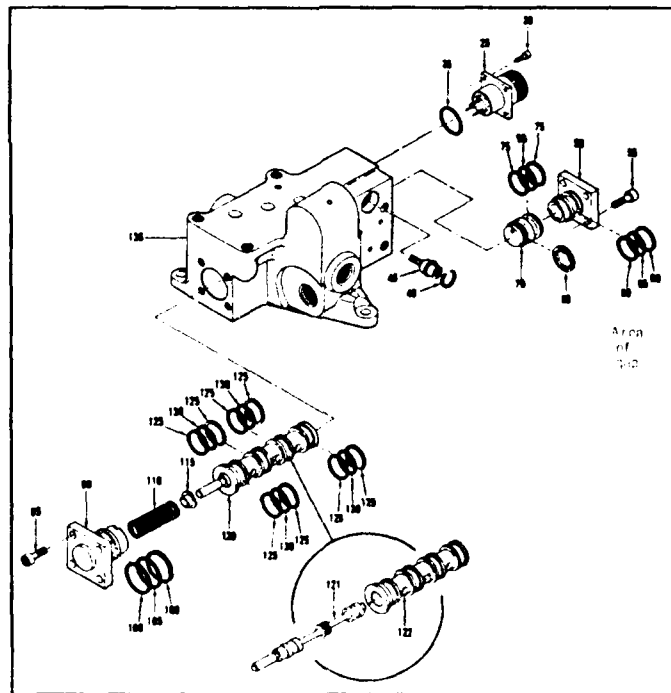
Figure 3.2-3 Breakout drawing of the autobrake module shutoff valve assembly.

The problem experienced with this type of unit was incomplete shutoff and seemed to indicate a problem with the shutoff valve assembly. Figure 3.2-3 is a breakout drawing of the shutoff valve assembly. Previous experience with X-ray radiography of this part has shown that the part is too complex to use a radiograph for investigation purposes. CT provides a means to observe the internal detail of the shutoff valve without the confusion of the complex externals. The autobrake module was brought to a medium resolution CT facility for nondestructive evaluation. A digital radiograph was taken, and CT slice heights were then selected to inspect the suspect shutoff spool valve and the other control spool valves. The first CT slice, in Figure 3.2-4 and the enlargement of the spool image in Figure 3.2-5, show that the shutoff spool valve had not returned to its seated/deenergized position. Subsequent slices clearly showed the capability to inspect the other areas of interest in the assembly. A strong possibility exists in the process of disassembly that the valve would have seated leaving no clear evidence of the failure.

CT proved to be a quick, effective way to determine the internal condition of the autobrake module. This nondestructive evaluation saved the tedious process of disassembly and notation of any and all observations that might be indicative of the problem.

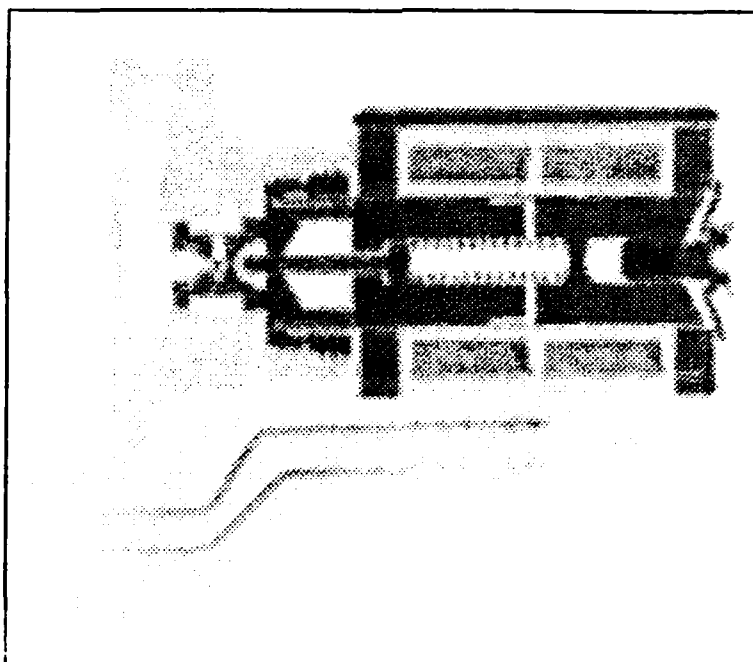
Figure 3.3-4 Longitudinal CT slice through a new solenoid valve.

This CT scanning was performed on a medium resolution (~ 1 lp/mm) CT system. Although the component was small enough to be scanned on a much higher resolution CT system, scheduling did not allow this option. However, even the medium resolution system could show the position of the ball on the seat. Figure 3.3-3 is a longitudinal scan of the burned unit and Figure 3.3-4 is of a new unit. In these scans the interest is in observing how well the ball is seated. With the resolution available, the edge of the ball is blurred, making the interpretation of contact difficult. A new solenoid, in the closed condition was scanned as a comparison. The fact that the ball was in the normally closed position was verified to the limits of the CT system.

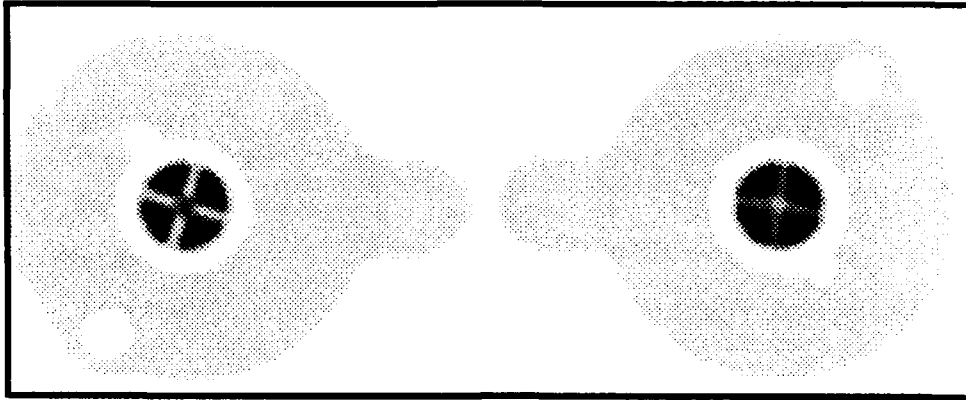
Figure 3.3-11 CT slice through the new (left) and burned (right) solenoid valves at CT system height 485.5.

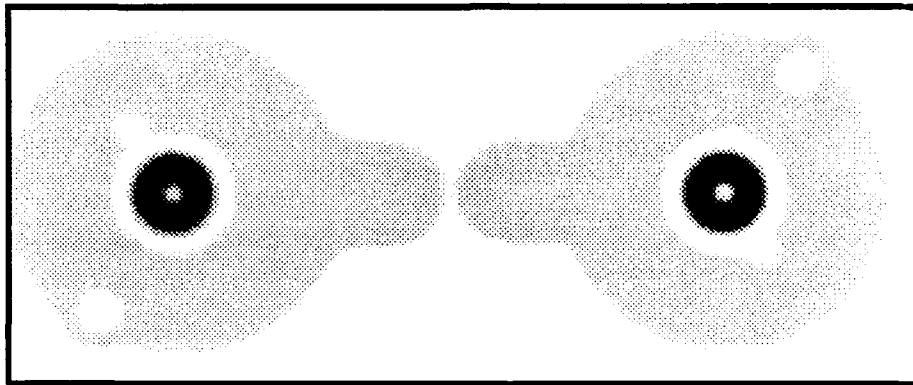
Figure 3.3-12 CT slice through the new (left) and burned (right) solenoid valves at CT system height 485.0.

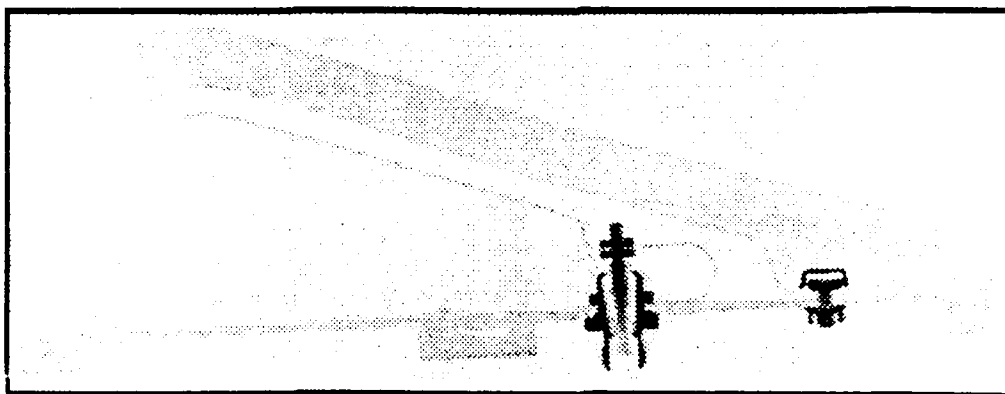
The antenna was CT scanned, and the images show very clearly the antenna element, potting, connections and allow dimensional measurements to be readily made. Figures 4.1-2 and 4.1-3 show two CT images across the unit from two different orientations. An interactive measurement was made of the internal dimension of interest which was determined to be $14.1 \text{ mm} \pm 0.1 \text{ mm}$ (see Figure 4.1-3). This measurement supported the conclusion that the unit was performing at specification limit because of the assembly process. This was additionally supported by the fact that there were no other physical anomalies found which could have resulted in marginal performance (i.e., voids or inclusions in the potted foam or an element misalignment). The nondestructive CT measurements played a significant role in the proper disposition of this unit

Figure 4.1-2 CT slice through the instrumentation wafer antenna.

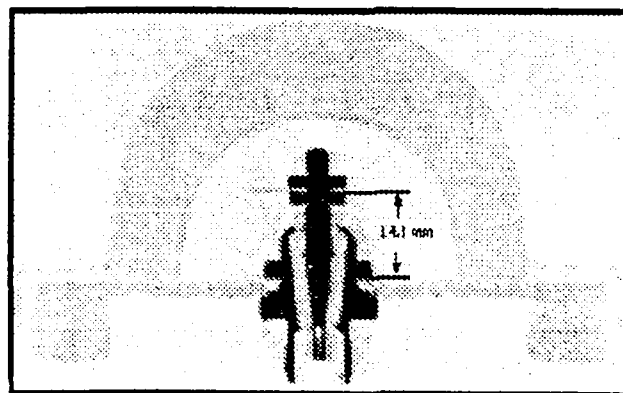
Figure 4.1-3 CT slice through the instrumentation wafer antenna.

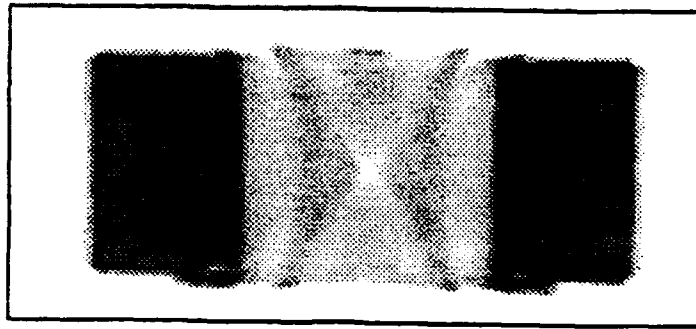
Figure 5.1-4 CT slice at location 1 on the drag brace bushing.

Computed tomography allows the observation of the interior of the new design without destructive sectioning that may relieve stresses. Figure 5.1-2 is a schematic of the elastomeric bushing which fits into the drag brace. The figure shows the location of the desired slices in the multilayered structure. Figure 5.1-3 shows the side view of this new bearing assembly design. Cylindrical section metal shims are embedded in the elastomer (to prevent it from ballooning out). CT slice locations were selected from digital radiographs of the drag brace. Figures 5.1-4, 5.1-5, 5.1-6, and 5.1-7 are CT slices taken at locations 1 through 4 respectively. The images show that the cylindrical metal shims in the elastomer have been distorted. Ideally they would appear as rectangular details in slices with this orientation. The characteristic "saddle" shape exhibited by the shims is a trait of a side load applied to this bushing which has left the material distorted. This information was supplied to the bearing manufacturer and will be used for future design changes.

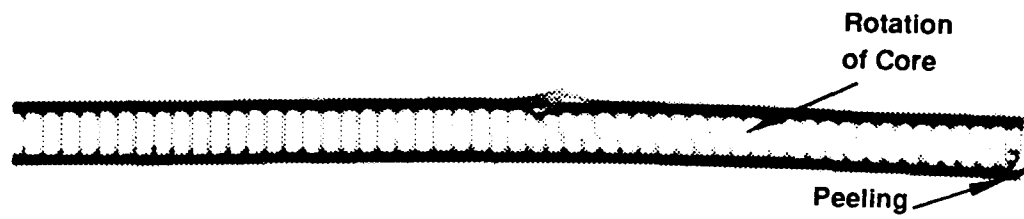
Figure 6.1-5 CT slice at location B.

Three CT slices (locations B, C, and D) were taken in a direction perpendicular to the slice A series as shown in Figure 6.1-2. One was taken down the center of the panel (slice C), and the other two, approximately 19 mm (0.75 inch) from each edge (slices B and D). Figure 6.1-5 shows the cross-sectional image produced at slice B. Rotation of the core walls due to shearing of the right half of the core can clearly be seen. Also, peeling of the core away from the lower skin is indicated in the lower right hand corner. This type of phenomenon would occur if the top sheet were sheared to the left relative to the bottom skin. The center region shows multiple delamination which indicates compressive loading along the face of the top plate. The left half of the panel did not undergo shear deformation. Figure 6.1-6 is a 2x magnification of the left side of the same image. The cores at the left end of the image reveal a slight kinking in several of the core walls, indicating a compressive loading perpendicular to the panels near that edge.

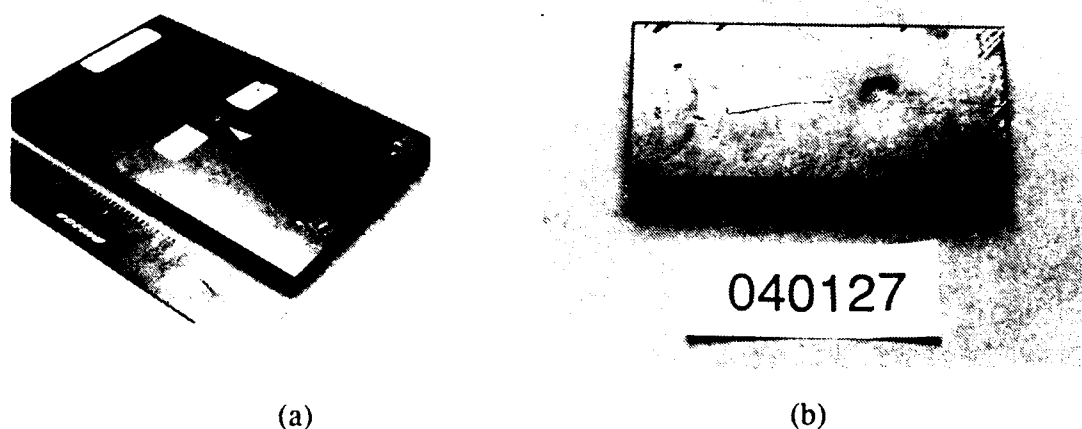
The assessment of damage in composite structures can be difficult. If destructive analysis is performed for assessing the damage, then each layer of the composite must be carefully removed and the surface photographed to determine the extent of damage on each layer. In an earlier task report [9] it was shown that high resolution CT systems could image features less than 0.1 mm in size (0.004 inch) in samples less than 25 mm (1 inch) in size. An example of applying this capability to composite damage is the photograph of a composite impact damaged test sample and a coupon extracted from the impact region of the sample shown in Figure 6.2-1. Figure 6.2-2 is a CT image through the center of the coupon showing the characteristic delamination pattern due to impact damage.

Figure 6.2-1 Photograph of the graphite epoxy composite sample a) impacted test panel, b) small coupon removed from the damaged region.
