COMPOSITE UNIT ACCELERATED LIFE TEST  
OF THE HIGH GAIN ARRAY

Contract Number N00014-93-C-2021

Texas Research Institute Austin, Inc. (TRI/Austin)  
Reliability Engineering Division  
A.V. Bray, S.L. Arnett, and S.C. Liberty  
9063 Bee Caves Road  
Austin, Texas 78733  
(512) 263-2101

13. ABSTRACT (Maximum 200 words) This report documents the composite unit life testing (CUALT) of a 20-element hydrophone array. The array was subjected to a CUALT which simulated five years of service life. After CUALT was completed, an autopsy was performed on the array to determine failure modes and mechanisms. This report also documents array design, mission profile, CUALT schedule and measurement data, autopsy results, and failure analysis.

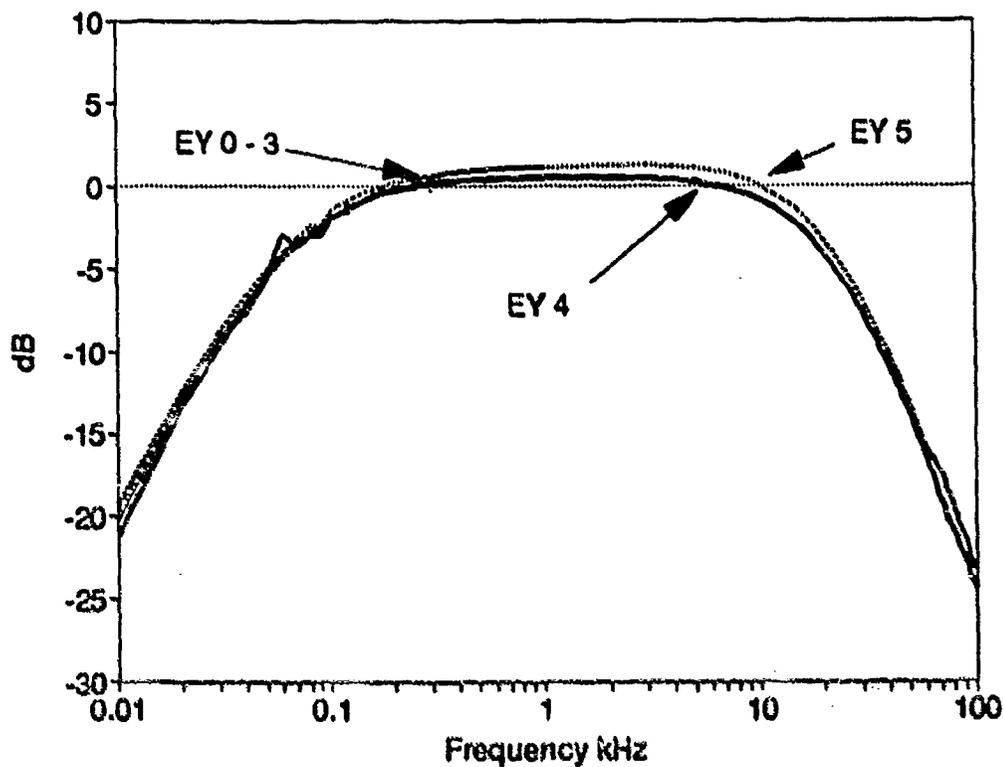
Figure 4. Hydrophone Gain Response Curves for Element H2

Figure 4 is an example set of hydrophone gain response curves for element H2 of the HGA prototype stove. Note that there is little or no variation from one EY to another for this element. Figure 5 shows the same data for element H10, whose response appears to be erratic for the EY 4 measurement period. The roll-off of EY 4 changed dramatically from the baseline data of EY 0 but was back to normal in EY 5 - an indication that the hot air exposure prior to the EY 5 measurement removed from the unit the moisture that had evidently been a problem in EY 4. The response curves for all elements are included in Appendix C.

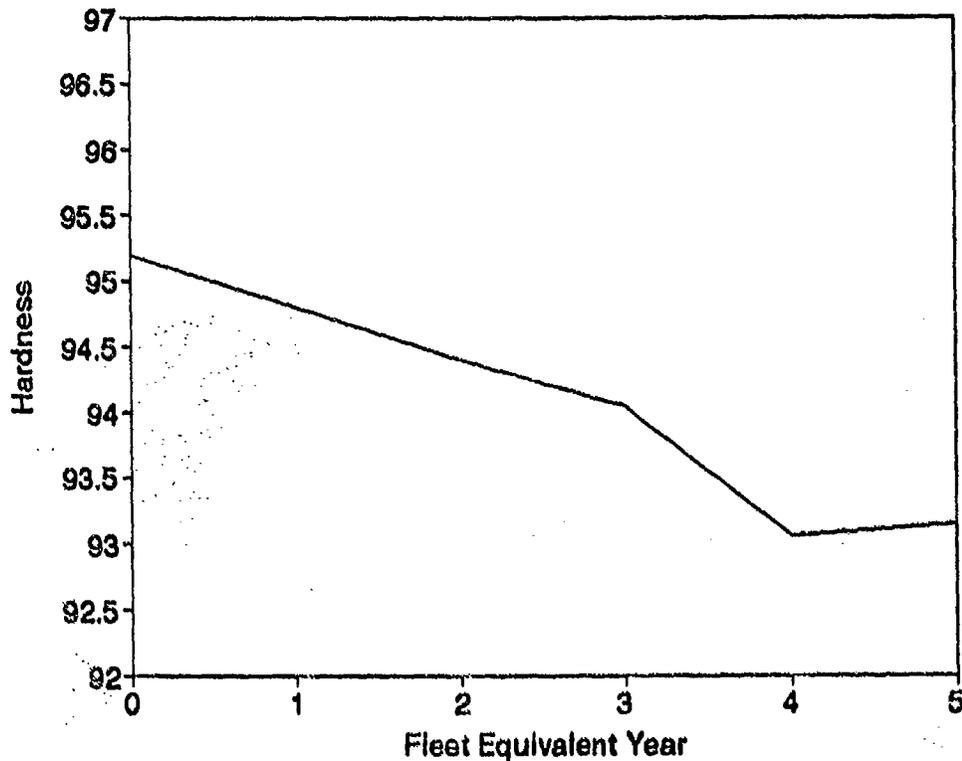
**Figure 6. Average Shore A Hardness for All Elements**

The Shore A hardness data, averaged over all elements, are shown in Figure 6. The polyurethane molding of the elements demonstrated a very high Shore A value which was not impacted by the ALT.

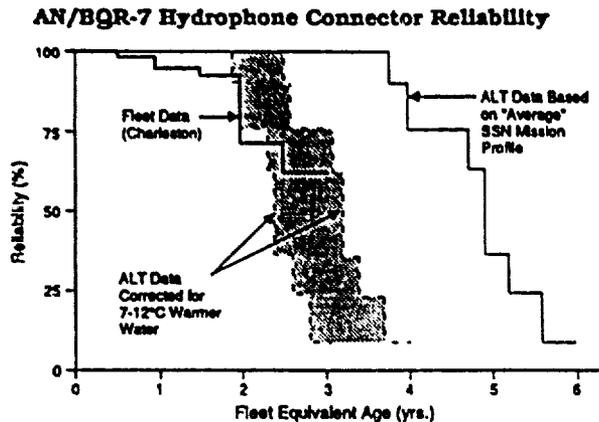
FIG. 2 A COMPARISON OF FLEET AND ALT RESULTS FOR THE MIL-C-24231 STANDARD CONNECTOR USED IN THE AN/BQR-7 SONAR

The ALT plan on which the laboratory tests were based was for an average submarine profile for units based in all ports [2]. The specific submarine used for the study was based in Charleston, S.C. in much warmer water than average. The primary failure mode for these connectors is cathodic delamination [4] of the polymer encapsulation material from the steel backshell of the connector, and this failure rate is accelerated by water temperature. The shaded region in Figure 2 shows the adjusted result had the ALT Plan been based on the warmer water exposure condition. This shows that the ALT scaling of the Fleet equivalent year was fairly accurate, and that ALT data are representative of the reliability of this connector in Fleet service. This connector has since been singled out for a higher reliability design which uses a glass reinforced epoxy composite backshell and eliminates the cathodic delamination failure mode [5].

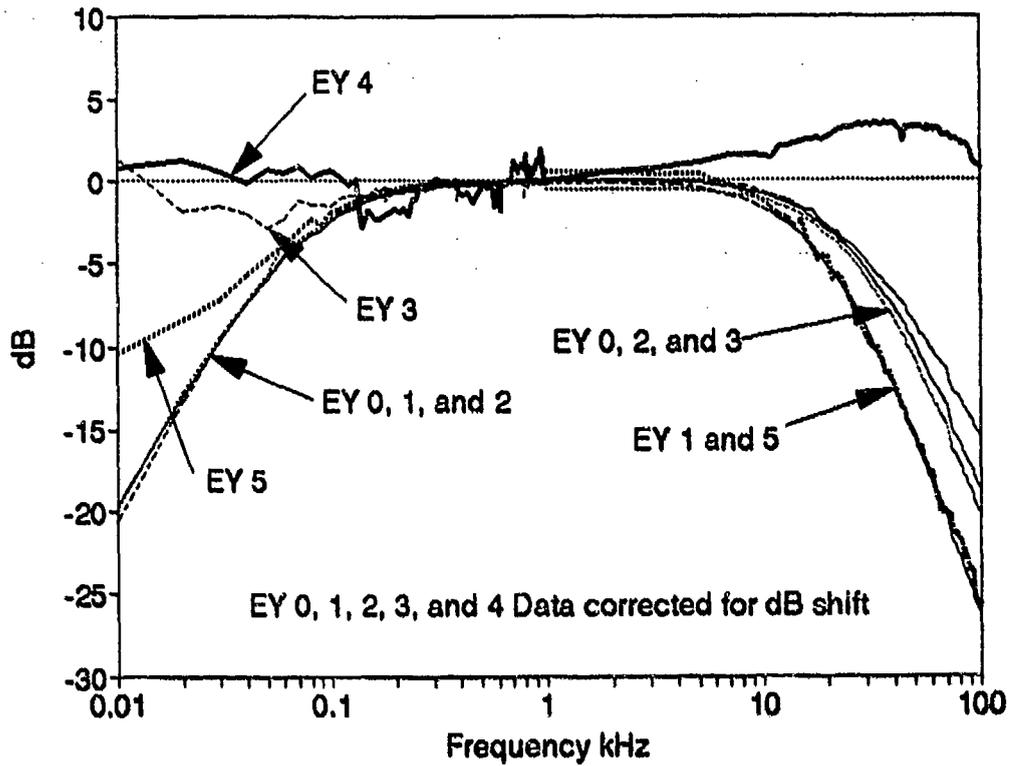
Element 7

Due to these anomalies, elements H7, H10 and H15 are cause for concern.
