USACERL Technical Report FM-93/07
January 1993
Corrosion Mitigation and
Management System

Corrosion Assessment of an Army Installation Gas Distribution System Using MicroGPIPER

by
Vicki L. Van Blaricum
Vincent F. Hock
Lewis F. Setliff

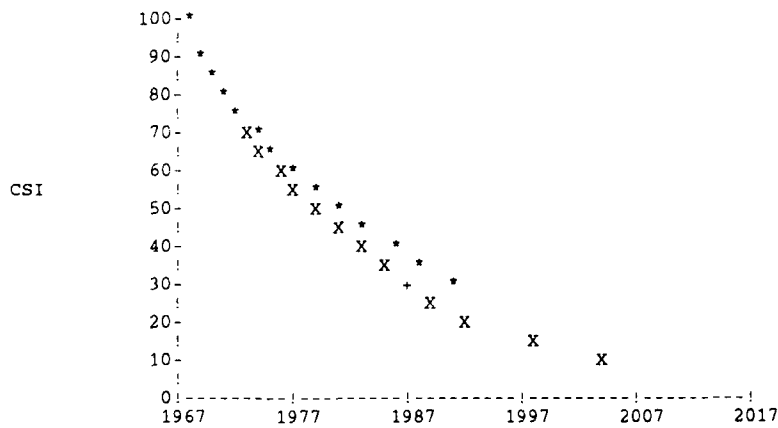
PIPE IDENTIFICATION :	BLDG. 5957	SECTION NUMBER:	1
SOIL RESISTIVITY:	6000.00	SOIL pH:	0.2800
COATING MATERIAL:	WRAP COAL TAR	WALL THICKNESS:	0.2800
YEAR INSTALLED:	1968	PIPE SIZE (OD):	6.0
PREDICTED FIRST LEAD (CSI<=30):	1987	ACTUAL FIRST LEAK:	1991.05.14
Adjusted Formula:	Max.Pit Depth = 0.0454 * (time ^ 0.58)		
Pit Depth (in inches) & Time (in years)

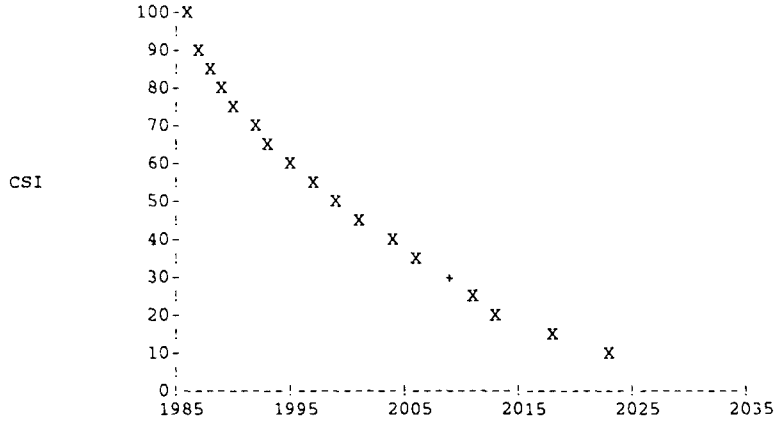
PIPE IDENTIFICATION : BLDG4323 SECTION NUMBER: 1
SOIL RESISTIVITY : 5155.0C SOIL pH : 5.35
COATING MATERIAL : WRAP COAL TAR WALL THICKNESS: 0.3650
YEAR INSTALLED : 1986 PIPE SIZE (OD): 10.0
PREDICTED FIRST LEAK (CSI<=30): 2009 ACTUAL FIRST LEAK: No leak.

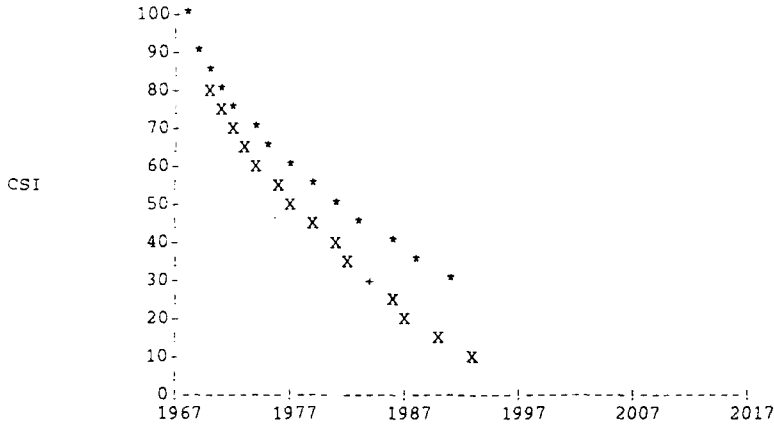
PIPE IDENTIFICATION : FOR&JACKSN SECTION NUMBER: 1
 SOIL RESISTIVITY : 3053.00 SOIL pH : 5.49
 COATING MATERIAL : WRAP COAL TAR WALL THICKNESS: 0.1400
 YEAR INSTALLED : 1968 PIPE SIZE (OD): 1.3
 PREDICTED FIRST LEAK (CSI<=30): 1984 ACTUAL FIRST LEAK: 1991.08.01

Adjusted Formula : Max.Pit Depth = 0.0227 * (time ^ 0.58)
 Pit Depth (in inches) and Time (in years)

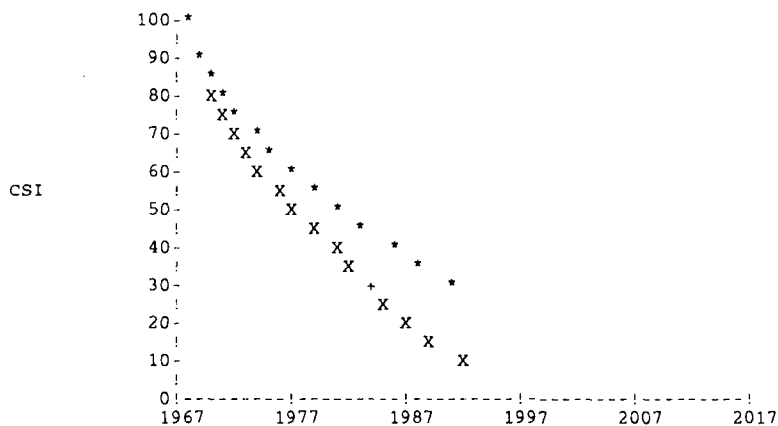
PIPE IDENTIFICATION : FORandJACKSN SECTION NUMBER: 2
 SOIL RESISTIVITY : 87.00 SOIL pH : 4.22
 COATING MATERIAL : WRAP COAL TAR WALL THICKNESS: 0.1400
 YEAR INSTALLED : 1968 PIPE SIZE (OD): 1.3
 PREDICTED FIRST LEAK (CSI<=30): 1984 ACTUAL FIRST LEAK: 1991.08.01

Adjusted Formula : Max.Pit Depth = 0.0227 * (time ^ 0.58)
 Pit Depth (in inches) and Time (in years)

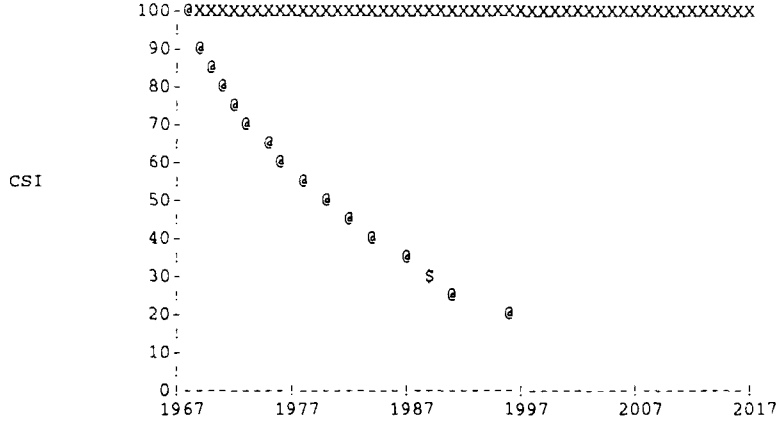
PIPE IDENTIFICATION : FOR&JACKSN SECTION NUMBER: 3
SOIL RESISTIVITY : 14493.00 SOIL pH : 5.95
COATING MATERIAL : WRAP COAL TAR WALL THICKNESS: 0.3220
YEAR INSTALLED : 1968 PIPE SIZE (OD): 8.0
PREDICTED FIRST LEAK (CSI<=30): 1989 ACTUAL FIRST LEAK: No leak.
CATHODIC PROTECTION w/ PIPE-to-SOIL POTENTIAL <= -0.85 VOLTS

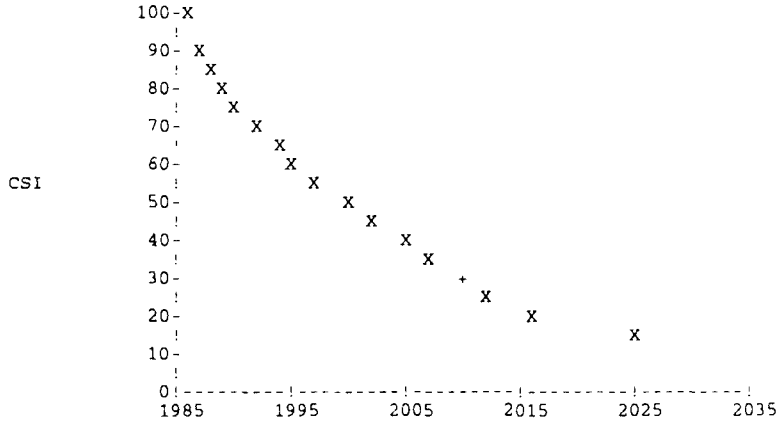
PIPE IDENTIFICATION : SUMP&CHEAT SECTION NUMBER: 1
SOIL RESISTIVITY : 7067.00 SOIL pH : 6.67
COATING MATERIAL : WRAP COAL TAR WALL THICKNESS: 0.3650
YEAR INSTALLED : 1986 PIPE SIZE (OD): 10.0
PREDICTED FIRST LEAK (CSI<=30): 2010 ACTUAL FIRST LEAK: No leak.
