Miscellaneous Paper CERC-93-2
March 1993

Scour Hole Problems Experienced by the Corps of Engineers; Data Presentation and Summary

*by W. Jeff Lillycrop, Steven A. Hughes
Coastal Engineering Research Center*

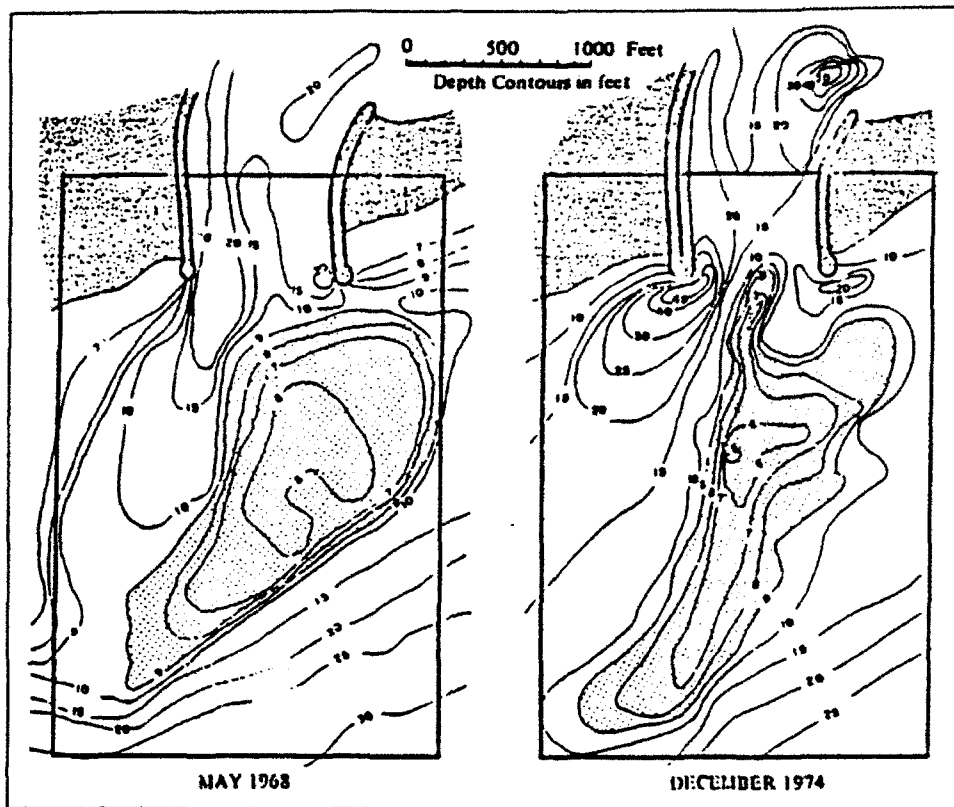
Figure 2. 1968 and 1974 bathymetry of Moriches Inlet

Bathymetry from 1968 shows no scour holes at Moriches Inlet (Chu and Nersesian 1992). However, data from 1974 (Figure 2) show the

existence of three scour holes, one located in the back bay, and two at the jetty tips. The hole located at the east jetty is transient, appearing and disappearing as illustrated in Figure 3. Chu and Nersesian (1992) speculate this transient trend may be caused by variations in longshore transport. The net transport in the vicinity of the inlet is from east to west; thus, as transport increases, the scour hole fills; as transport decreases, the hole reforms.

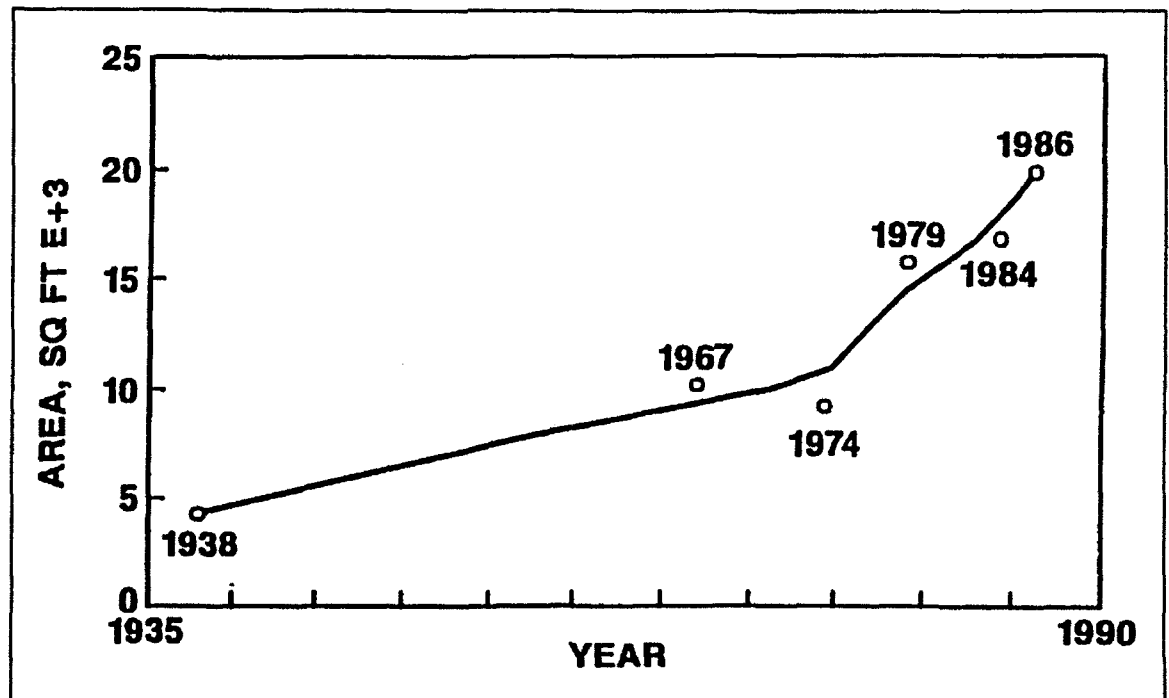
Figure 8. Inlet cross sections, Indian River Inlet

shows 1988 bathymetry conditions, and Figure 8 presents inlet cross-sectional area at different dates since construction. The increase up until the mid-1970's was gradual. In the mid-1970's the inlet cross-sectional area increase accelerated. During this same period, several large, localized scour holes formed at the tip of the north jetty and immediately on either side of the bridge piers. The scour holes at the bridge piers have depths greater than elevation -90 mlw and are continuing to deepen. The scour hole at the jetty tip has caused structural failure, and approximately 300 ft of jetty has been lost. Scour at the bridge has caused remedial action to be taken by the Delaware State Department of Transportation. In 1989 the state spent \$2.7 million to place rubble material adjacent to the bridge piers in order to halt undermining.

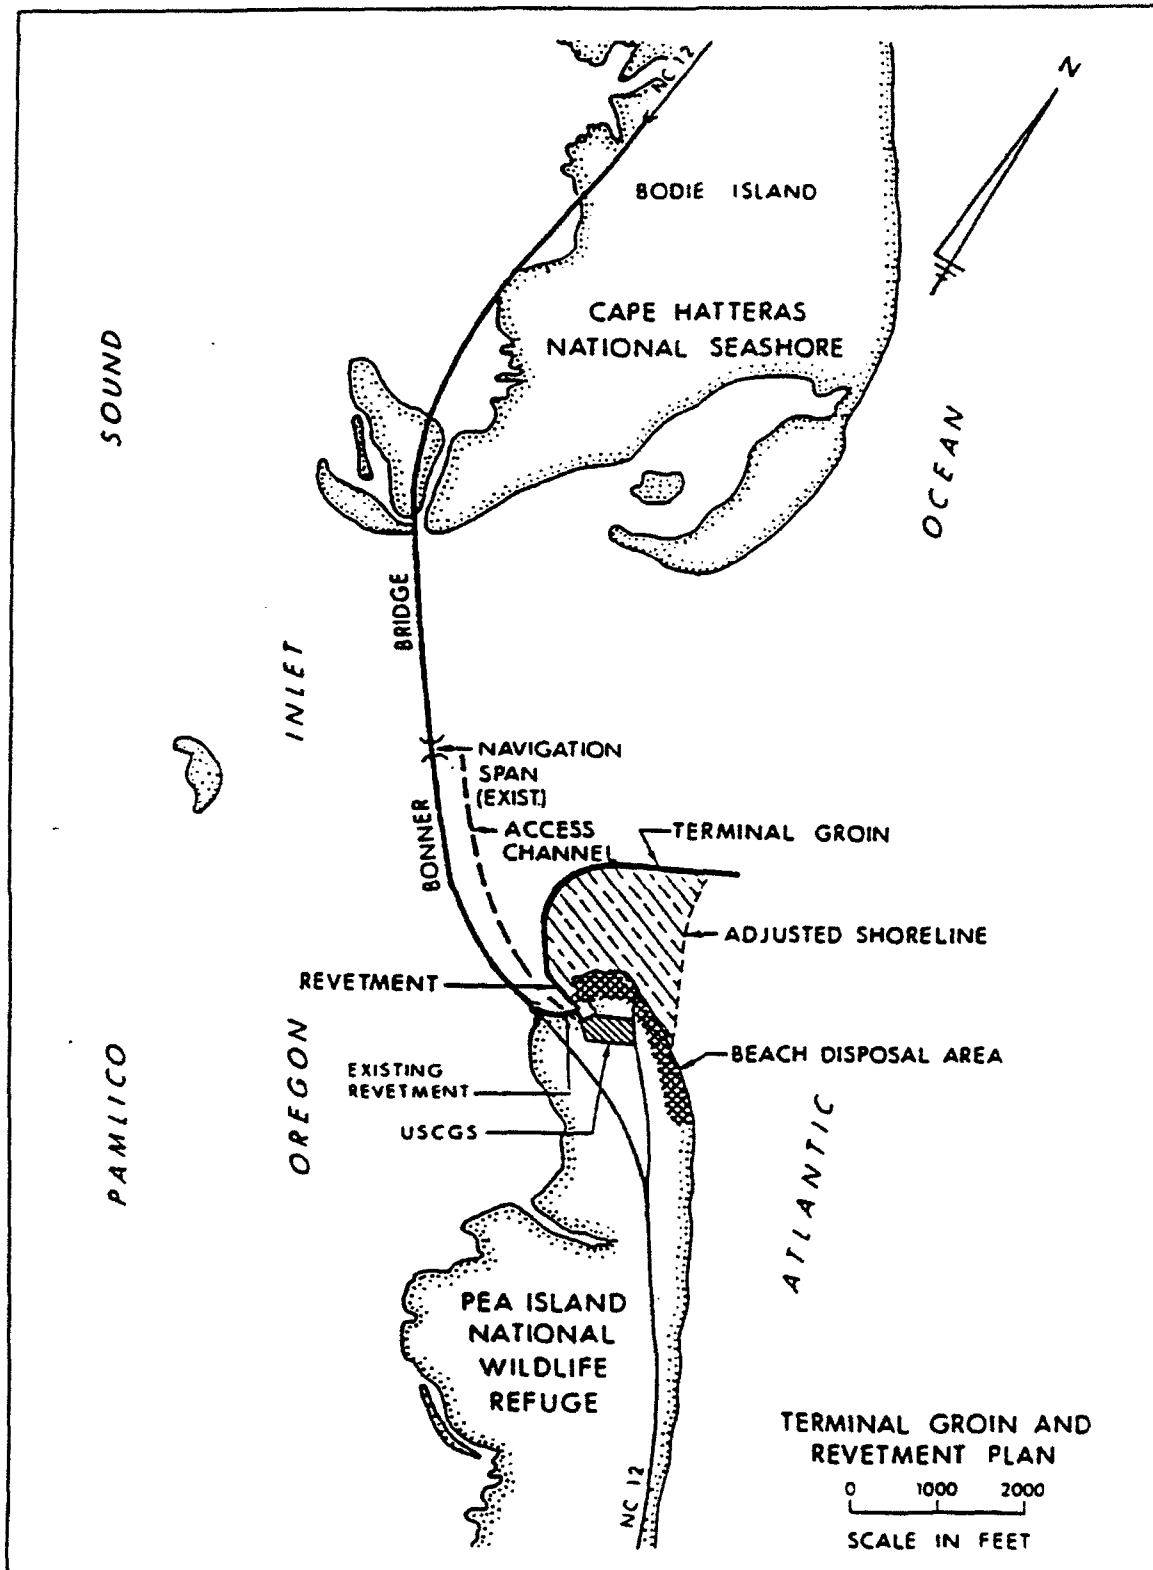
Figure 12. Oregon Inlet and terminal groin

The extent of scour that occurred during construction is shown in Figure 13. Center-line stations on this figure refer to the positions indicated on the terminal groin plan view given in Figure 12.

It was speculated during the May 1991 workshop that the primary cause of scour at Oregon Inlet was the ebb-flow tidal current because the deepest scour was observed on the channel side of the groin. Waves were discounted as a process contributing to the scour because most waves break on the ebb shoal, thus decreasing their effect. However, there is a possibility that nearshore currents generated by waves during storm conditions could have contributed to the scour. Aerial photographs of the groin showed currents being trained along the structure.

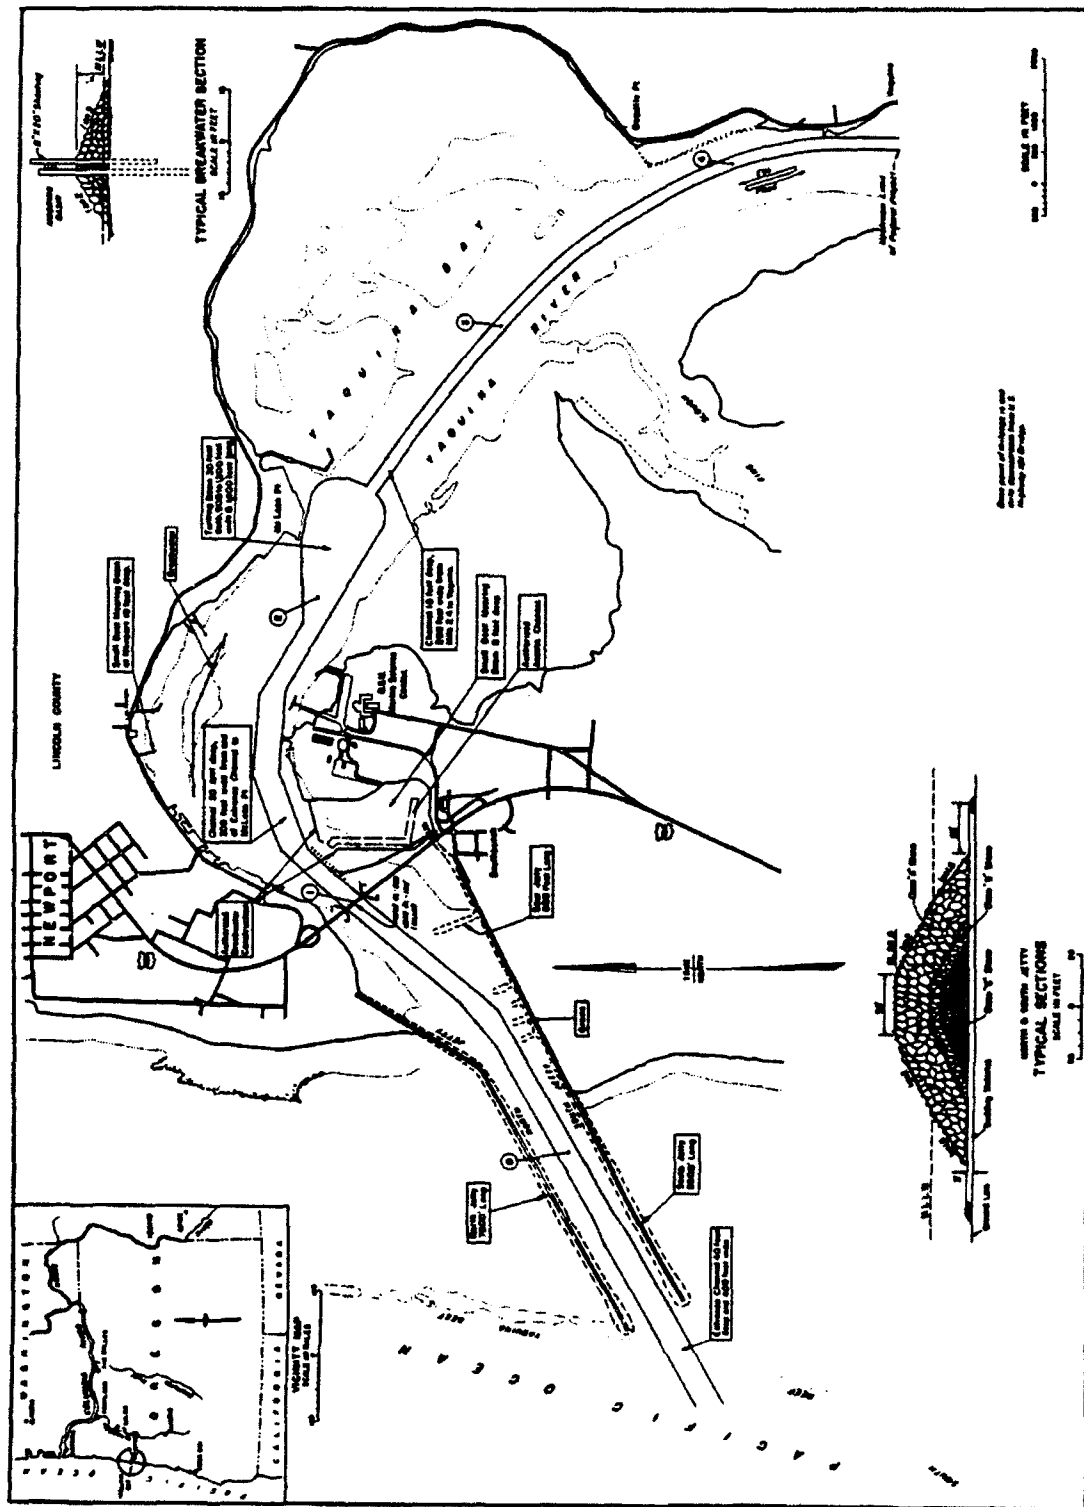
Figure 35. Yaquina Bay and Harbor, Oregon, site location map

Monitoring of the Yaquina north jetty under the MCCC Program has revealed that the latest repair is starting to suffer the same fate as its predecessors, with a "notch" forming near the tip. Two workshops have been held to try and determine the cause of jetty deterioration at Yaquina. The most recent workshop, held in August 1991, appears to have narrowed the possible damage mechanisms to scour and toe instability.

The tip of the north Yaquina jetty intersects an offshore reef as indicated in Figure 35.

Very recent geophysical evidence indicates that the bottom material immediately landward of the reef is a fairly deep deposit of littoral sand. It is hypothesized that waves in severe storm conditions cross over the hard bottom of the reef and scour sediment from the bottom just landward of the reef and right at the toe of the "notch" area. This causes toe failure and slumping of the structure's armor layer into the hole. After the storm, milder wave conditions move littoral material into the scour hole and cover up some of the missing armor units.

The three most recent repair efforts generally focused on repairing the outermost 400 ft of the jetty tip which waves had "beaten down" below the water level. Only the most recent repair was designed with the benefit of physical model tests; however, these tests were limited to study of armor stone stability under wave attack.

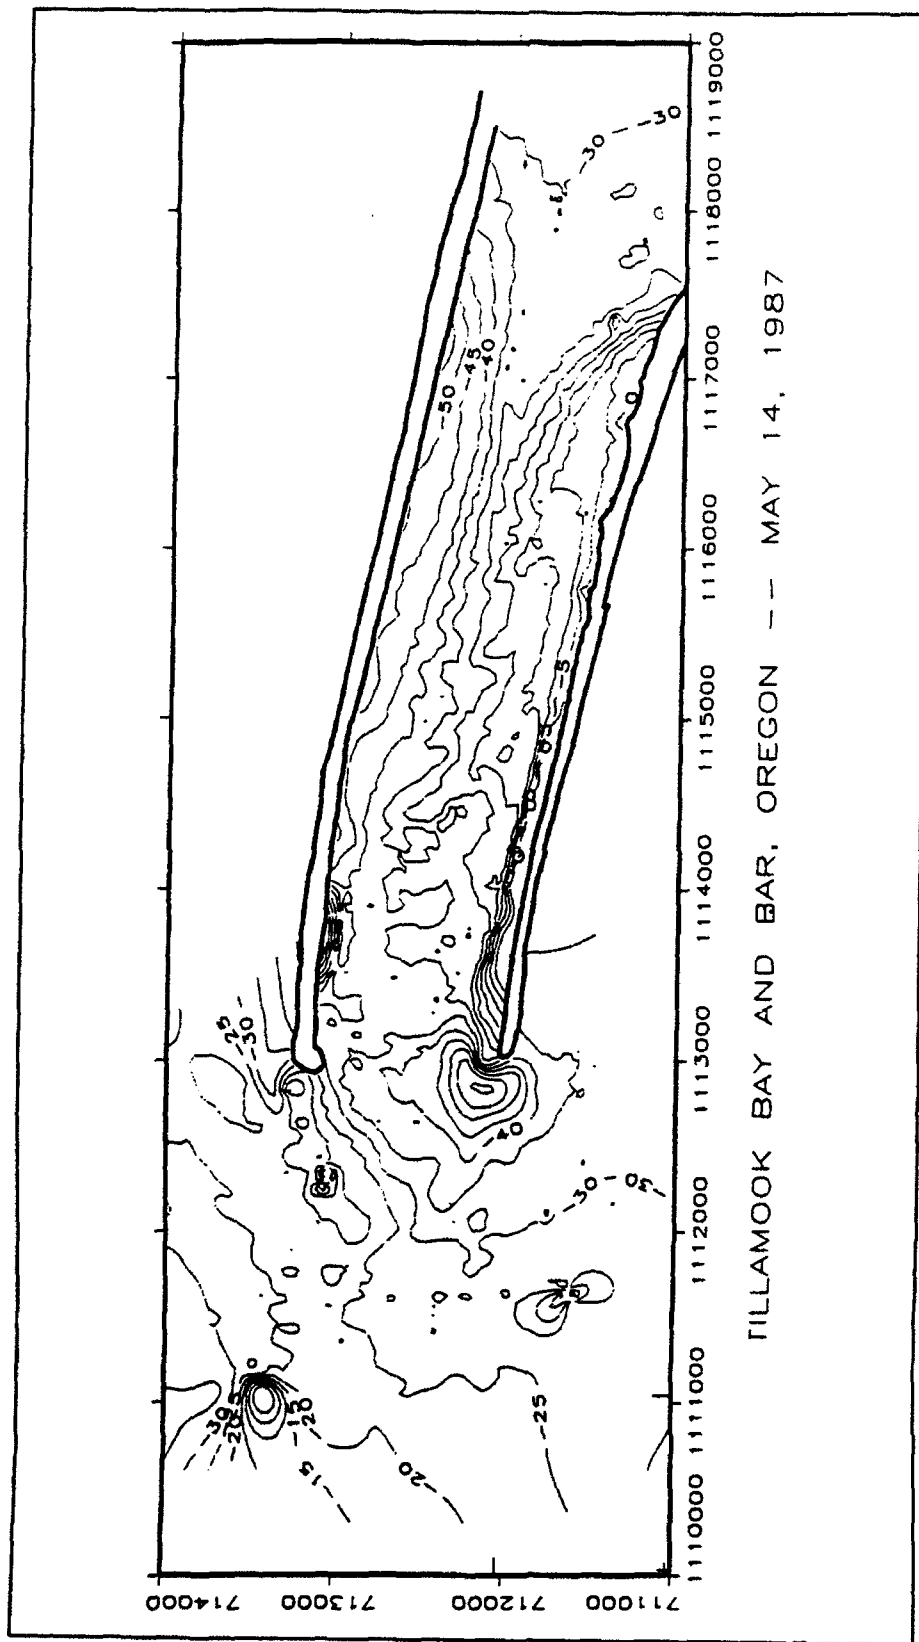
Figure 37. Tillamook Bay and Bar, May 14, 1987

Scour accompanying construction of the south jetty was generally on the order of 5 - 10 ft below normal depths, and it occurred just ahead of construction. Scour holes have formed at the tips of both jetties. Surveys dated 1987 indicate a large kidney-shaped scour hole at the tip of the south jetty having a maximum depth of about 61 ft below mllw (Figure 37). Surrounding depths average about 30 - 40 ft. The authorized channel depth is 24 ft. There was once a scour hole at the tip of the north jetty, but it has disappeared along with 300 ft of the north jetty. The end of the north jetty was recapped during the summer of 1991.

A scour problem also exists along the channel side of the north jetty well inside the entrance channel. The shape and location of this hole indicate that it is probably formed by ebb-flowing currents exiting the bay and being directed by the geometry across the channel to the north side. The hole is about 50 ft deep while the surrounding area has a depth closer to 25 ft. The proximity of the hole adjacent to the structure causes concern about erosion of the structure toe.
