**DEPARTMENT OF DEFENCE  
DEFENCE SCIENCE AND TECHNOLOGY ORGANISATION  
AERONAUTICAL RESEARCH LABORATORY**

General Document 37

**AIRCRAFT ACCIDENT INVESTIGATION AT ARL  
THE FIRST 50 YEARS**

*Early Australian experience with the investigation of aircraft accidents is covered briefly as a prelude to the foundation of the Aeronautical Research Laboratory. With its foundation, a more scientific approach was possible. ARL was quickly involved with accident investigation, an activity which has been maintained throughout its fifty year history. This report examines ARL experiences during those fifty years with the idea of providing some useful guidelines for the next half-century.*

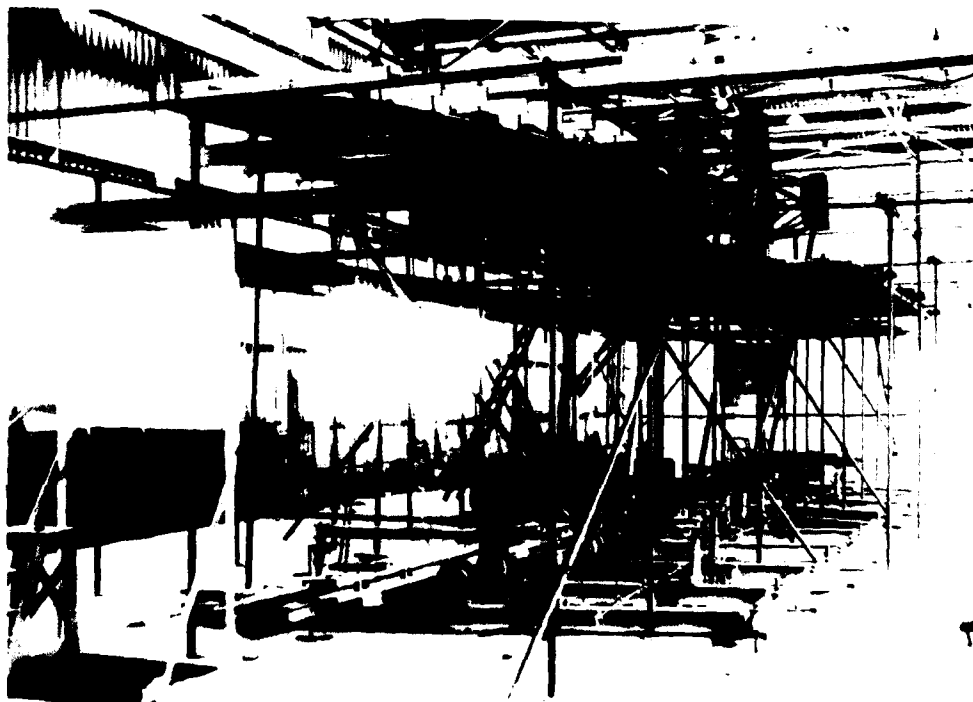
This early work on Anson wing failures generated a comprehensive program of research. The static strength of Anson wings was investigated in a full-scale structural test, Fig. 3. Improved structural analysis techniques were formulated for wooden box beams while the strength and stiffness characteristics of plywood panels and shells were investigated. The ageing properties of UFD were quantified leading, ultimately, to the final grounding, in Australia, of all aircraft constructed with this resin. The effect on bonding strength of extreme temperature and humidity cycles was examined; work which continues to this day in connection with modern fibre reinforced composite materials.

**Fig. 3** Anson wing under test. This was the first full-scale wing test to be carried out by ARL

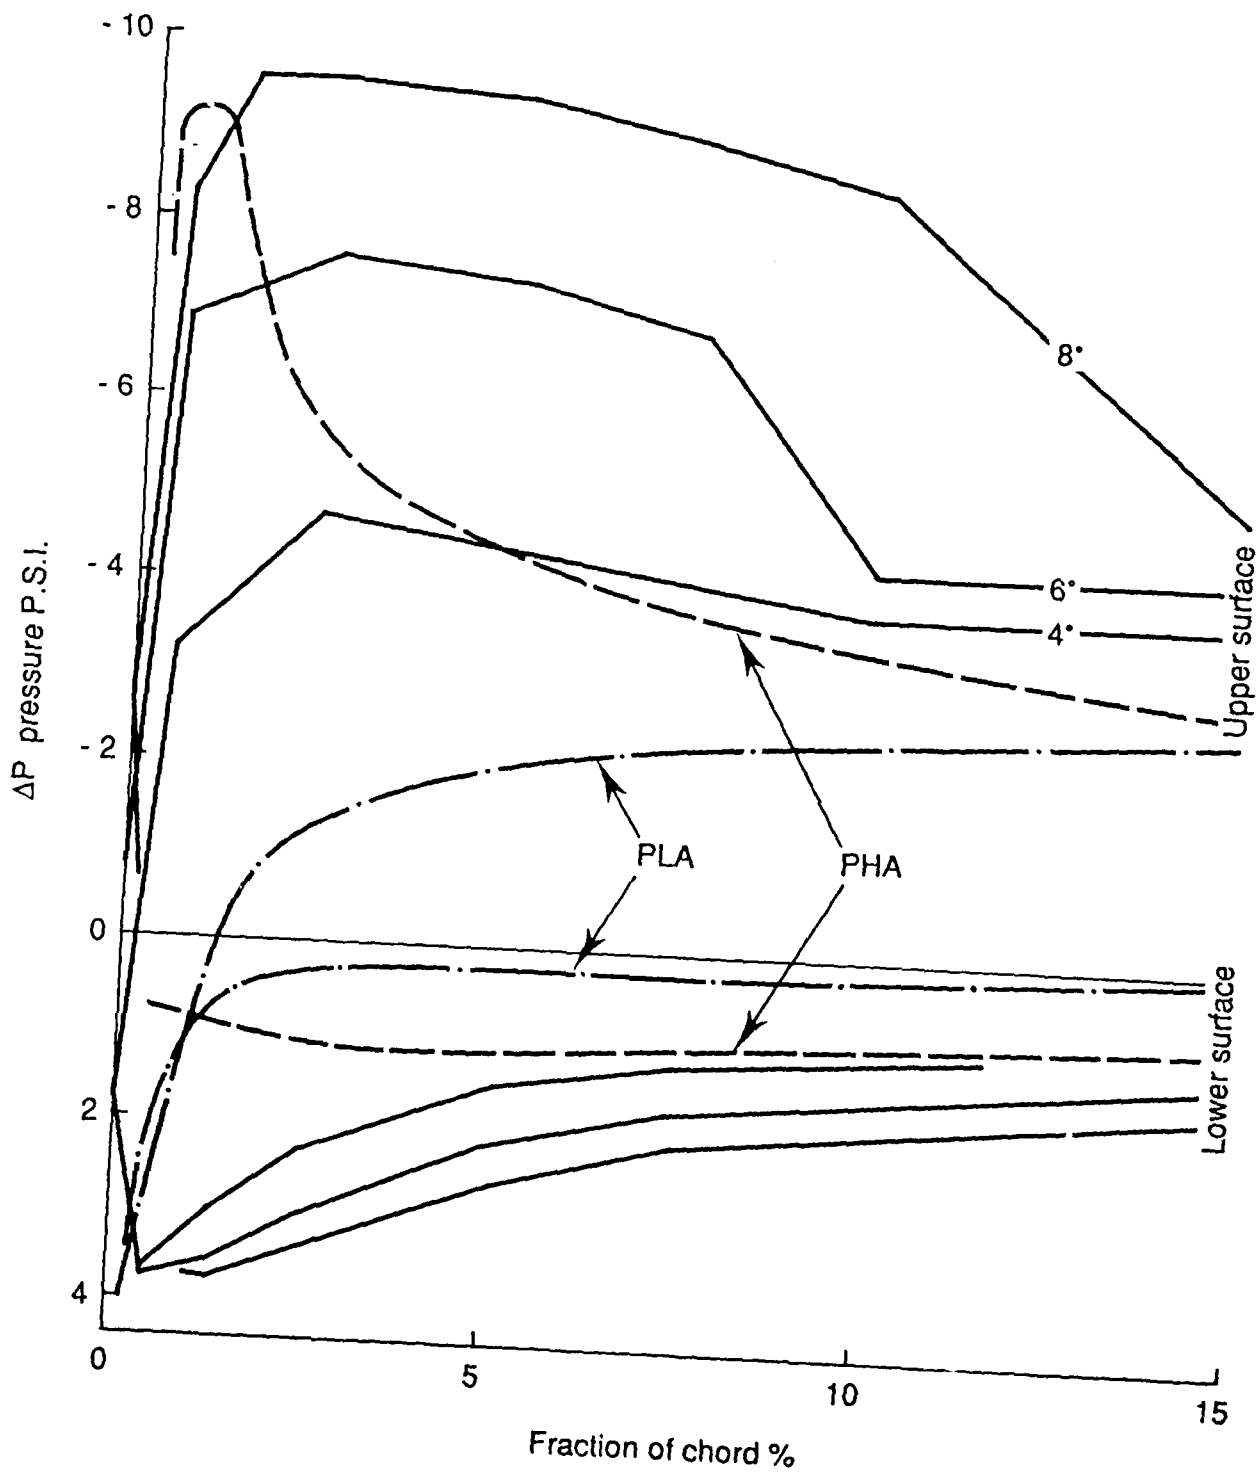
The wind tunnel data from NACA TN3162 show that, with Mach number increasing from 0.52 to 0.62 and  $\alpha$  increasing from  $4^\circ$  to  $8^\circ$ , there is a region where the area of supersonic flow suddenly expands to cover all of the first 15% of chord, i.e. the entire leading edge. The supersonic flow is reflected in the very high suction recorded over the upper surface as shown in Fig. 20 for a Mach number of 0.57. Since A9-754 was flying at 380 KIAS in an ambient temperature of  $28^\circ\text{C}$ , this is the Mach number appropriate to the accident.

For convenience, the pressure distributions for the PHA and PLA (positive low  $\infty$ ) design cases are also shown in Fig. 20. While these curves are not strictly comparable with the raw two-dimensional wind tunnel data, they are sufficiently compatible to suggest that the total lift load on the leading edge for  $\infty = 8^\circ$  is roughly double that for the critical PHA design case.

- a. pilot induced overload in that the pilot exceeded the placard limitation of 3g,
- b. manufacturing deficiency in that the leading edge ribs were below the specified thickness,
- c. design deficiency in that transonic compressibility effects had been ignored.

Fig. 20 Chordwise pressure distributions at M0.57 for various angles of attack. NACA 64A410 section

A reduction in placard limits was recommended. Lockheed carried out an independent investigation of this accident using a fairly crude finite element model and with aerodynamic loads derived from QUADPAN, an aerodynamics computer code specifically restricted to subsonic flow. They concluded, predictably, that the Orion fully met the design requirements and the accident could not possibly have happened in the way in which it did.

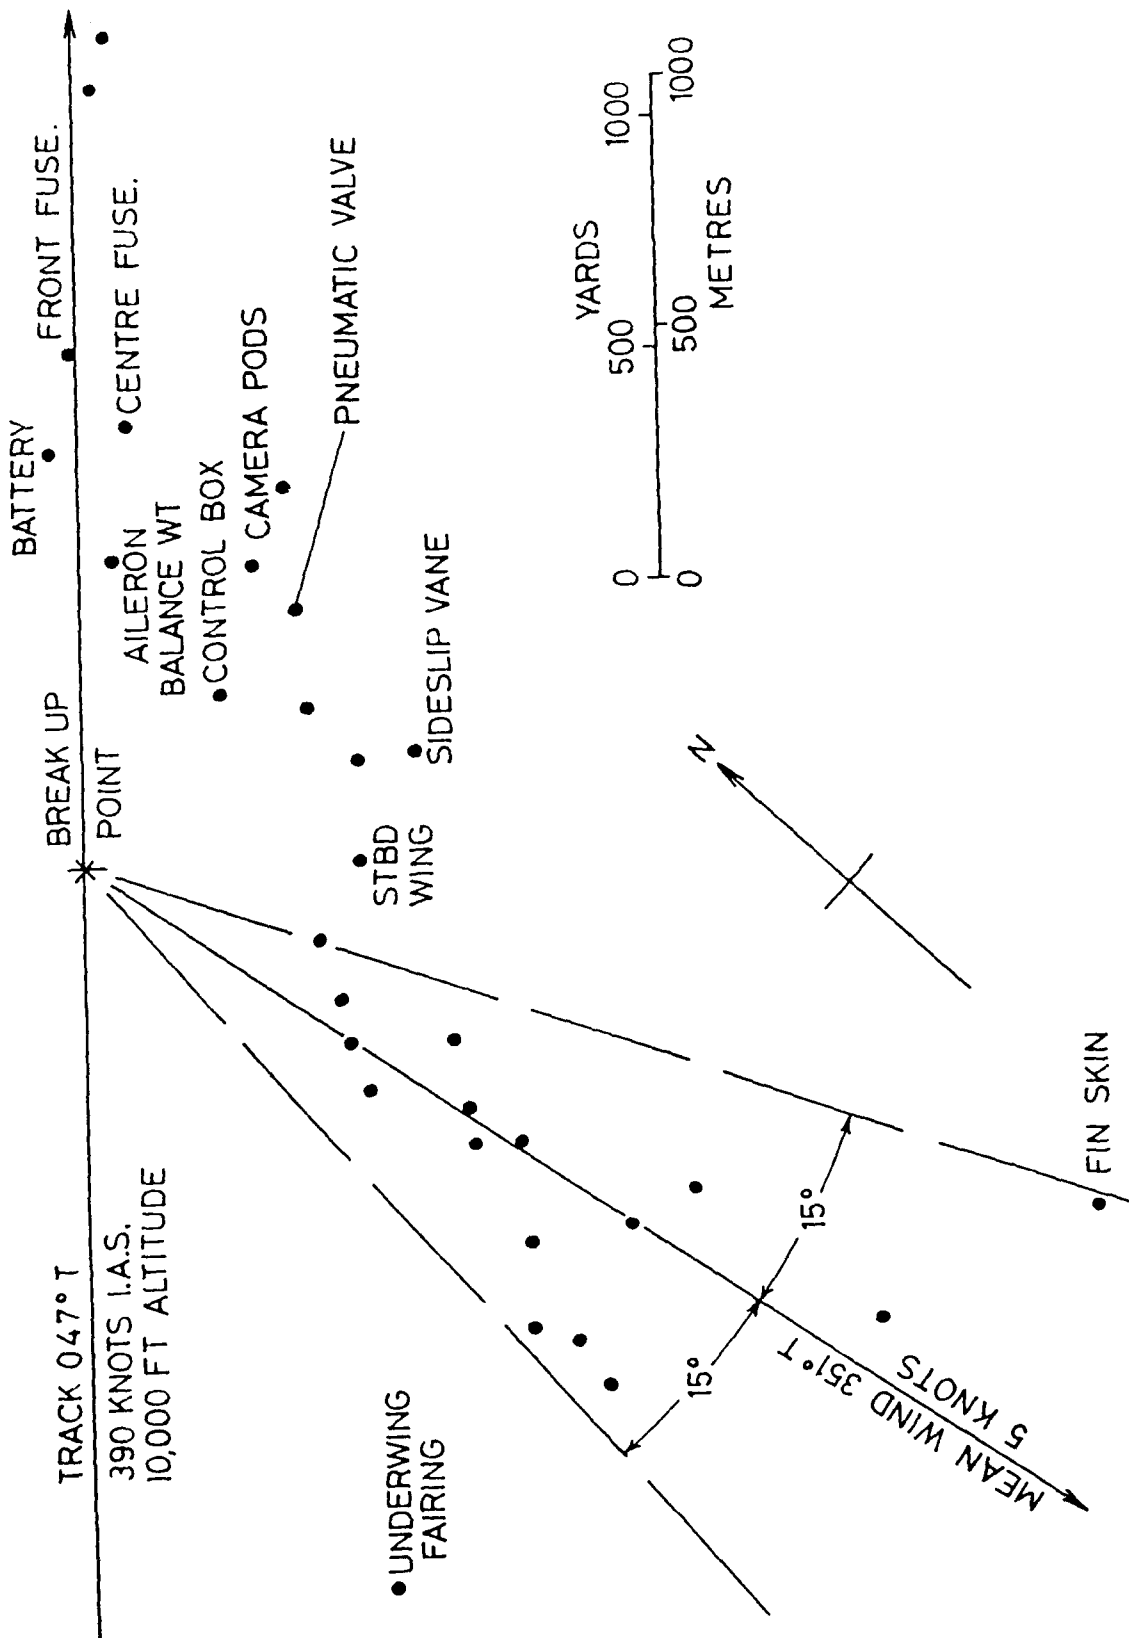
Fig. 34

Jindiviks A92-413 and WRE.493 broke up in flight on 19 February 1965 and 14 March 1968 respectively. Neither of these accidents was investigated by ARL. From an examination of the wreckage layout of A92-413, Fig. 34, the investigating authority concluded that break-up had been initiated by failure of the fin since fin pieces were furthest from the aircraft flight path. Changes to fin manufacturing procedures were recommended. This accident was significant in that it provided the first positive indication that separation of the underwing fairing preceded break-up.

Jindivik A92-413 Woomera 19 February 1965

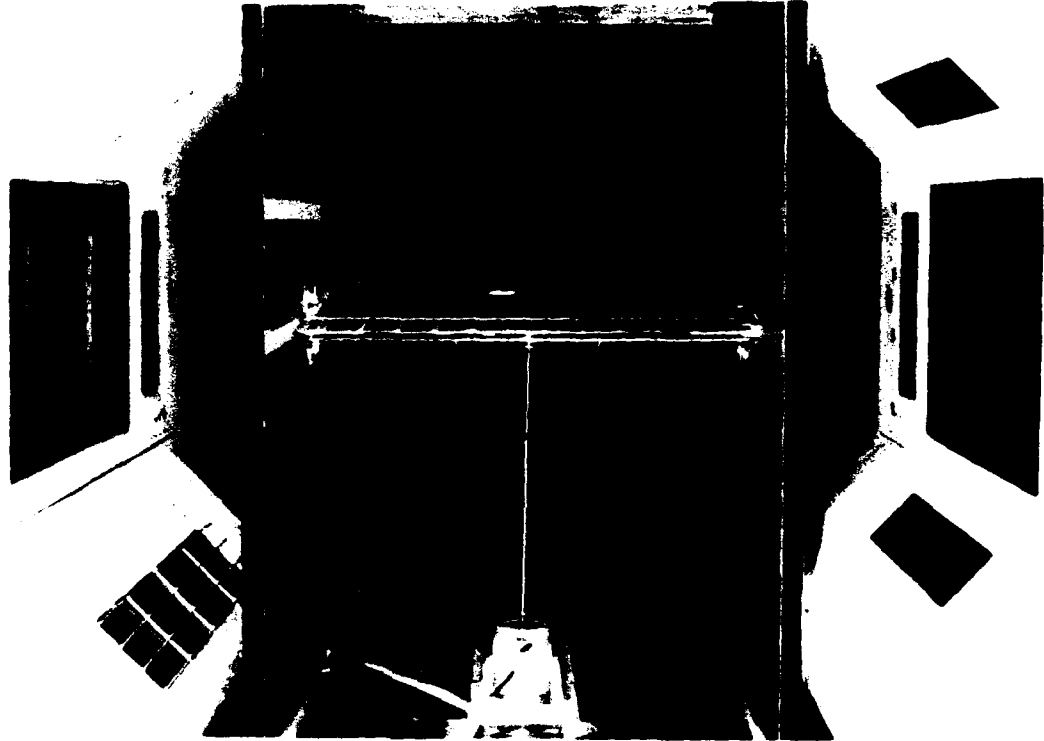
Available unsteady aerodynamic data were considered inadequate for the reliable prediction of the forces acting on a control surface fitted with trailing edge T strips. To obtain better data, a two-dimensional wind tunnel model was prepared by modifying a section of Nomad tailplane and fitting it with 47 pressure tappings enabling the chordwise pressure distribution to be measured. During wind tunnel testing, shakers oscillated the tabs at various frequencies to represent the conditions prevailing during flutter, Fig. 35. Tests were carried out at tunnel speeds of 80 and 100 knots, with and without T strips. The results obtained enabled the preparation of a correction matrix to modify the theoretical pressure distributions so as to agree with measured values.

**Fig. 35** Nomad tailplane under test in the ARL low speed tunnel. Trailing edge T strips were not fitted for this test

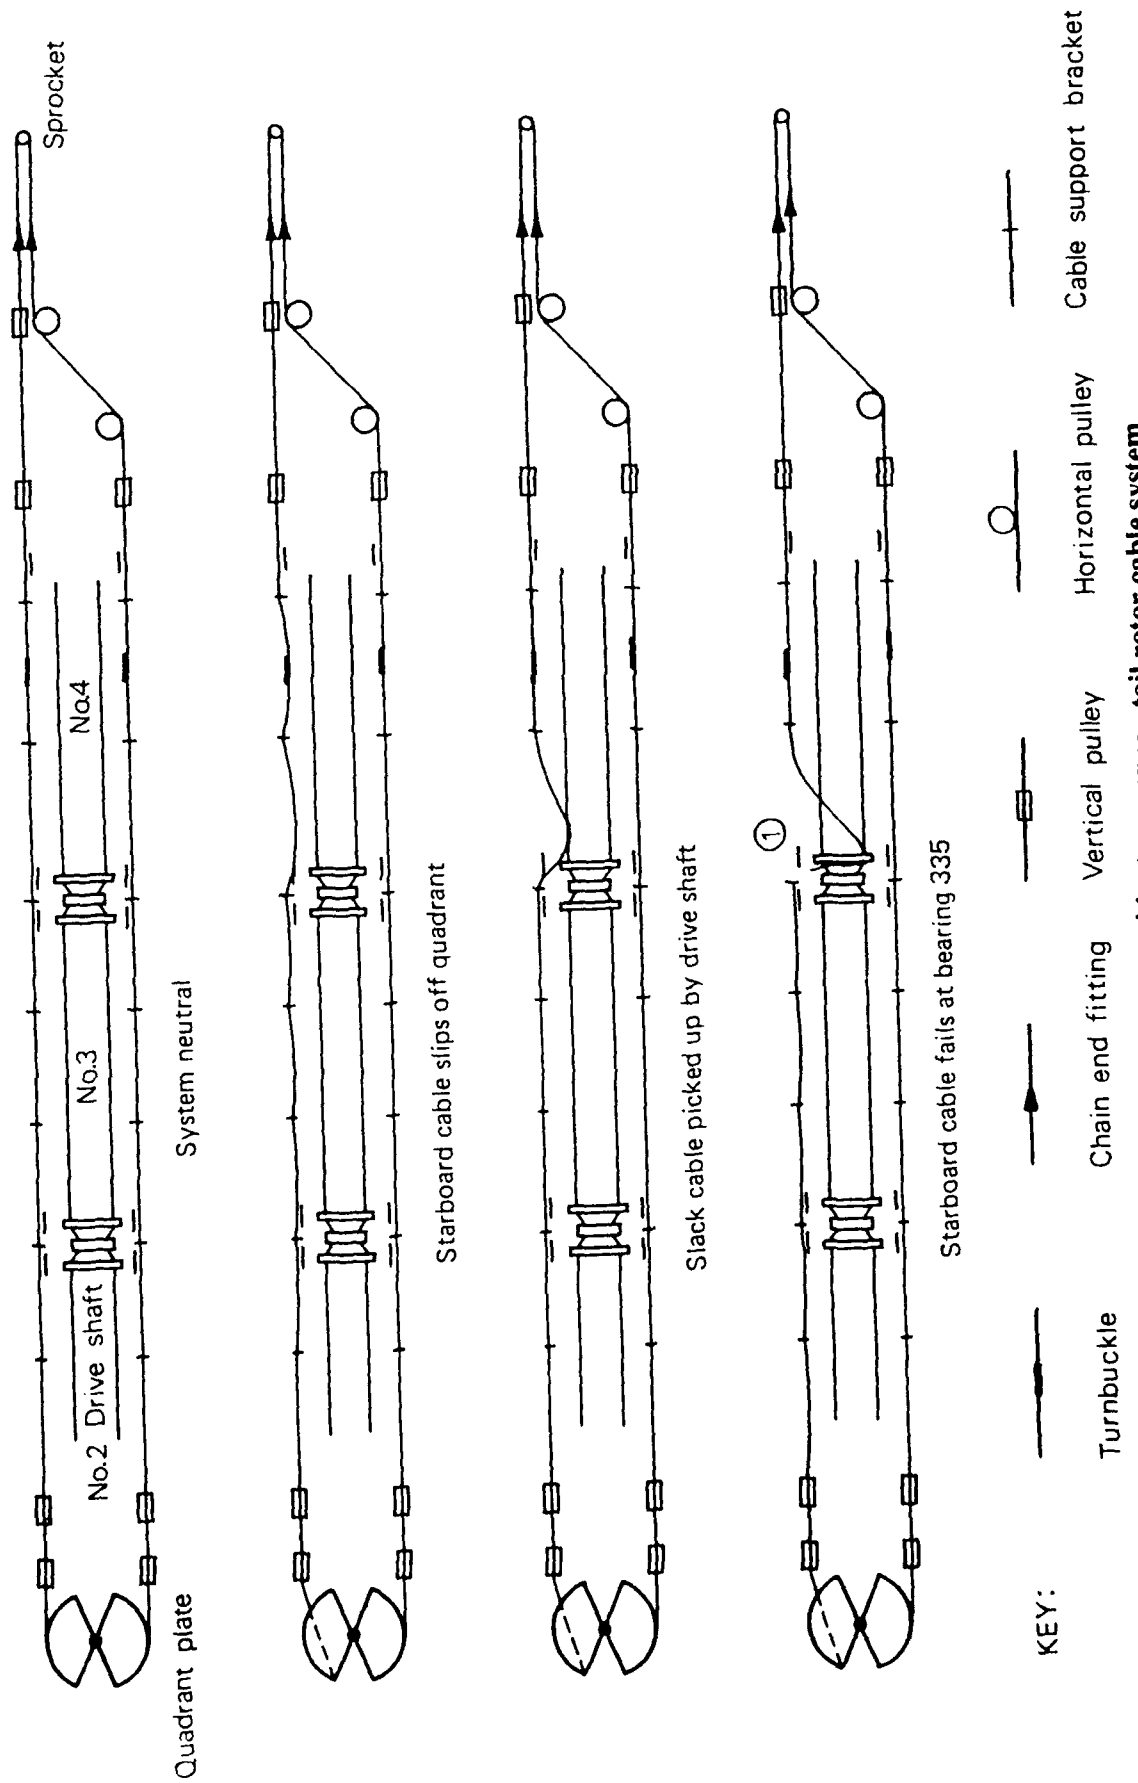
Eventually, it jumped over a cable shield to be picked up by one of the bolts securing the Marman clamp of the tail rotor No. 4 drive shaft forward coupling. Shaft rotation pulled the starboard cable hard against the adjacent fairlead until the cable failed primarily in overload bending; failure 1 of Fig. 45.

Fig. 45 Postulated accident sequence - tail rotor cable system

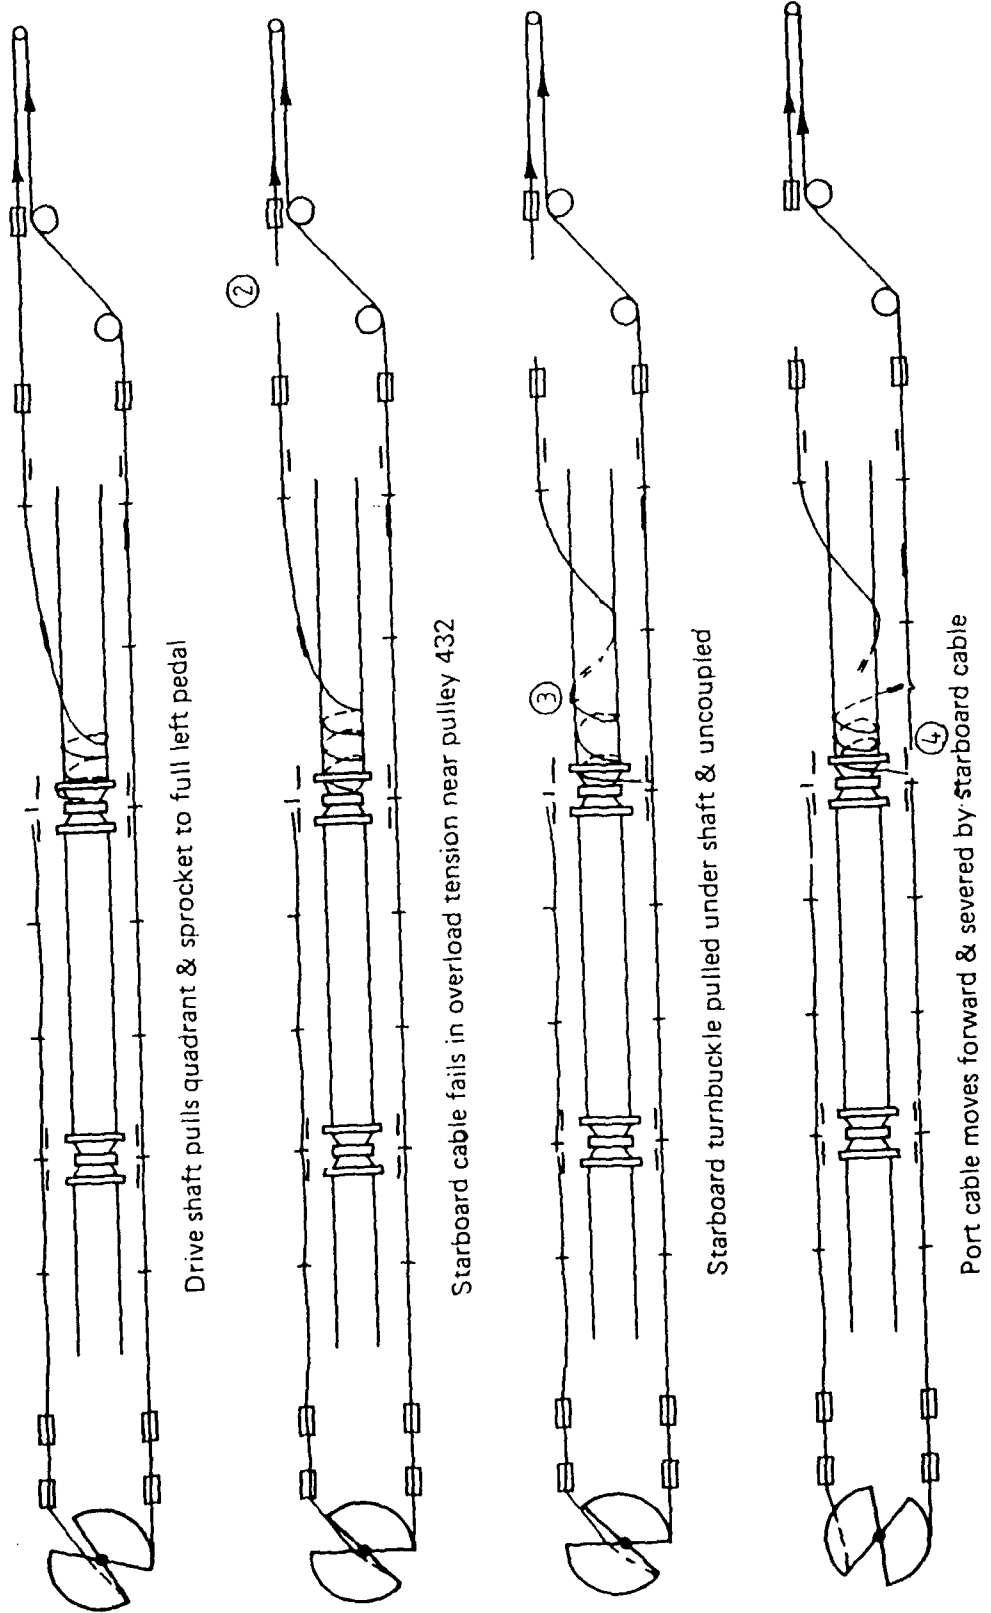
Drive shaft pulls quadrant & sprocket to full left pedal

Starboard cable fails in overload tension near pulley 432

Port cable moves forward & severed by starboard cable

**Fig. 46 Further stages in the failure of the tail rotor cable system**

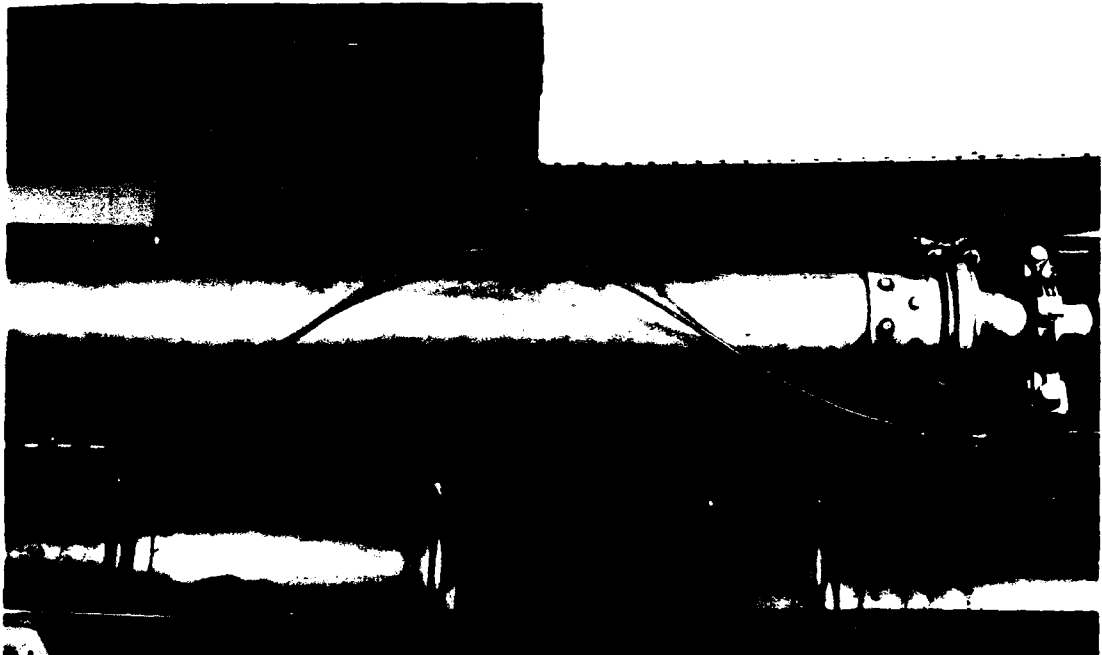
The accident sequence was now clear. A slack cable was simulated in the laboratory, Fig. 48, by allowing a correctly tensioned cable to slip off the quadrant. Vibration tests on the slack cable demonstrated that it would quickly jump over the cable shield and, inevitably, come into contact with rivet heads on the drive shaft, Fig. 49. The friction of this contact would pull the cable into a position where it would be picked up by a coupling bolt, Fig. 50. In consequence, there would be an abrupt application of full left pedal, the tail rotor blades would contact the fin, the aircraft would yaw wildly and violent mast bumping would result. The question was, why did the starboard cable slip off the quadrant?

**Fig. 48**      **Laboratory simulation of slack starboard cable**

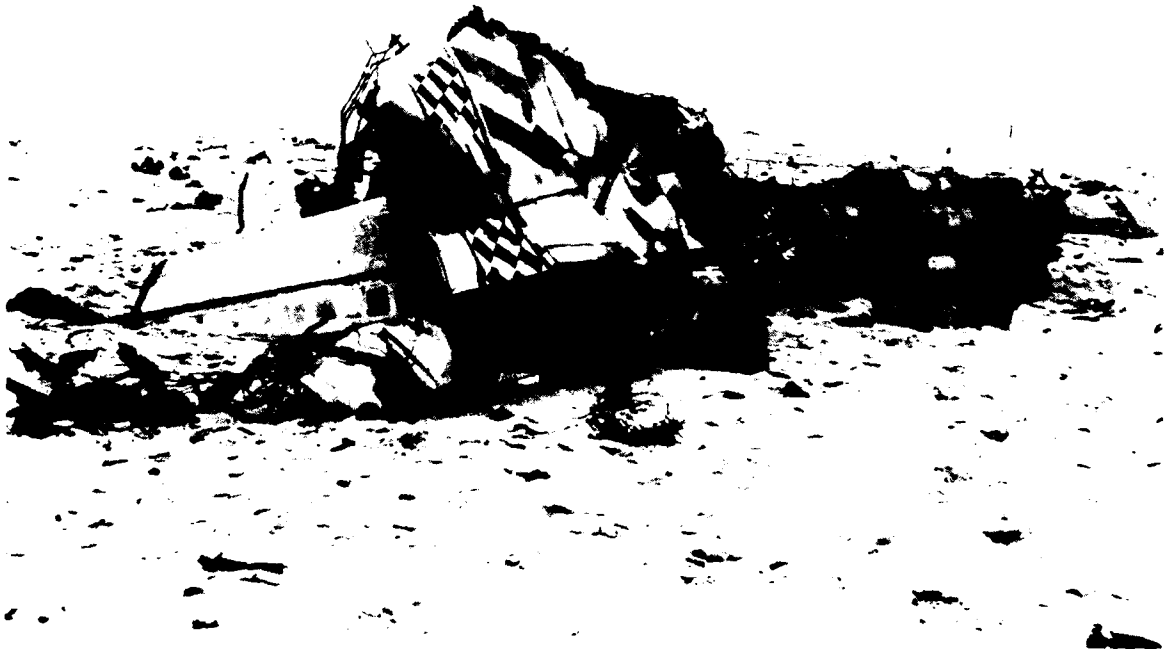
On 10 February 1960, CAC Sabre A94-924 crashed near Williamtown, NSW, Fig 55, after its engine failed at a height of 600 ft. A strip examination of the engine disclosed fatigue failures in the gear teeth of the high pressure fuel pump drive. Four weeks later, Sabre A94-926 suffered a similar fate when it crashed near Williamtown on 7 March 1960 following engine failure at 200 ft, Fig. 56. On this occasion, the engine failure resulted when a distorted and displaced cooling air duct allowed the turbine disc to overheat. The disquieting feature of these two accidents was that in neither case had the pilot attempted to eject; while the canopy had been jettisoned, the ejection seat gun had not fired.

**Fig. 55**      **A94-924 on the beach near Williamtown**

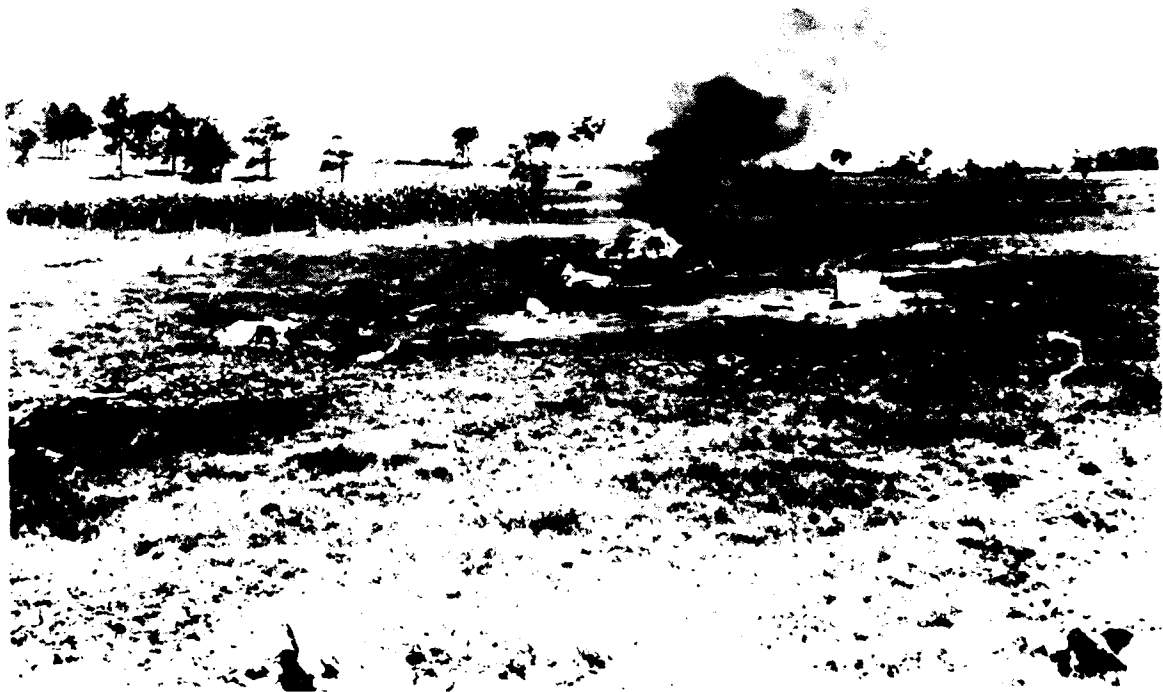
**Fig. 56**      **A94-926 ended its days in a paddock**

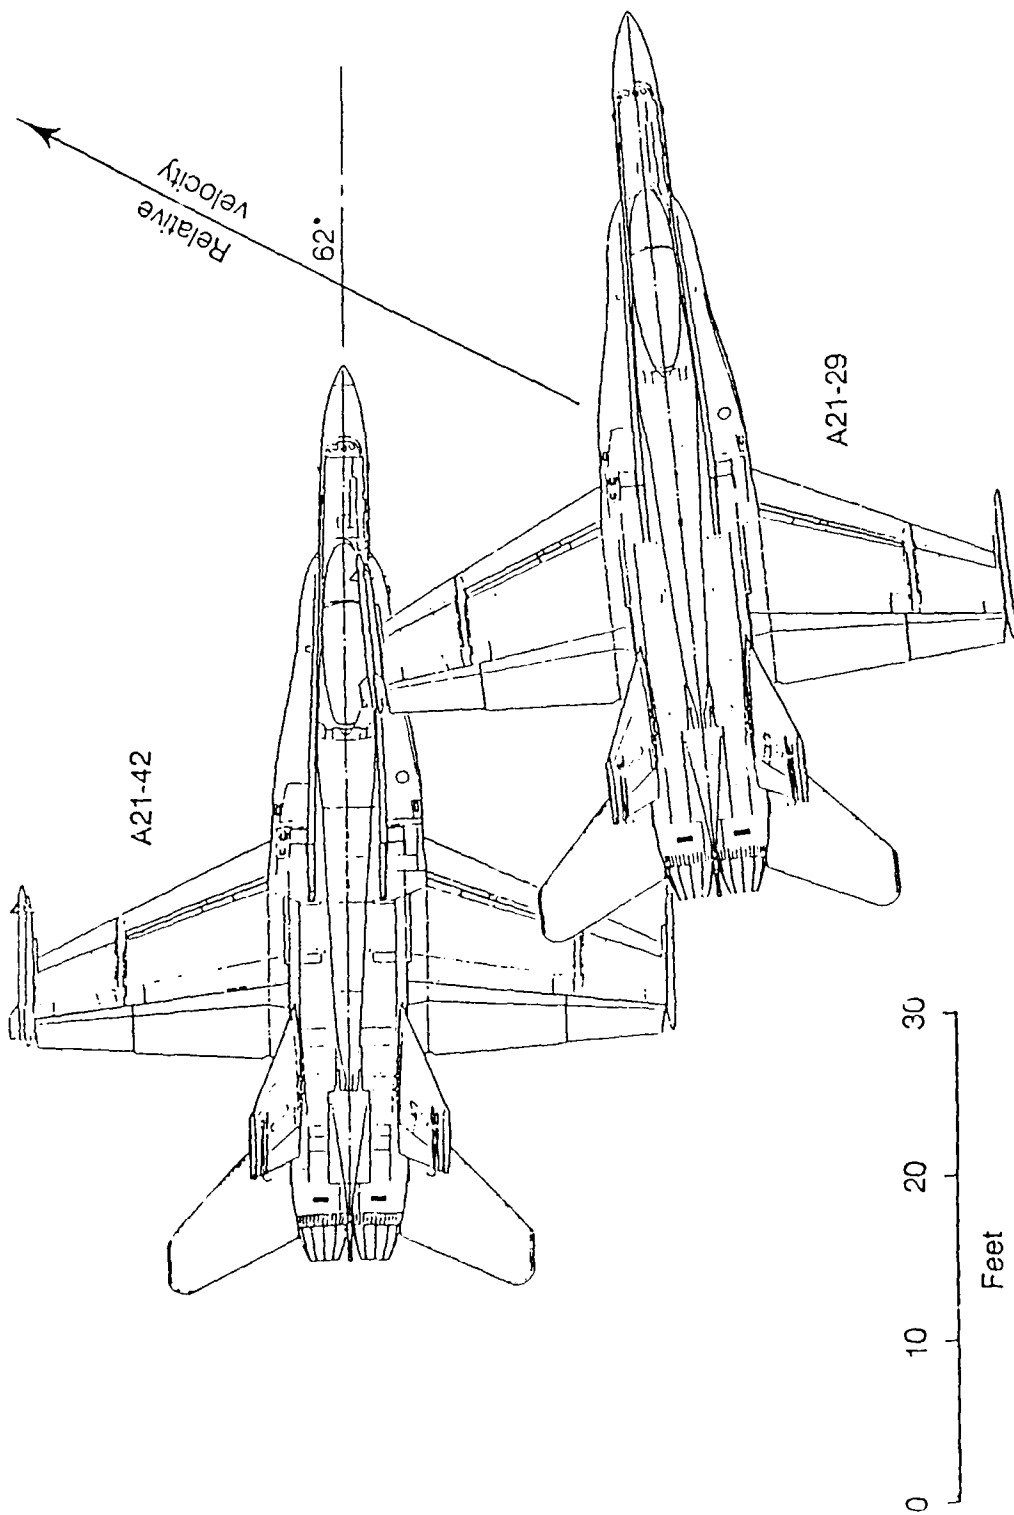
- a. The forward section of the missile on the port wing of 29 impacted the windscreen of 42, Fig. 61. The seeker head, fuze and warhead separated from the missile and the windscreen disintegrated.
- b. The missile motor impacted the canopy which was destroyed. The motor separated from its launcher and struck the pilot's head and the ejection seat.
- c. Simultaneously, the nose of the launcher on the starboard wing of 42 contacted the port jet orifice of 29 causing the launcher to separate.

Reconstruction of the collision geometry enabled the relative velocity vector to be established. As shown in Fig. 61, this was essentially lateral with a magnitude of only 50-55 knots. Under the circumstances, it was not surprising that the pilot of A21-42 failed to see A21-29 nor that he failed to eject.

**Fig. 61**  $t = 0$  the two aircraft at initial contact with the port missile of A21-29 impacting the windscreen of A21-42 and the starboard launcher of A21-42 touching the port jet orifice of A21-29

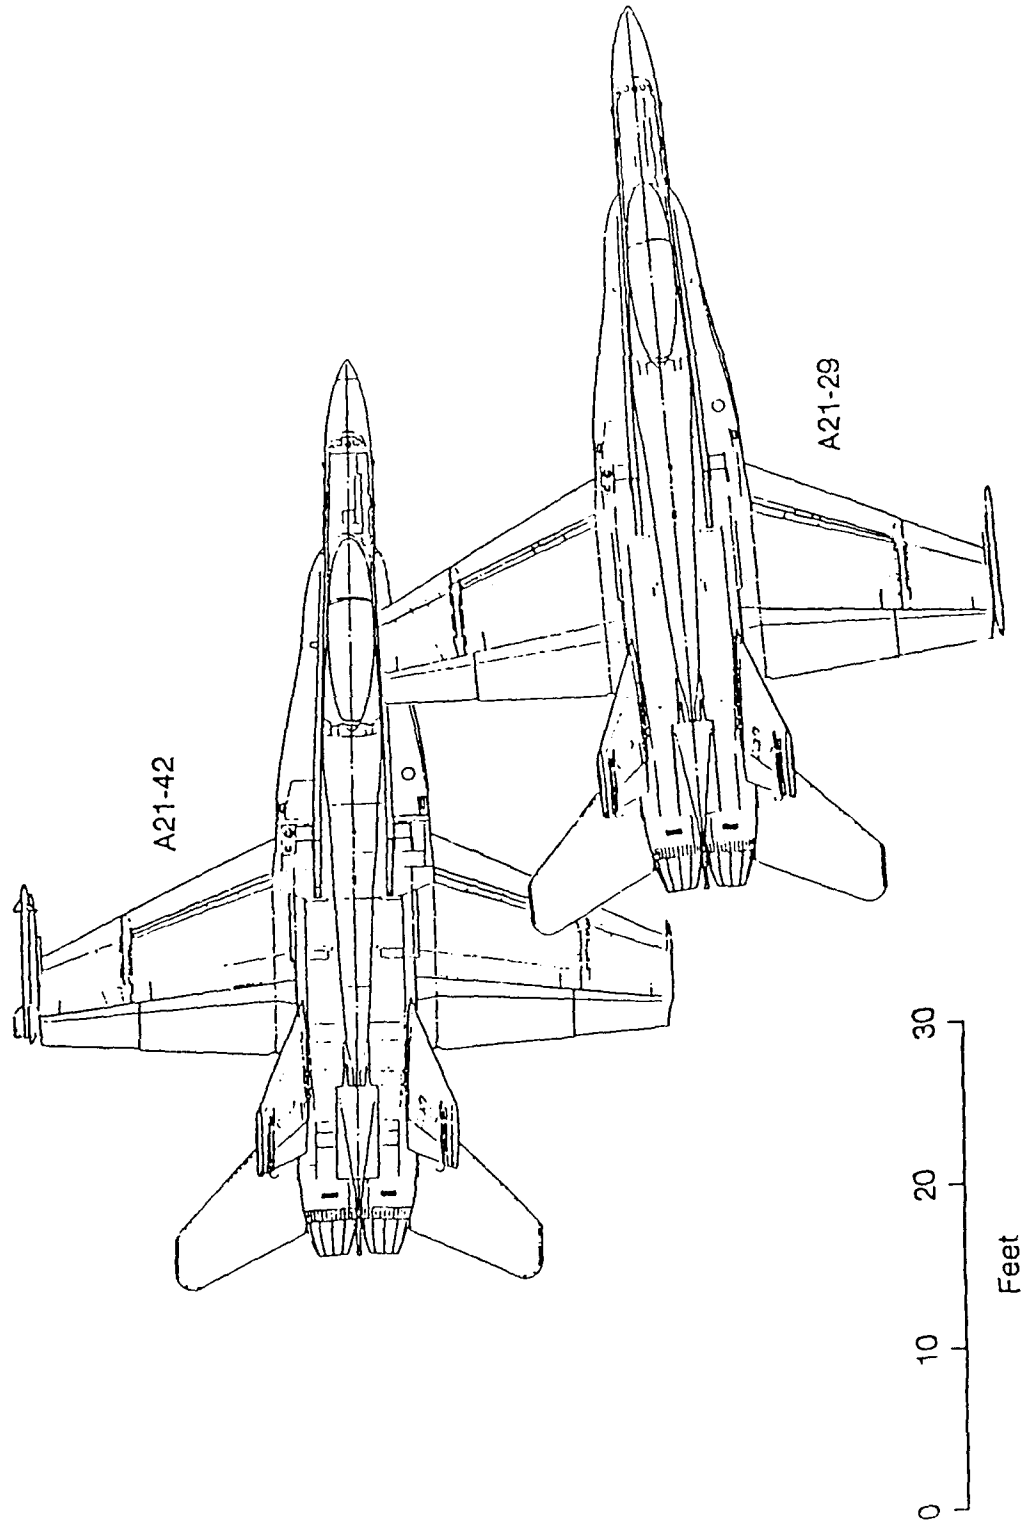
**Fig. 62**  $t = 0.022$  sec following separation of the missile, the port wing of A21-29 penetrates the cockpit of A21-42 while the port tailplane of A21-29 contacts the starboard wing of A21-42

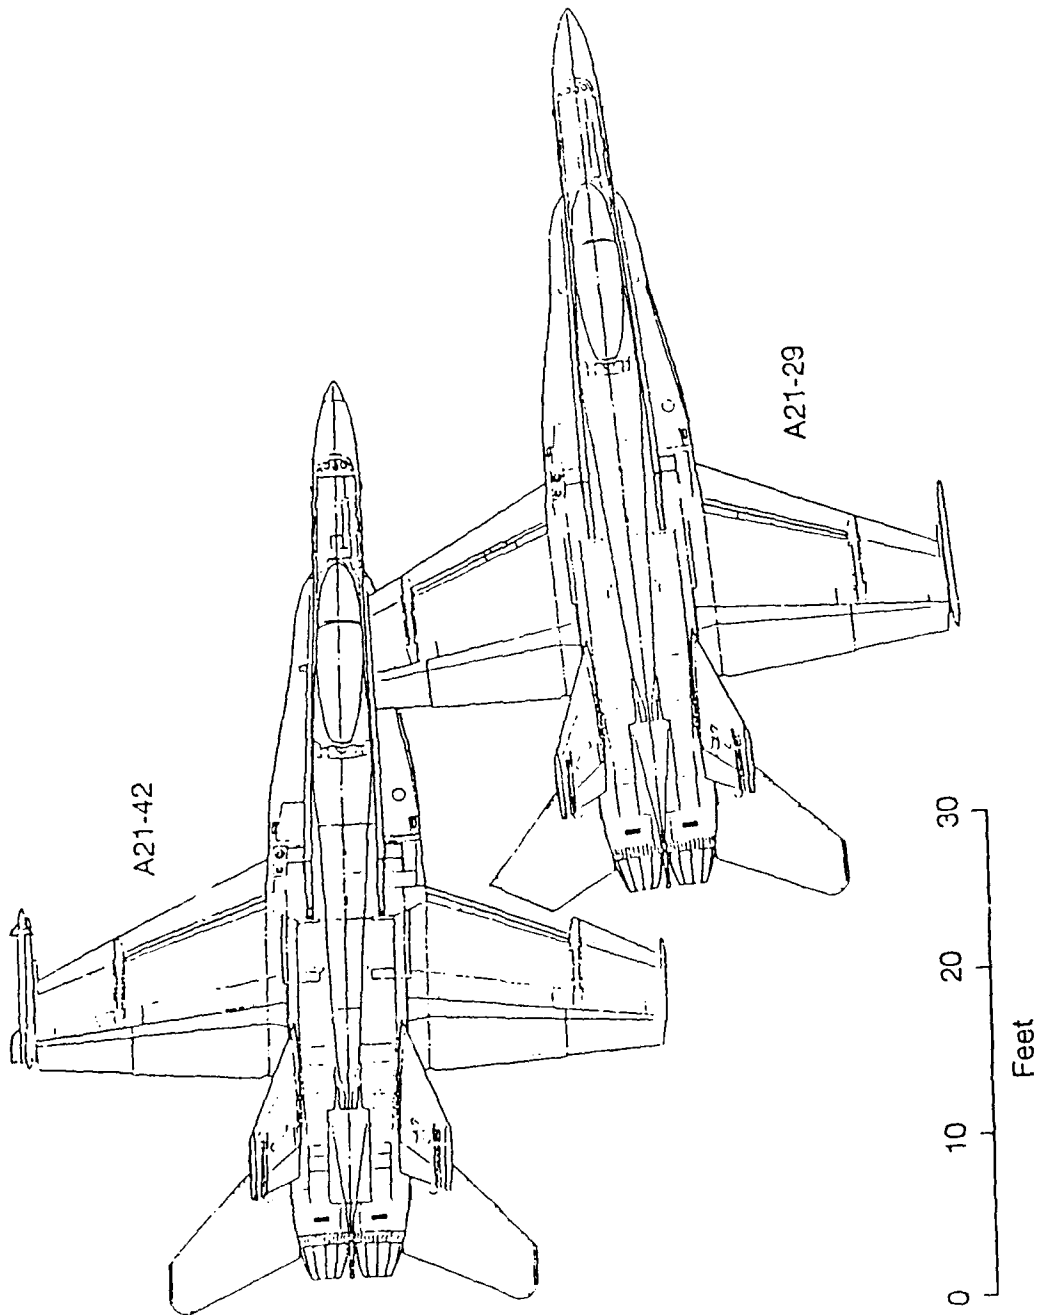
- 
- d. The nose of 29's port launcher contacted the canopy frame just above the cockpit sill and the launcher failed approximately 2 ft aft of the nose.
  - e. The main body of the port launcher passed beneath the cockpit sill cutting through the pilot, destroying the ejection seat and forcing the control column hard left, Fig. 62. The port tailplane of 29 was now in contact with the starboard wing of 42.
  - f. With 42 commencing to roll to port, the port wing of 29 moved progressively downwards to the leading edge extension, disintegrating as it entered the cockpit. Cockpit equipment was forced out of 42 through the port side of the fuselage.
  - g. The starboard leading edge flap separated from 42 while the port tailplane tip was removed from 29, Fig 63.
  - h. After 0.125 seconds, the two aircraft separated with 42 rolling and turning to port before falling into a spin.

**Fig. 63** *t = 0.125 sec the port wing of A21-29 continues to penetrate the cockpit of A21-42; the port tailplane tip of A21-29 breaks off while the inboard leading edge flap separates from A21-42*
