United States  
General Accounting Office  
Washington, D.C. 20548

January 29, 1991

# Executive Summary

On April 19, 1989, 47 sailors died when five bags of propellant ignited in the open chamber of the center 16-inch gun of the battleship U.S.S. Iowa's turret II. The Navy's investigation concluded that the explosion resulted from a deliberate act and not from a defect in the gun or propellant.

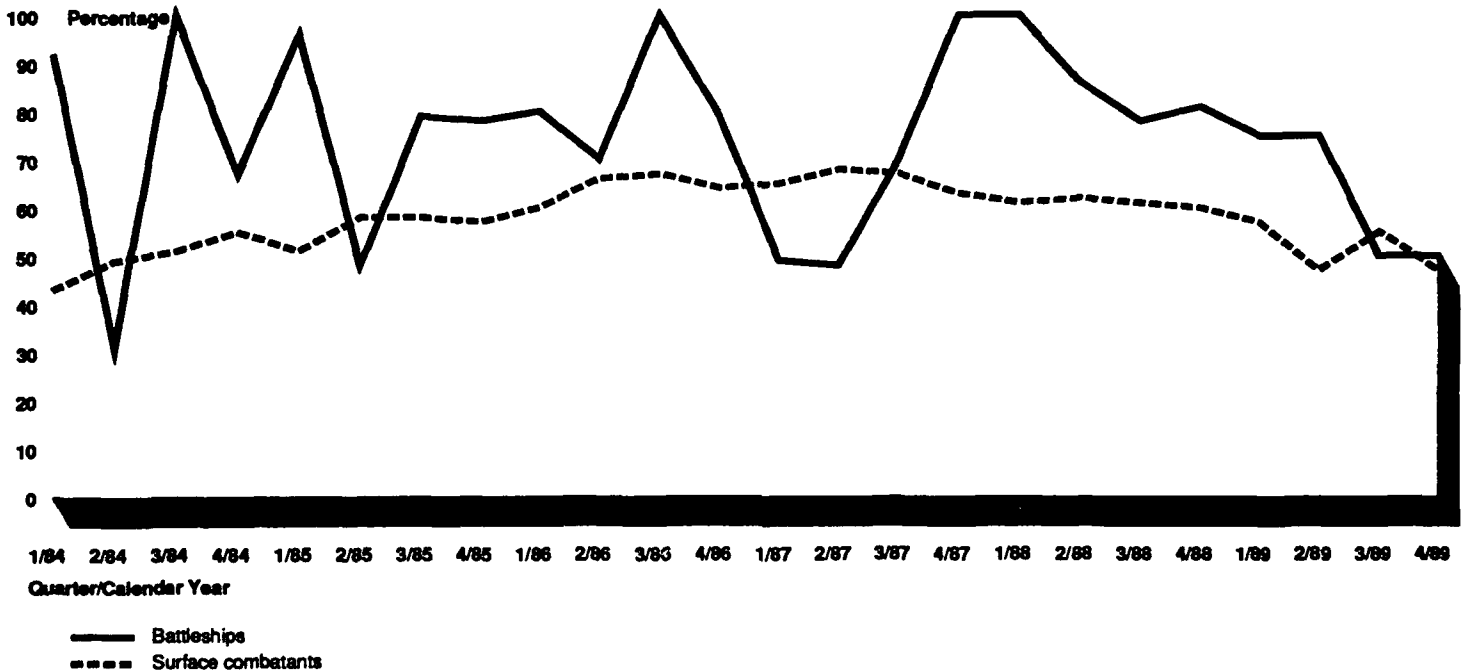
Figure 3.1: Operating Time Free of Serious Equipment Failures

For a broader comparison, we compared the battleships' overall equipment readiness to that of other Navy surface combatants to determine if the battleships, as a group of ships, present any undue material or supply support problems. As figure 3.1 shows, between 1984 and 1989 the battleships operated without any failures that had a major impact on or precluded the ships from performing a primary mission for a substantially greater percentage of time than did surface combatants as a whole. The battleships had the better record in this regard for 19 of the 24 quarters in this period. Additionally, the battleships reported no failures of this severity during four quarters. During the period covered by the comparison, the number of battleships in commission increased from one to four while the total number of surface combatants ranged from about 180 to about 200. The battleships' experience showed more variation than did the surface combatants because of the small number of battleships in commission.

There were no distinct overall differences between the battleships and the surface ships in the proportion of the total number of equipment failures due to the unavailability of repair parts, about 62 percent of the total failures in each case. However, only about 3 percent of the battleships' total supply-related failures had a major impact on or precluded the ships from performing a primary mission while about 11 percent of the supply-related failures for all surface ships were so categorized.

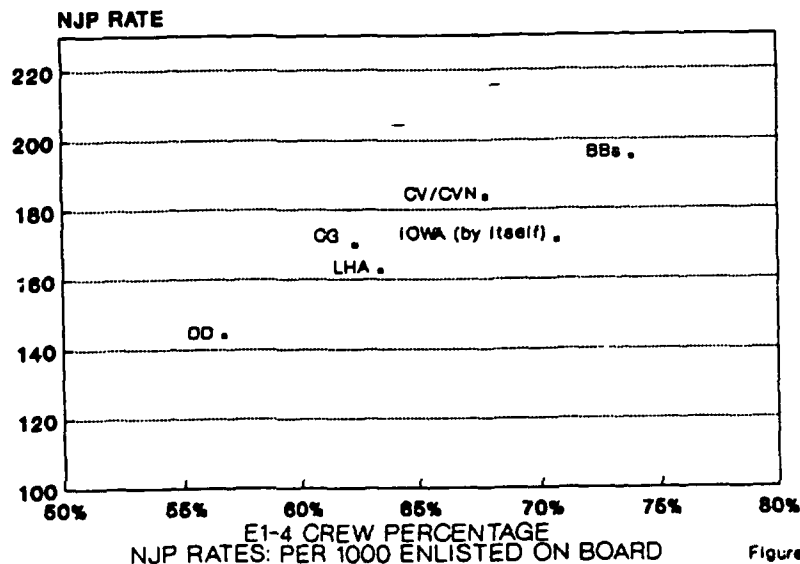
Figure 4

The following chart shows the impact in a more pronounced manner. Connecting the point on the graph would have a very strong correlation, indicating the connection between a junior crew and an anticipated increase in Non-judicial punishment cases. Accordingly, the discipline on the IOWA was not worse, but actually better than could have been predicted.

**AFLOAT NON-JUDICIAL PUNISHMENT (NJP) RATES  
VS. CREW SENIORITY**  
NJP RATES BY CLASS
