**TECHNICAL
REPORT**

FEAP TR-FM-93/06
July 1993

Demonstration of Polyscann Ultrasonic Butt-Fusion Inspection System for Polyethylene Pipes

by
Orange S. Marshall, Jr., and James B. Hunt
U.S. Army Construction Engineering Research Laboratories
Champaign, IL 61826-9005

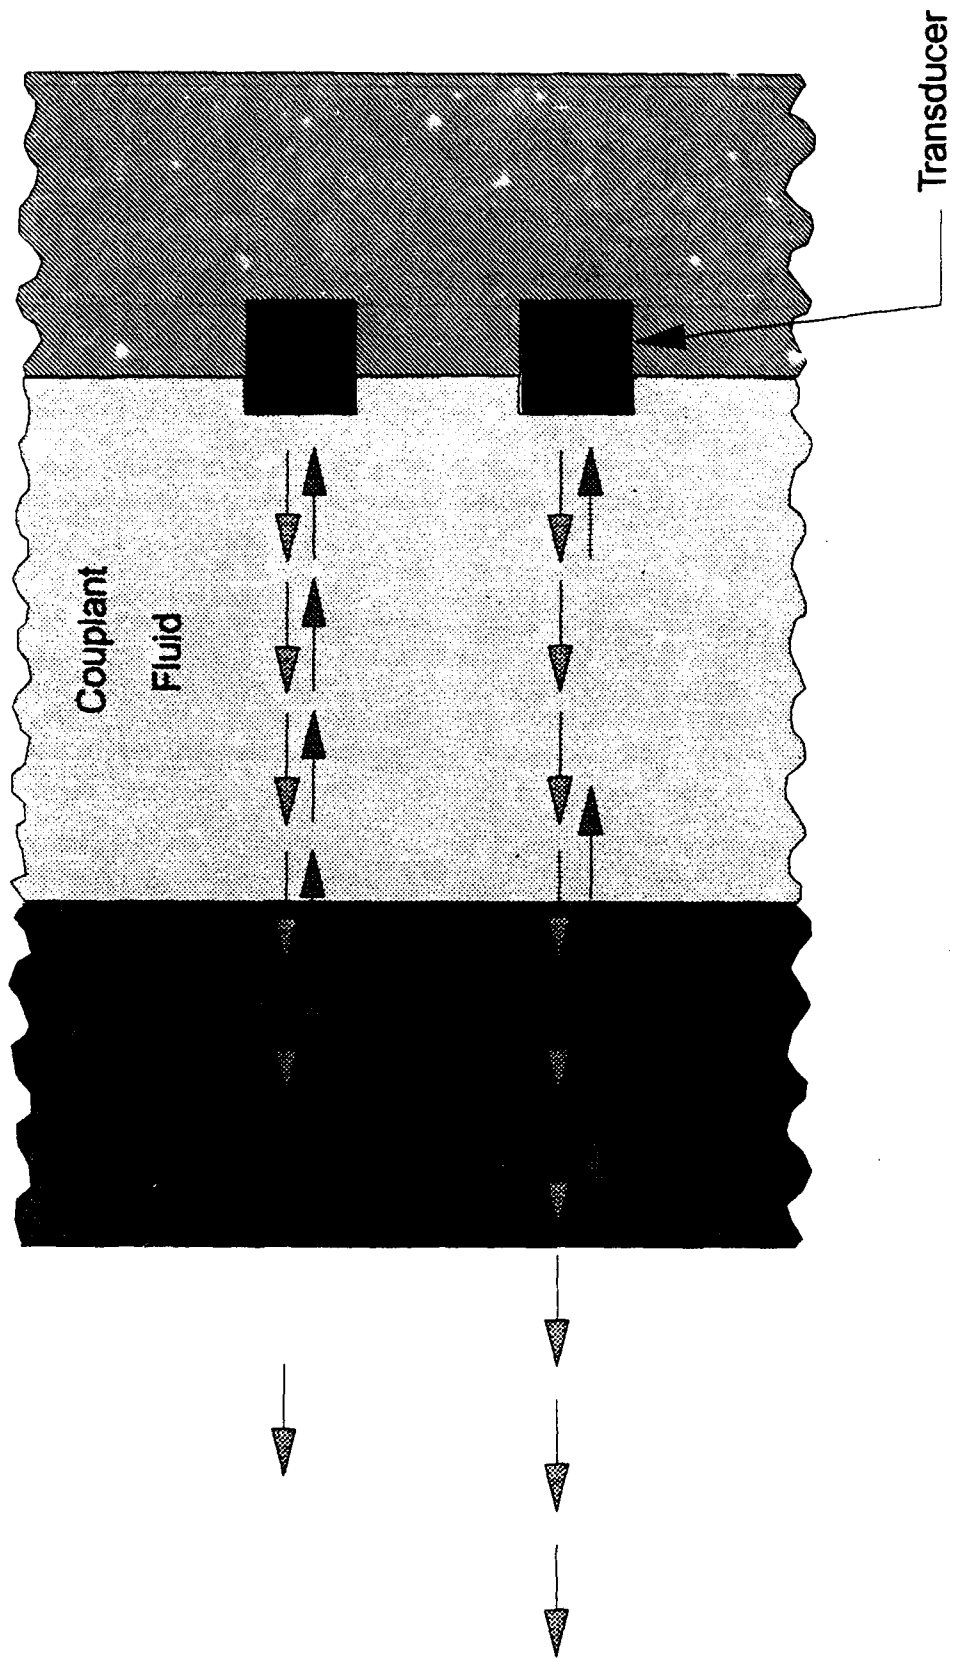
Figure 1. Schematic of \bar{x} pulse-Echo Method.

The ultrasonic method used for flaw detection was initially developed during World War I for locating objects underwater—particularly submarines. During World War II ultrasonic techniques were applied to nondestructive testing, or NDT. The NDT method is called the *pulse-echo* method because it transmits the ultrasound in pulses and detects the intensity of sound echoed back due to material boundaries, flaws forming a type of boundary in the material. Figure 1 is a schematic depicting the pulse-echo method.

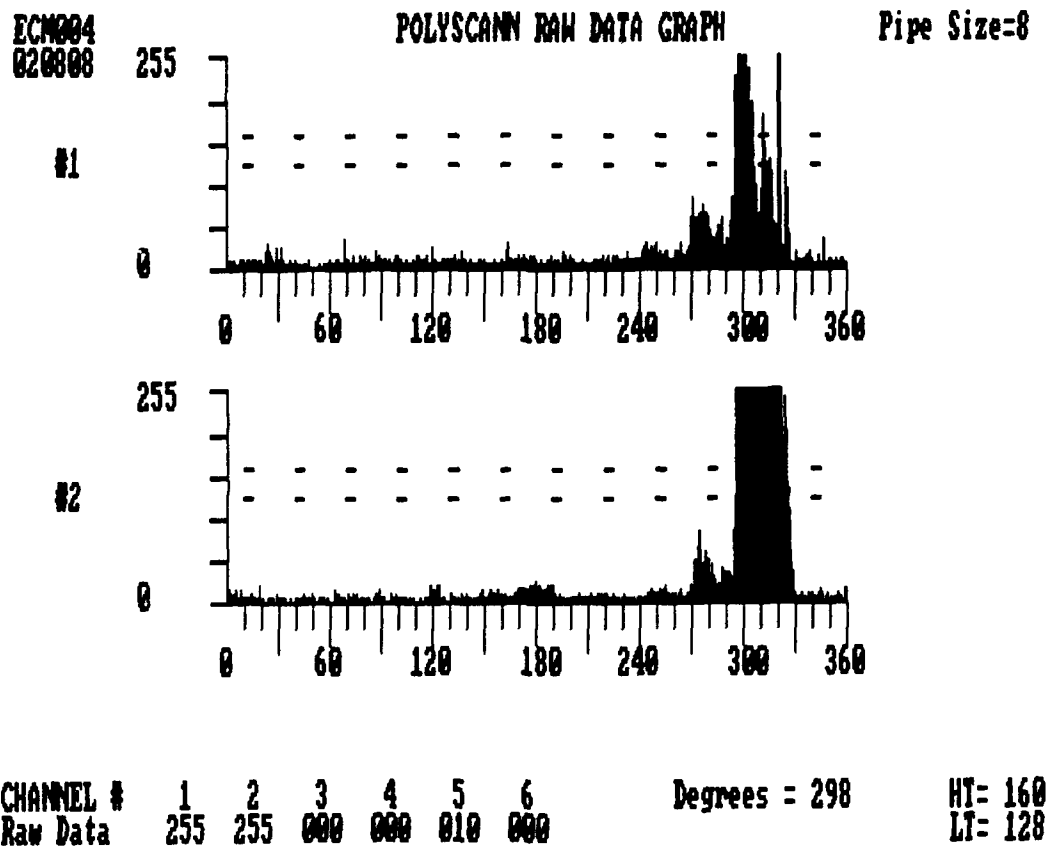
Figure 2. Graph of Transducer Position vs Echo Intensity.

Figure 2 is a graph of the transducer position around the circumference of the pipe versus the echo intensity (wave amplitude) detected. The scale, based on the material density, is relative. A peak at 127.5 indicates an area of near half the normal polyethylene density and a peak at 255 indicates the density of air. Polyethylene is a crystalline polymer and has, by nature, a density gradient throughout, due to localized crystalline and amorphous regions, as well as other additives such as colorants, ultraviolet light stabilizers, processing impurities, etc. These all can provide a source of echo due to their density differences, producing a background sound level. Genuine flaws usually provide a much higher intensity

of sound reflectance because of large density changes, so they can be detected by their intensities. The Polyscann equipment electronically filters all low-intensity echoes and records only those reaching at least 128 on the intensity scale on the report printout. The system reports a flaw if intensity exceeds 160. The two horizontal lines on each graph in Figure 2 represent these two threshold amplitudes.

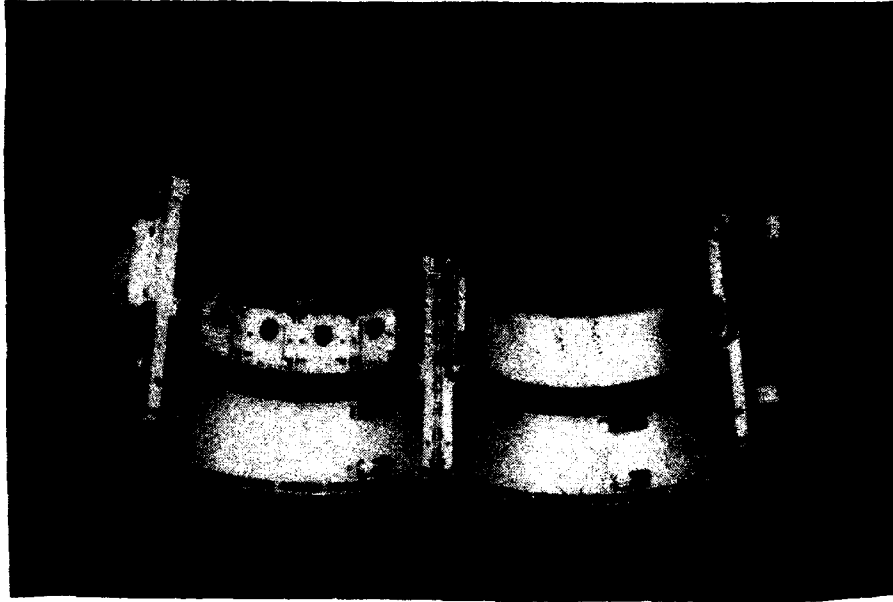
Figure 6. Seals Requiring Lubrication.

It was discovered on the first butt-joint tested, that if the valve lubricant and sealant was applied properly by forming about a quarter-inch bead of sealant between pipe seals along the plate seal (see Figure 6), the leakage of excessive amounts of coupling fluid observed in many of the laboratory tests could be eliminated.

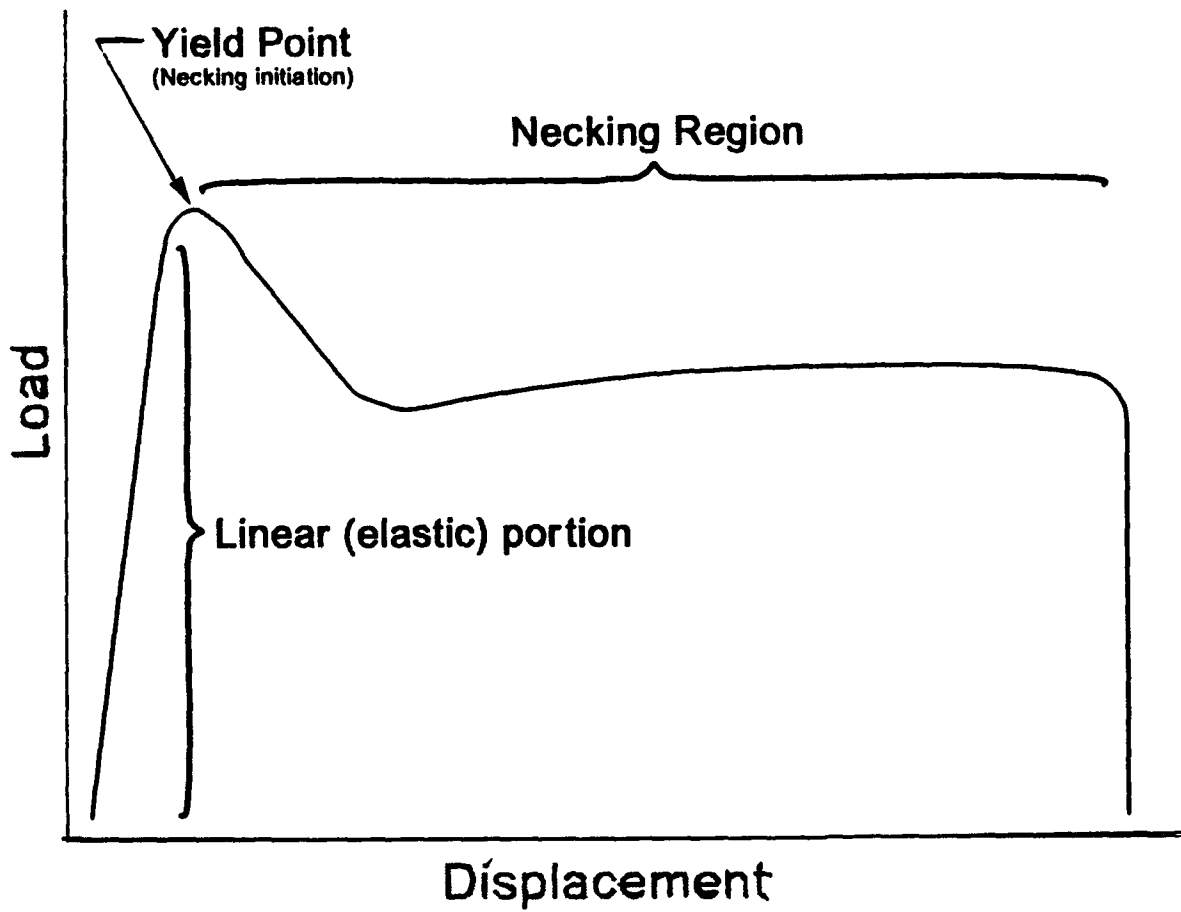
Figure 27. Typical Load-Versus-Displacement Graph.

As indicated in Figure 27, the load reaches a peak, then reduces to a plateau that continues until the sample breaks. The peak value indicates the point where the necking phenomenon begins. At that point the cross-sectional area of the sample begins to decrease and the load required to pull the specimen is reduced. A true stress-strain curve that accounts for the differences in cross-sectional area would begin a plateau at that point, without any noticeable significant reduction in stress.

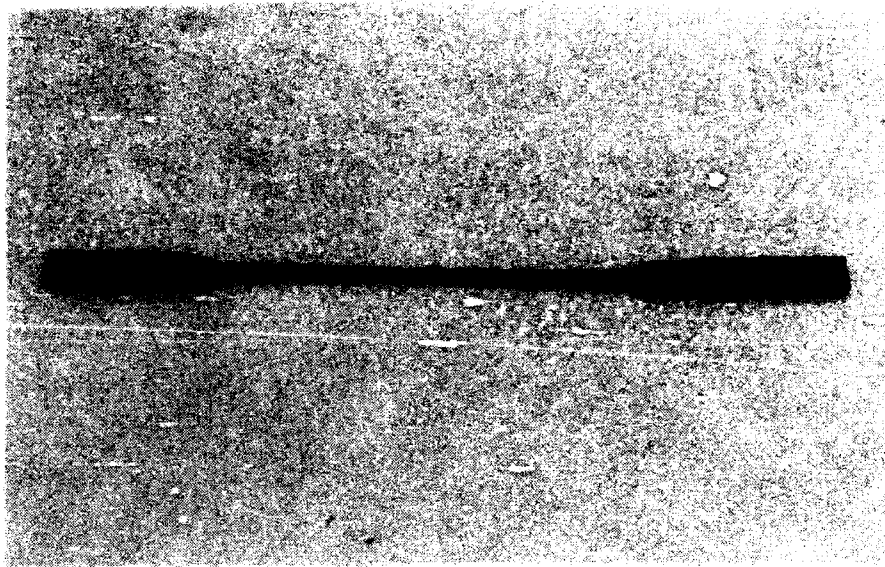
Figure 28. Example of Necking in Joint Specimen.

necking of the sample to minimize the likelihood of catastrophic pipe failure. Figure 28 shows the normal necking phenomenon for polyethylene. Figure 29 shows a non-necking break at the butt-fusion joint. Pipe samples where both the inside and the outside tensile samples failed were judged as failures. Where only one of the two tensile samples failed, the joint was judged as marginally passing.
