DOT/FAA/CT-93/78
DOT-VNTSC-FAA-93-10

Full-Scale Testing and Analysis of Curved Aircraft Fuselage Panels

Final Report

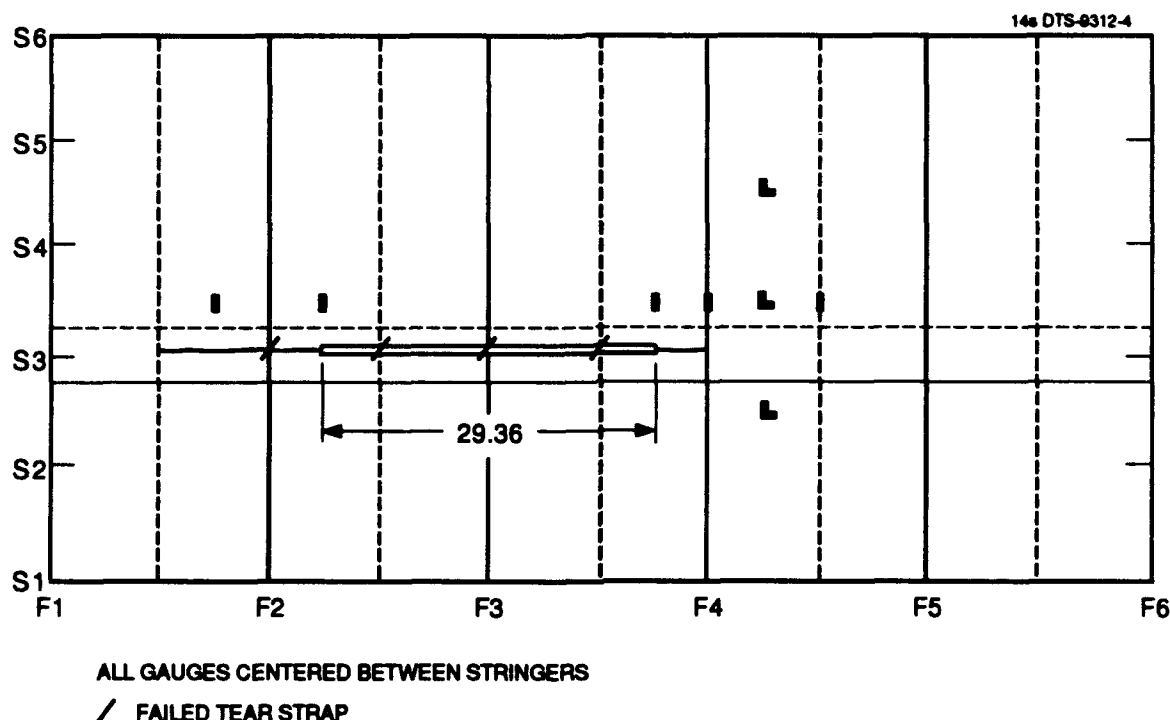
Figure 16. Panel 11 - After Fracture

grew to the tear strap between F1 and F2. The final crack is shown in Figure 16. A photograph of the failed panel is shown in Figure 17.
