WL-TR-92-4040

DURABILITY OF ADHESIVELY BONDED STRUCTURE

Al E. Hohman
Charles M. Standard
LTV Aerospace and Defense Company
Missiles Division
P.O. Box 650003
Dallas, Texas 75265-0003

Final Report for Period April 1991 - March 1992

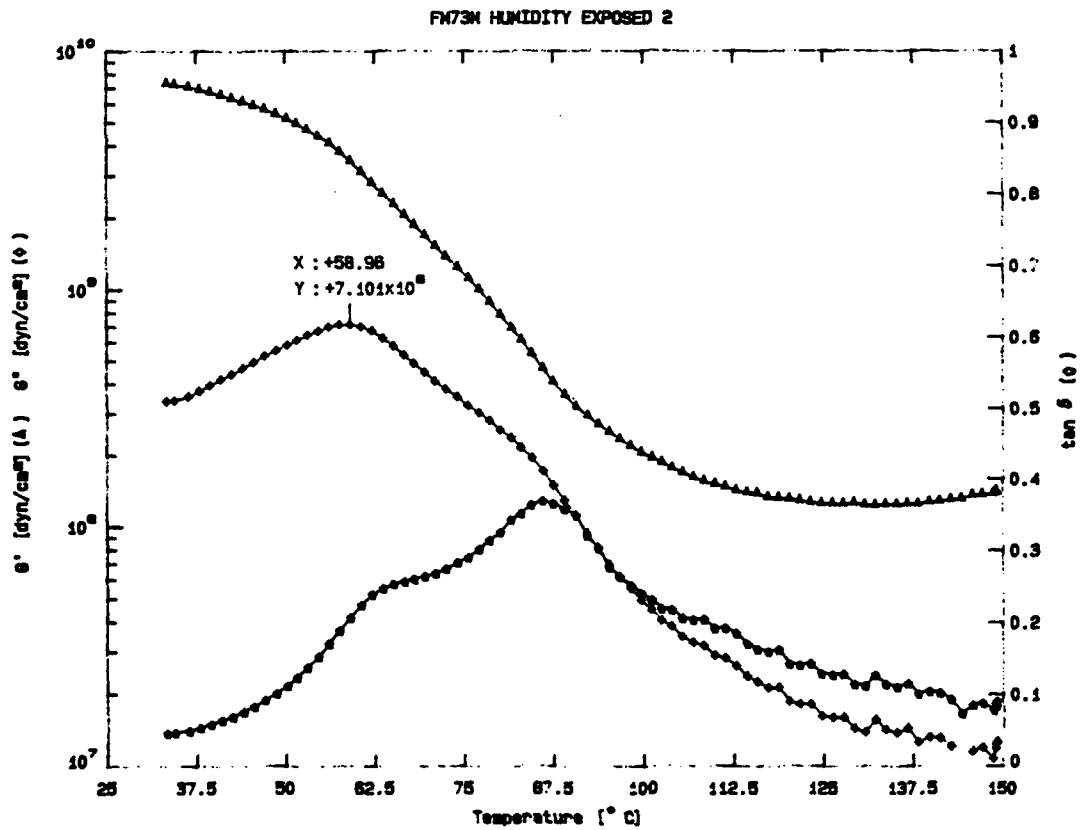
Figure 21: Moisture Conditioned FM 73M Elastic, Loss Modulus and Glass Transition

Initial reduction in strength is a result of moisture ingress into the primer and adhesive. This is shown by the wedge specimens in which the crack progresses as a cohesive failure to a lengthened crack after moisture conditioning. This shows the lower crack resistance within the adhesive to the constant stress in the wet condition. The crack generally remained as a cohesive separation in both adhesives, applied over phosphoric acid anodize (Figure 20). This reduction in strength is accompanied by a reduction in the modulus of elasticity as shown by the neat film measurements of torsional modulus in Figures 21, 22 and 23.

Rheological properties of the two adhesives in the "dry" and "wet" condition are shown in Figures 21 through 23. Both FM 73M and FM 300M show a broad peak in the G'' , loss modulus, demonstrating a significant elastomeric property throughout the ranges of measurement. The G' , modulus of elasticity, is reduced for both adhesives after moisture
