CULTURAL RESOURCES SURVEY

LONG BRANCH LAKE

Macon County, Missouri

HISTORIC ARCHITECTURAL RESOURCES

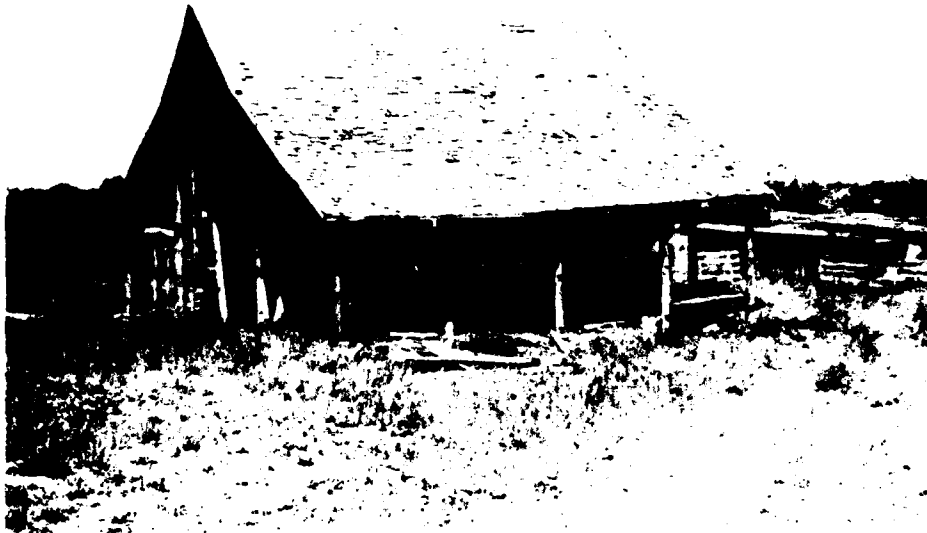
Barn, viewer facing Northeast

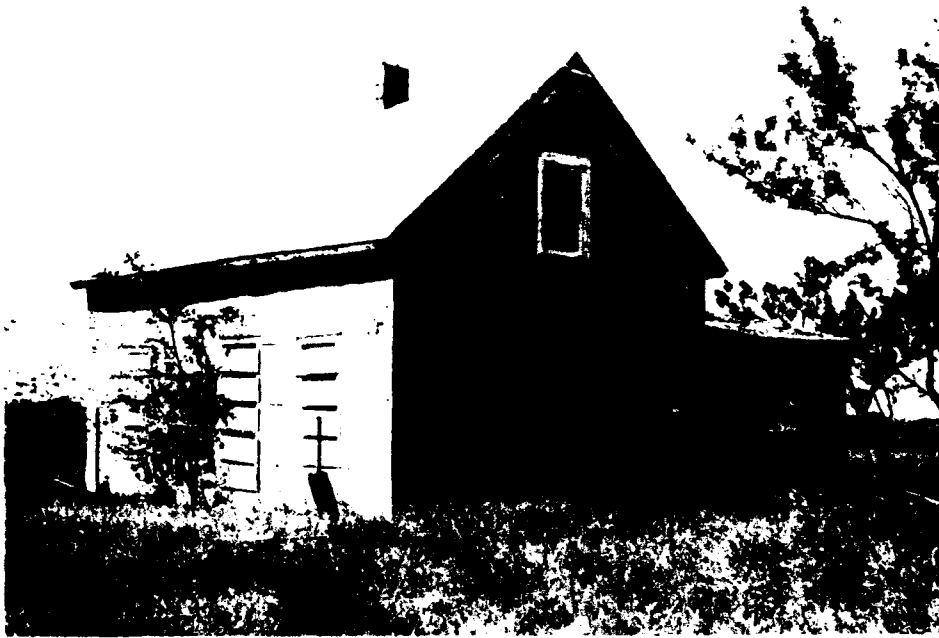
Log cabin house, viewer facing Southwest

At the present time, this last addition has been removed, and the remaining structure is fenced in by barbed wire and warning signs. At the time of inspection, the house had been broken into, and evidences of a drinking party were seen, together with minor vandalism, such as writing on walls, and the like.

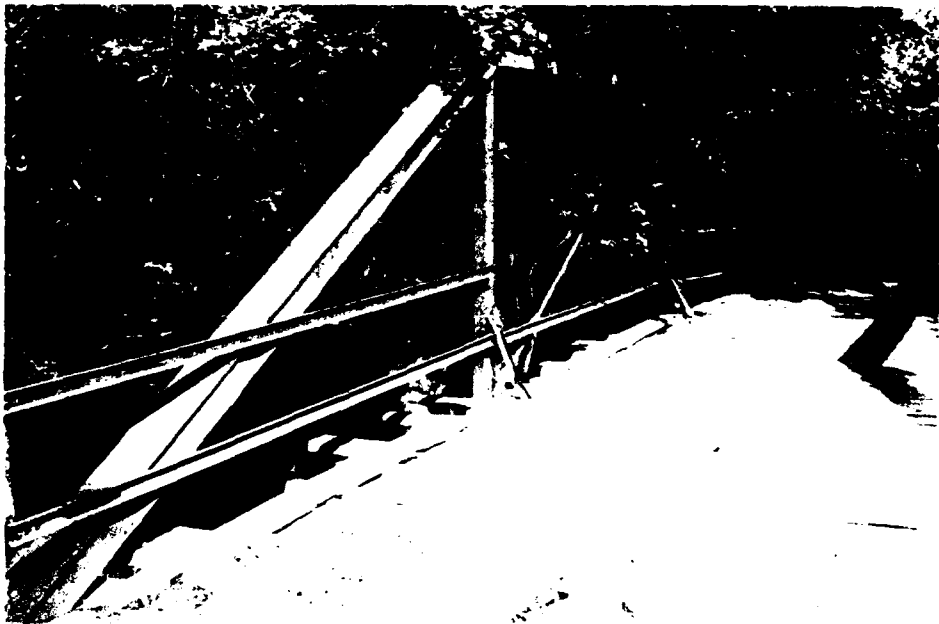
Closer view of bridge
