Report No. CG-D-05-94

AIRCRAFT CORROSION STUDY

J.T. Stropki
and
R.D. Smith

FINAL REPORT
December 1993

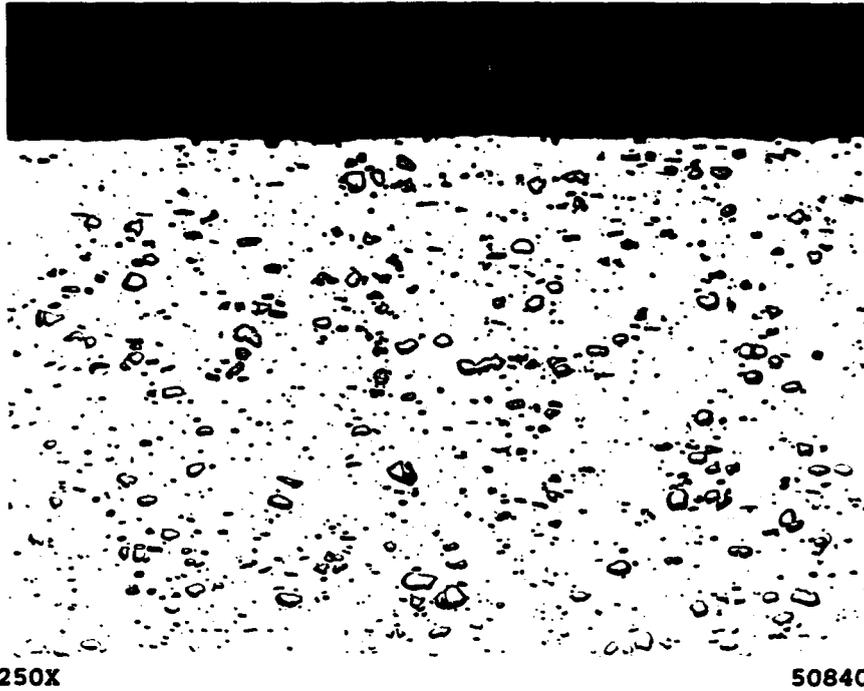
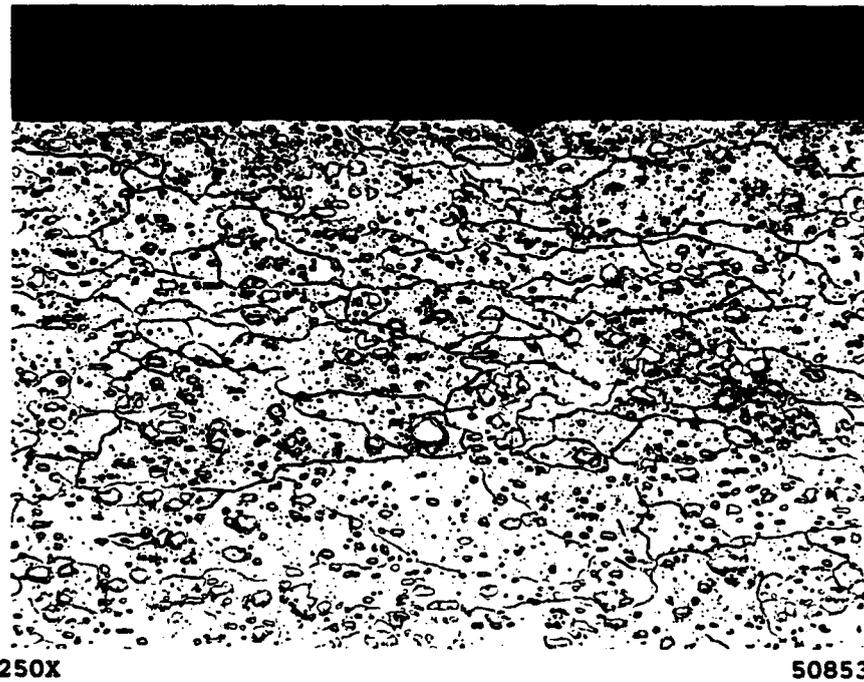
Figure 3. Photomicrographs documenting the microstructure of Specimen No. 3, Alloy 2219-O (bare).

As shown in Figure 3, the microstructure for sample No. 3 (Alloy 2219-0) contained a large number of coarse intermetallic compounds. These compounds were uniformly dispersed throughout the individual grains of this alloy; that distribution contributes to this material's resistance to degradation by elevated temperatures. As expected from a comparison of mechanical properties, the average microhardness measured for this particular material was significantly lower than measurements obtained for the 2024-T3 and French alloys.

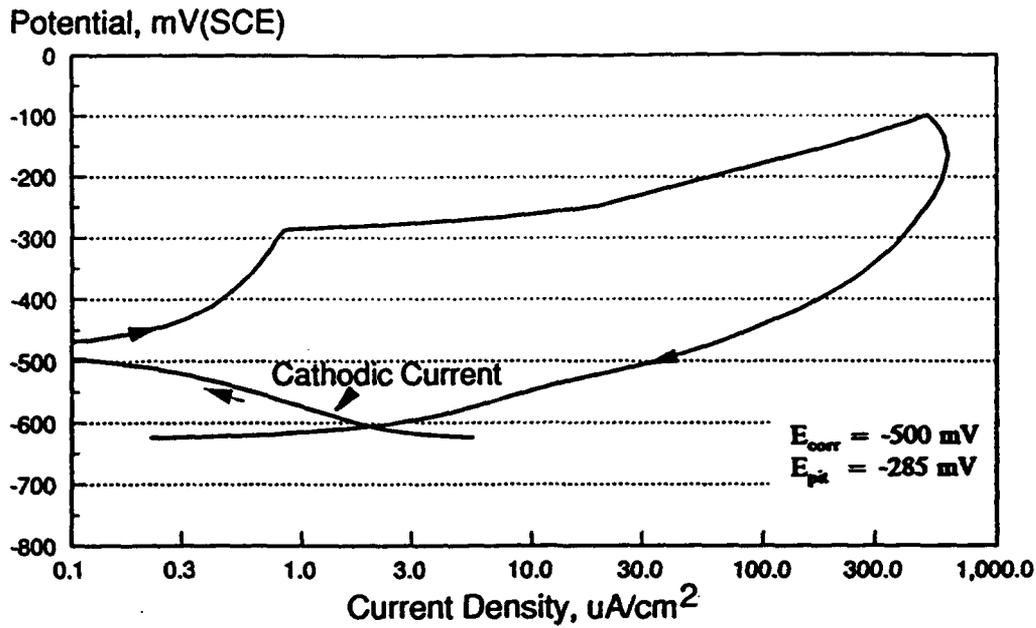
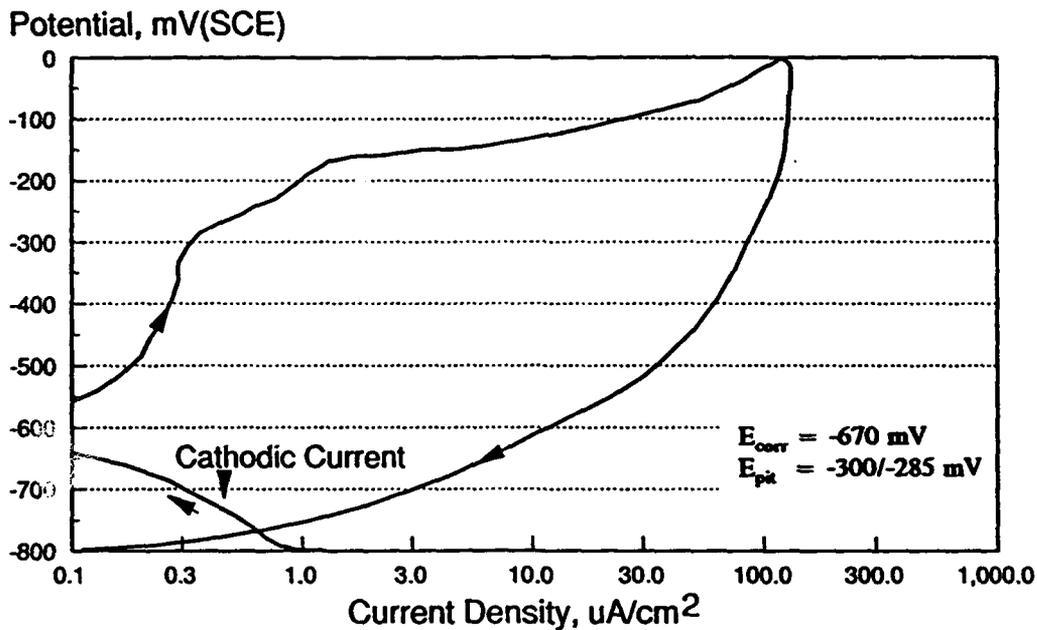
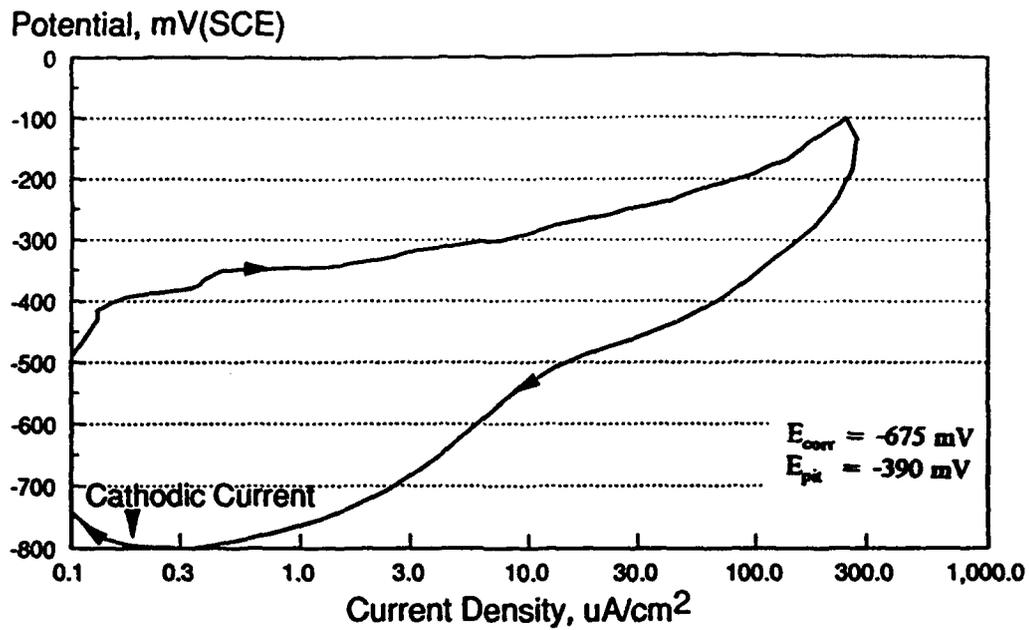
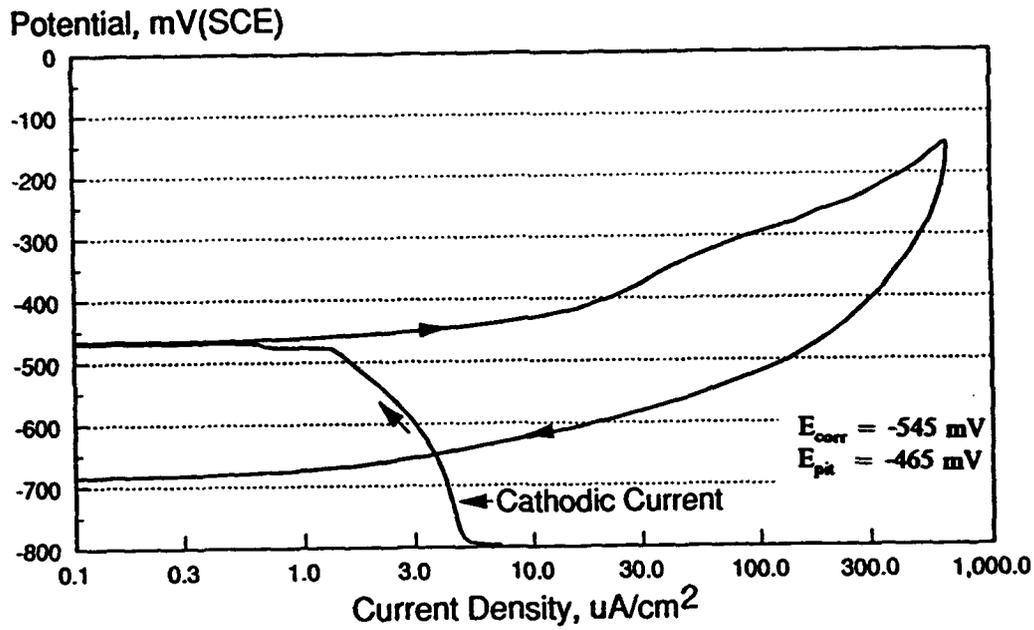
Figure 10. Anodic polarization curves for four aluminum alloys (test environment: 100 ppm each of Cl , SO_4 , and HCO_3 ions).

Figures 10a through 10d document the anodic polarization curves obtained for the four aluminum alloys after testing in ASTM D1384. An analysis of each curve indicates that Alloy 2024-T3 ($E_{np} = -285$ mV) and the French alloy ($E_{np} = -300/-285$ mV) are the most resistant to pitting corrosion. Conversely, the pitting potential measured for the anodized Alloy 2024-T3 sample was approximately -390 mV. The suspected source of this worse-than-expected result may be attributed to the quality of the protective anodized film on the surface of the test sample. Any scratches or discontinuities in the film would result in a decrease in corrosion resistance and an increased susceptibility to pitting corrosion.

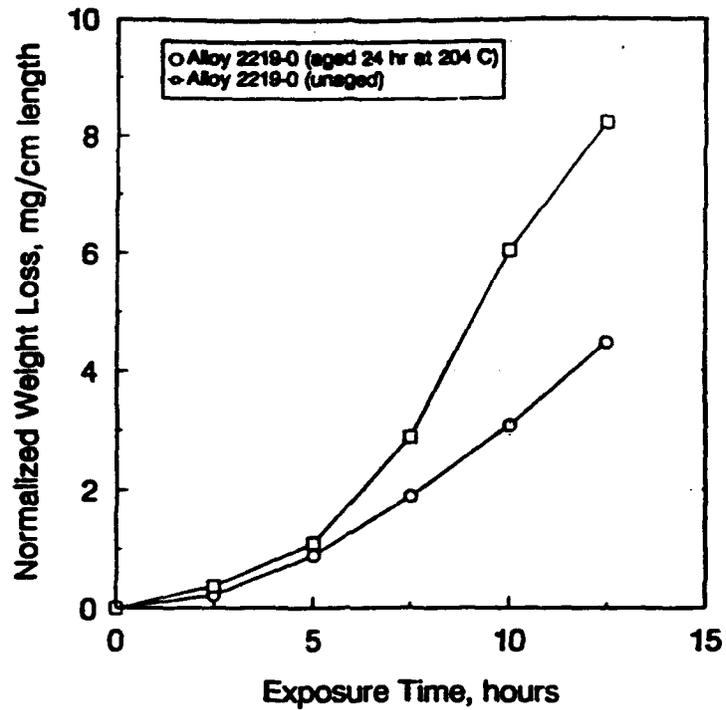
a. New and Aged Alloy 2219-0

The two sets of data plotted in Figure 15a document the erosion rates for both aged and unaged samples of Alloy 2219-0. A comparison among the data confirms that conditions used to artificially age the respective sample were significant enough to increase the inherent erosion resistance of this soft (Knoop hardness = 47) aluminum alloy. However, it was observed that the data collected after 12.5 hours of testing indicated that the inherent erosion resistance of this aluminum alloy was approximately six times less than the resistance measured for the French and 2024-T3 alloys. Examinations performed on both samples verified erosion-related perforations through the 0.043-inch-thick material after 12.5 hours of testing. This result along with the data

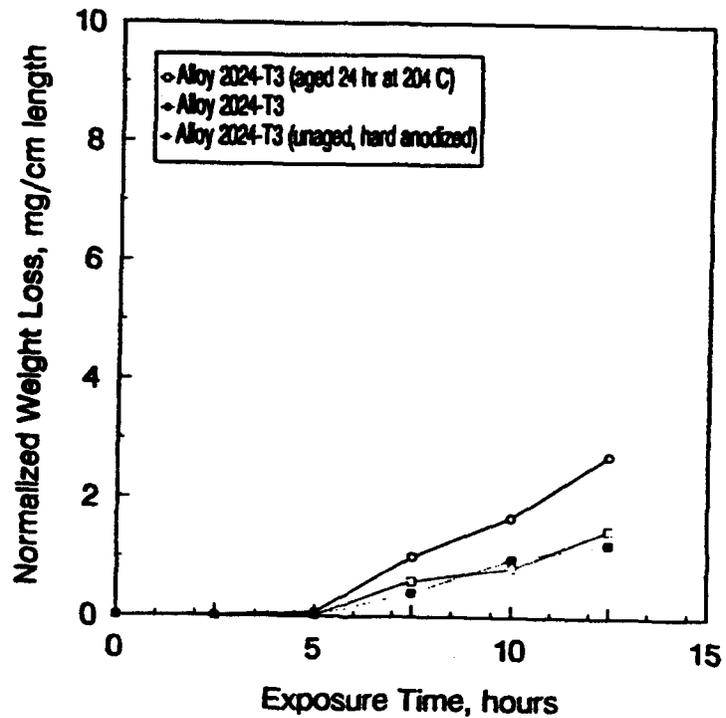
b. New, Aged, and Hard Anodized Alloy 2043-T3

Data presented in Figure 15b serve to illustrate the erosion-related performance between the aged (24 hours at 204°C), unaged, and unaged hard anodized (HA) Alloy 2024-T3 samples. The thick (0.0025 to 0.003 inch) anodic film on the test surface of the HA sample was produced to improve corrosion and erosion resistance of Alloy 2024-T3.

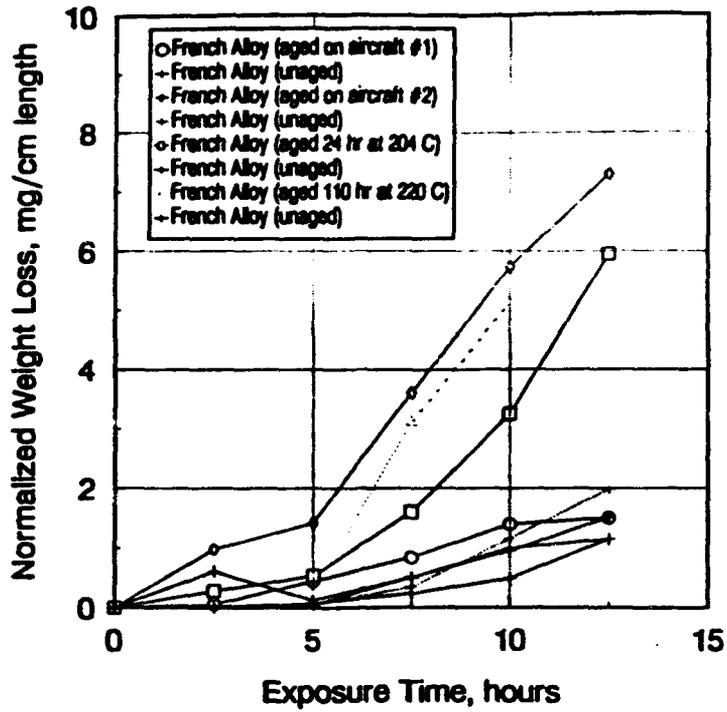
c. New and Aged French Alloy

Figure 15c documents the normalized erosion rates measured for the French alloy samples. Data collected for the four unaged (control) samples indicates that the erosion test was reproducible. Normalized rates for this particular sample ranged between 1.01 and 1.99 mg/cm, with the average rate calculated at 1.41 mg/cm.

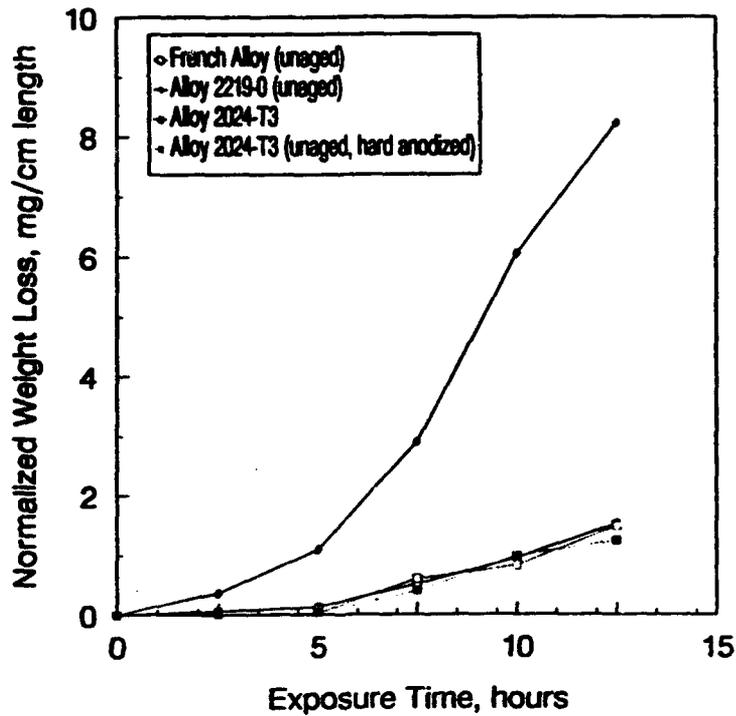
d. New French/2024-T3 and 2219-0 Alloys

A comparison among the four unaged samples tested during this task is provided in Figure 15d. The data indicate that the erosion-related performance of the hard anodized and bare Alloy 2024-T3 samples and the French alloy is equivalent. As stated in the previous text, the rate of erosion increased after 5 hours of exposure testing. Conversely, the data collected for Alloy 2219-0 suggest that this aluminum alloy should not be considered as a candidate replacement material for the outer wing slats of the HU-25A aircraft. The same conclusion was obtained from the corrosion testing conducted on this material.
