**AIRBASE STRUCTURAL FACILITY
POSTATTACK RECOVERY - FOAL
EAGLE DEMONSTRATION**

**D.H. MERKLE, D.L. READ,
R.A. REID, J.M. UNDERWOOD,
N.F. KARASZEWSKI**

APRIL 1993

FINAL REPORT

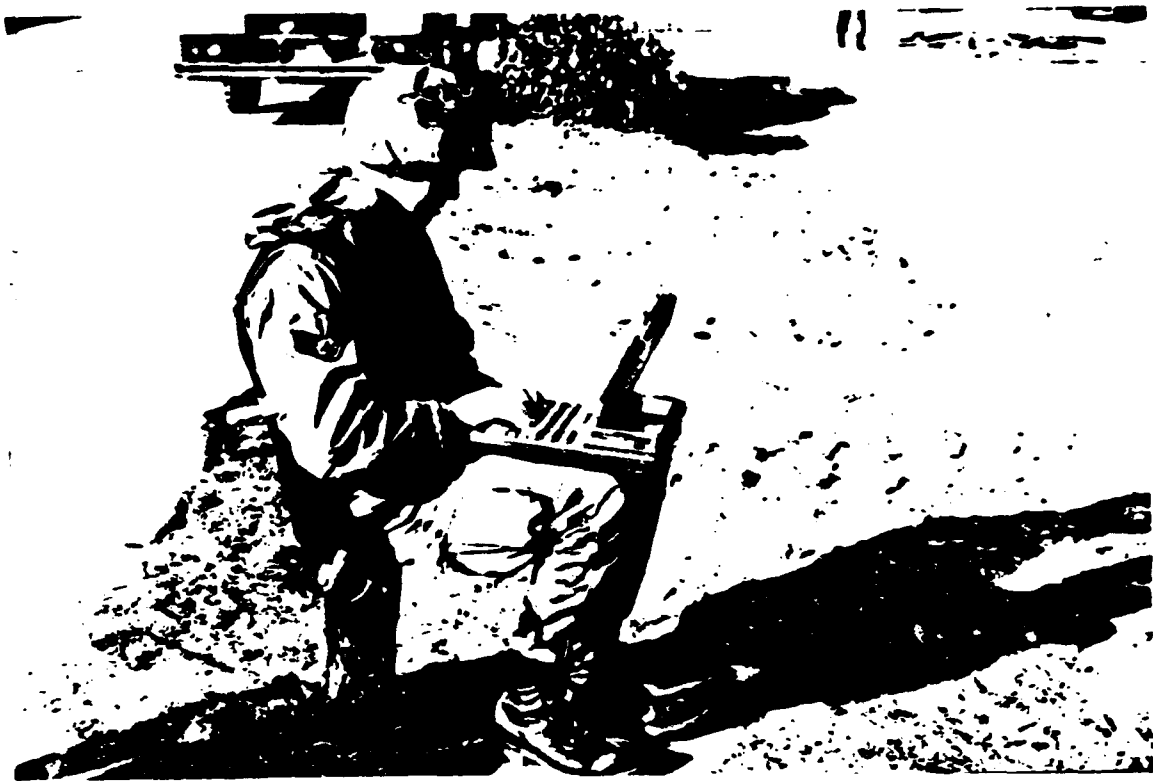
Figure 19. POST-DAM Expert System Being Used In The Field.

In addition to the POST-DAM demonstration described above, the expert system was used in the field by 51 CES personnel immediately prior to the earth berm/precast slab wall replacement demonstration on 5 November 1991. Figure 19 shows the expert system being used in the field. No problem was encountered during this process.
