## INVESTIGATION OF THE GENERATOR ROTOR BURST AT THE PITTSBURG STATION OF THE PACIFIC GAS AND ELECTRIC COMPANY

The recent fracture of a large generator rotor (125,000 kw - 3600 rpm) led to an extensive investigation aimed at determining the cause. This paper describes the various facets of this investigation, the results obtained, and the probable cause of the burst.

On March 18, 1956, the generator rotor of the 169,118-kva Pittsburg Unit No. 1, of the Pacific Gas and Electric Company, burst during an overspeed-governor trip test. This test was being made before placing the turbine-generator into operation following an inspection and overhaul of the turbine.

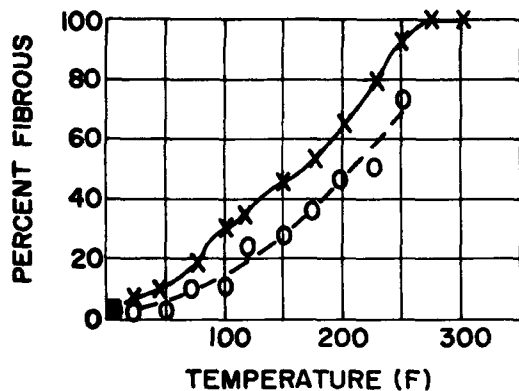
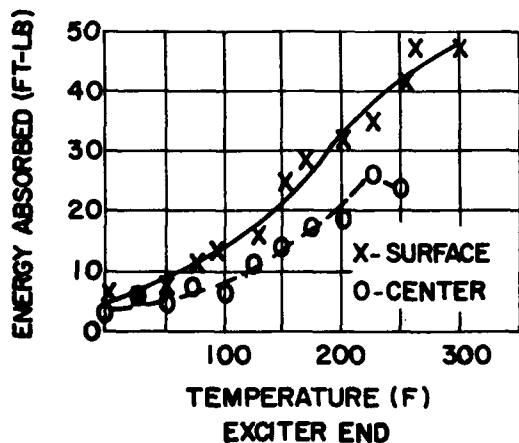
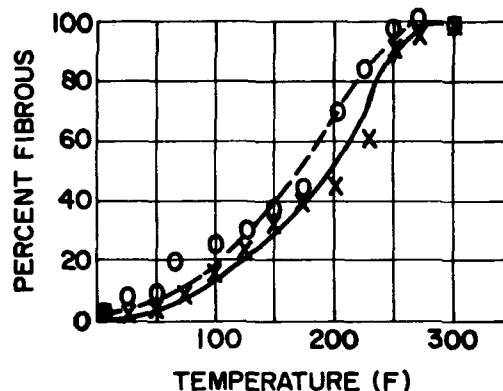
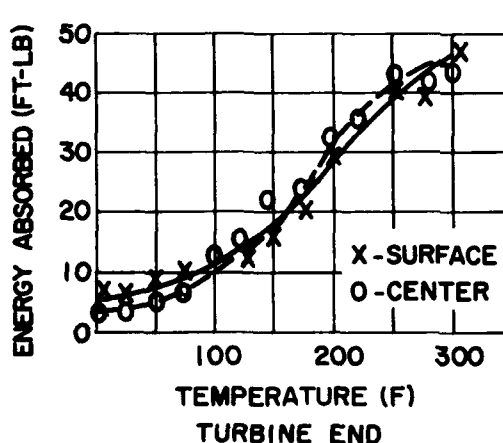
Fig. 5. Charpy V-notch impact-energy and fibrous-appearance curves

The energy absorbed and fracture appearance of the Charpy specimens over a range of temperature is presented in Fig. 5. These results show a variation in fracture-appearance transition temperature with location in the forging which is summarized in Table 4.

The main-body temperature was estimated as about 85 F when the forging burst, and at this temperature the center material at the exciter end has a V-notch Charpy impact value of 7 ft-lb, indicating relatively low resistance to crack propagation.

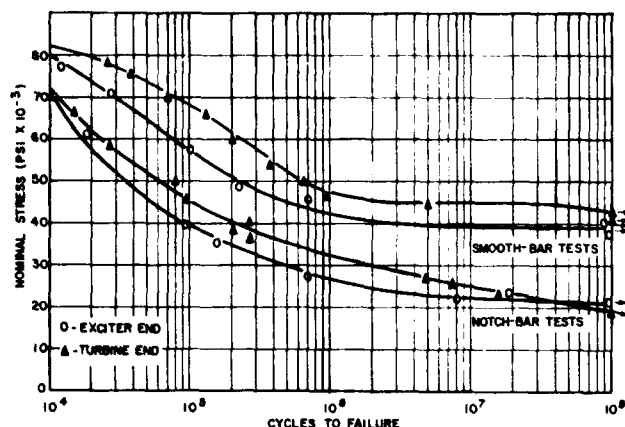
Fig. 6. Smooth and notched-bar fatigue strength

Fatigue test results from smooth- and notched-bar cantilever specimens, in the radial direction of material from the exciter and turbine ends of the forging body are shown in Fig. 6. The cross-section of the smooth bar was 0.343 inch x 0.625 inch. The notched bars were 0.493 inch x 0.625 inch, with two notches 75 mils deep giving a net section the same as the smooth bar. The radius at the bottom of each notch was 20 mils. This gave a theoretical stress concentration factor of approximately 2.6. The  $10^8$ -cycle smooth-bar fatigue strength is 37 percent of the tensile strength at the exciter end and 40.7 percent at the turbine end, while the notched fatigue strength is 20.7 and 18.7 respectively. These results are similar to those obtained on several other large turbine and generator rotors so far examined.

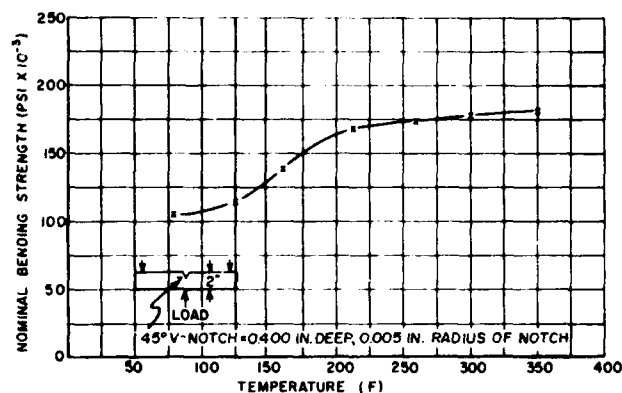
Fig. 8. Temperature dependence of notched-bend strength

Here nominal bending strength is merely the product of bending moment at fracture times the inverse-section modulus of the net section at the root of the notch. It will be noted that bending strengths of the notched bars decrease with increasing size of bar. Although the data presented were obtained at ambient temperatures, it has been found that the nominal bending strength of larger notch-bend specimens from similar material increased quite rapidly with moderate increases in temperature. Typical results are shown in Fig. 8. The material at the exciter end of the main body shows lower nominal bending strength than at the turbine end.

While the stress levels required to produce fracture in the various notched-bend specimens are considerably higher than the stress of 24,000 psi which existed at the solid center of the Pittsburg rotor at 3920 rpm, these notch-bend tests do show decreased load-carrying ability with increase in specimen size; and further, that the material fractures rather than deforms in relieving severe localized stresses.
