Structural Evaluation of Riveted Spillway Gates

Final report

Prepared for U.S. Army Corps of Engineers
Washington, DC 20314-1000

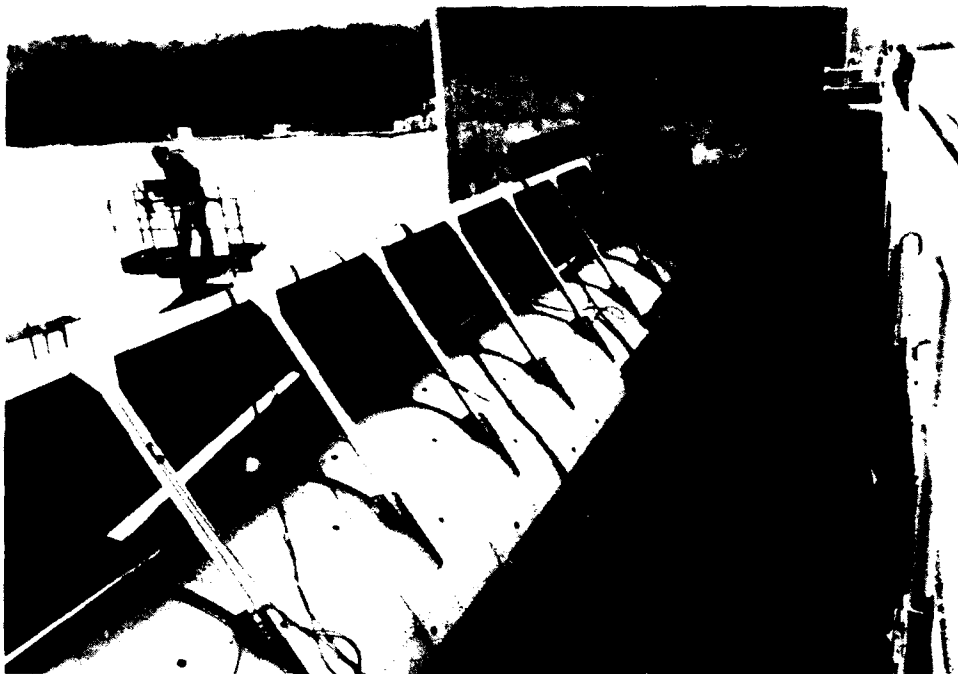
Figure 6. Roller gate with apron framing

Pitting corrosion. Pitting corrosion occurs on bare metal surfaces as well as under paint films; it is characterized by small cavities penetrating into the surface with little extension along the surface. If pitting occurs under paint, it can result in the formation of a blister and failure of the paint system. Although closeup photographs were not obtained, pitting was observed on the roller gate that was undergoing repainting during the onsite inspection at Lock and Dam No. 9 (Figure 6).¹

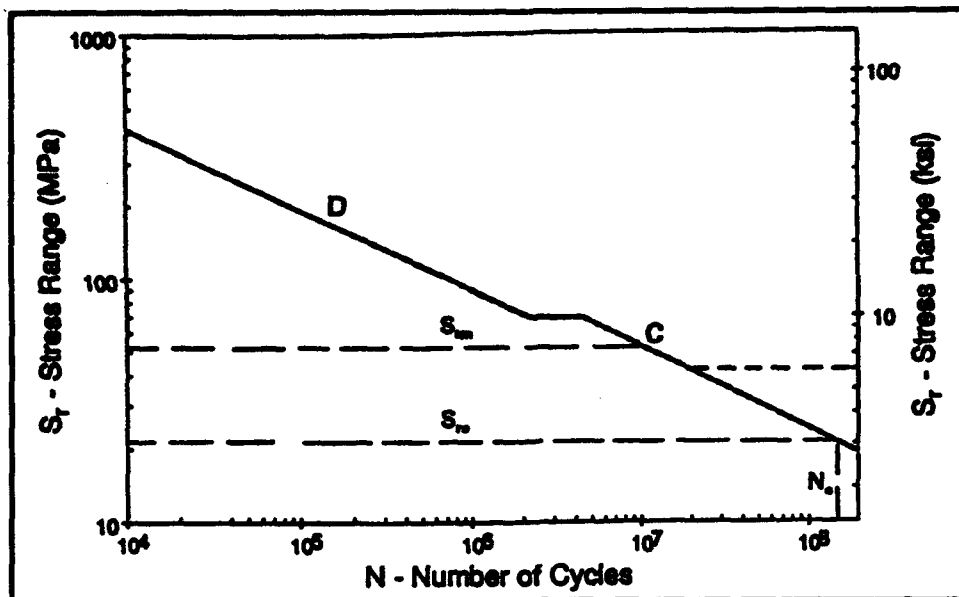
Figure 31. Estimation of fatigue life of riveted spillway gates members

Figure 31 demonstrates the procedure of estimating the fatigue life, N_e , of a riveted spillway gate member which is subjected to variable-amplitude stress ranges represented by Figure 29. In this case, the highest stress range, S_{rm} , in the stress-range histogram is greater than 6 ksi, the assumed fatigue limit; eventual fatigue damage may occur. The estimated fatigue life is obtained by locating the intersection of the equivalent stress range, S_{re} , and the extension of the Category C line, as shown in Figure 31 (Keating and Fisher 1989; Fisher et al. 1987).

At the detail to be evaluated, S_{rm} and S_{re} are the highest stress ranges and the equivalent constant-amplitude stress range, respectively.
