CLEAN-COAL TECHNOLOGY BY-PRODUCTS USED IN A HIGHWAY EMBANKMENT STABILIZATION DEMONSTRATION PROJECT

A Thesis

The Ohio State University 1994

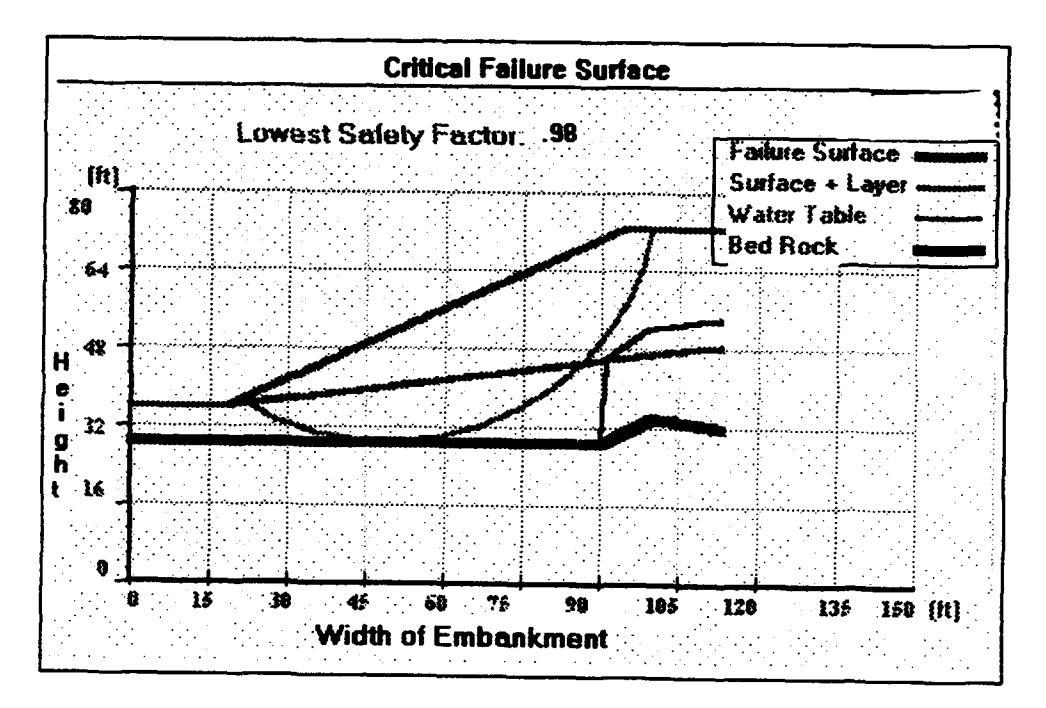
The next scenario involved modifying the existing embankment geometry by adding the effects of an artificial drain. The intent of this exercise was to determine whether the FGD by-product was needed, or whether traditional drain installation would solve the slope stability problem. Figure 3.4 shows the critical failure surface with the input file simulating a drain between the natural soil and the underlying bedrock. There appears to be no difference in the predicted critical failure surface between this scenario and the original condition.

Figure 3.4. SR 541 Embankment, Original Profile, Simulated Drain.

The significant information to be gained from this scenario is that removing the material, installing a drain, and replacing the original material to form the identical embankment would do very little for the long-term stability of the slope. If the friction angle of the natural soil is left as zero, then all of the soil's strength must be due to cohesion, which is unaffected by the lowering of the water table. The calculated factor of safety for this scenario, 0.98, is virtually the same as the factor of safety calculated for the previous scenario, 0.95. The slight difference in the values may be attributable to the program generating incrementally different failure surfaces due to the reconfiguration of the input file. It should be noted that the excavation and reconstruction labor costs associated with stabilizing this embankment are relatively independent of which material is chosen for the reconstruction effort.

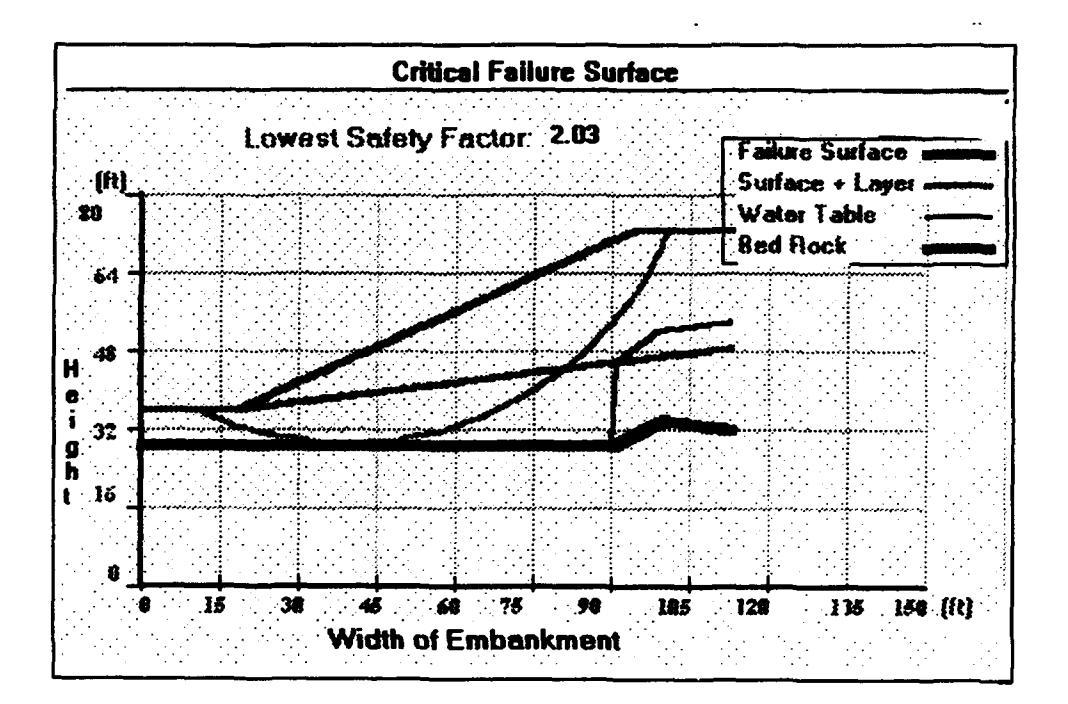
it is possible that the clay-based select material could become saturated and degrade in strength. The calculated factor of safety would continue to approach one as the strength parameters of the borrow decreased, eventually falling below one and failing. This may be a logical explanation for what actually occurred and why the embankment lasted for approximately 20 years without serious incident.

Figure 3.5. SR 541 Embankment, Original Profile, Drained Condition.

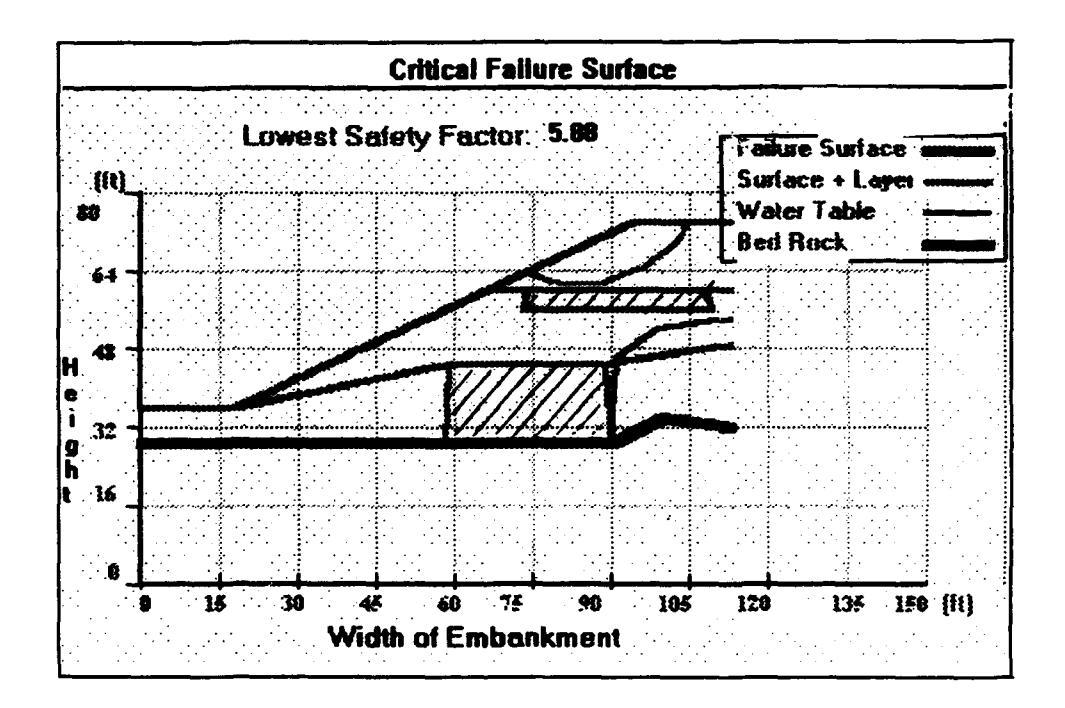
Figure 3.6. SR 541 Embankment, FGD By-Product Reinforcement, Critical Failure.

The friction angle for the natural material was left as zero and the embankment material was assigned its original material properties. The layer atop the second buttress was a combination of crushed shale and select borrow and was given material properties similar to the embankment material. The assigned values proved to be sufficient, as numerous trials showed the shale layer had little effect on the overall embankment stability. The effect of the FGD by-product reinforcement system can best be viewed as Figure 3.7.
