FEAP-TR-FM-94/09
June 1994

Demonstration of a Field Rehabilitation Technique for Removing Corrosive Solder Flux in Cold Water Copper Piping Systems

by
O.S. Marshall, V.L. Van Blaricum, R.H. Knoll, V.F. Hock, and J.R. Myers
U.S. Army Construction Engineering Research Laboratories
Champaign, IL 61826-9005

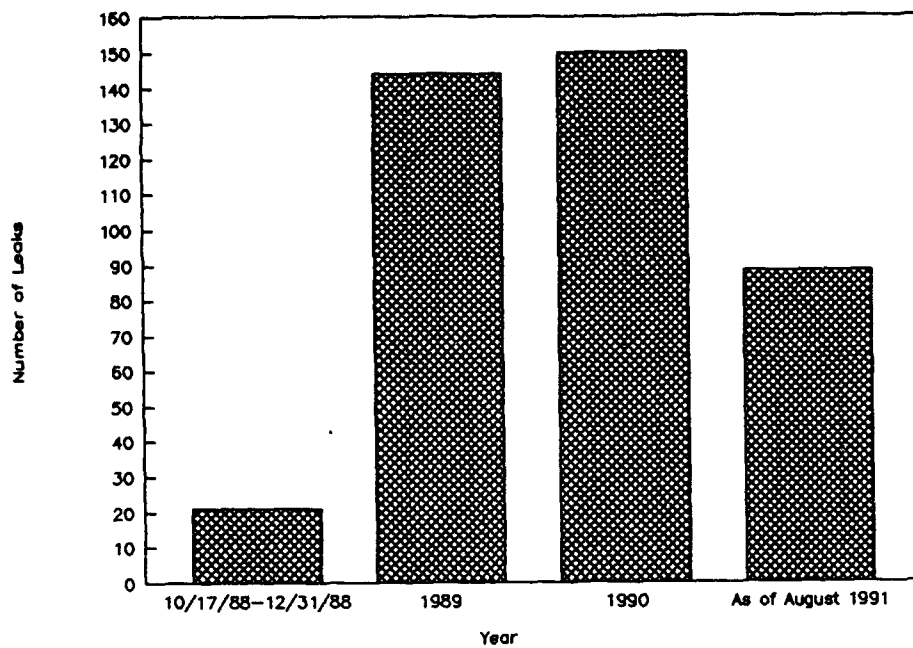
Figure 8. Total Number of Leaks per Year for Series 6900.

During the return trip to Fort Stewart in August 1991, data from service calls for leak repairs from buildings in series 6900 through 7400 were collected. Table 2 lists the age of each series. The data spanned the period from October 17, 1988 to August 1991. This data was then analyzed for the first five buildings used in the demonstration field test searching for their leak history and also the total number of leaks experienced by the building series during the 4 years. A plot of the number of leaks versus time shows that the number of leaks in 1990 was greater than 1989. Based on the data through August, it is believed that the number of leaks in 1991 will be greater than in 1990. Figures 8 through 13 show the number of leaks for each building series. The fact that the number of leaks at Fort Stewart is growing each year indicates that solder flux corrosion is still a major problem. When the age of building series is compared to the number of service calls for leaks it can be seen that the older series, such as the 7300's and 7400's, has the largest number of leaks per month. Figures 14 through 19 show the frequency of service calls for each building series.

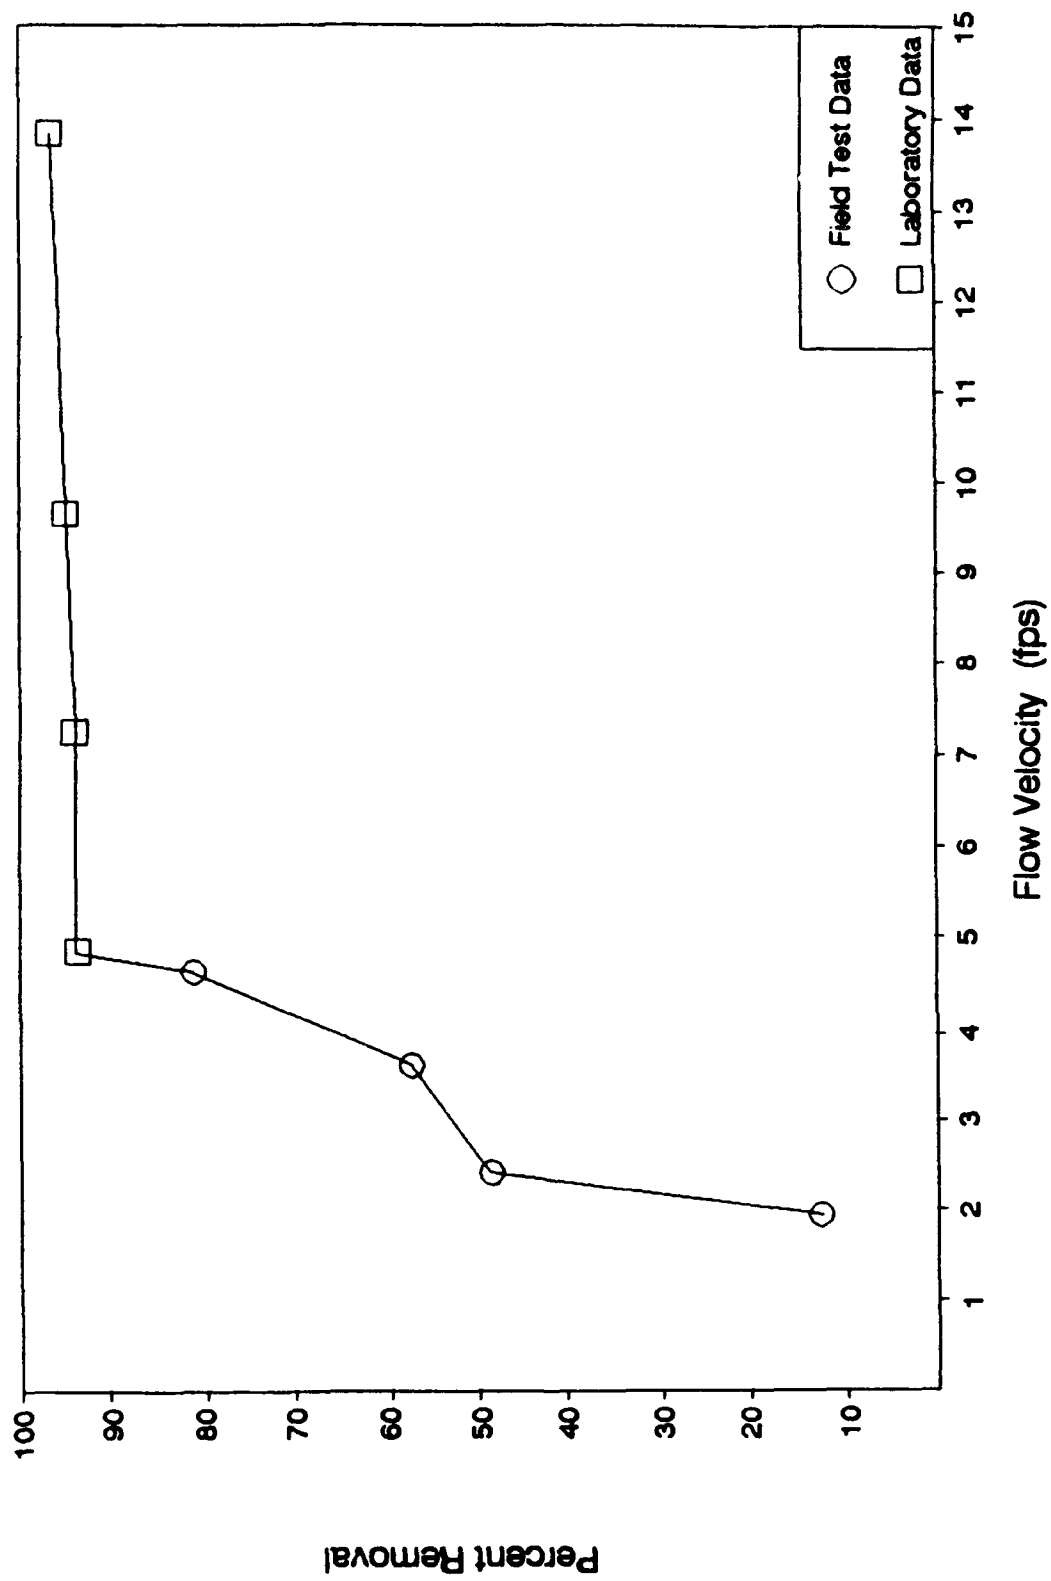
Figure 37. Chloride Removal Versus Flow Velocity.

1. Due to boiler capacity limitations, the velocities used in the laboratory could not be reproduced in the field (as seen in the results presented in Figure 37).

2. The joints tested in the laboratory were assembled days or weeks before flushing. The joints in the field had been in use for approximately 12 years. It is believed that aging of the flux and presence of corrosion products could affect the rate of chloride ion removal.

3. The laboratory test loops were constructed with a controlled amount of soldering flux. Obviously, the systems in the field were not constructed under controlled conditions, and the amount of flux in pipe specimens may have varied greatly.
