DOT/FAA/CT-90/10

Fuselage Burnthrough from Large Exterior Fuel Fires

July 1994

Final Report

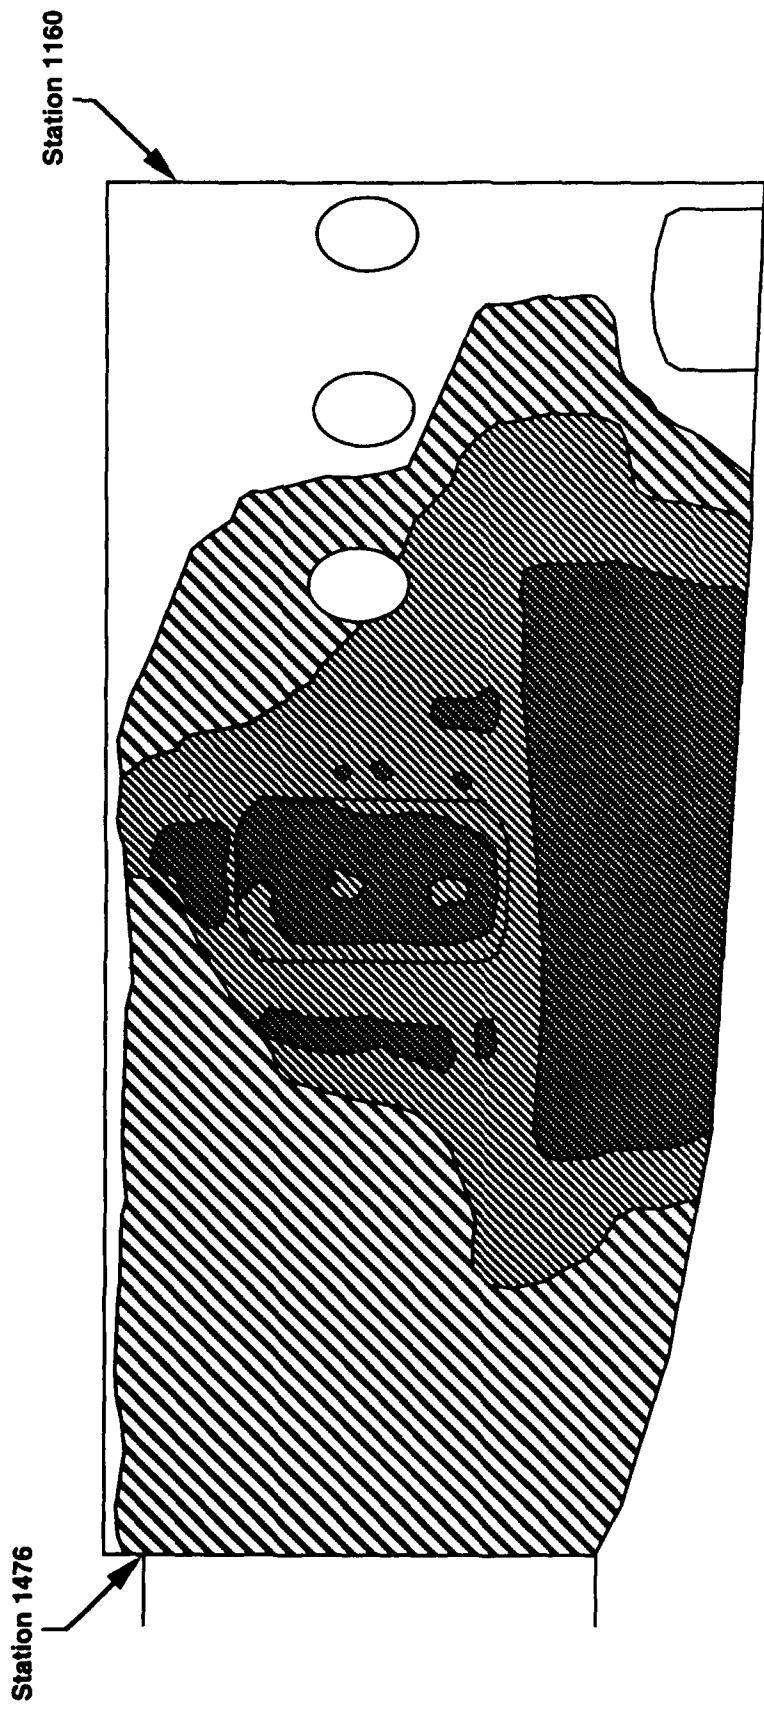
FIGURE A-8. TEST 1 EXTERIOR FIRE DAMAGE, AFT SECTION FUSELAGE STARBOARD SIDE

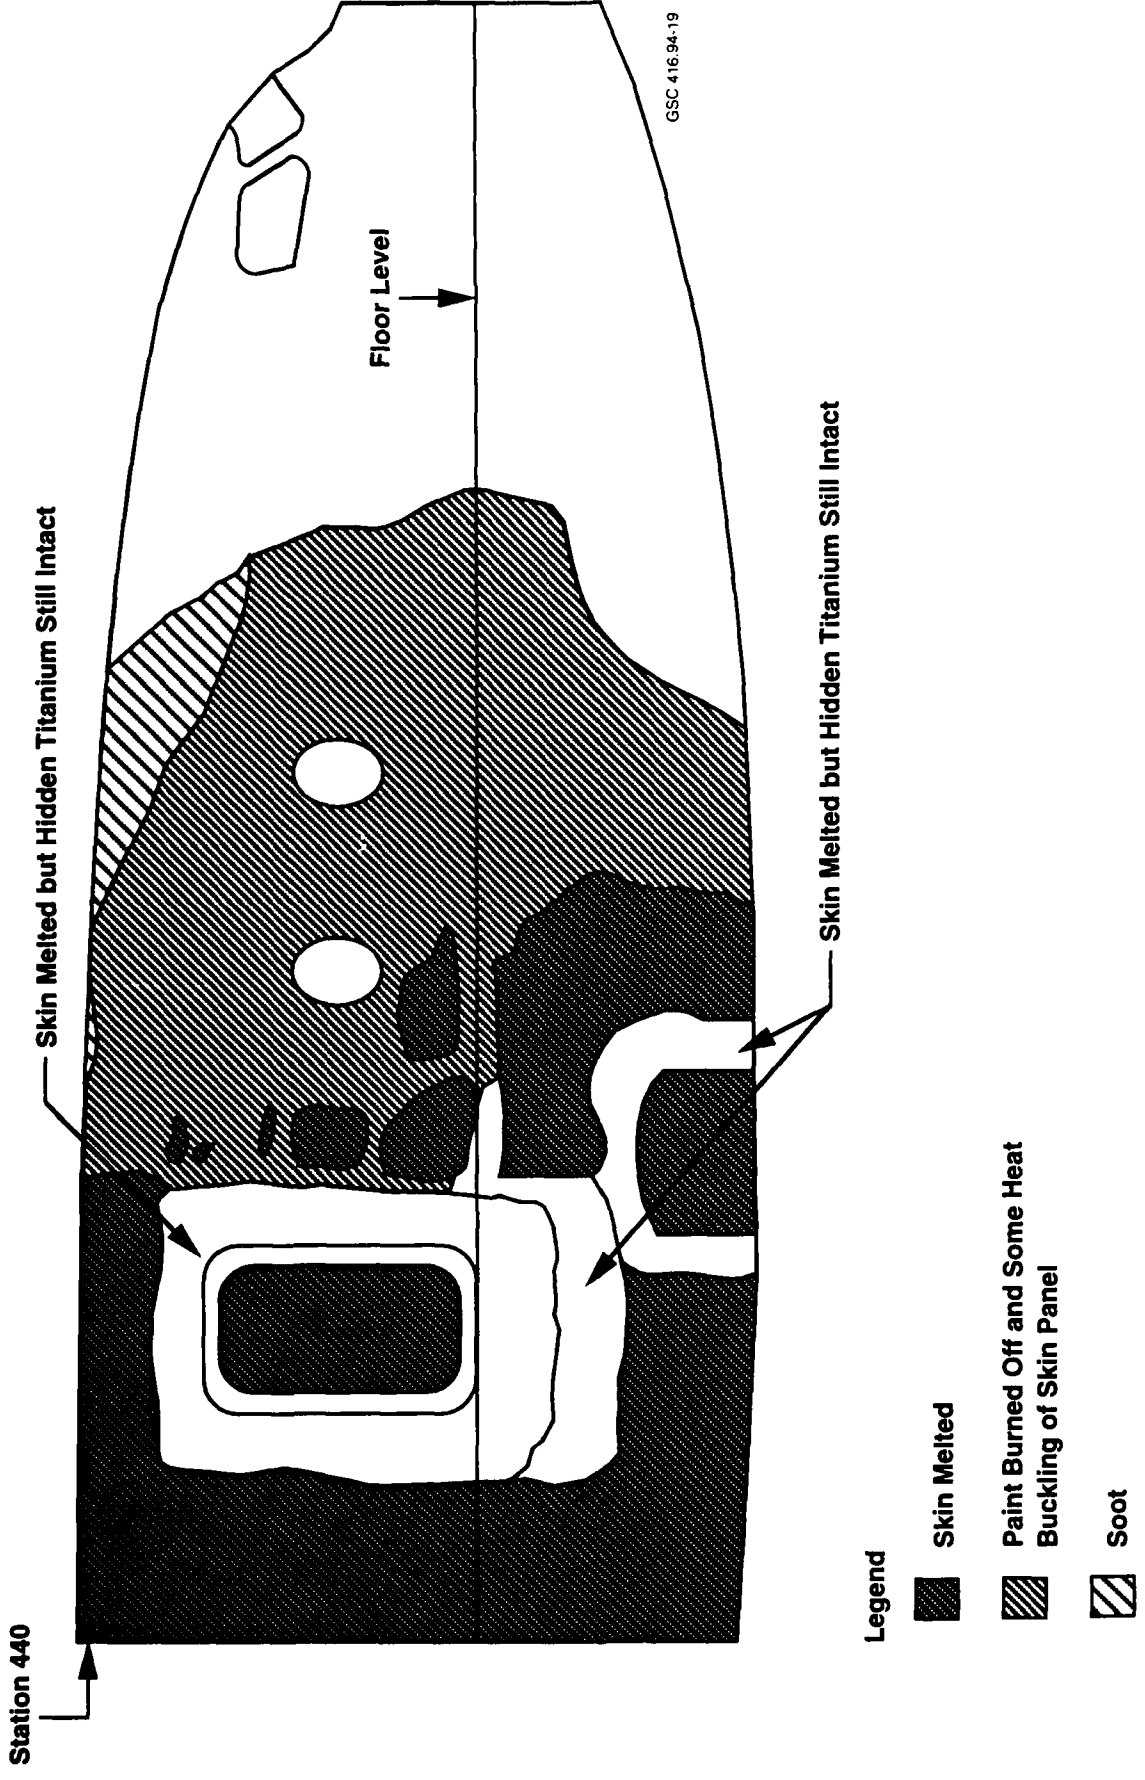
FIGURE B-8. TEST 2 EXTERIOR FIRE DAMAGE DIAGRAM, FORWARD FUSELAGE STARBOARD SIDE

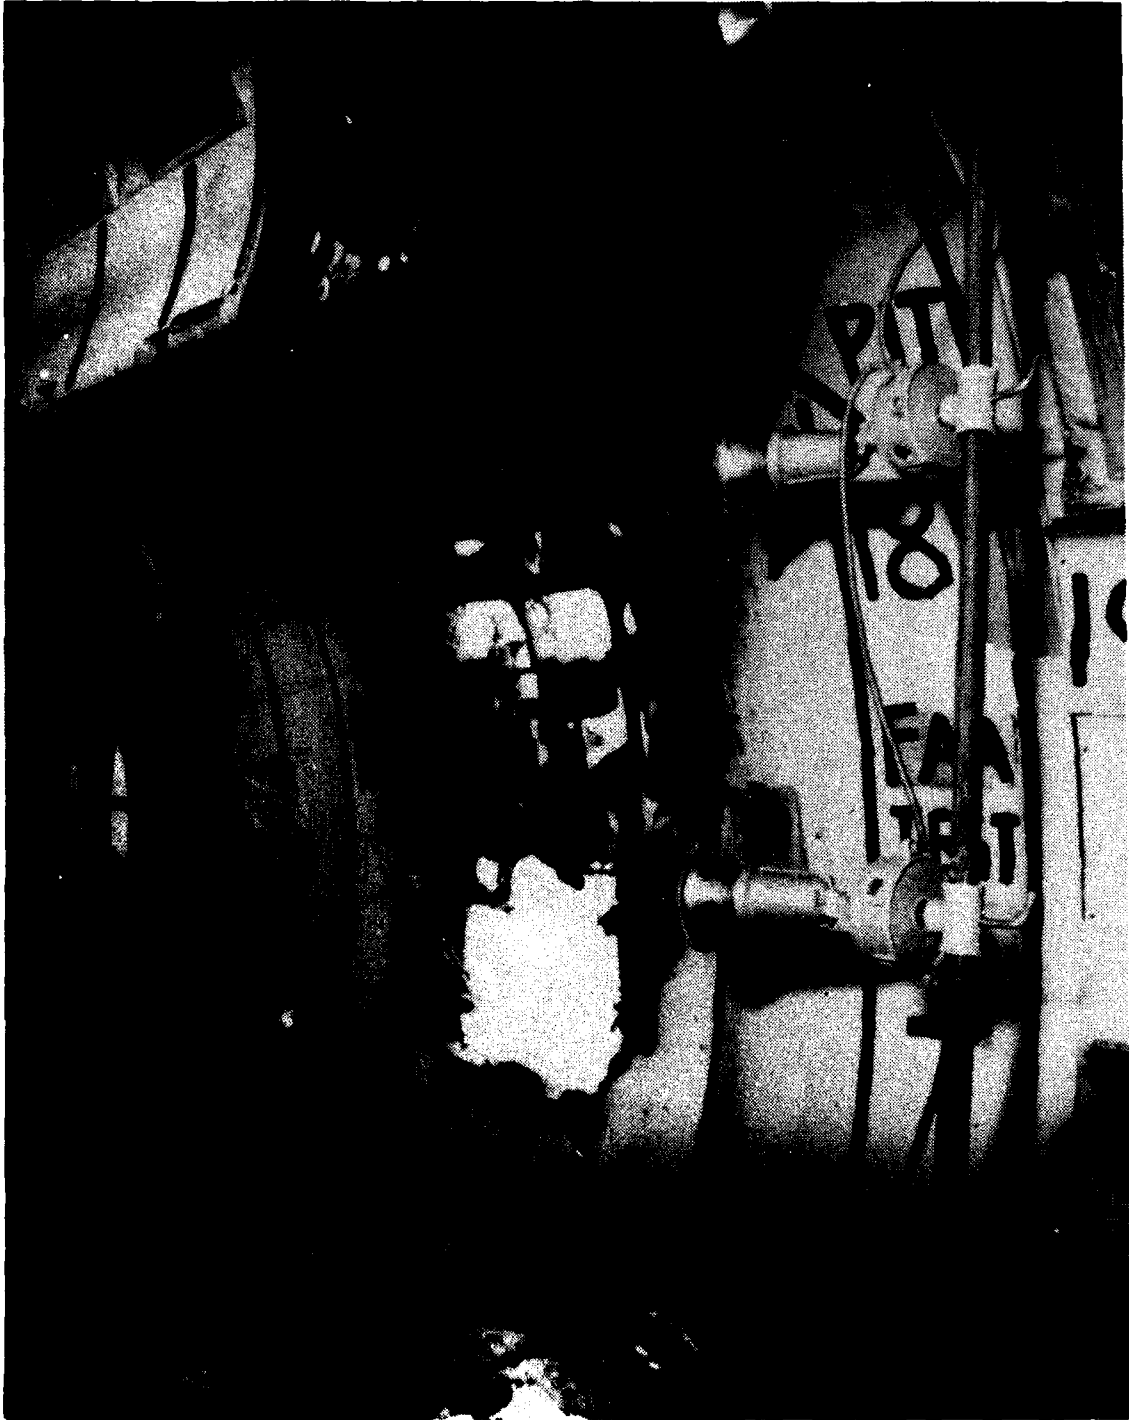
FIGURE B-10. TEST 2 CABIN INTERIOR STARBOARD SIDE SERVICE DOOR

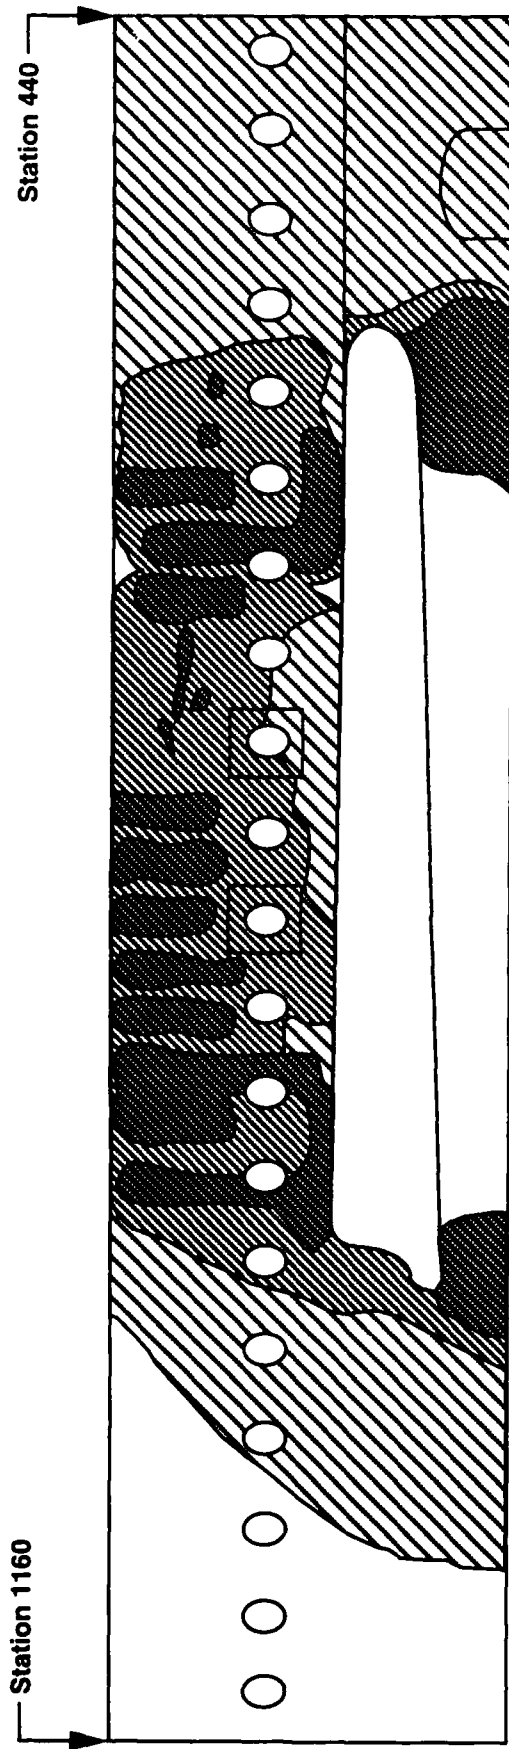
FIGURE C-7. TEST 3 EXTERIOR FIRE DAMAGE, CENTER SECTION FUSELAGE STARBOARD SIDE

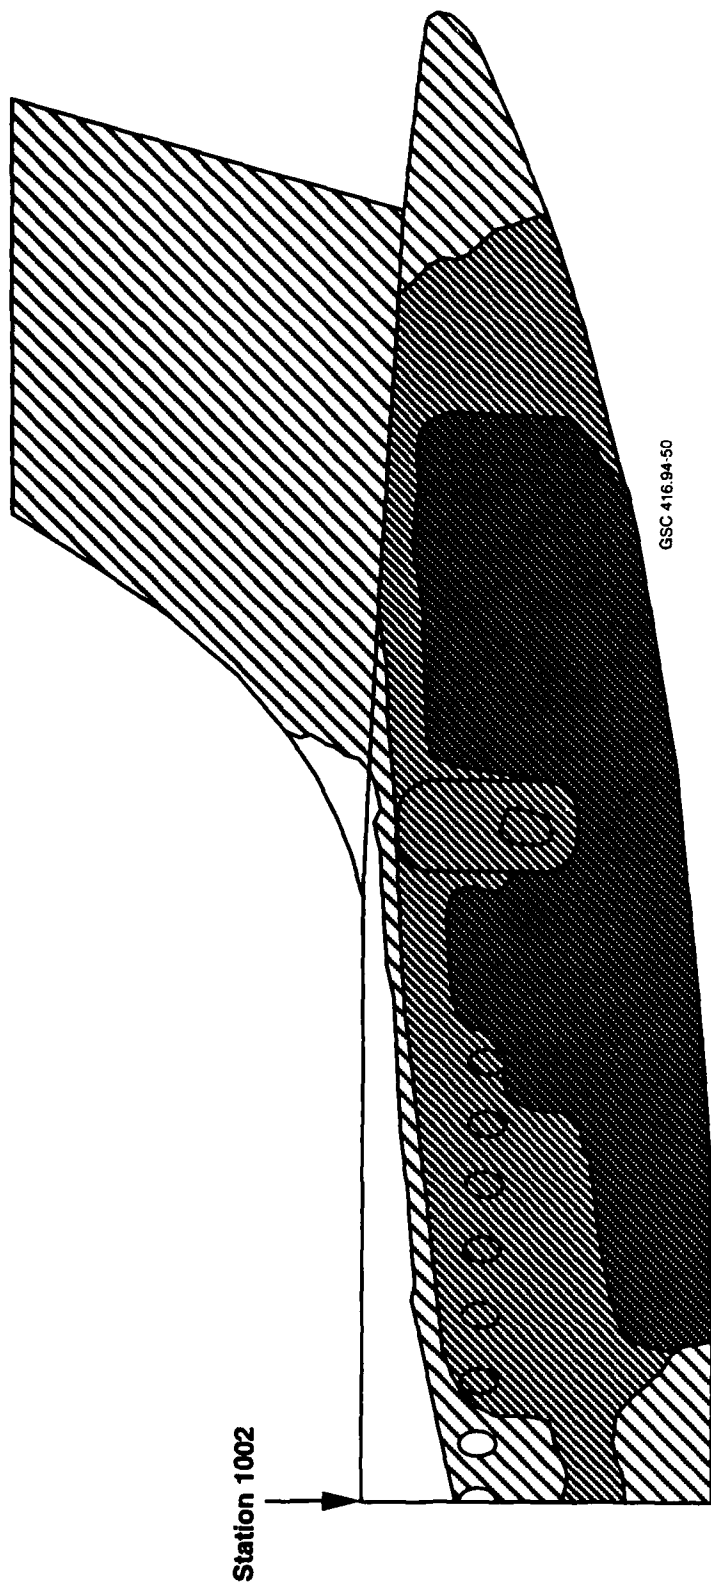
FIGURE D-16. TEST 4 EXTERIOR FIRE DAMAGE, AFT SECTION FUSELAGE PORT SIDE

Paint Burned Off and Some Heat Buckling of Skin Panel

Soot

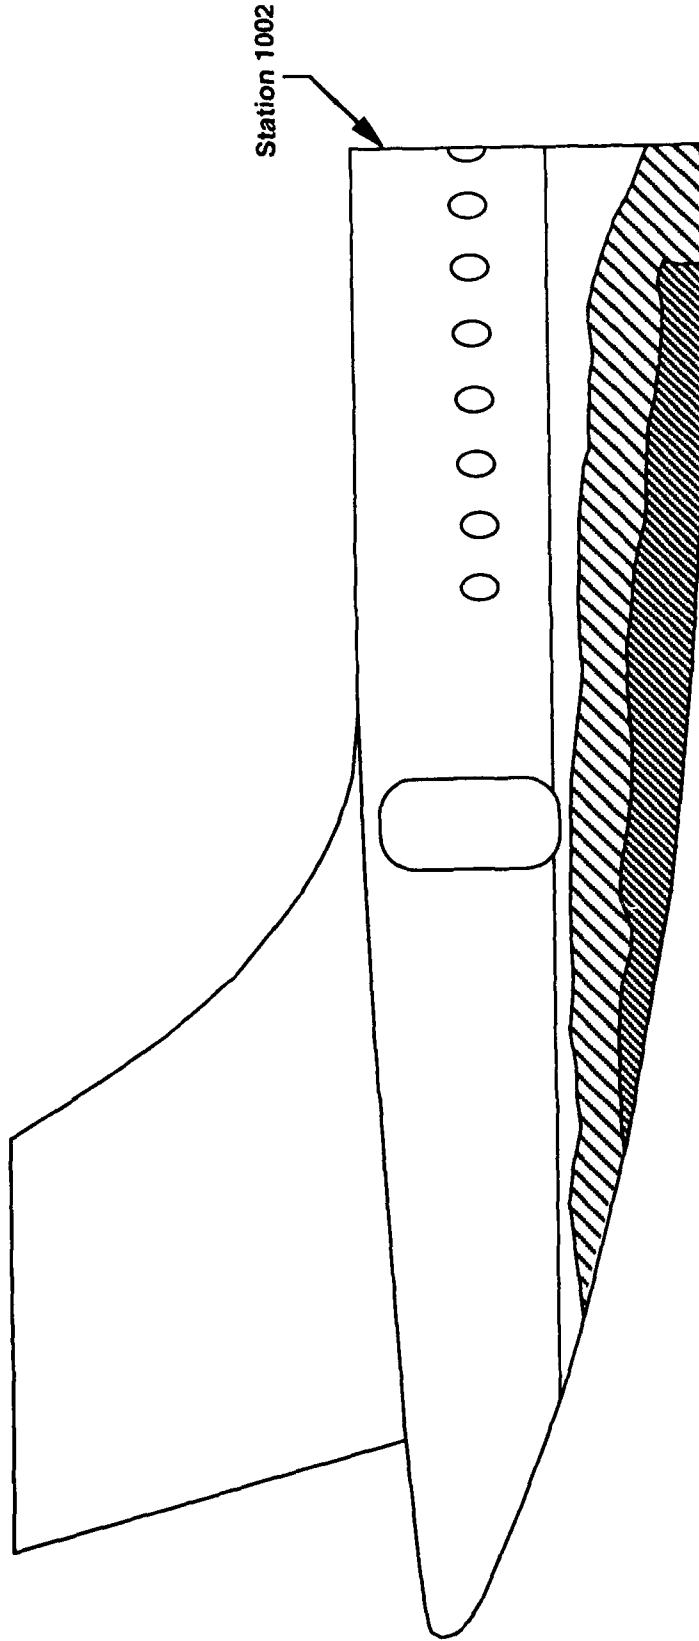
FIGURE D-17. TEST 4 EXTERIOR FIRE DAMAGE AFT SECTION FUSELAGE STARBOARD SIDE

Paint Burned Off and Some Heat
-

Soot

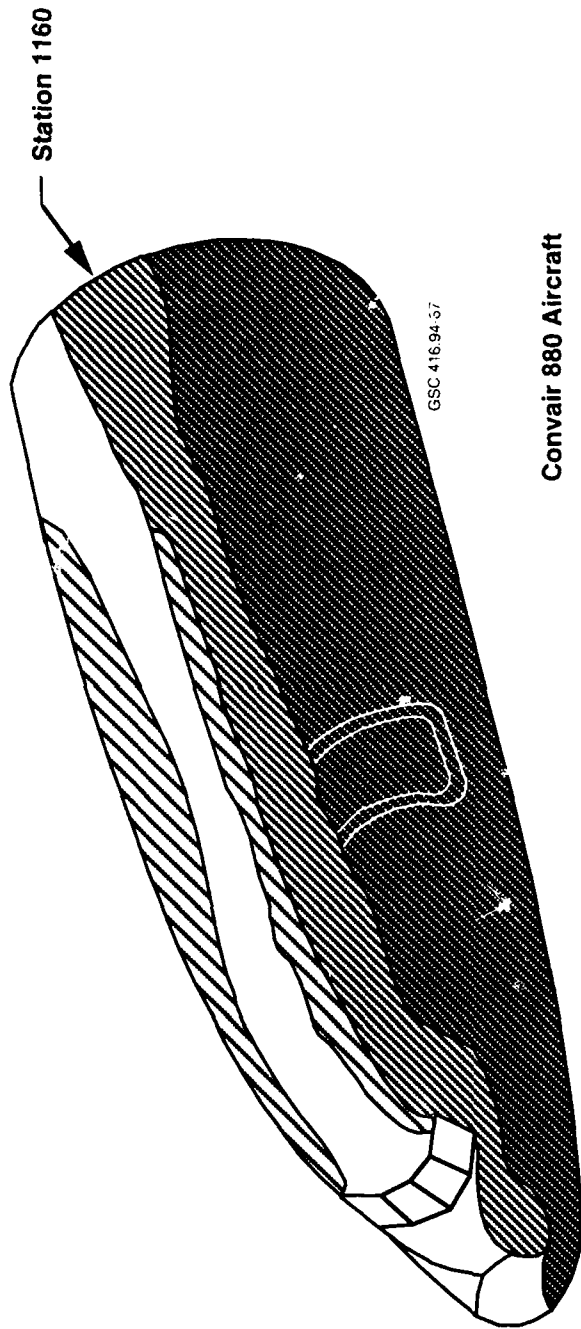
FIGURE E-13. TEST 5 EXTERIOR FIRE DAMAGE, FORWARD SECTION FUSELAGE PORT SIDE

Paint Burned Off and Some Heat

Soot

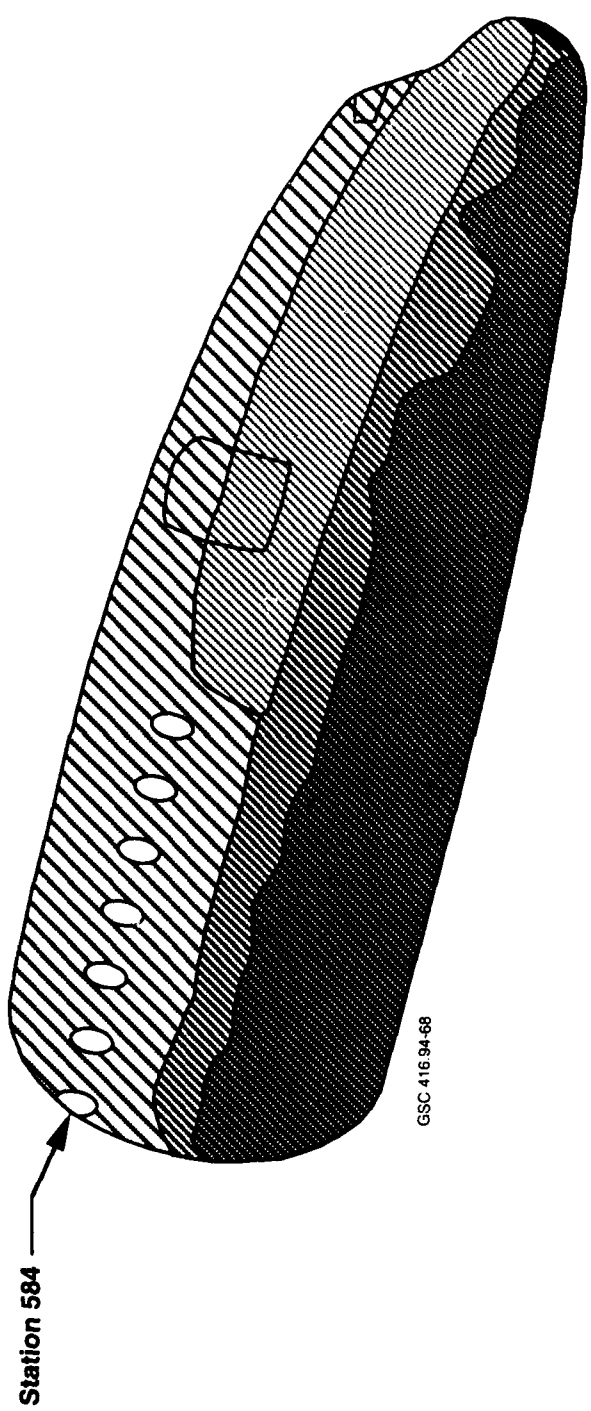
FIGURE E-14. TEST 5 EXTERIOR FIRE DAMAGE, FORWARD SECTION FUSELAGE STARBOARD SIDE

-   Skin Melted
-   Paint Burned Off and Some Heat Buckling of Skin Panel
-

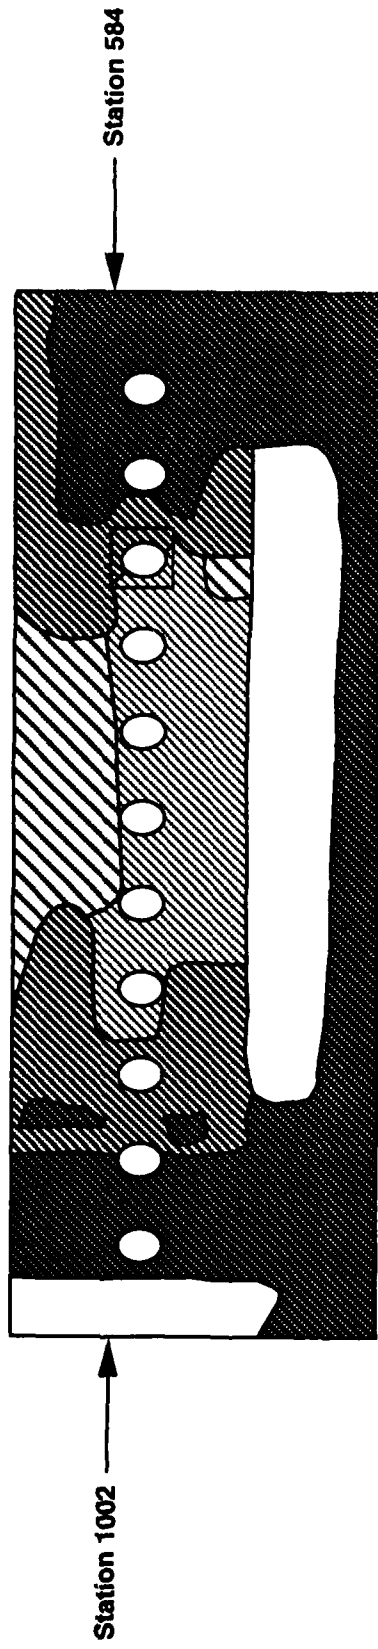
FIGURE F-7. TEST 6 EXTERIOR FIRE DAMAGE, CENTER SECTION FUSELAGE PORT SIDE

- Legend
- Skin Melted
 - ▨ Paint Burned Off and Some Heat Buckling of Skin Panel
 - ▧ Soot
