WL-TR-94-2092

RECIRCULATING CAVITY CASING  
TREATMENT FAILURE

PAUL T. KERNEY  
TEST & EVALUATION SECTION  
TECHNOLOGY BRANCH  
TURBINE ENGINE DIVISION

AUG 1994

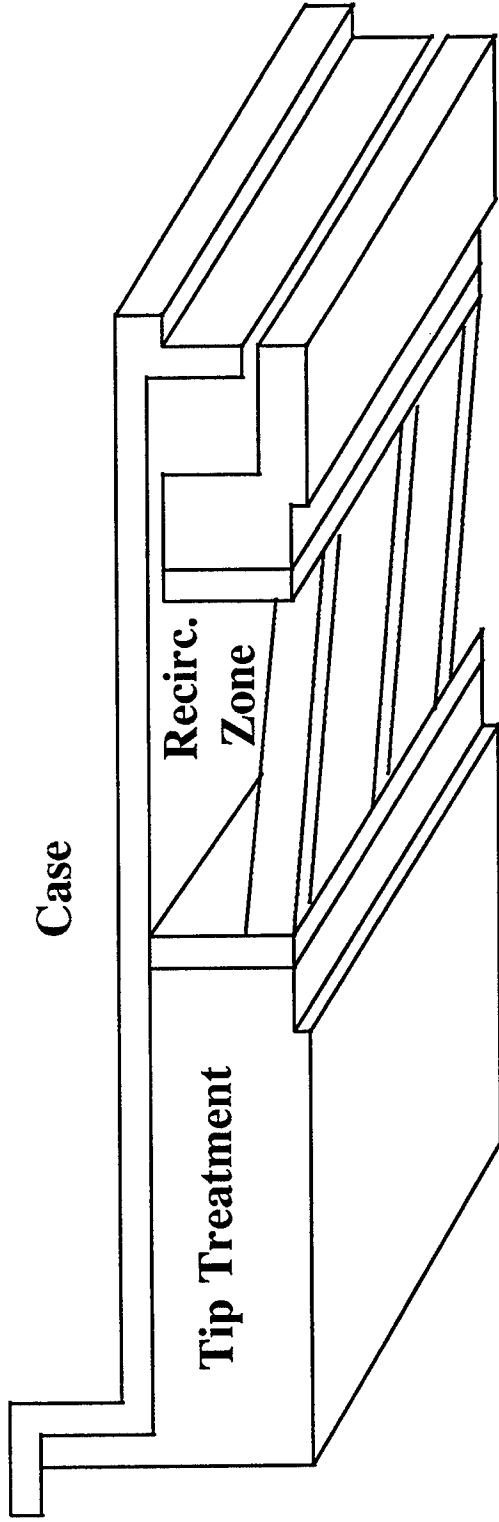
Figure 3 Schematic of Recirculating Cavity Casing Treatment

Angled slots above the first stage rotor tip join the flow path to a circumferentially continuous cavity radially beyond the slots. This is shown schematically in Figure 3. This new concept in casing treatments is made out of 6061-T6 aluminum alloy and provides 0.22-inch "fingers" above the rotor angled 15° to the axial direction. These fingers are also angled 50° to the radial direction and provides a recirculation cavity above the rotor of about 3.5 inches.
