USACERL Technical Report FE-95/04  
November 1994

# **Improving Central Heating Plant Performance at the Defense Construction Supply Center (DCSC)**

## **Advanced Operation and Maintenance Methods**

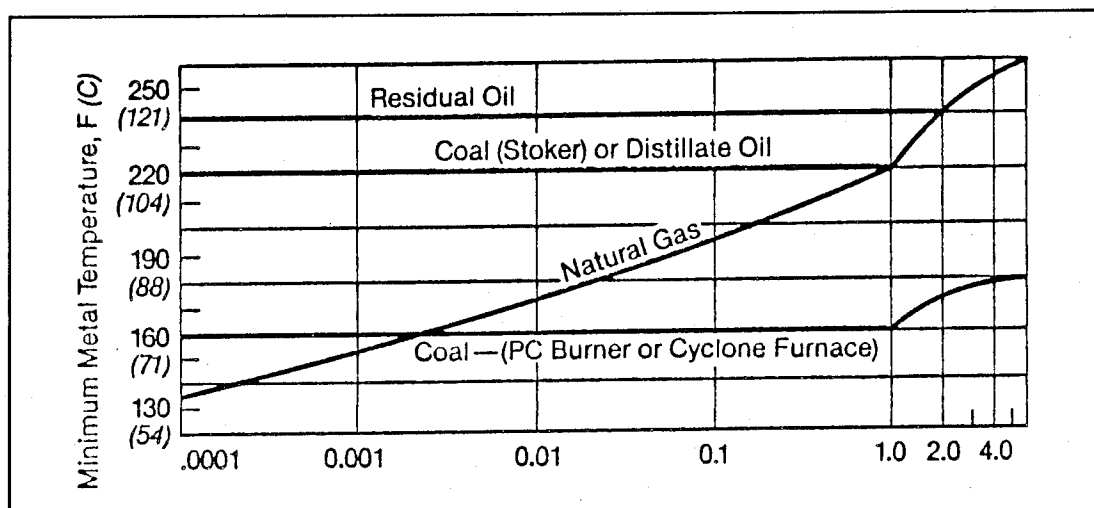
Figure 4. Relationship between sulfur in coal and acid dew point.

Broken discharge wires are caused by corrosion fatigue resulting from frequent operation below the flue gas acid dew point. Figure 4 shows the relationship between sulfur in coal and acid dew point. For test conditions of about 1 percent sulfur coal and 5 percent moisture flue gas, the acid dew point is 287 °F ( $^{\circ}\text{F} = [^{\circ}\text{C} \times 1.8] + 32$ ). The incoming temperature should be about 90 °F above the acid dew point to prevent

corrosion throughout the ESP. The ESP's walls will be much cooler than the center of the gas stream so the inlet gas temperature should be about 377 °F.

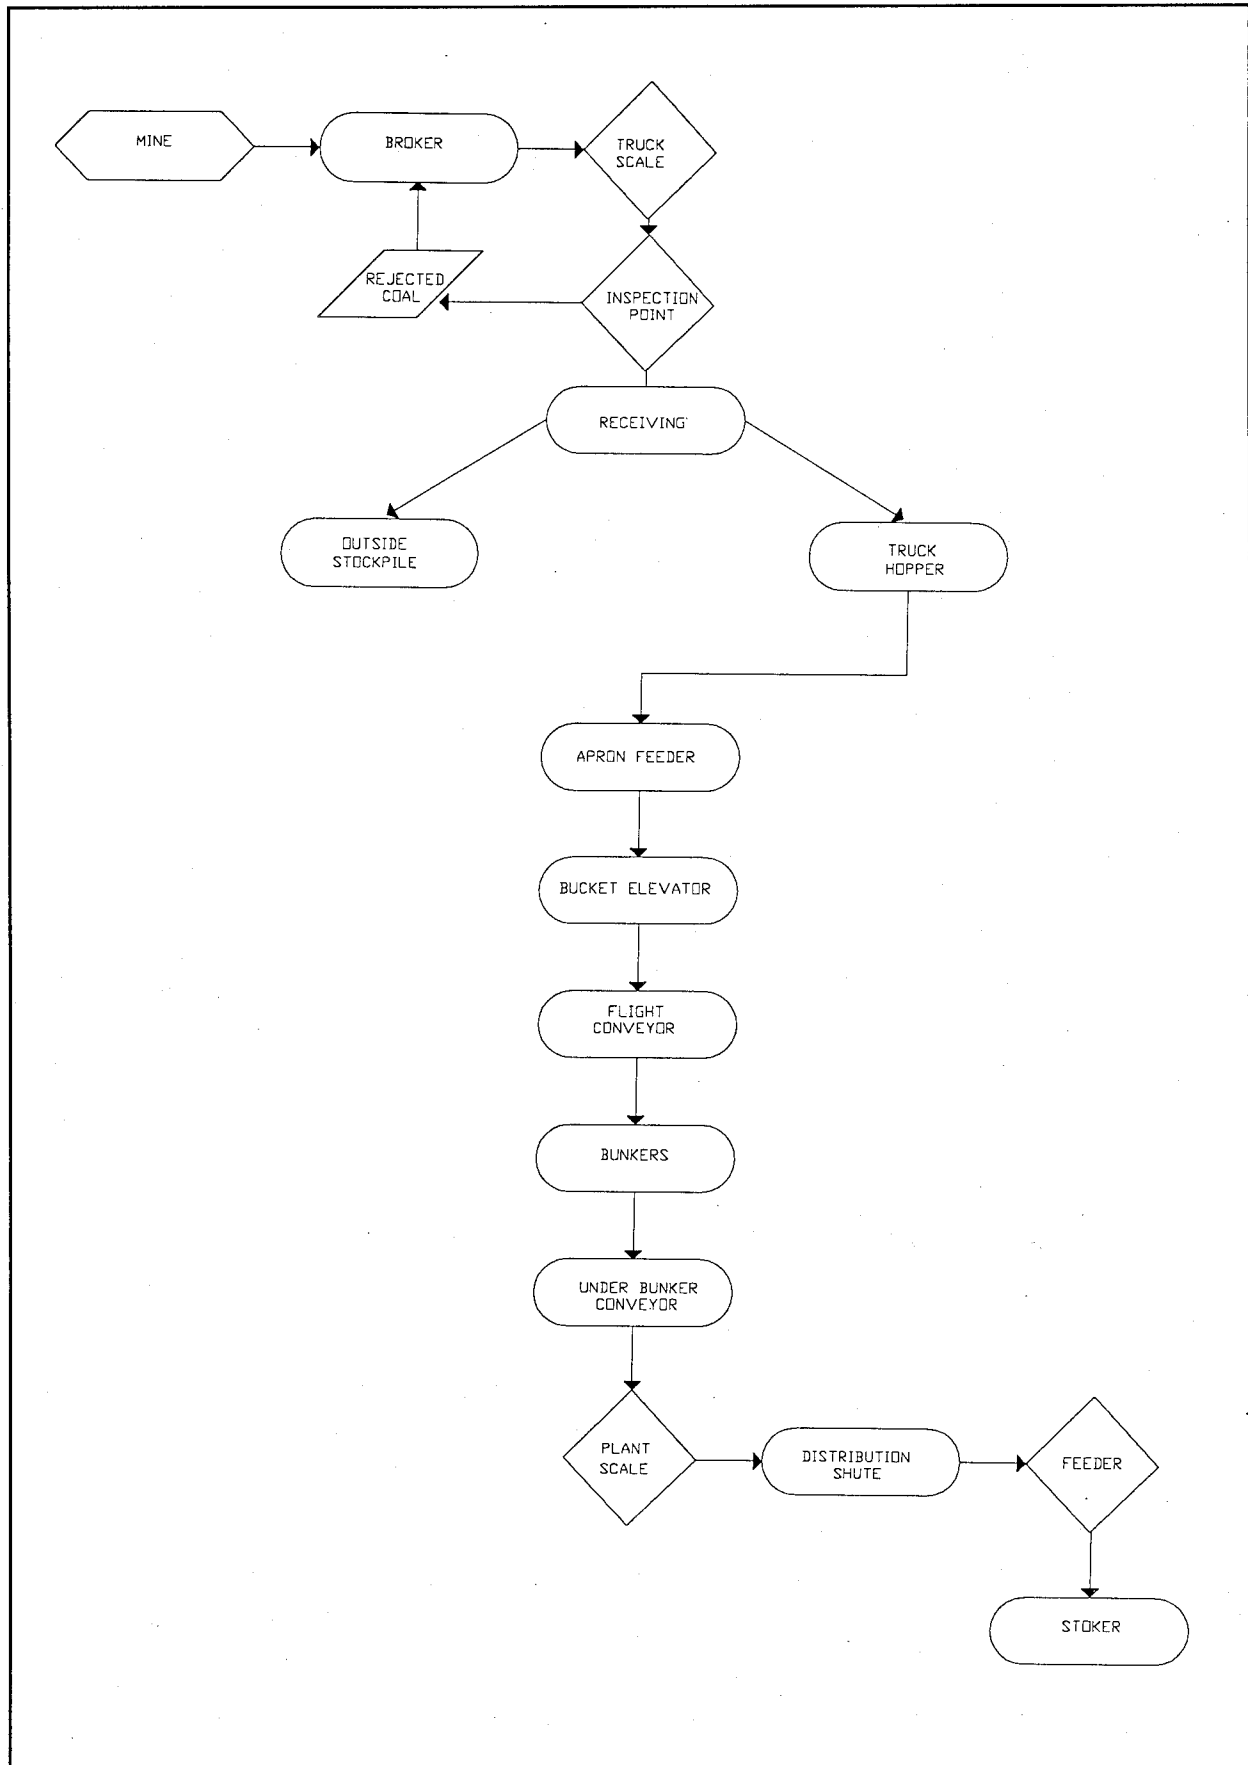
Figure 5. Schematic of DCSC coal storage and handling system.

Figure 5 shows a schematic representation of the DCSC coal storage and handling system. Overall, the coal-handling equipment appeared to be in good working order.

This procedure is not good practice for bituminous stoker coal for several reasons. Piling the coal creates fines by agitation and segregates the coals. As discussed earlier, fines do not burn well in spreader stokers. Segregation occurs because large pieces of coal tend roll to the outside and lower edges of the pile creating areas of small pieces and areas of big pieces. In other words, the coal sizes are not equally distributed in the pile. The coal size distribution delivered to the feeder hopper must meet the specifications required by the stoker.

Second, large piles (over 10 ft tall) tend to spontaneously combust because, as the coal in the middle of the pile oxidizes, the resulting heat cannot dissipate through the thick pile. The heat builds up until the coal begins to burn. DCSC personnel noted that occasional fires are not unusual.

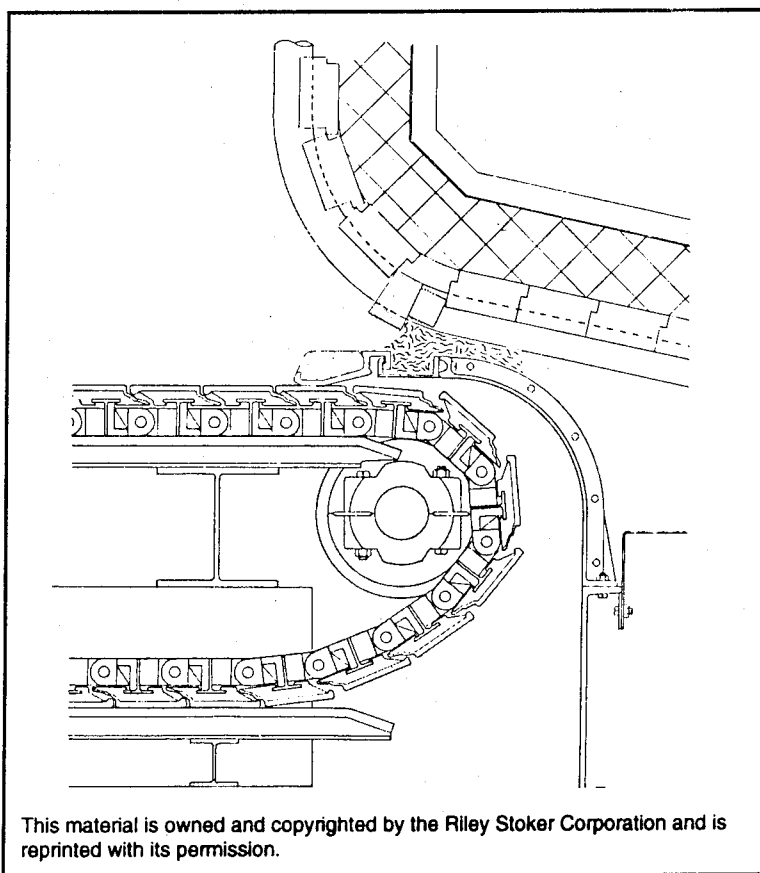
Figure 13. Travel grate details—refractory-filled air seals.

The side air seals were adequate and the stationary castings were in excellent condition. The sealing clips were in very good condition. However, the clips did not

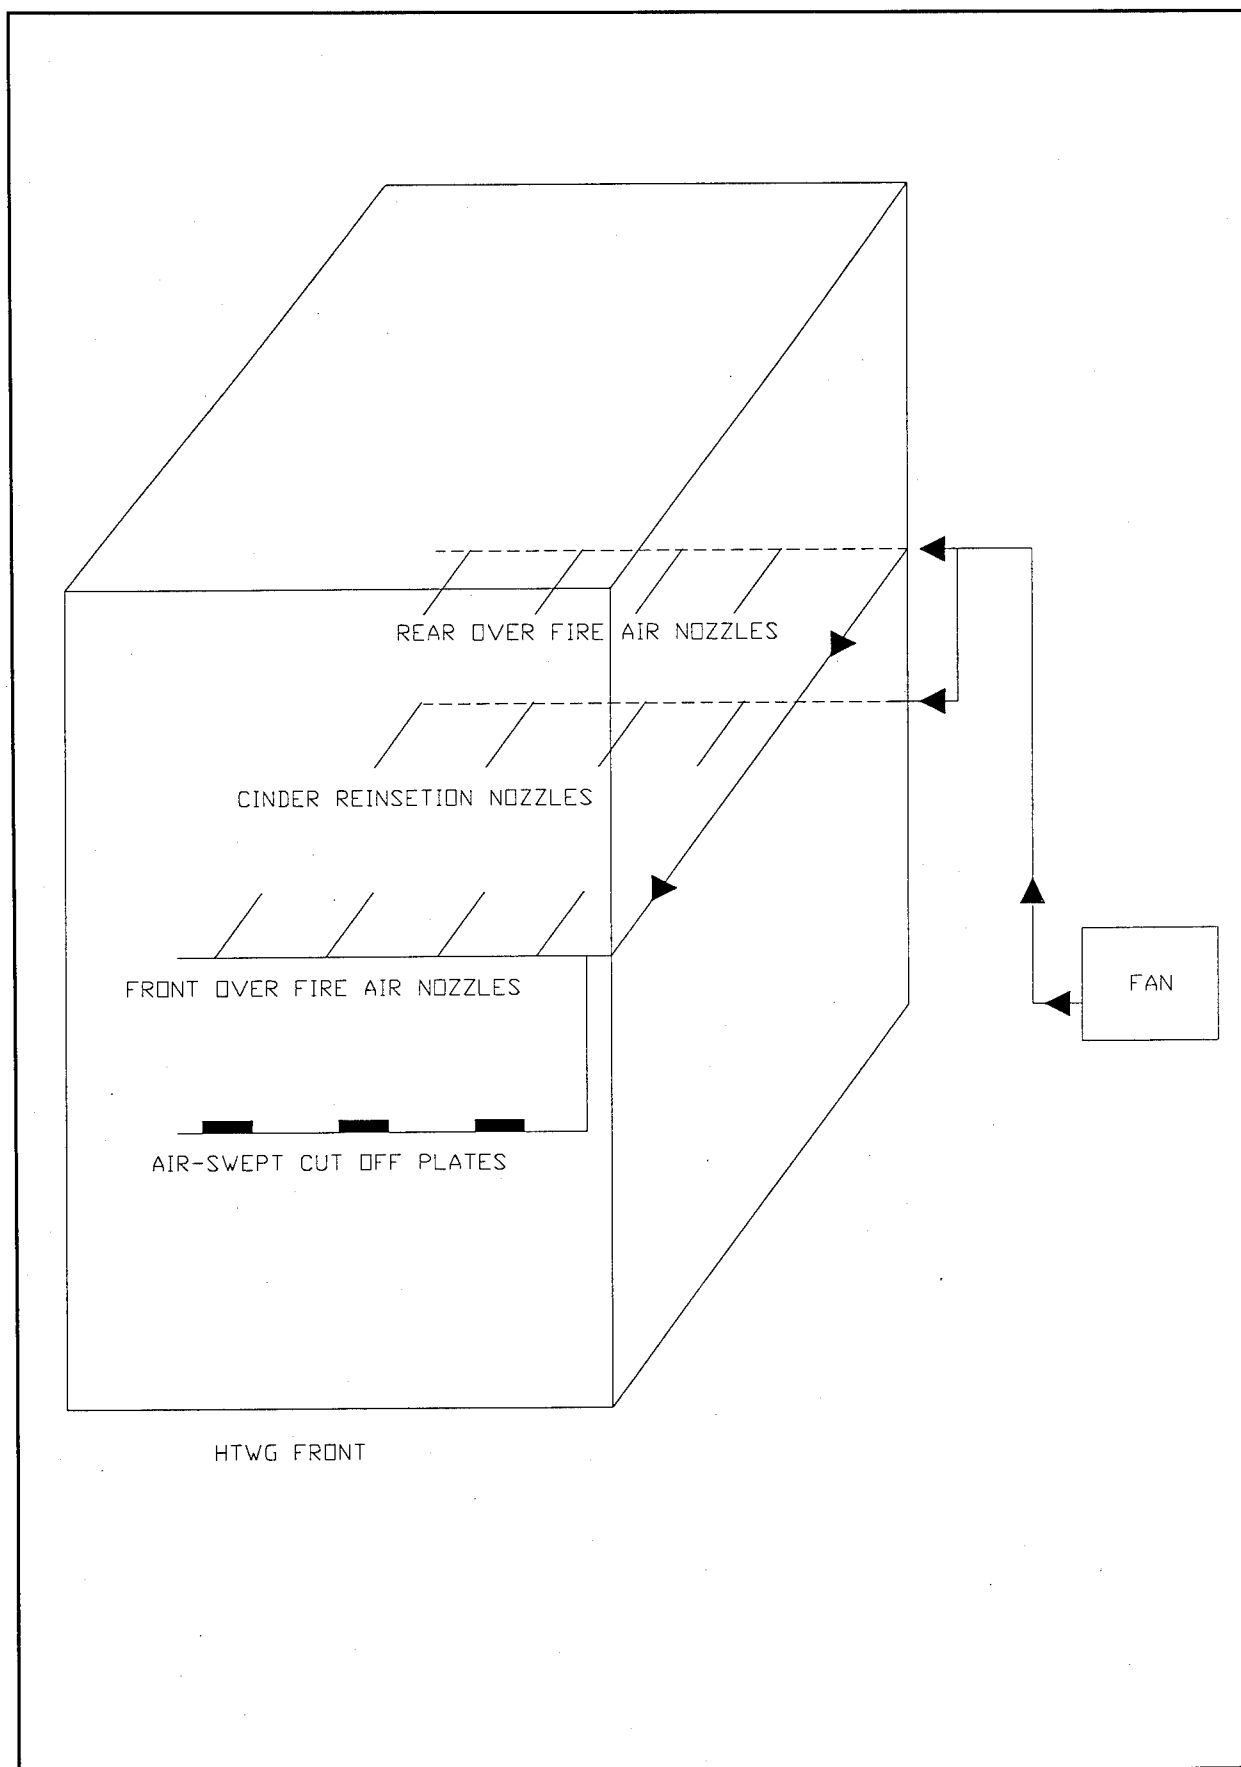
Figure 14. Overfire air system schematic.

The overfire air systems for all three units are identical. Figure 14 schematically represents the overfire air system. Each has a single fan that discharges into two headers. A front header serves the air-swept cut-off plates in each of the three feeders. A rear header serves both the one row of overfire air nozzles and the three cinder reinjection nozzles returning fly-ash from the HTWG last pass hopper to the furnace. The fan produces a maximum of 25 in. static pressure. For maximum effectiveness, the rear overfire air nozzles should have at least 25 in. of static pressure for this furnace design. The ash reinjection nozzles can use about 10 in. of static pressure. Since both are fed from the same header, either one or both, must be compromised. This system should be redesigned to take advantage of newer and more effective designs.

On HTWG no. 2, one of the overfire air lines passing through the hopper was defective. The 2-1/2 in. pipe was broken at a pipe flange and was separated by about 2 in. Because of this leak, about 50 percent of the air supplied by the fan was escaping into the last pass hopper.

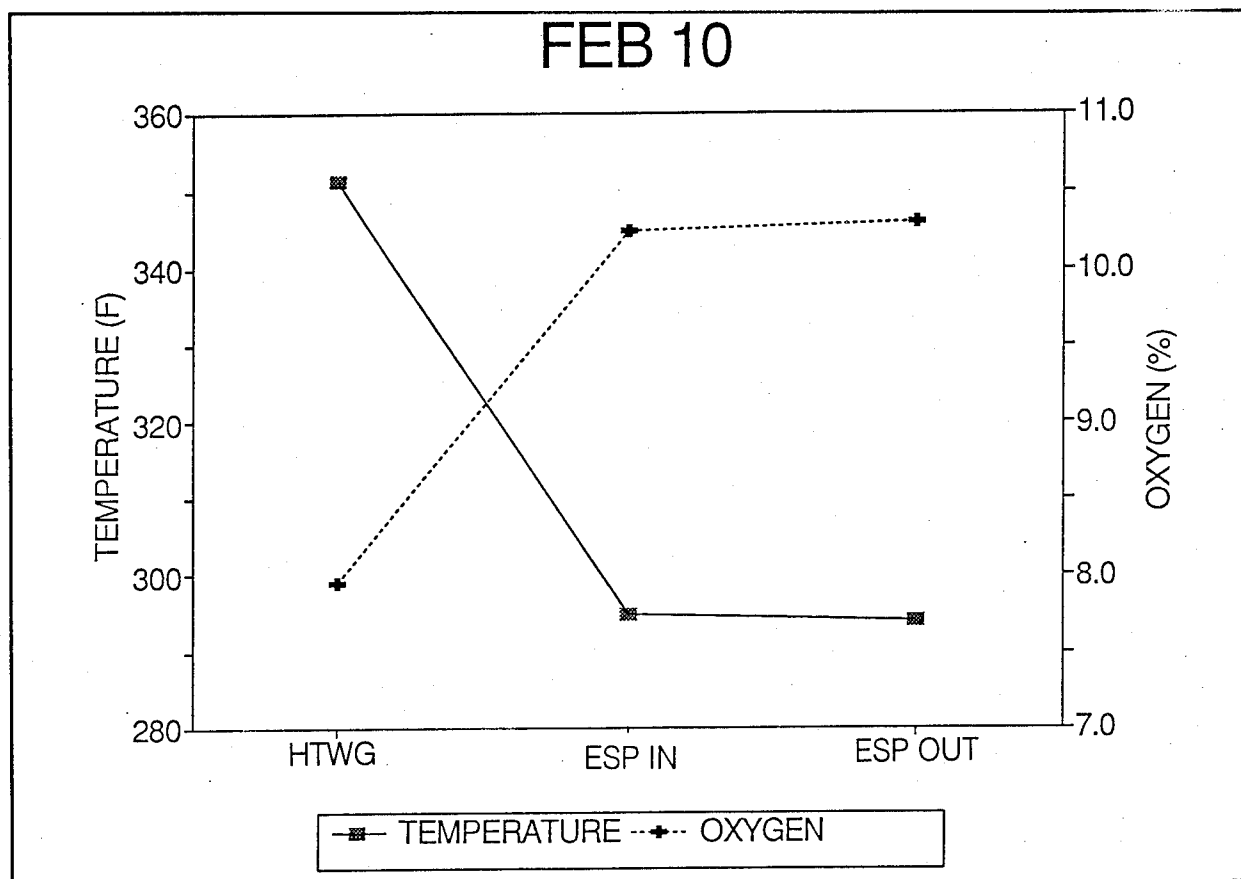
Figure 25. I.D. fan test air infiltration.

Table 13 summarizes the combustion and air infiltration data from the test runs. The average plant output was about 65 MBtu/hr with a combustion efficiency of about 86 percent. Figure 25 shows the air infiltration through the ductwork and ESP. The graph again indicates a significant amount of infiltration between the HTWG and the ESP inlet, caused by leaking bypass dampers and stack caps. The temperature is adequate to protect against acid corrosion.
