Monitoring of the Yaquina Bay Entrance North Jetty at Newport, Oregon; Summary and Results

by *Steven A. Hughes, Terri L. Prickett,
Michael W. Tubman, William D. Corson*

Final report

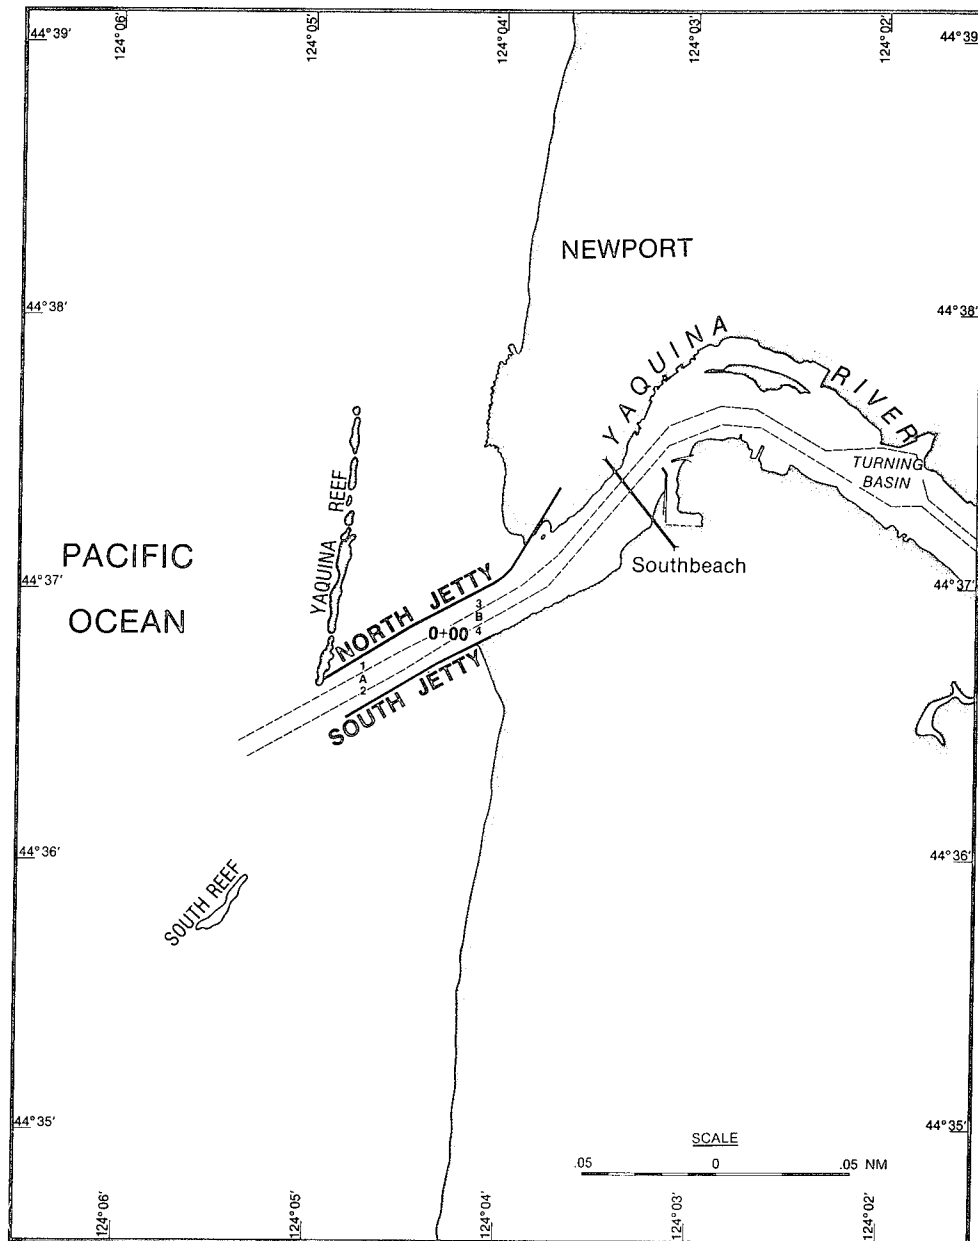
Figure 1. Yaquina Bay navigation channel jetty system¹

Almost immediately after completion of the 1966 north jetty extension, the seaward tip of the north jetty began to unravel under the fury of winter

storms. By 1970 about 95 m (310 ft) had been lost from the tip of the north jetty as waves “beat the structure down below water level.” The partially damaged structure then appeared to reach a somewhat more stable configuration with minimal losses of jetty length occurring over the next several years.

The north jetty was rebuilt to its authorized length in 1978, and it suffered the same fate over the next several winter storm seasons. By 1988 the structure had lost approximately 137 m (450 ft) from the seawardmost tip of the jetty. Meanwhile, the south jetty at Yaquina Bay, which was lengthened in 1972, did not suffer any damage despite being of similar construction, situated at similar depth, and presumably exposed to similar wave conditions.

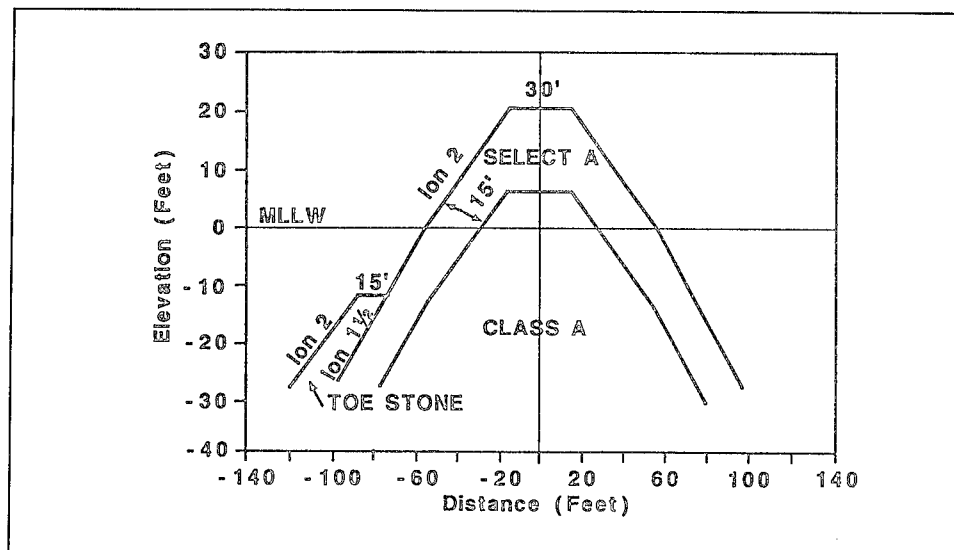
Figure 5. Yaquina Bay north jetty cross section, 1978 rehabilitation

Rehabilitation of the outer 140 m (460 ft) of the Yaquina Bay north jetty was authorized in 1976 and work was completed in September 1978 at an estimated cost of \$4,400,000. Figure 5 shows the jetty cross section as designed for this rehabilitation. The class "A" core stone averaged 12.2 tonnes (13.5 tons) with minimum size of 9.2 tonnes (10.1 tons), and the select class "A" stone averaged 18 tonnes (19.8 tons) (minimum 13.5 tonnes (14.9 tons)), which was reduced from the armor stone size used on the 1966 jetty extension. The design wave height for this rehabilitation of the north jetty was 6.2 m (20.2 ft). In addition, a 4.6-m-wide (15-ft-wide) berm at -3 m (-10 ft) mllw was added to the channel side of the jetty, as shown on Figure 5.

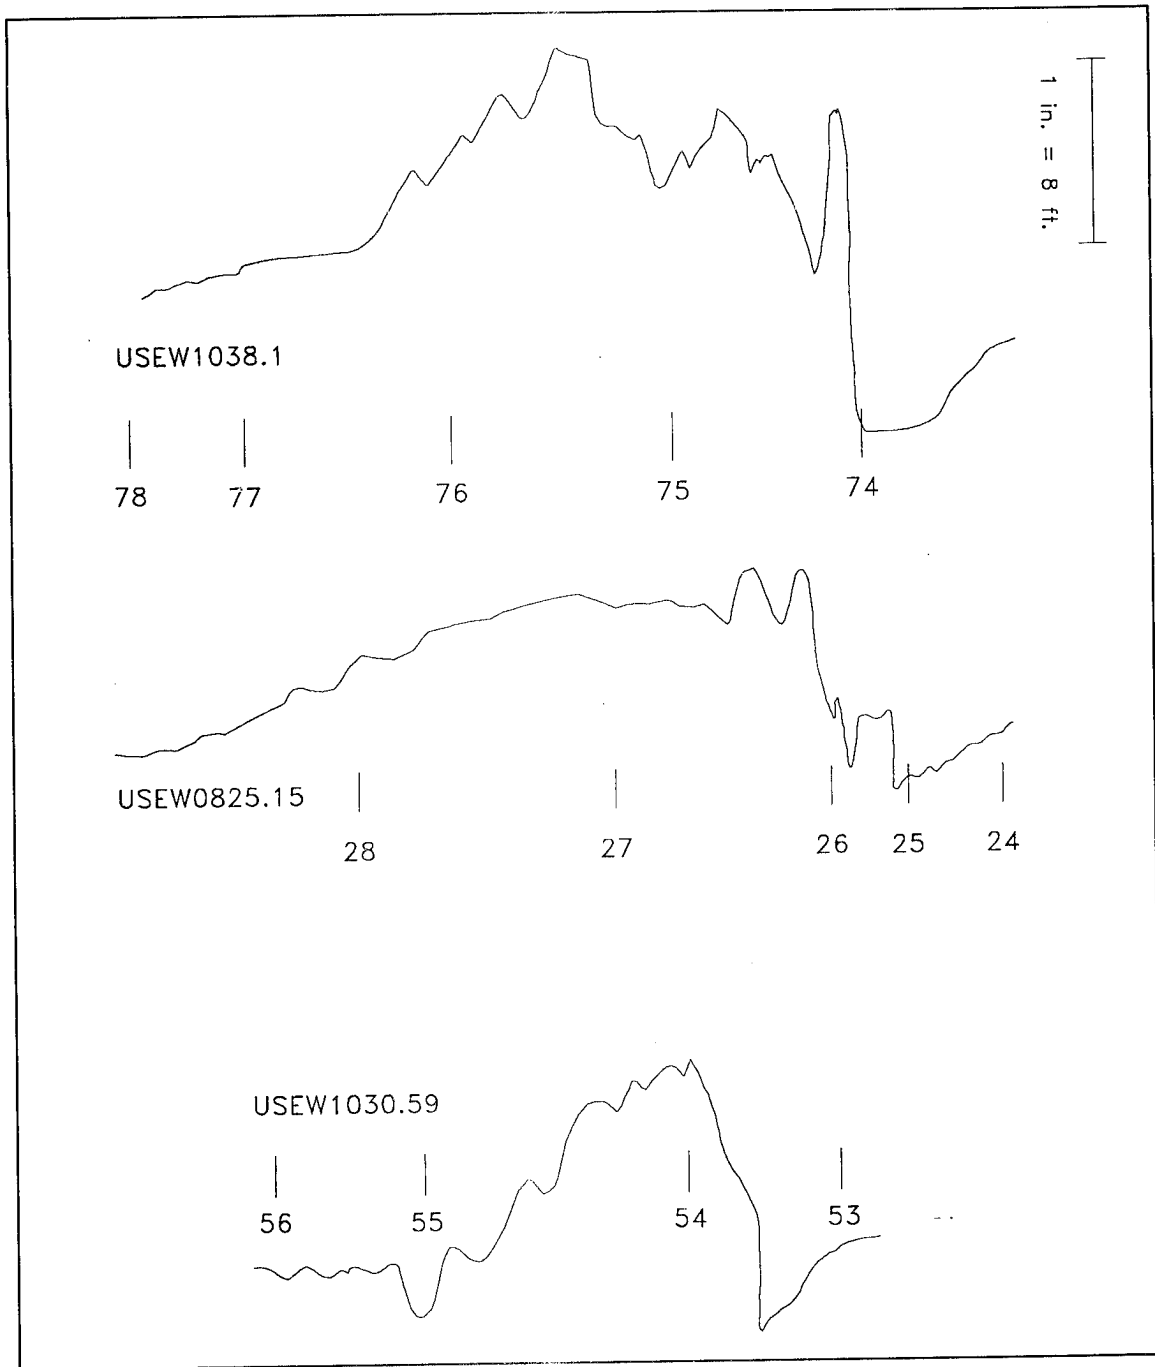
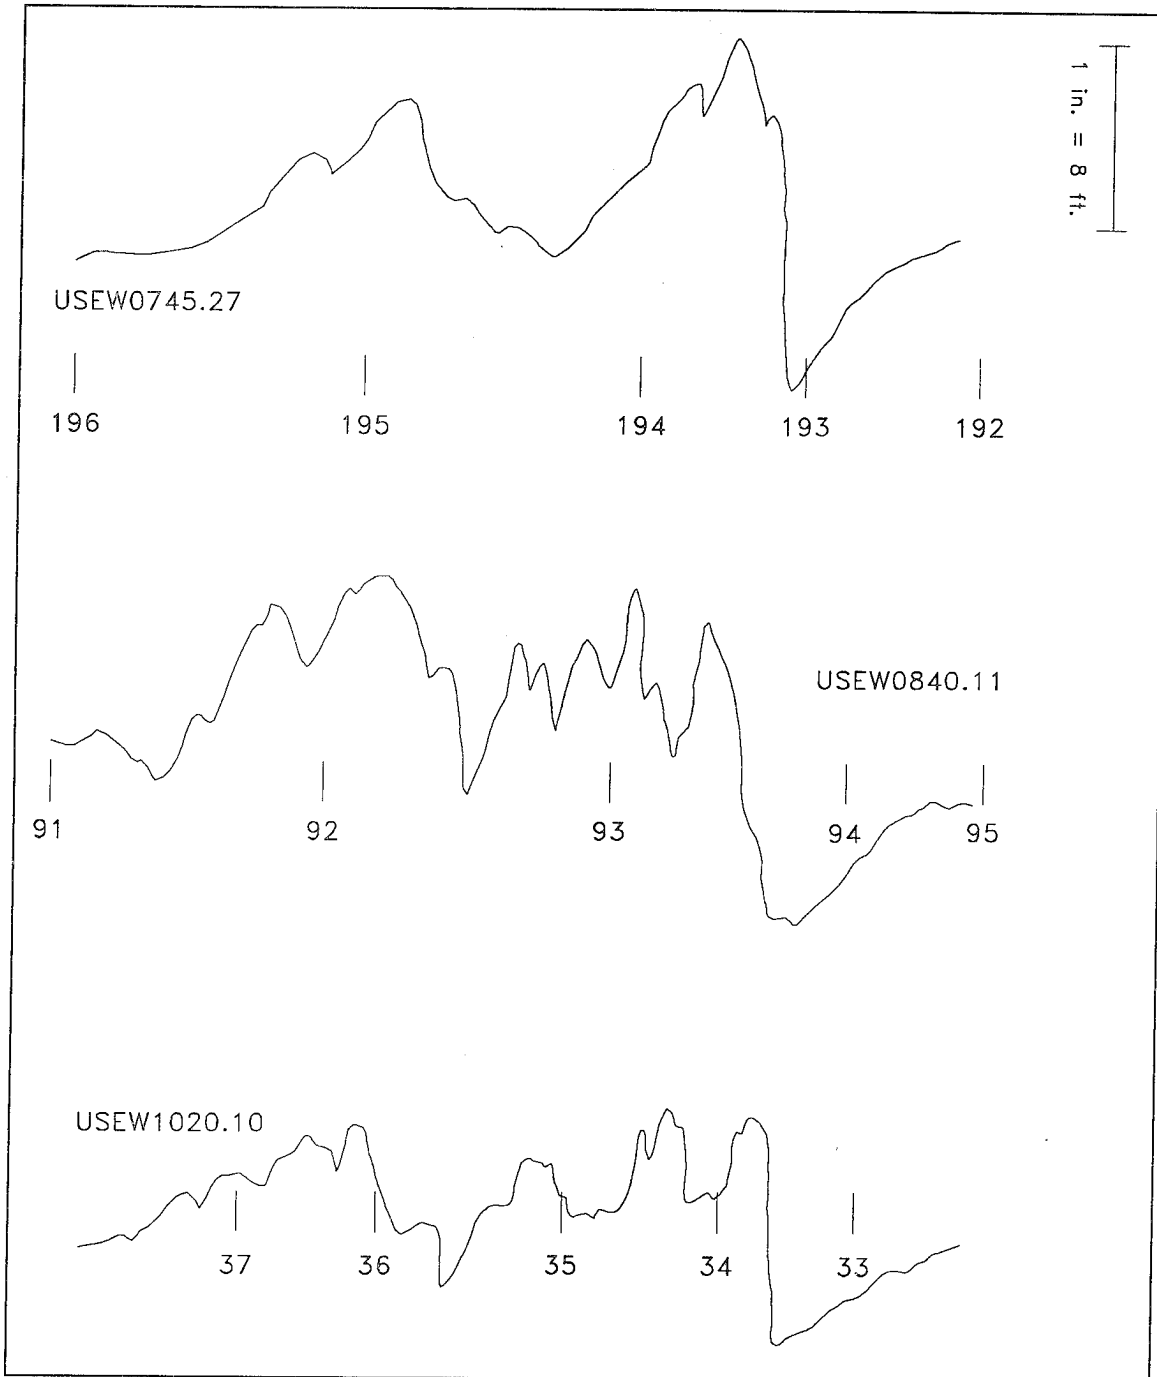
Figure 30. Echo sounder profiles for "north side of jetty" region (Continued)

Bottom profiles for the echo sounder trace lines overlain on Figure 29 are displayed in Figure 30. Generally, the profiles are arranged in order beginning with the most northerly profile and moving closer to the side-scan sonar track. The bathymetric traces are relatively smooth and hummocky with the exception of a roughness element near event mark 74 on track line USEW1038.1 (top profile on page 89), and some roughness elements around event mark 93 on track line USEW0840.11 (middle profile on page 90).

Despite the geometric distortion problem, it is clear there are no rounded objects indicative of jetty armor stones on the side-scan sonar image near event mark 74 on track line USEW1038.1 (Figure 29). Therefore, it is concluded that the roughness element visible on the corresponding profile on Figure 30 is a result of the track line crossing the reef rock finger indicated on the side-scan sonar image at event mark 74.

A similar conclusion is drawn regarding the roughness elements shown on Figure 30 profile USEW0840.11 in the vicinity of event mark 93. As seen on Figure 29, this echo sounder track line overlays reef rock fingers, but there is no indication of armor stones in the image near event mark 93. The round image approximately halfway between event marks 93 and 94 along track line USEW0840.11 was most likely caused by the presence of a hole in the reef rather than an armor stone. Interpretation of the remaining four bathymetric profiles shown in Figure 30 resulted in the conclusion that all six echo sounder track lines crossed the Yaquina Reef to the north of any armor jetty stones.

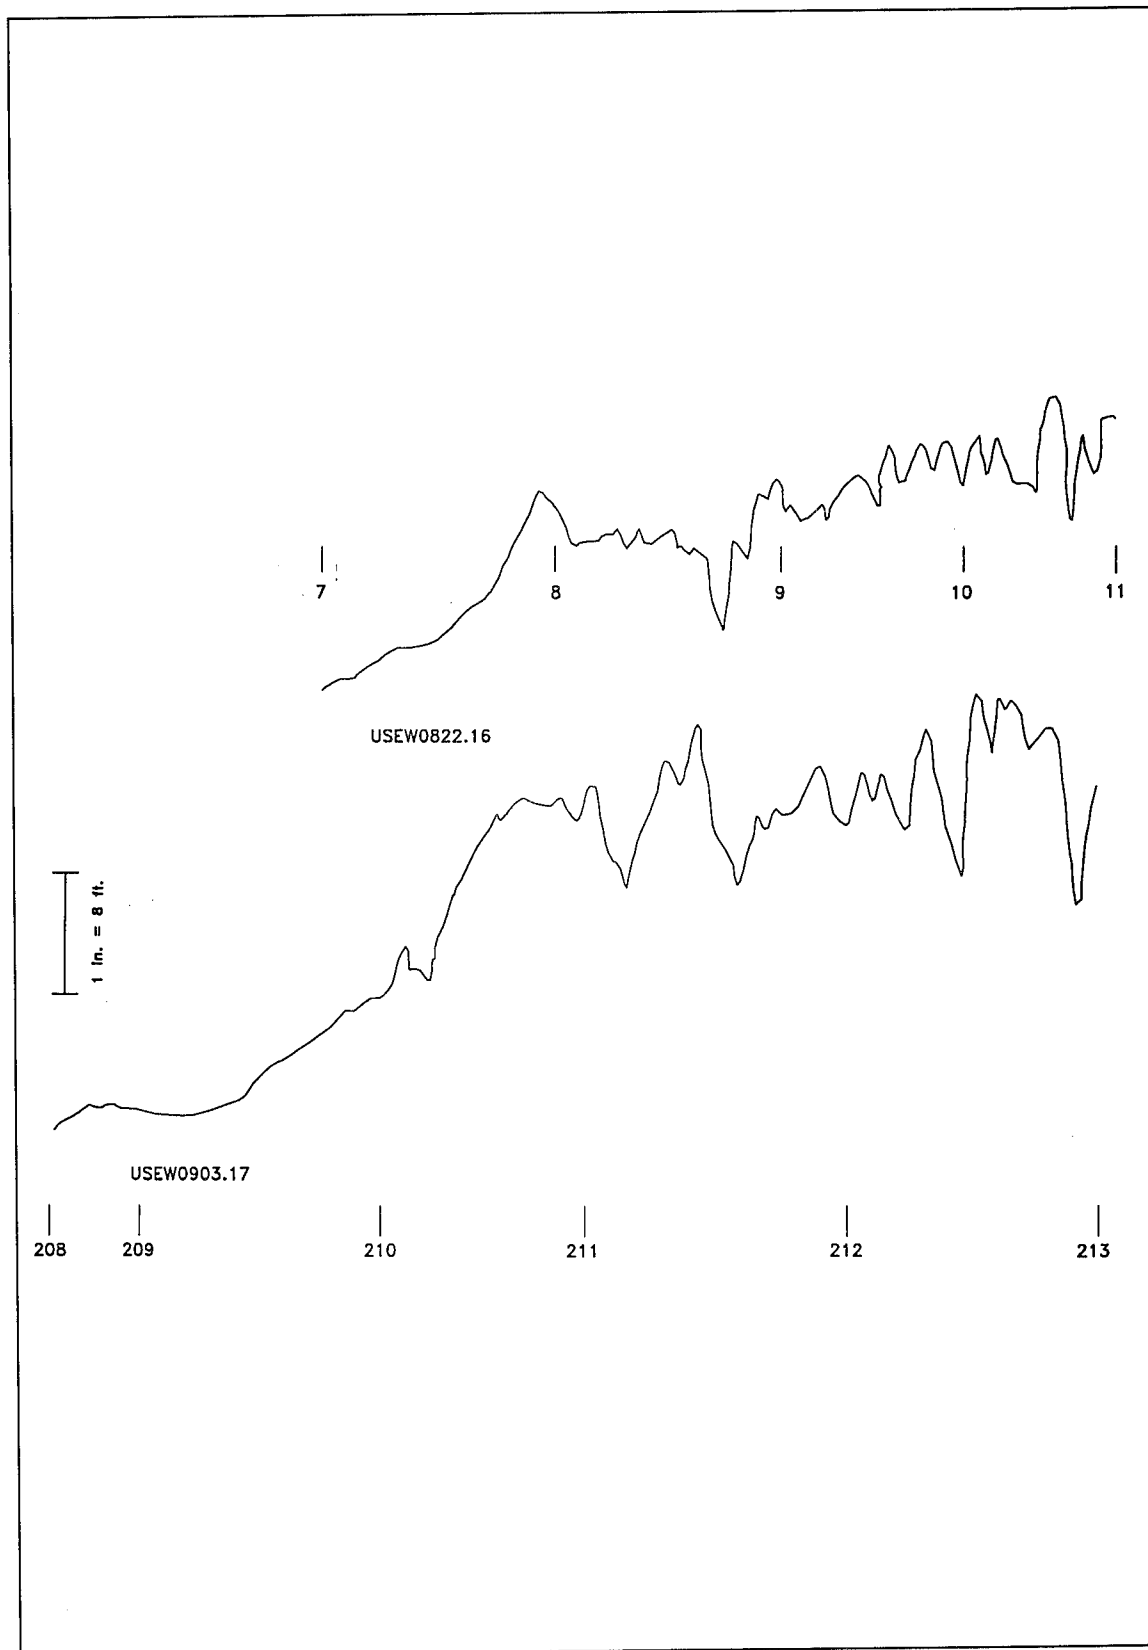
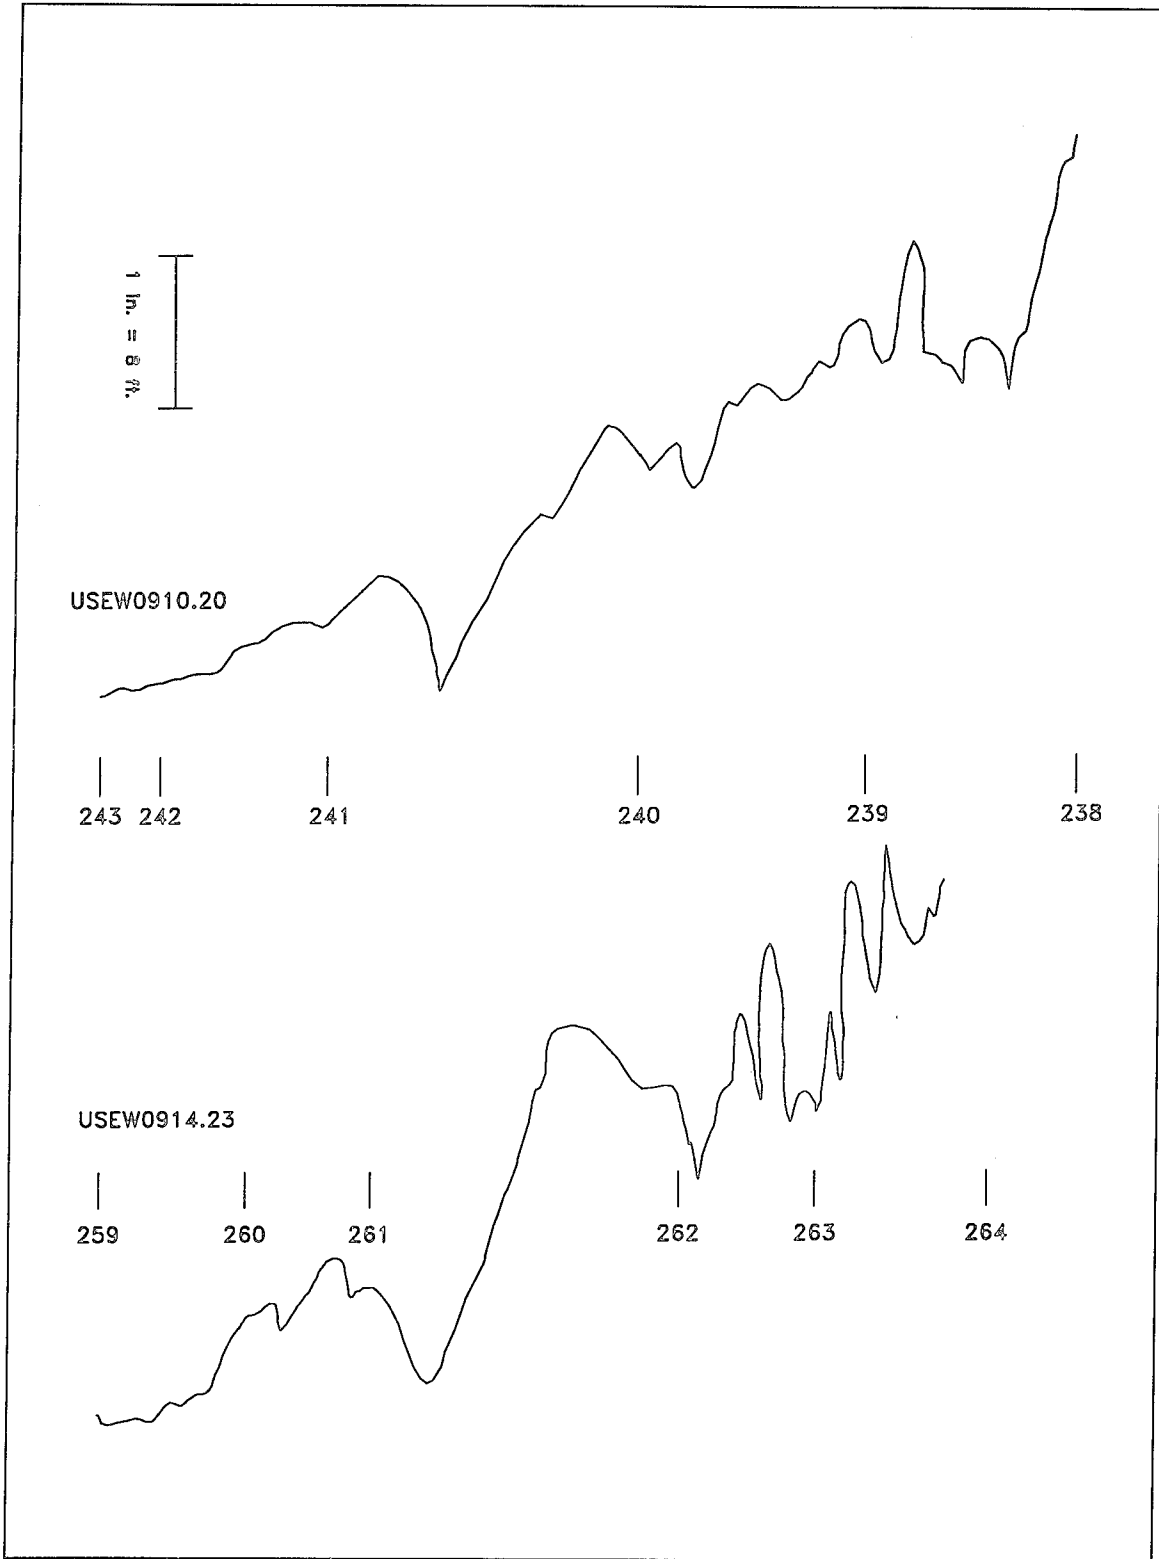
Figure 32. Echo sounder profiles for "northwest side of jetty" region (Continued)

On the corresponding bathymetric profile (bottom profile on page 93) there is a peaked bottom feature shown between event marks 211 and 212. Interpretation of the side-scan sonar record in this location concluded that this peaked feature is a wide rock finger. Around event mark 212 there are evenly spaced roughness elements similar to those seen around event mark 10 on track line USEW0822.16. These roughness elements are also interpreted to be overlapping jetty stones. In conclusion, the interpretation for track line USEW0903.17 was that the track line crossed the Yaquina Reef beginning at event mark 210, and continued until event mark 212, where it then crossed over the toe of the north jetty.

Roughness elements also appeared on bathymetric profile USEW0910.20 near event mark 239 and on profile USEW0914.23 starting near event mark 262 and continuing toward event mark 264 (see Figure 32). These roughness elements were interpreted to be individual jetty stones resting on the seafloor. The corresponding side-scan sonar image of Figure 31 shows the transition from unconsolidated sediment to rock to be at event mark 241 along track line USEW0910.20 and at event mark 260 along track line USEW0914.23.

The interpretation for these two echo sounder track lines was that track line USEW09010.20 began crossing over the reef at event mark 241, and continued until mark 239 where it crossed over the jetty. Similarly, trackline USEW0914.23 started crossing the reef at event mark 260 until event mark 262, where it started crossing the jetty. Finally it is noted that all four bathymetric profiles clearly show the smooth hummocky appearance interpreted to be reef rock on their western end (left side of profiles in Figure 32).

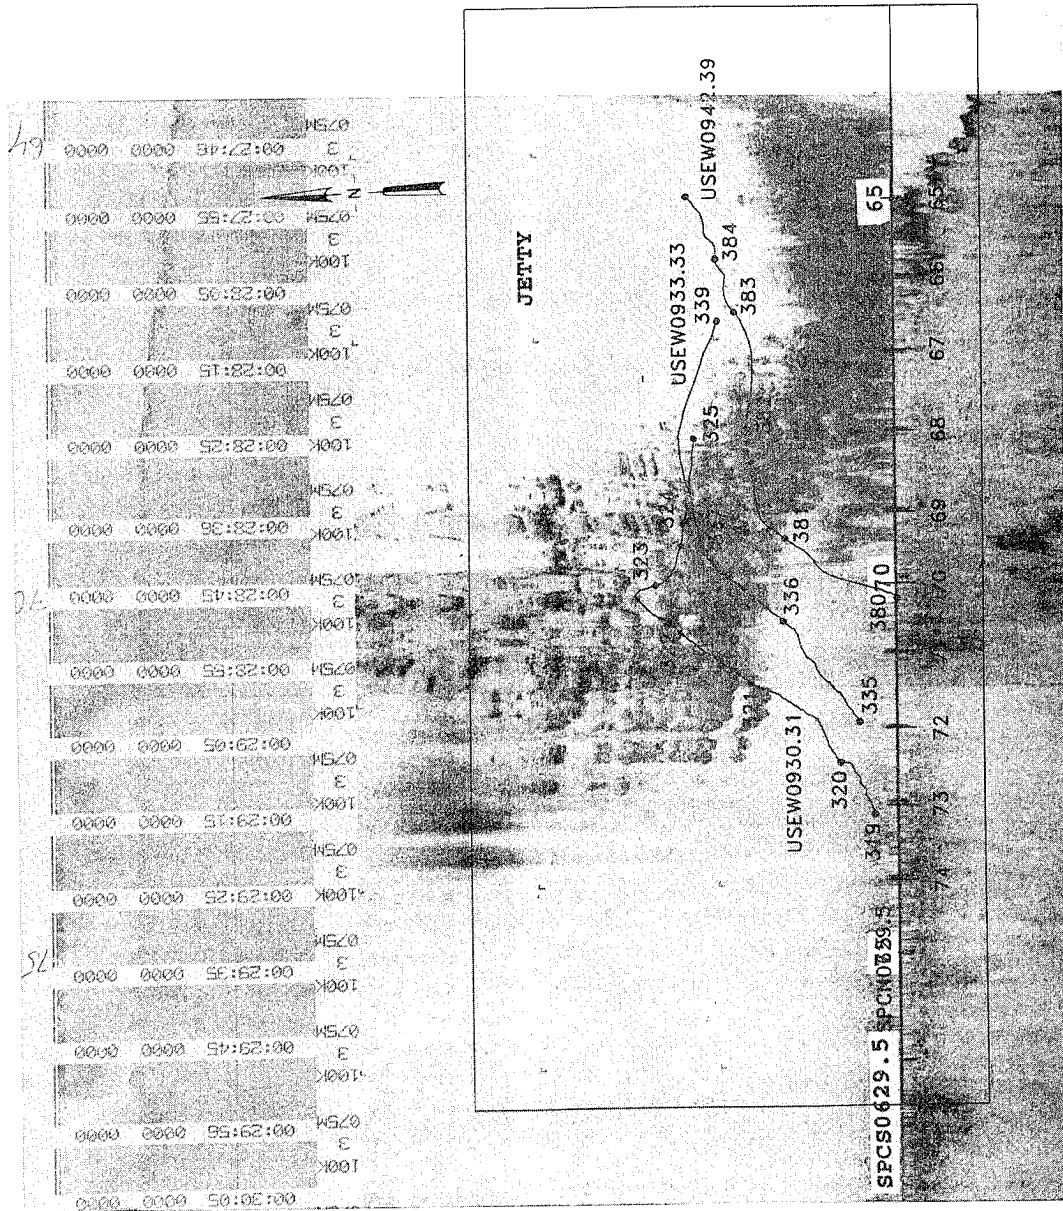
Figure 35. Side-scan sonar record along trackline SPCS0629.2 for "southwest side of jetty" region

Figure 35 shows the side-scan sonar image recorded along trackline SPCS0629.5 for the southwest side of the jetty. The portion of the figure above the track line is directed toward the north jetty in a north direction. The left side of the figure is seaward of the jetty. Overlain on the image are three bathymetric track lines that were rescaled to correspond to the side-scan

The side-scan sonar image of Figure 35 indicated that the transition from offshore unconsolidated sediments to rock occurred along echo sounder trackline USEW0930.31 near event mark 321, along track line USEW0933.33 between event marks 336 and 337, and along trackline USEW0942.39 between event marks 381 and 382. All three bathymetric profiles on Figure 36 showed a large scour trench just seaward of the rock area (southwest of the north jetty tip).

The identified rock portions of all three bathymetric profiles contained small regularly spaced roughness elements characteristic of overlapping jetty armor stones. Rounded objects were also seen in the Figure 35 side-scan sonar image over all portions that were indicative of rock. None of the bathymetric profiles had portions containing the smooth hummocky appearance of reef rock, with the possible exception of around event mark 322 along trackline USEW0930.31. However, the interpretation of these data in conjunction with other data led to the conclusion that there is no exposed reef in this immediate area. The presence of the deep scour trench immediately seaward of the jetty supports the contention that the toe of the north jetty in this region is resting on sand rather than resting on a portion of the reef that was covered with sand.

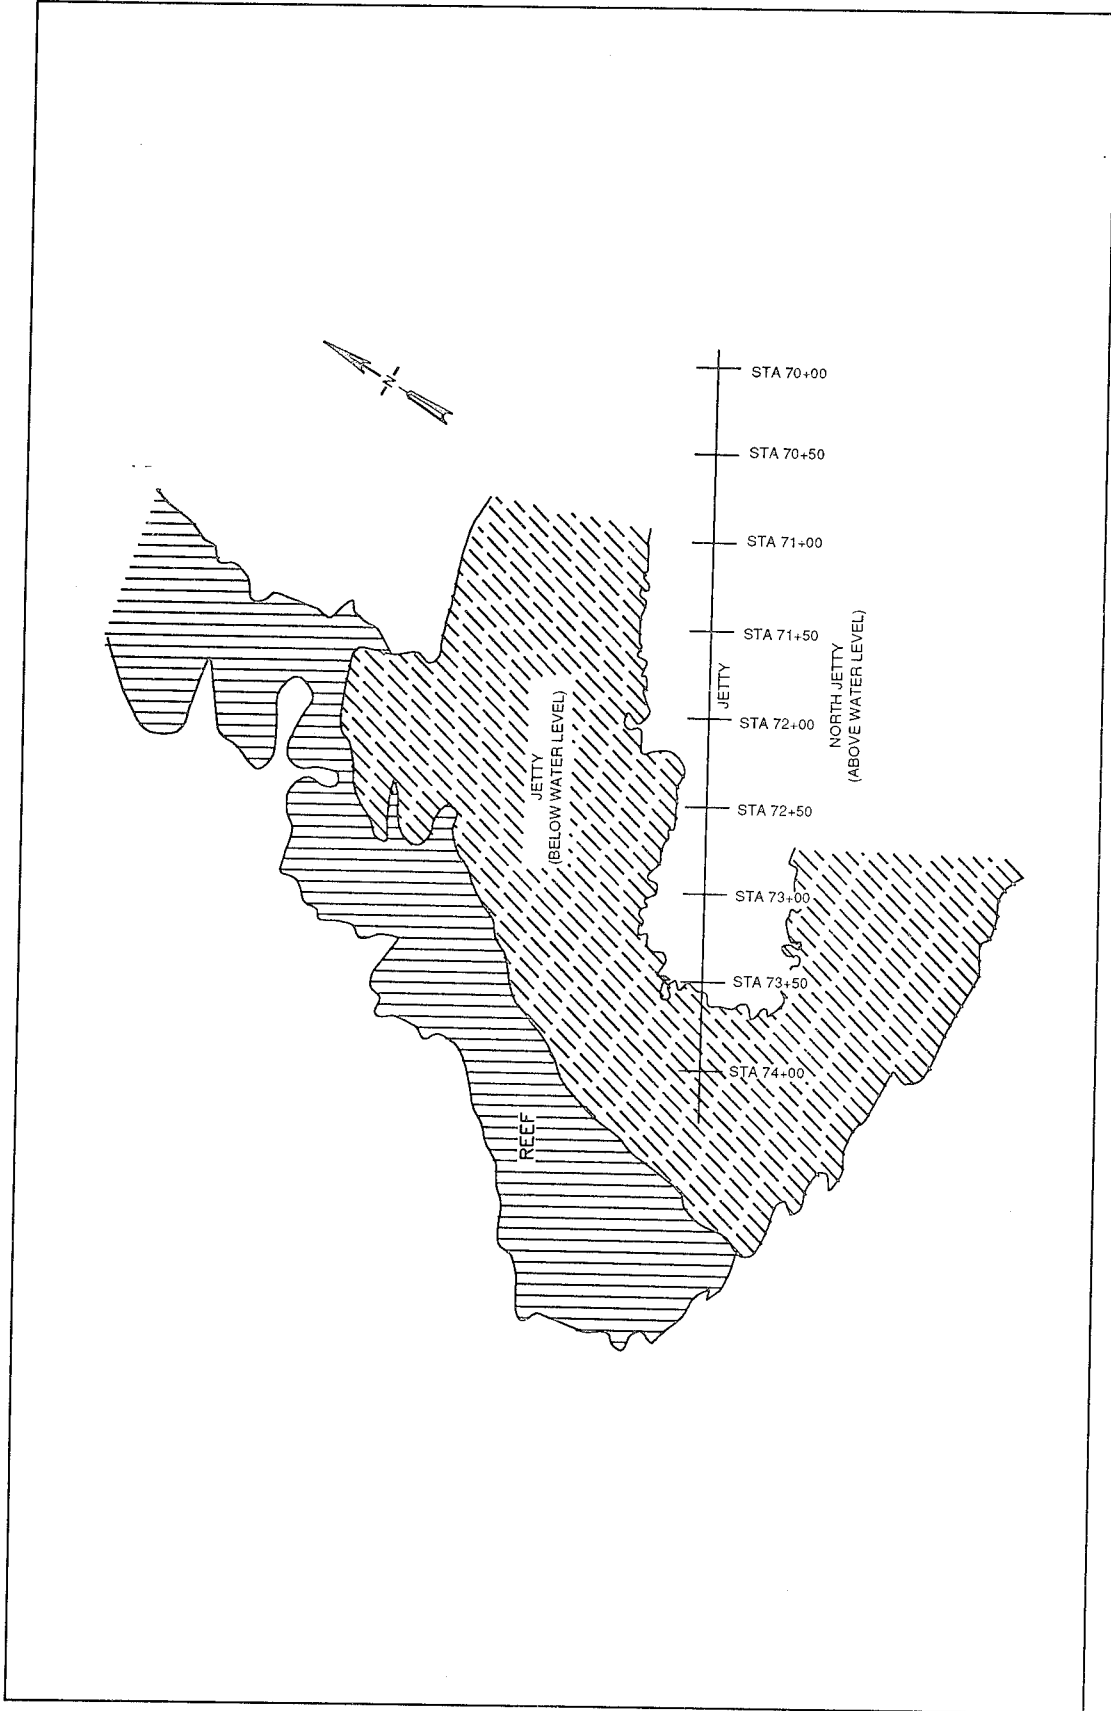
Figure 37. Position of Yaquina Bay north jetty relative to Yaquina Reef

The four side-scan sonar images presented in Figures 29, 31, 33, and 35 were used to delineate the border between rock and unconsolidated sand around the Yaquina Bay north jetty head. This demarcation line was drawn on Figure 37 to show its position relative to the above-water portion of the north jetty.

portion of the Yaquina Reef sticks out seaward of the northwest tip of the Yaquina Bay north jetty. However, interpreting roughness elements on the bathymetric profiles as jetty armor stones involved a certain degree of subjectivity. Therefore, the line marking the toe of the north jetty on Figure 37 is not absolutely definitive.

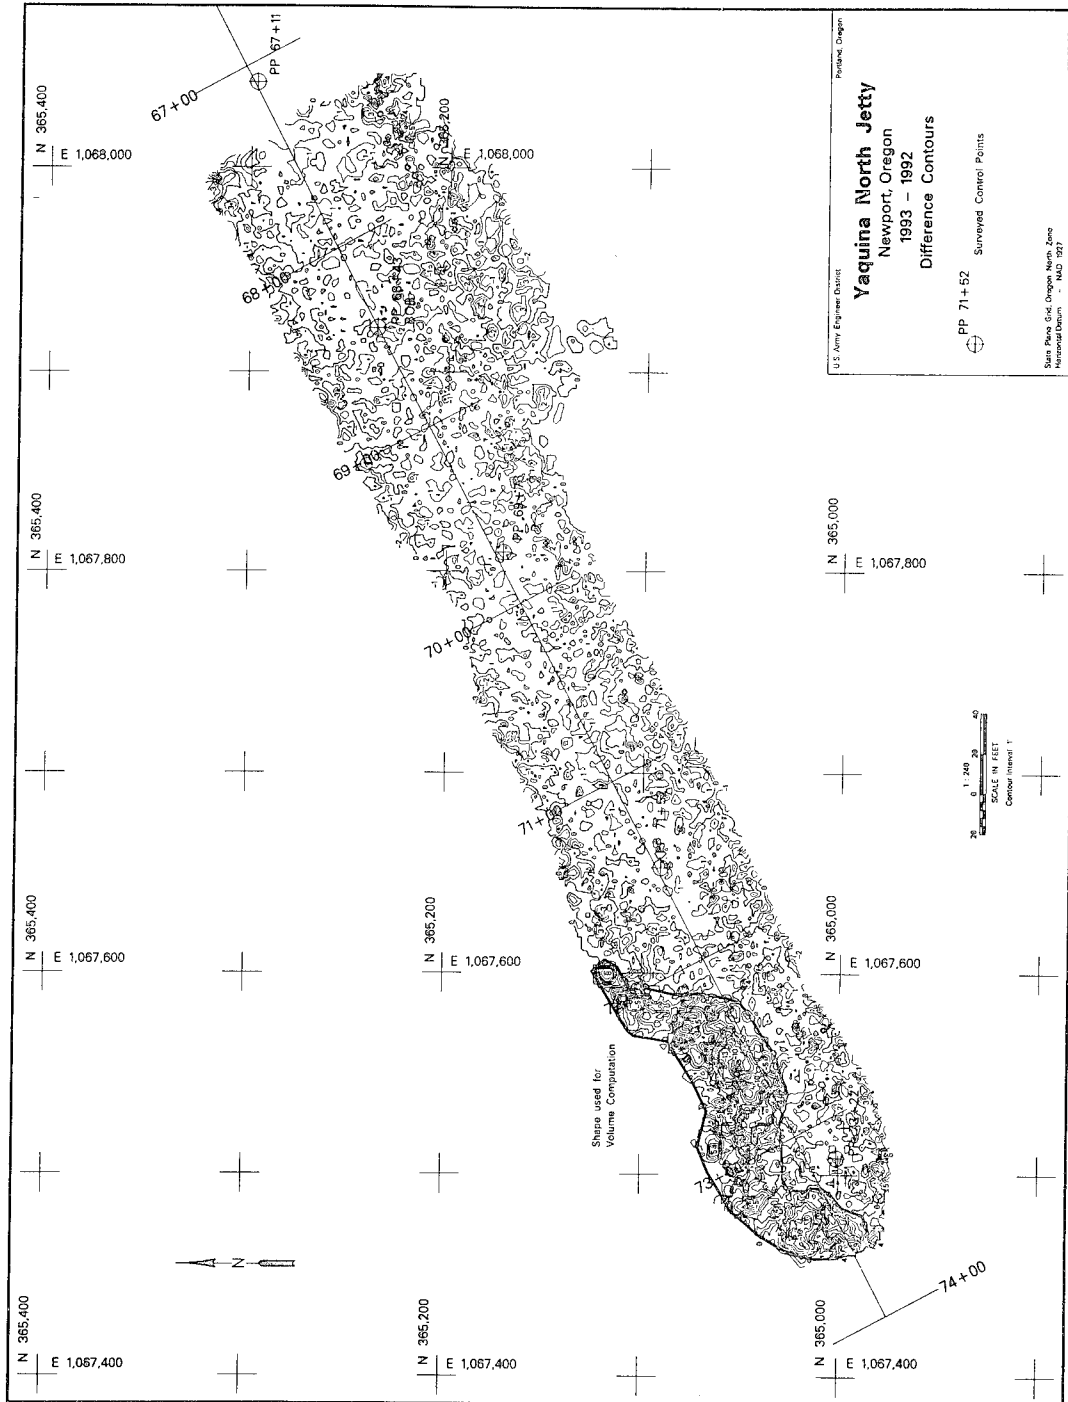
Figure 43. Difference between 1992 and 1993 north jetty contours

As mentioned, gridded elevations from different dates can be combined to produce difference contours. Figure 43 shows the difference contours found between stereo models for the 1992 and 1993 overflights. This figure is included only to give an impression of the product. The original products

have different colored contours to denote positive and negative differences, and they are far more informative than what is shown in black and white on Figure 43.

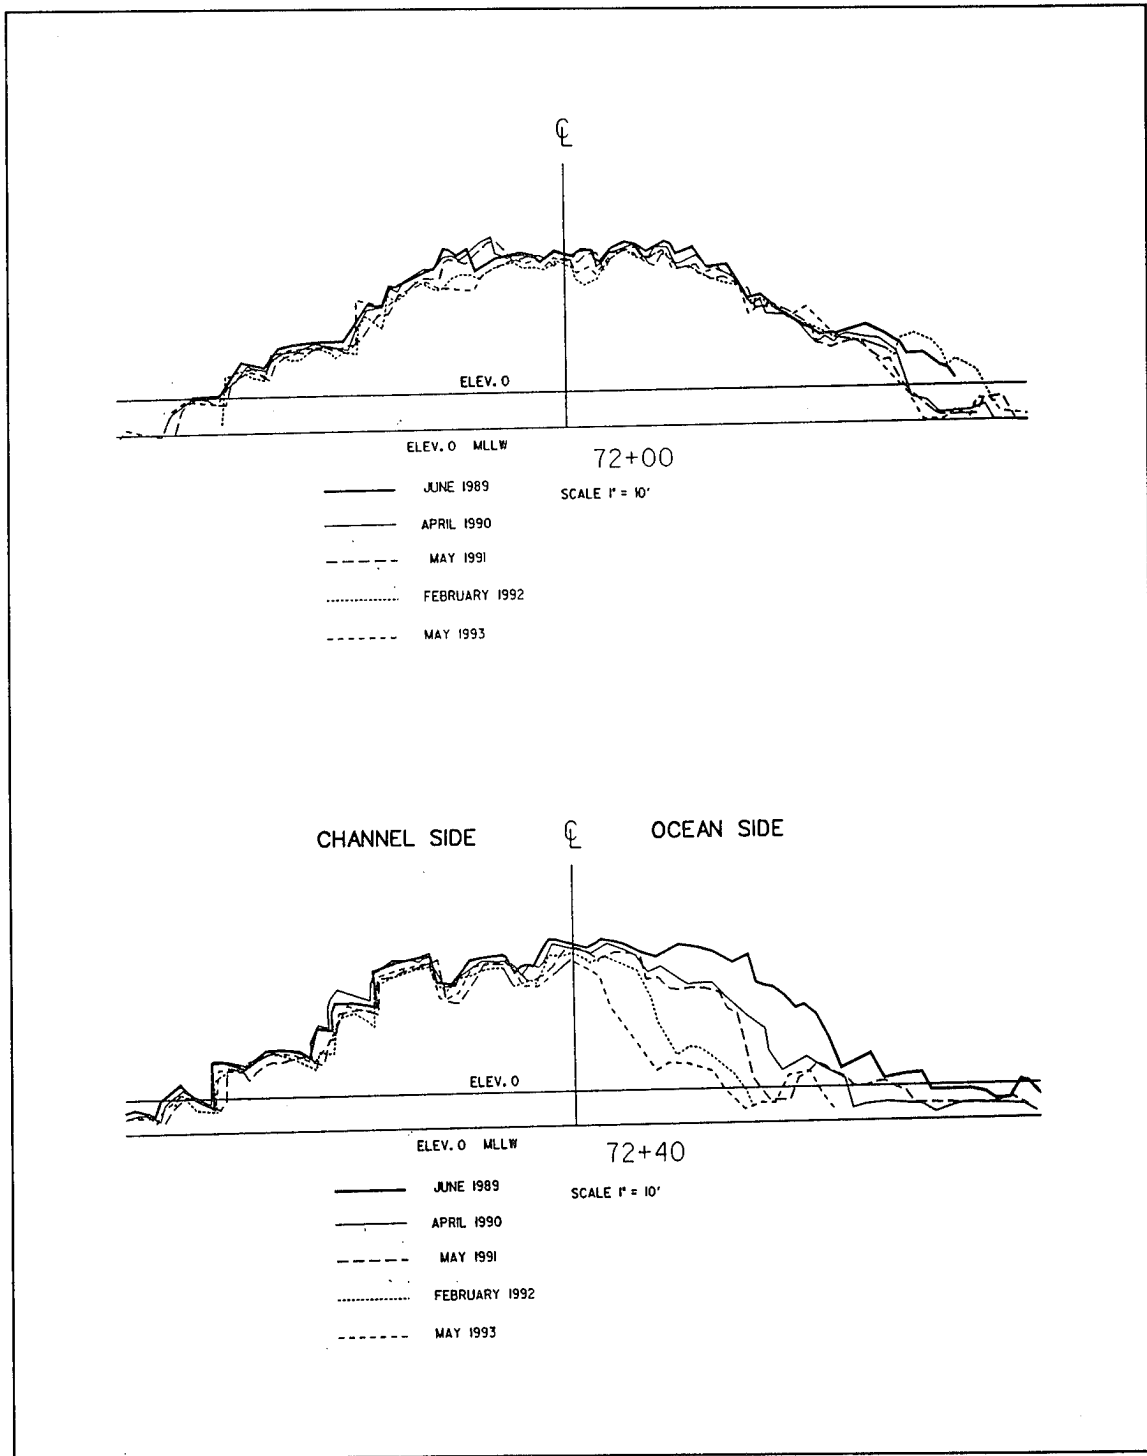
Figure 45. Stereo model jetty profile comparisons, ranges 72+00 and 72+40

- c. The most profile change occurred in the vicinity of the "notch" (Figure 45, range 72+40). Significant damage occurred between the years 1989 - 1991. This was followed by a year when the only armor stone losses in the notch area occurred on the landward side of the notch. However, between the 1992 and 1993 overflights, massive profile losses occurred in the notch area to the extent that stones were lost over much of the structure's crest (see range 72+70, Figure 46).

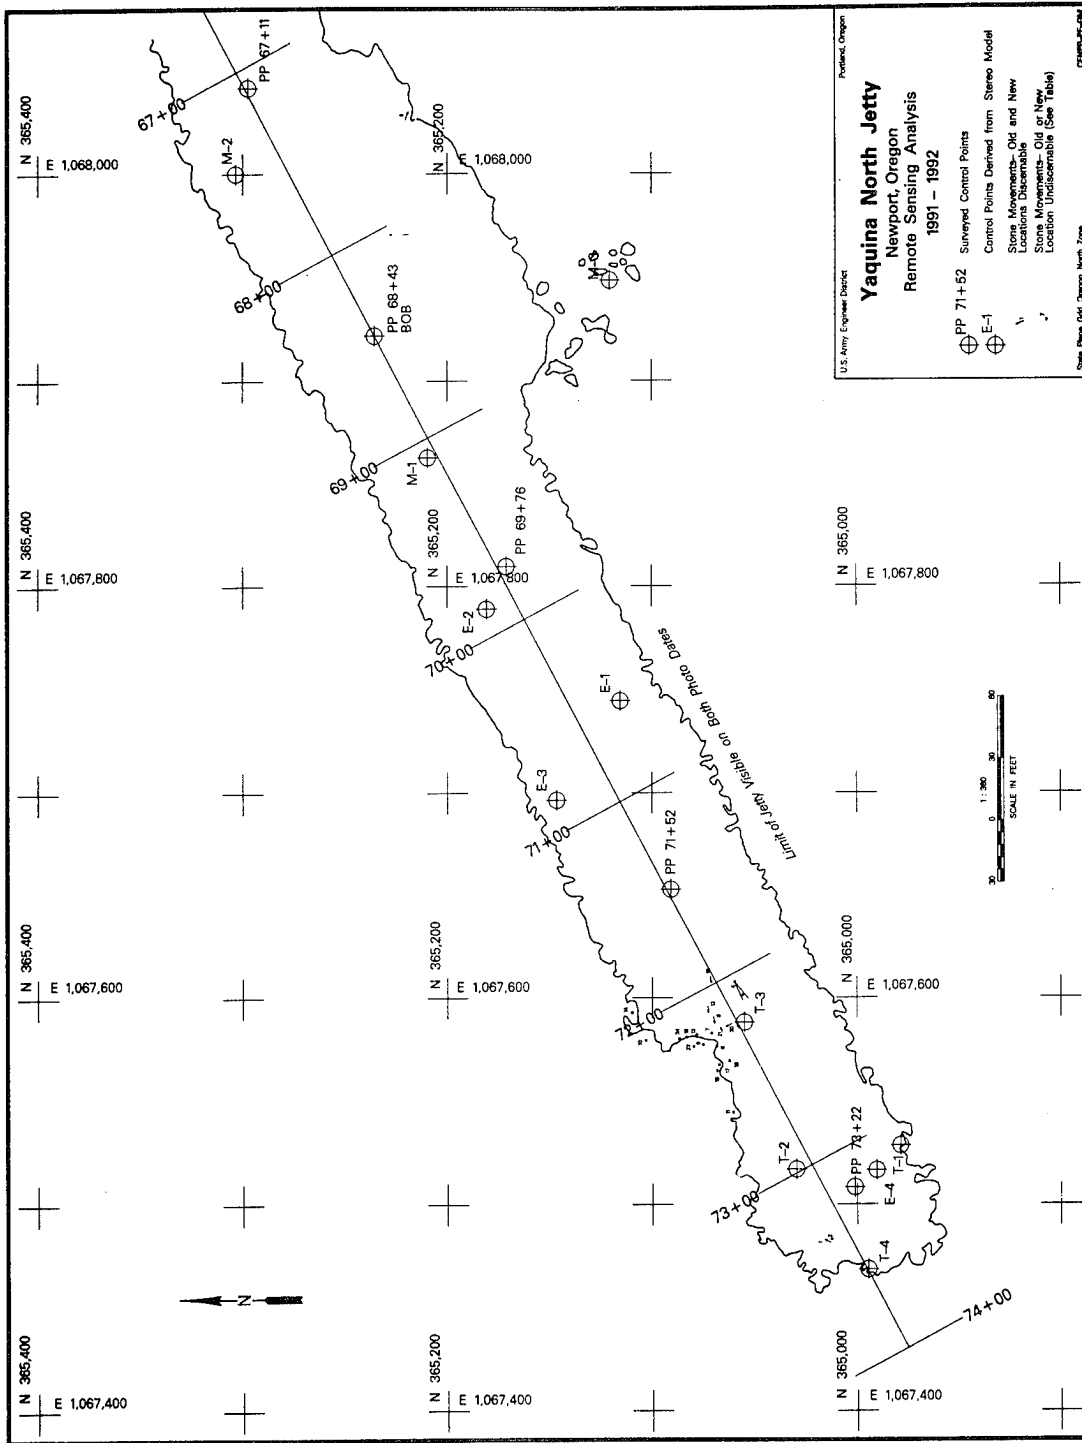
Figure 48. Individual armor stone movements between 1991 and 1992

Stone #	Length of Movement (In Feet)	Direction of Movement	Comments
1	2.6	N60.0E	Stone moved and rotated under stone #2.
2			Stable Rock.
3	No entry, stable.		
4			Rotated 15 degrees cc about centroid.
5			Rotated and moved.
6			Stone no longer visible.
7			Stone no longer visible.
8	2.5	S81.7W	Moved.
9			Stone no longer visible.
10			Stone not on 1991 photo, possibly from above.
11			Stone not on 1991 photo, possibly from above.
12			Stone no longer visible.
13	2.9	S87.3W	Moved.
14			Stone not on 1991 photo, origin unknown.
15			Stone no longer visible.
16			Stone no longer visible.
17			Stone no longer visible.
18			Stone no longer visible.
19	2.6	S80.0W	Moved.
20	2.4	N25.7W	Moved.
21	1.3	N67.7E	Moved, partially beneath stone #8.
22			Stone no longer visible.
23			Stone no longer visible.
24			Stone no longer visible.

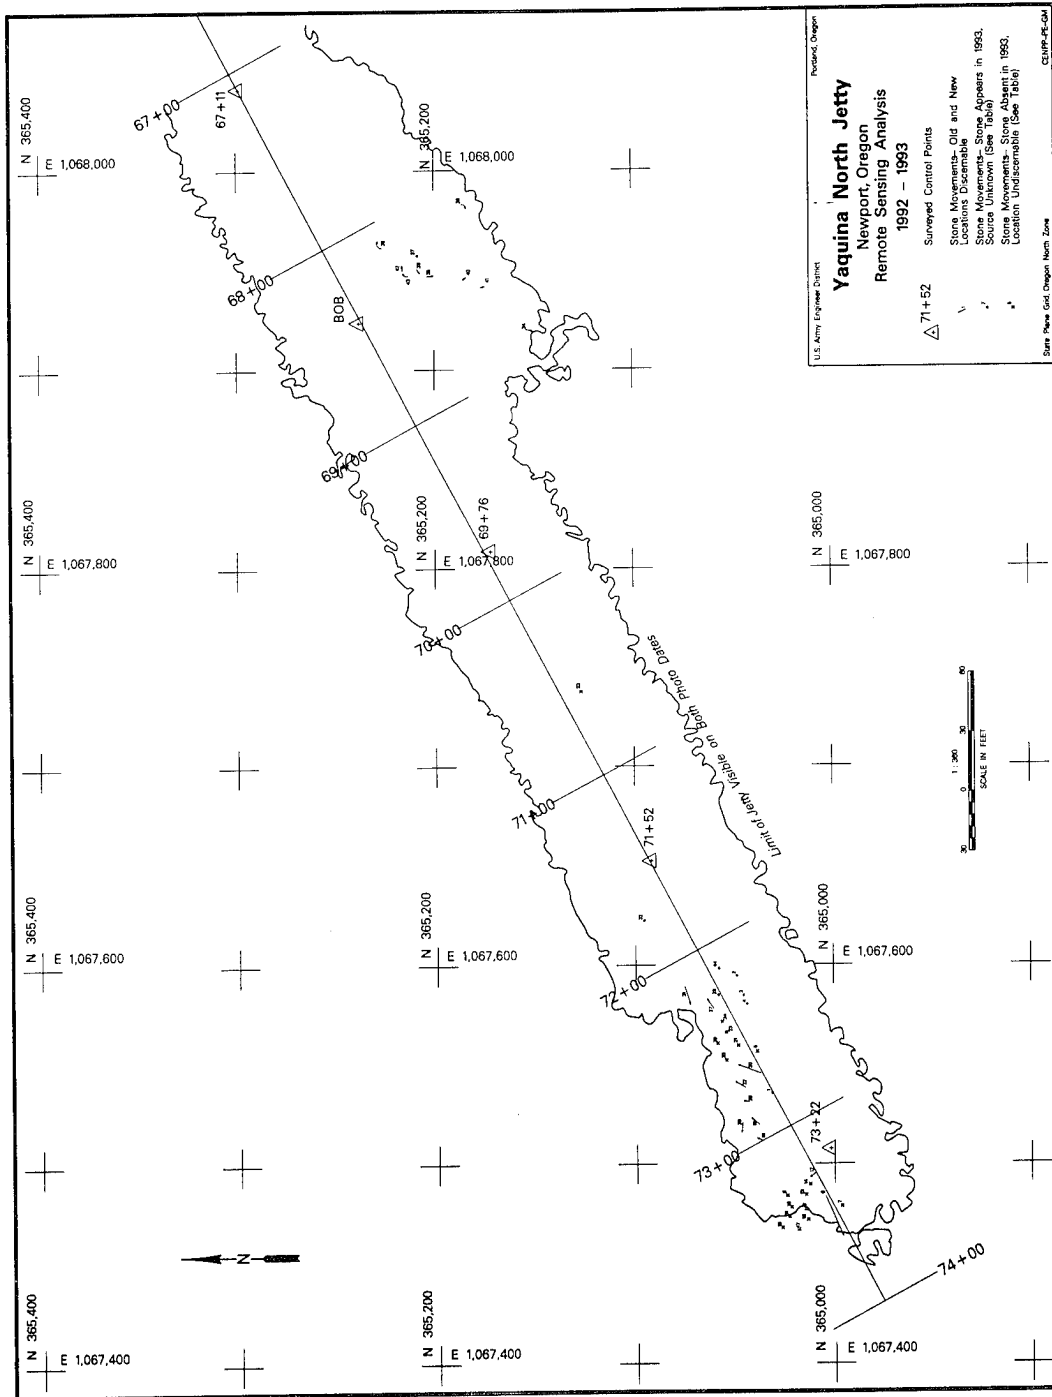
Figure 50. Individual armor stone movement between 1992 and 1993

The winter season between 1992 and 1993 resulted in the loss of approximately 17 identifiable armor stones as determined from aerial photography. Ten of the larger select class "A" stones were lost from the previously stable region at the very tip of the north jetty as shown on the stone movement drawing (Figure 50). More stones were undoubtedly lost from underneath the removed top stones, but the actual number cannot be determined because they cannot be identified on the earlier photographs. Curiously, eight stones on the 1993 photographs were identified that were not present in the 1992 photographs. It is presumed that these armor stones, located high on the crest near the jetty center line, were swept up the structure slope from the notch area or from somewhere below the waterline. Also, some stone movement was noted on the channel side of the north jetty around Station 68+50 (see Figure 50).

CENPP-PE-GM		Photo	26 May 1993
		Dates:	23 February 1992
YAQUINA NORTH JETTY			
Stone Movement Determinations			
1992 - 1993			
Stone #	Length of Movement (In Feet)	Direction of Movement	Comments
1			Appears in 1993, source unknown.
2			Appears in 1993, source unknown.
3			Appears in 1993, source unknown.
4			Appears in 1993, source unknown.
5			Stone absent in 1993, exact location unknown.
6	21.1	S 66.4 W	
7			Stone absent in 1993, exact location unknown.
8			Stone absent in 1993, exact location unknown.
9			Stone absent in 1993, exact location unknown.
10			Stone absent in 1993, exact location unknown.
11			Stone absent in 1993, exact location unknown.
12	3.3	N 38.8 W	
13			Stone absent in 1993, exact location unknown.
14			Stone absent in 1993, exact location unknown.
15			Stone absent in 1993, exact location unknown.
16			Stone absent in 1993, exact location unknown.
17			Stone absent in 1993, exact location unknown.
