Monitoring of the Yaquina Bay Entrance North Jetty at Newport, Oregon; Summary and Results

by *Steven A. Hughes, Terri L. Prickett,
Michael W. Tubman, William D. Corson*

Final report

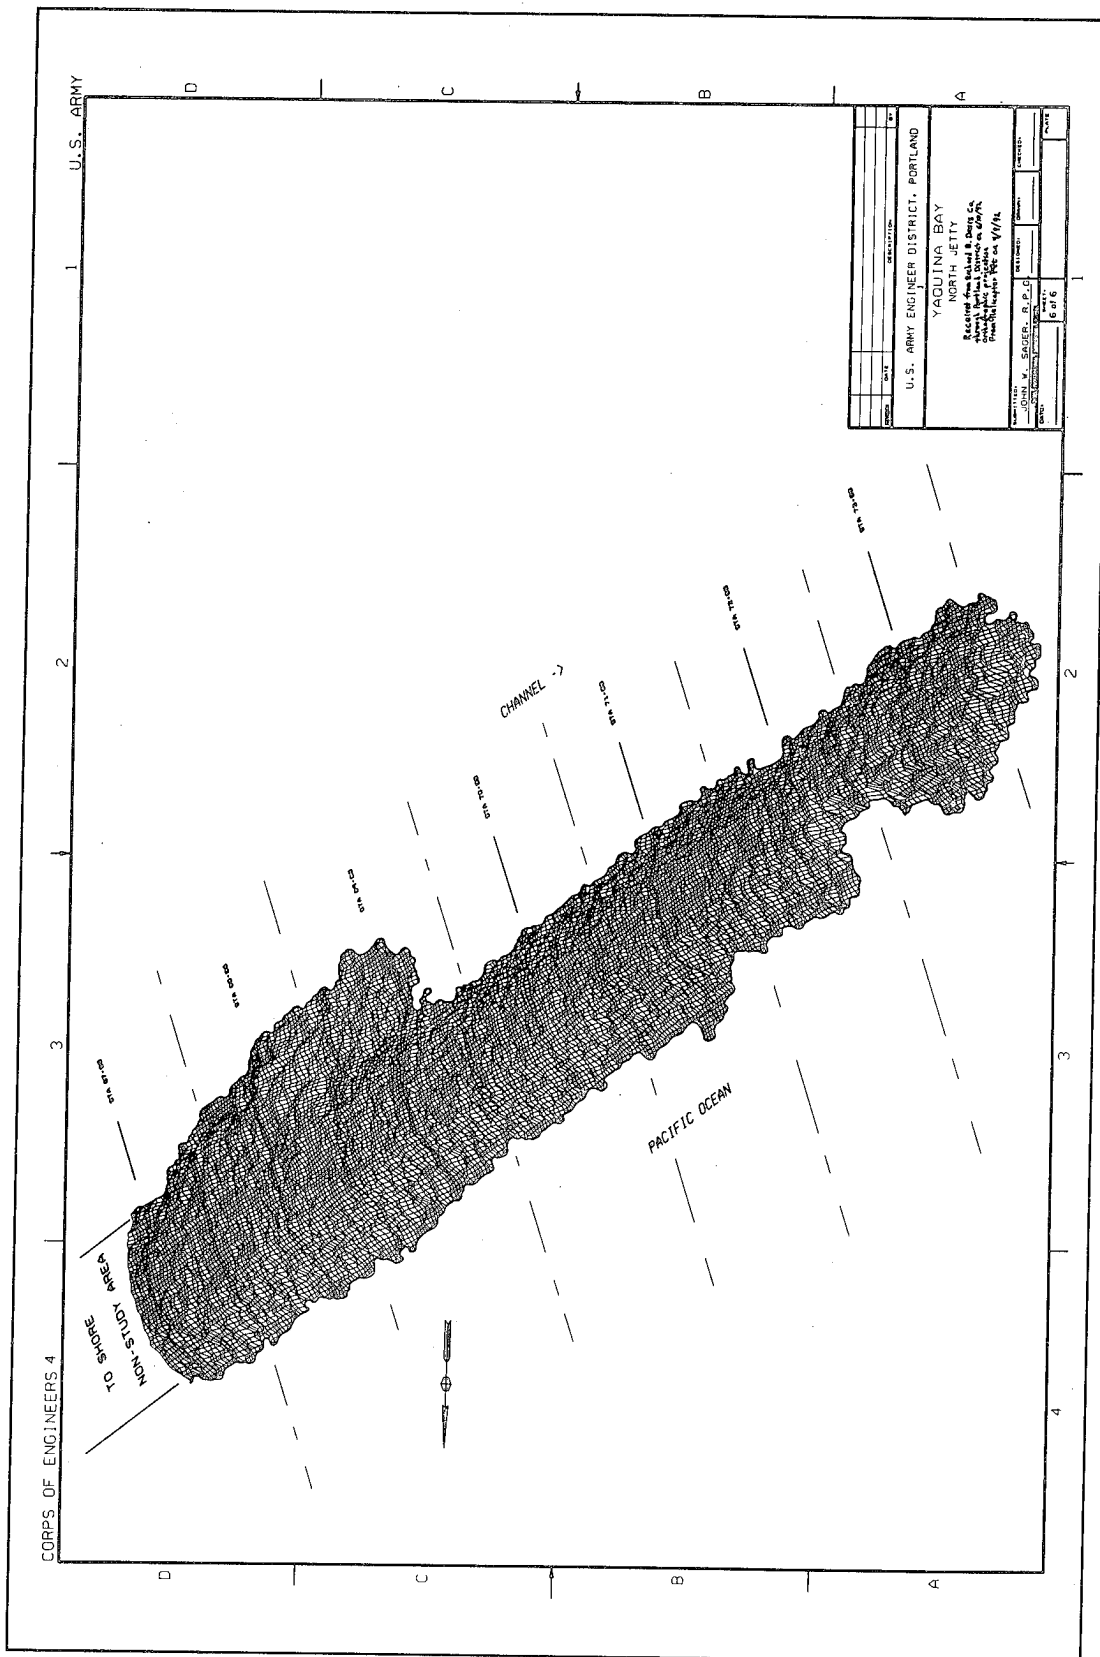
Figure 56. Orthogonal projection from the 1992 helicopter overflight

photogrammetry shown in Figure 40. A "mesh" orthographic projection of the jetty also was plotted from the stereo model, as shown in Figure 56.

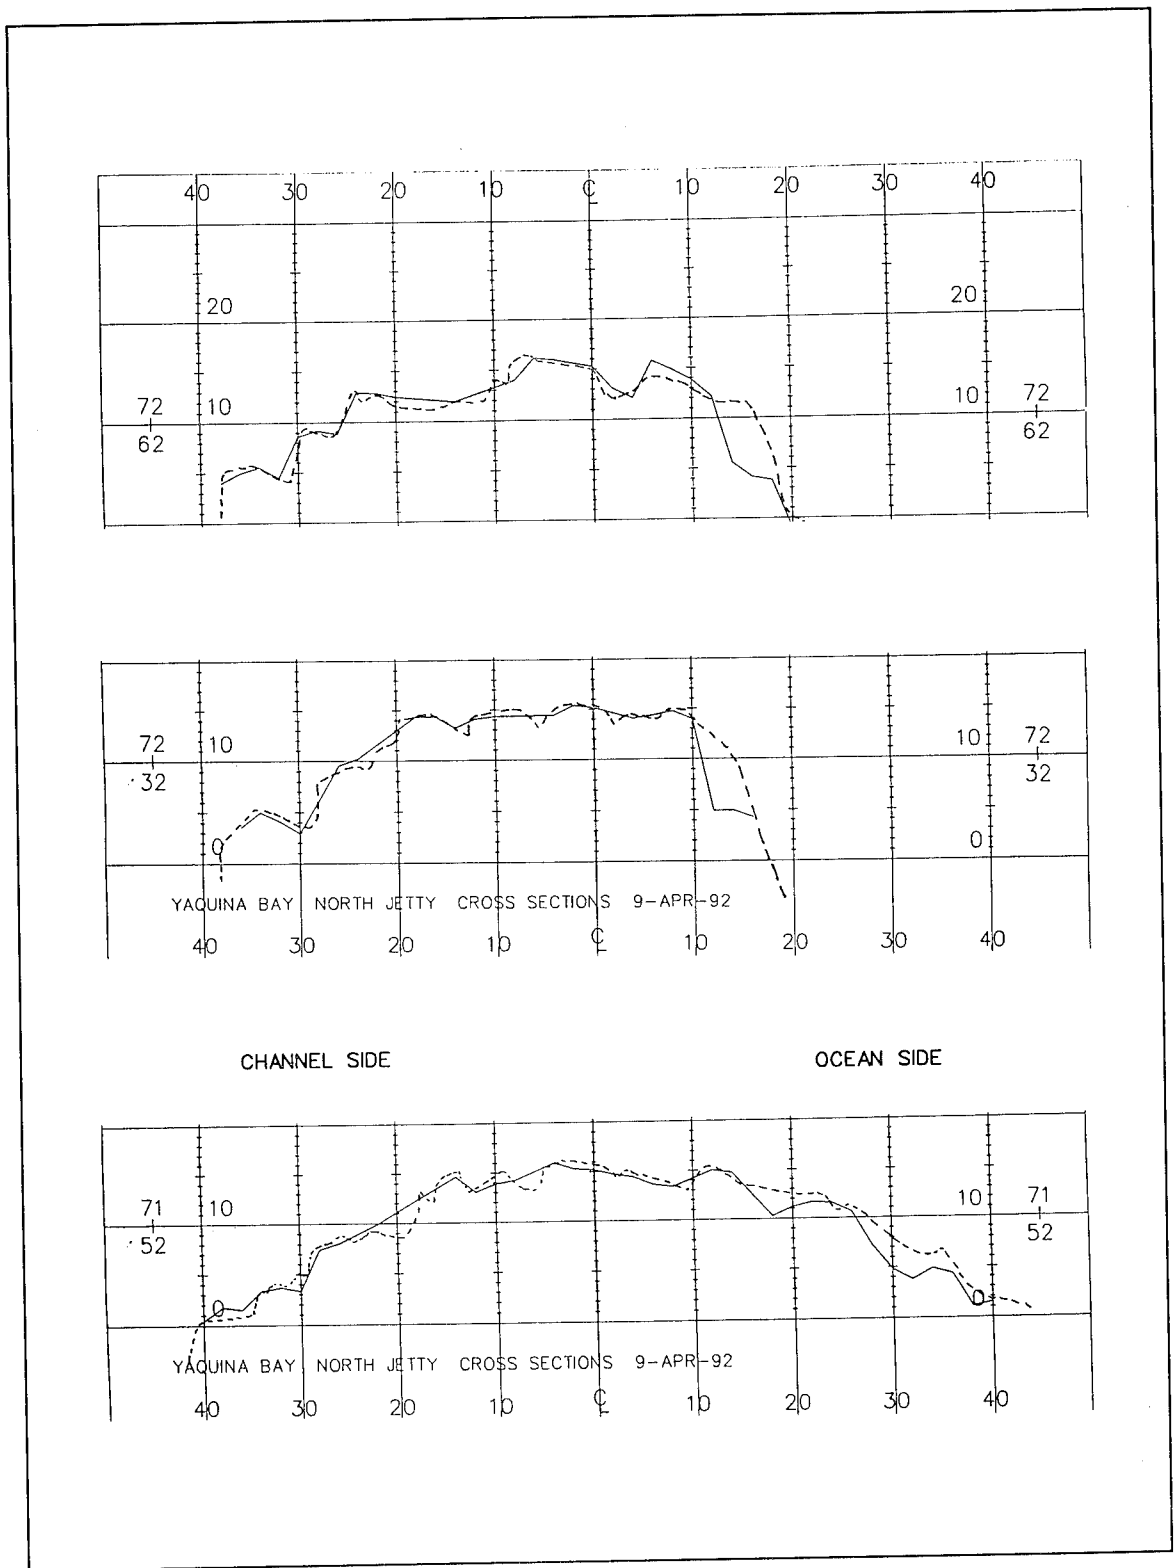
Figure 57. Comparison between 1992 helicopter (solid line) and fixed-wing (dashed line) cross sections

Figure 57 compares three of the 1992 helicopter cross sections (solid line) to the respective fixed-wing cross section (dashed line) that were obtained about 6 weeks earlier. For this limited comparison, reasonable agreement is observed overall, but isolated differences in elevation up to about 3 m (10 ft) are noted. This may be due to misalignment of the coordinate systems used in the two stereo models or interpretation of the stereo photographs. Whichever the case, it is not possible to state absolutely which profiles are correct without further ground-truth from land-based surveys.

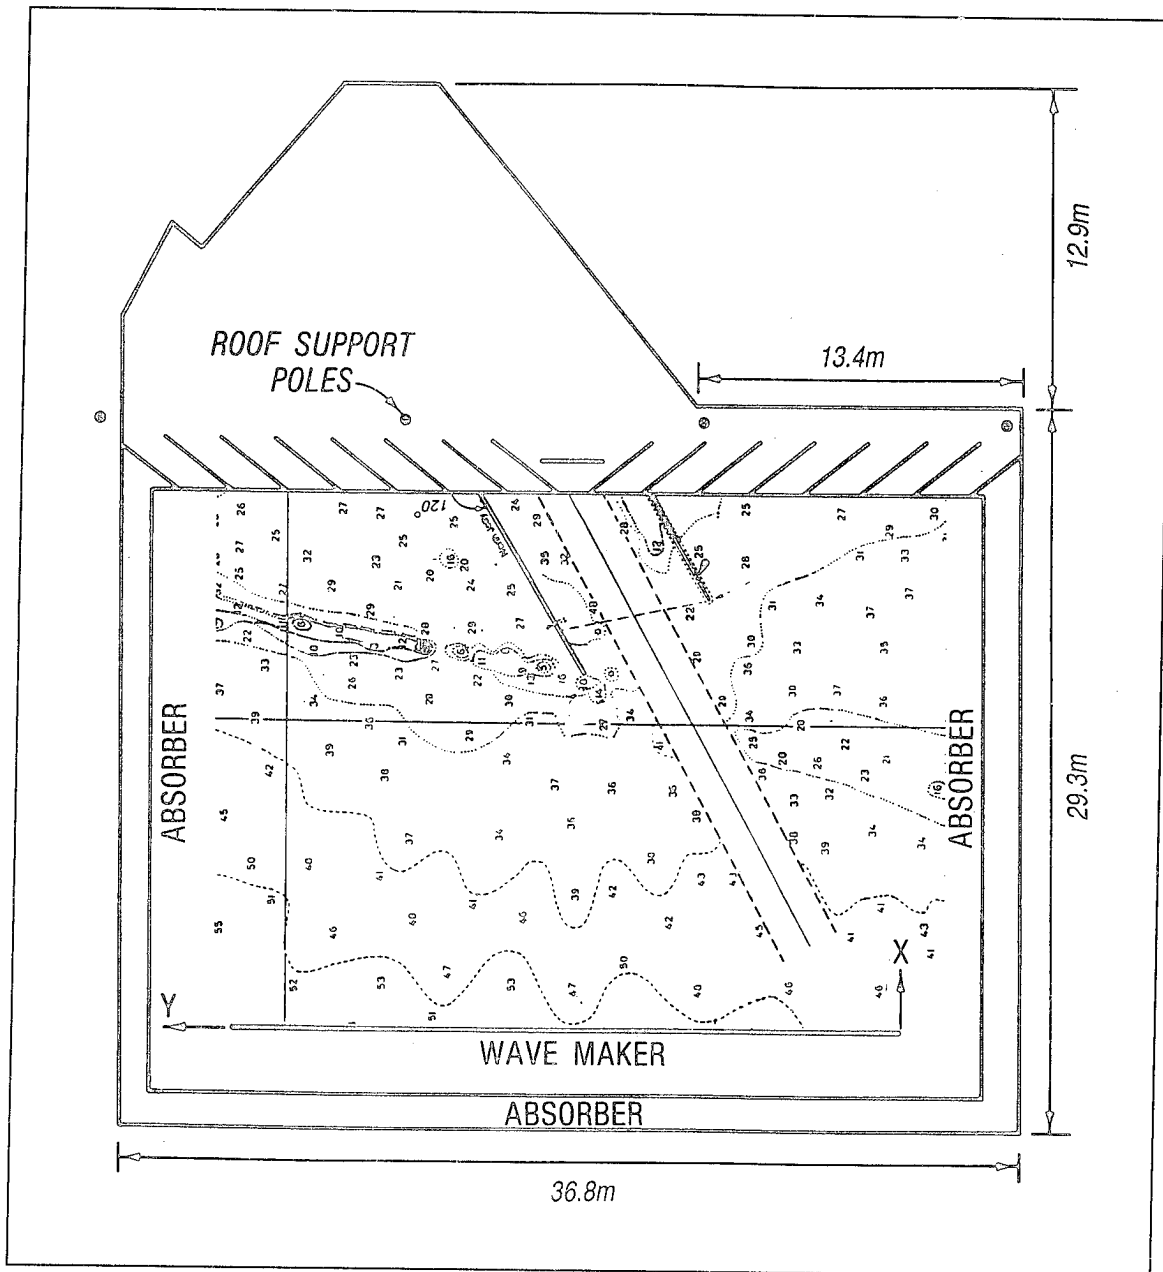
Figure 58. Physical model layout for stability study of 1978 north jetty rehabilitation

The wave board in the basin was located at a depth corresponding to -17.7 m (-58 ft) mllw in the prototype, and the molded bathymetry extending from the wave board to the jetty was intended to provide the same wave transformation in the model that occurs in the prototype. The model plan view is shown in Figure 58. Passive wave absorbers consisting of "horsehair" rubberized mats placed on metal support frames were used to minimize wave reflections by the basin boundaries.

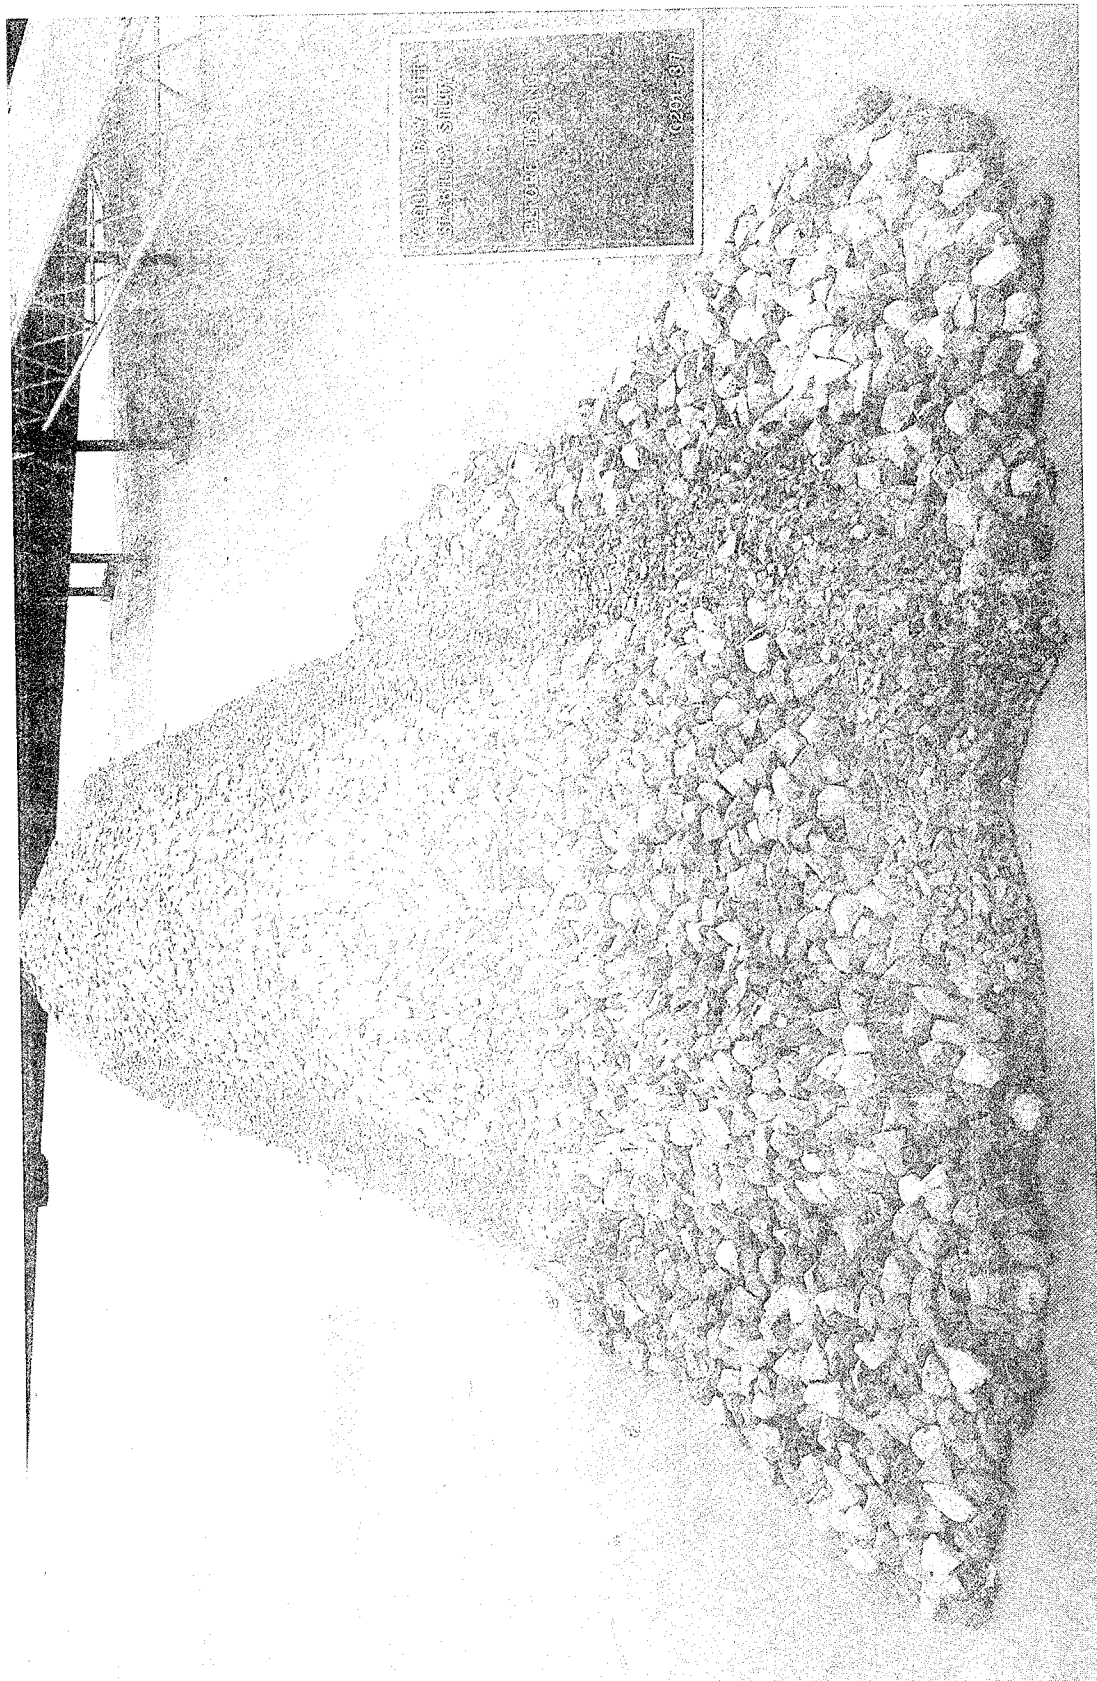
Figure 61. Photograph of model north jetty from stability study of 1978 rehabilitation

the portion of the jetty that had been damaged before the 1978 rehabilitation. Therefore, bedding and core materials were placed in a manner similar to a new construction, but with a wider base. The two layers of select class "A" stone used as the primary armor were specially shaped parallelepiped stones with a maximum length between two and three times the shortest dimension. Scaling for the 1:45 scale model resulted in average select "A" class 18-tonne (20-ton) armor stones in the prototype being represented by model armor stones with a mass of about 0.2 kg (0.44 lb). These model armor stones were handmade to Portland District specifications. Above mllw, stones were placed with their long axis perpendicular to the jetty slope. Below the waterline, stone placement was random. Special placement of the slab-like armor stones results in increased stability compared to randomly placed stone. Figure 61 shows a photograph of the completed north jetty model structure.

Throughout the entire physical model series of stability tests the recorded damage in the model did not even begin to resemble the extensive damage that actually occurred at Yaquina during the winter of 1979 - 1980. After a review of the physical modeling technology, it was concluded that past armor layer instability at the Yaquina Bay north jetty was not a result of wave attack alone, but instead a combination of waves and other environmental conditions such as strong currents or toe scour.

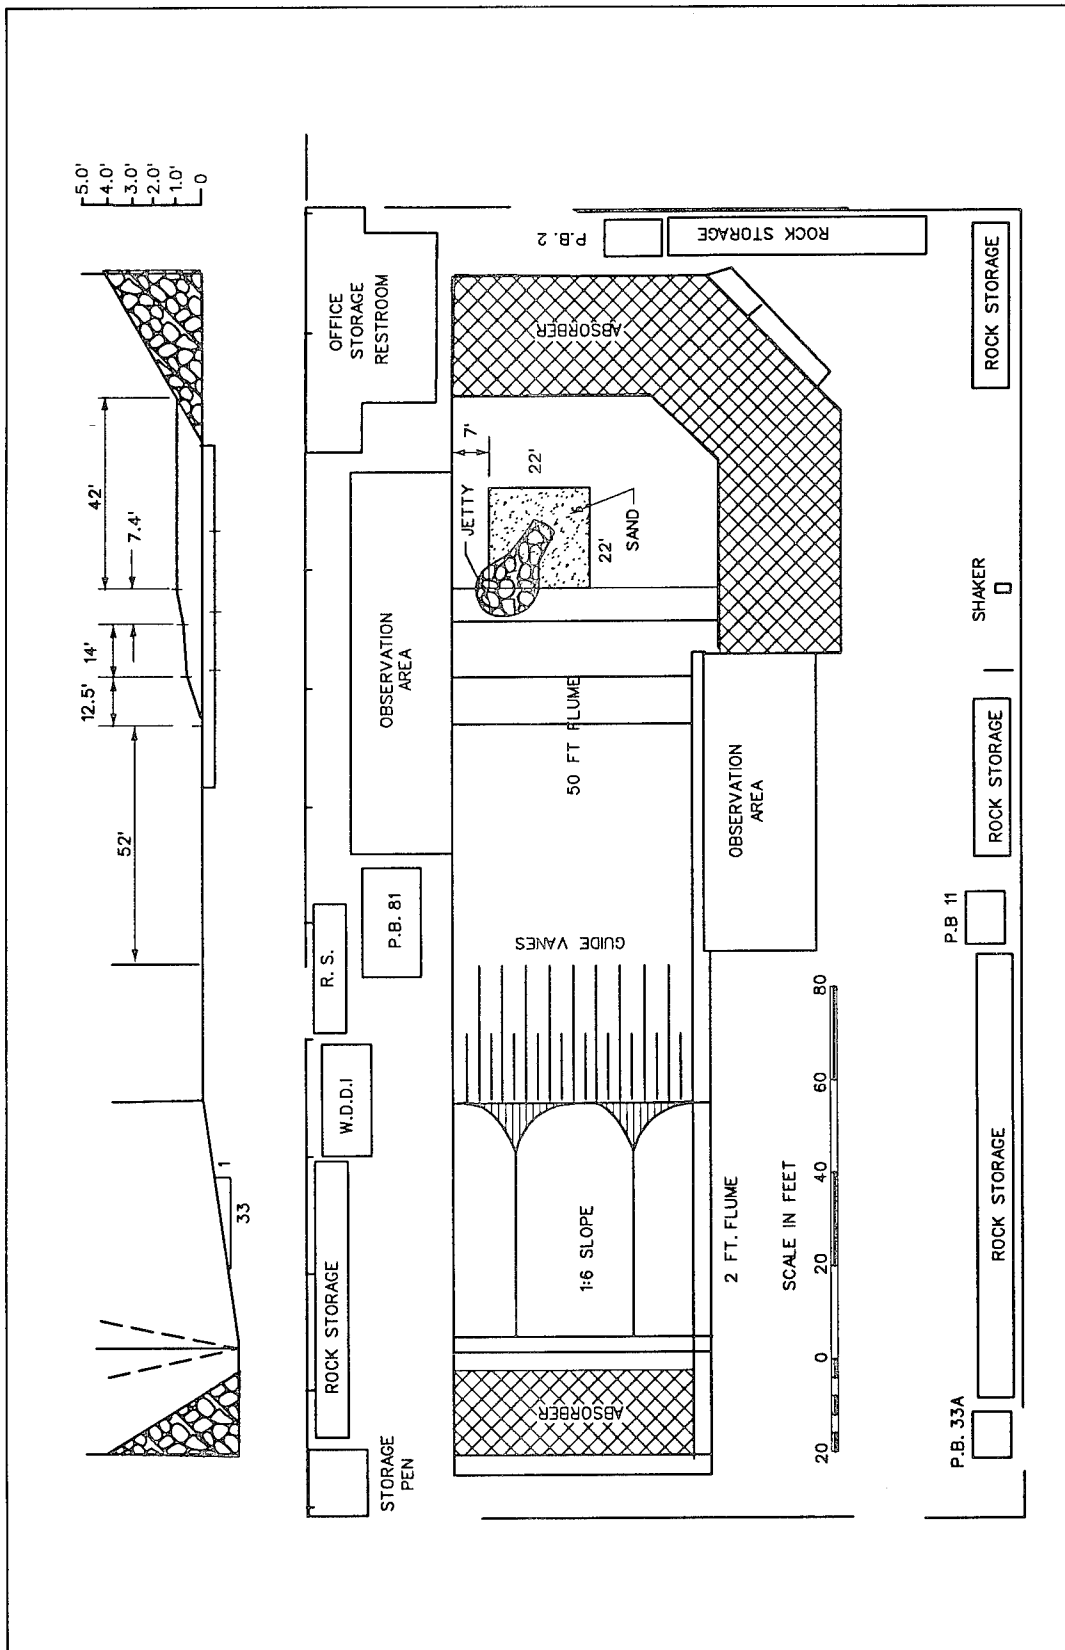
Figure 62. L-Shaped Flume plan view with movable-bed Yaquina Bay north jetty model

- b. The movable-bed portion of the model consisted of a sand pit located in the concrete floor of the model facility. The model jetty was constructed over a sand bed (median grain size diameter 0.13 mm) with the tip of the jetty resting on the concrete bottom, which simulated the hard reef bottom (see Figure 62). The straight edge of concrete next to the sand bed was used to represent the landward edge of the Yaquina Reef. (In the prototype this demarcation line is not straight.)

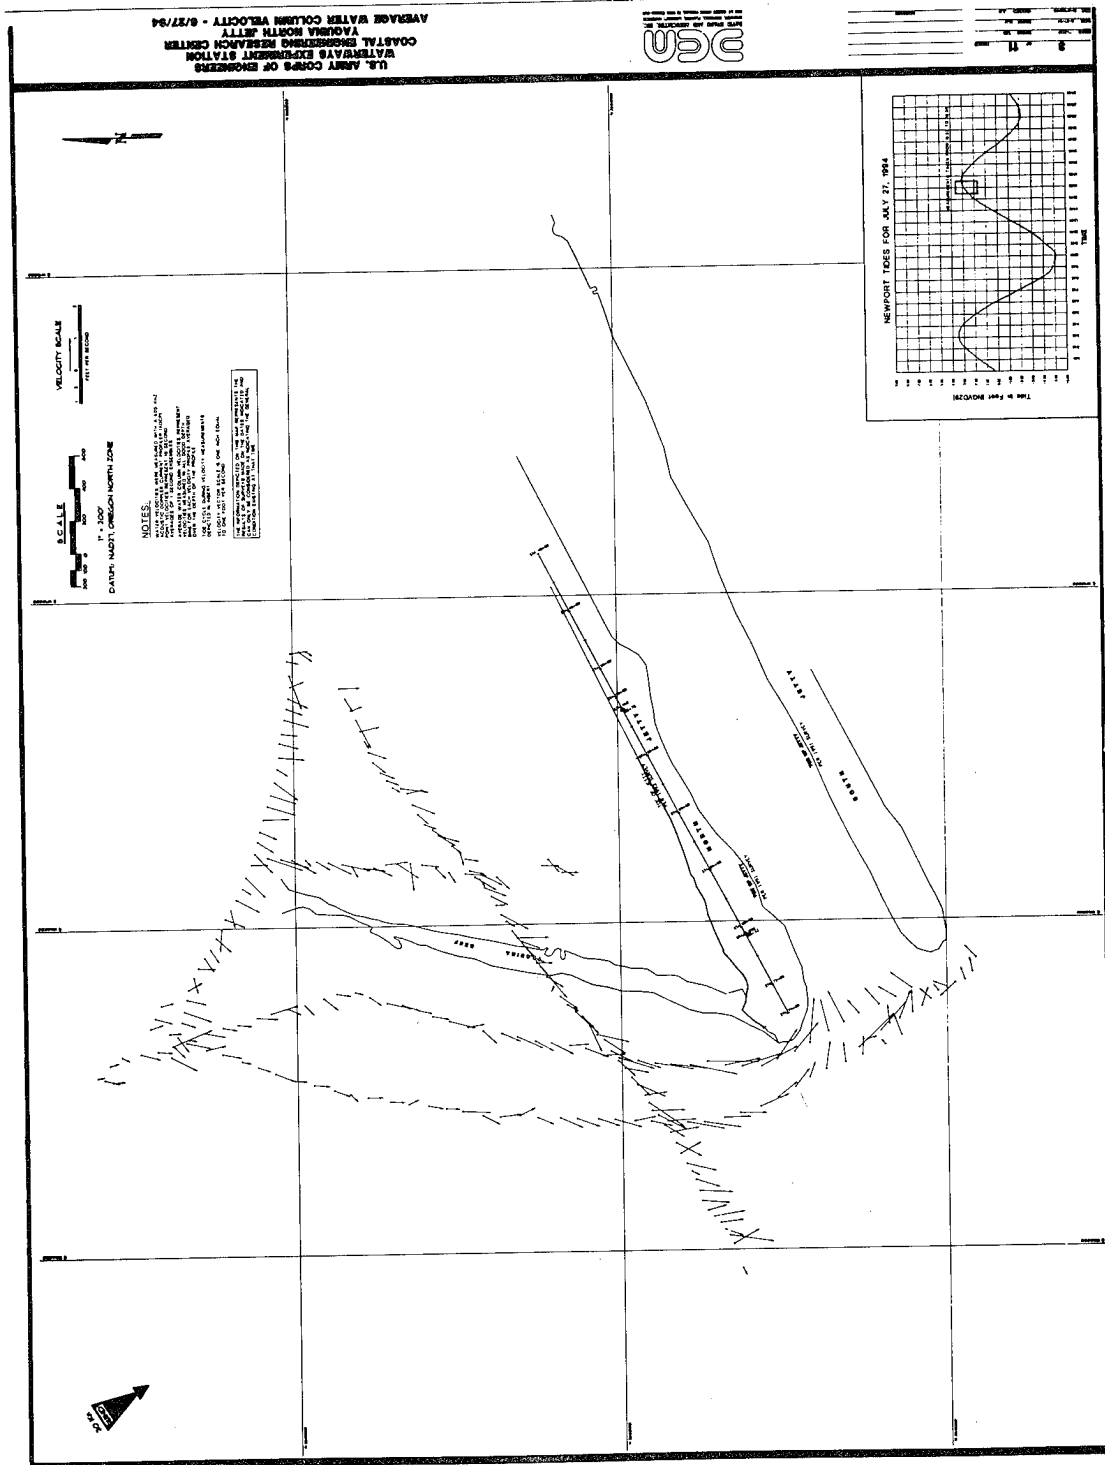
Figure 67. Depth-averaged current velocity vectors at Yaquina Bay north jetty (27 June 1994)

The currents shown on Figure 67 indicated a fairly uniform southerly longshore current of about 20-30 cm/s (0.7-1.0 ft/s). Closer to the north jetty, flow was directed seaward parallel to the jetty, but magnitudes on this trackline were not very large. From the data it cannot be determined if higher seaward velocities were present closer to the north jetty. Current magnitude increased close to the jetty tip due to flood currents in the entrance channel. Despite moderately rough conditions, flow velocities measured on June 27 did not appear to be out of the ordinary.

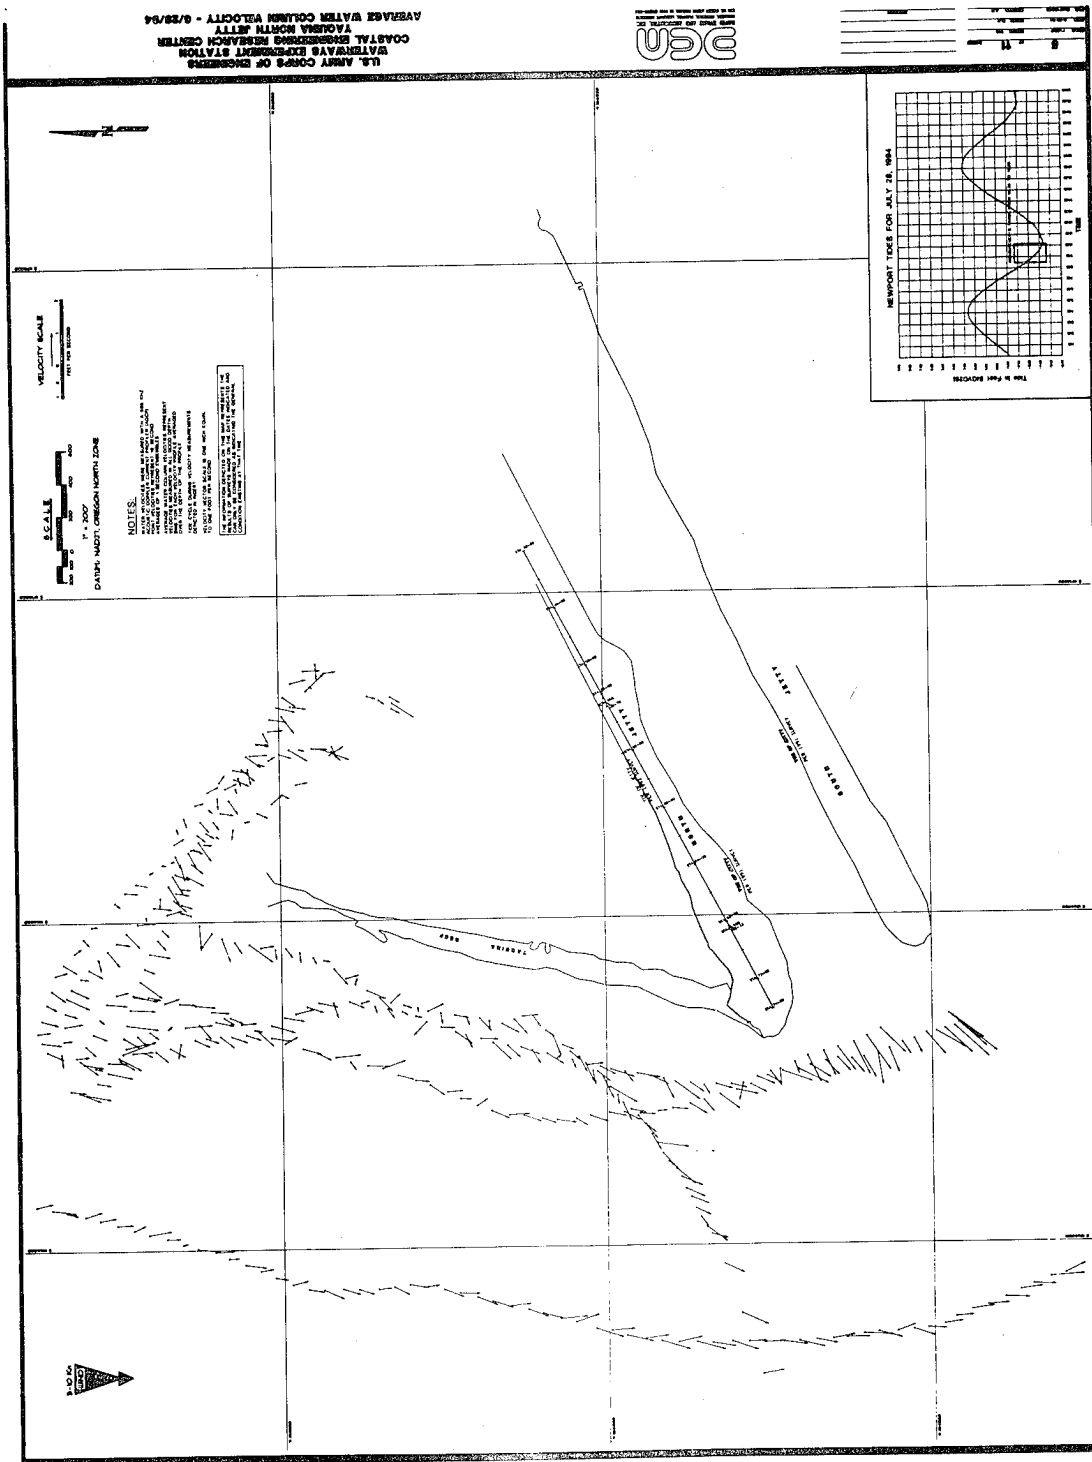
Figure 68. Depth-averaged current velocity vectors at Yaquina Bay north jetty (28 June 1994)

Waves consistently breaking over Yaquina Reef at low tide prevented the survey vessel from running tracklines landward of the reef parallel to the north jetty or parallel to the reef. Consequently, the vector plot of Figure 68 provides information primarily on current patterns seaward of the reef and entrance system. Close to the reef, the longshore current field exhibited fairly constant current magnitudes less than 30 cm/s (1 ft/s), but current direction varied substantially about the mean southerly direction. Farther offshore, the southerly longshore currents appeared more uniform both in magnitude and direction. Ebb currents were present across the Yaquina Bay entrance, but at this stage of the tide, little tidal influence was evident along the seawardmost trackline.

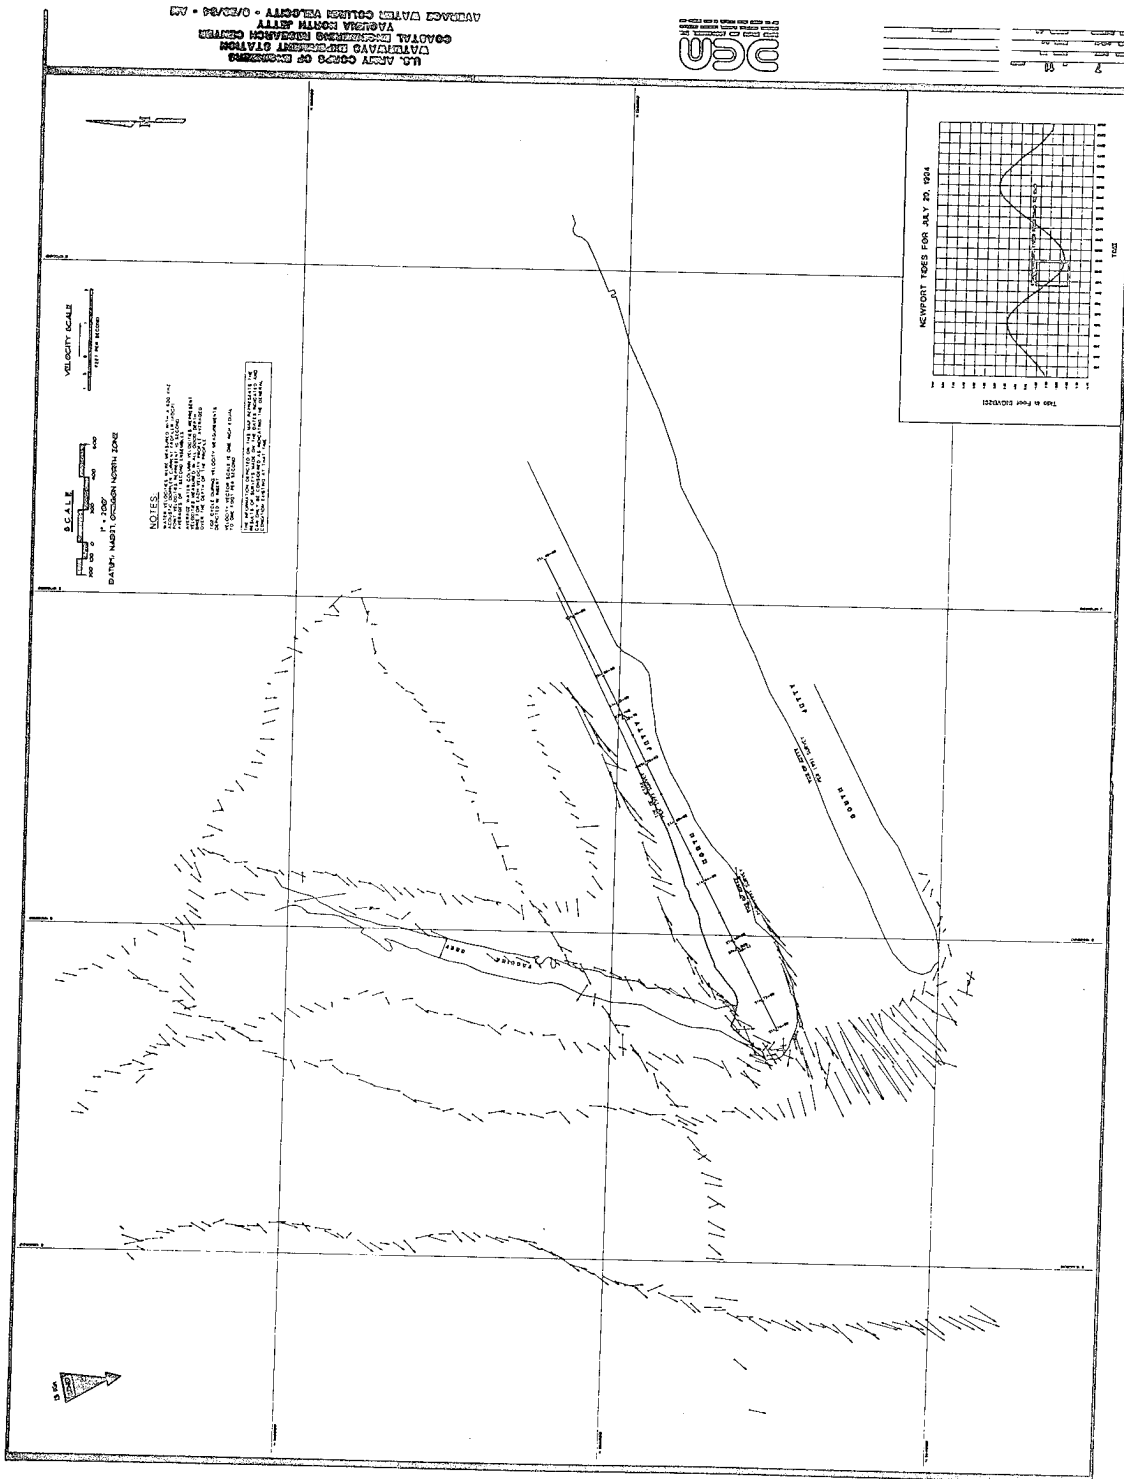
Figure 69. Depth-averaged current velocity vectors at Yaquina Bay north jetty (morning of 29 June 1994)

the lower corner of the figure. Longshore current velocities were relatively weak with average magnitudes around 10-20 cm/s (0.3-0.7 ft/s) during the survey period. However, even with this weak forcing, the role played by the north jetty in accelerating the longshore flow and redirecting it seaward is evident. Largest flow velocities on Figure 69 correspond to the ebb tidal flow at the navigation entrance.

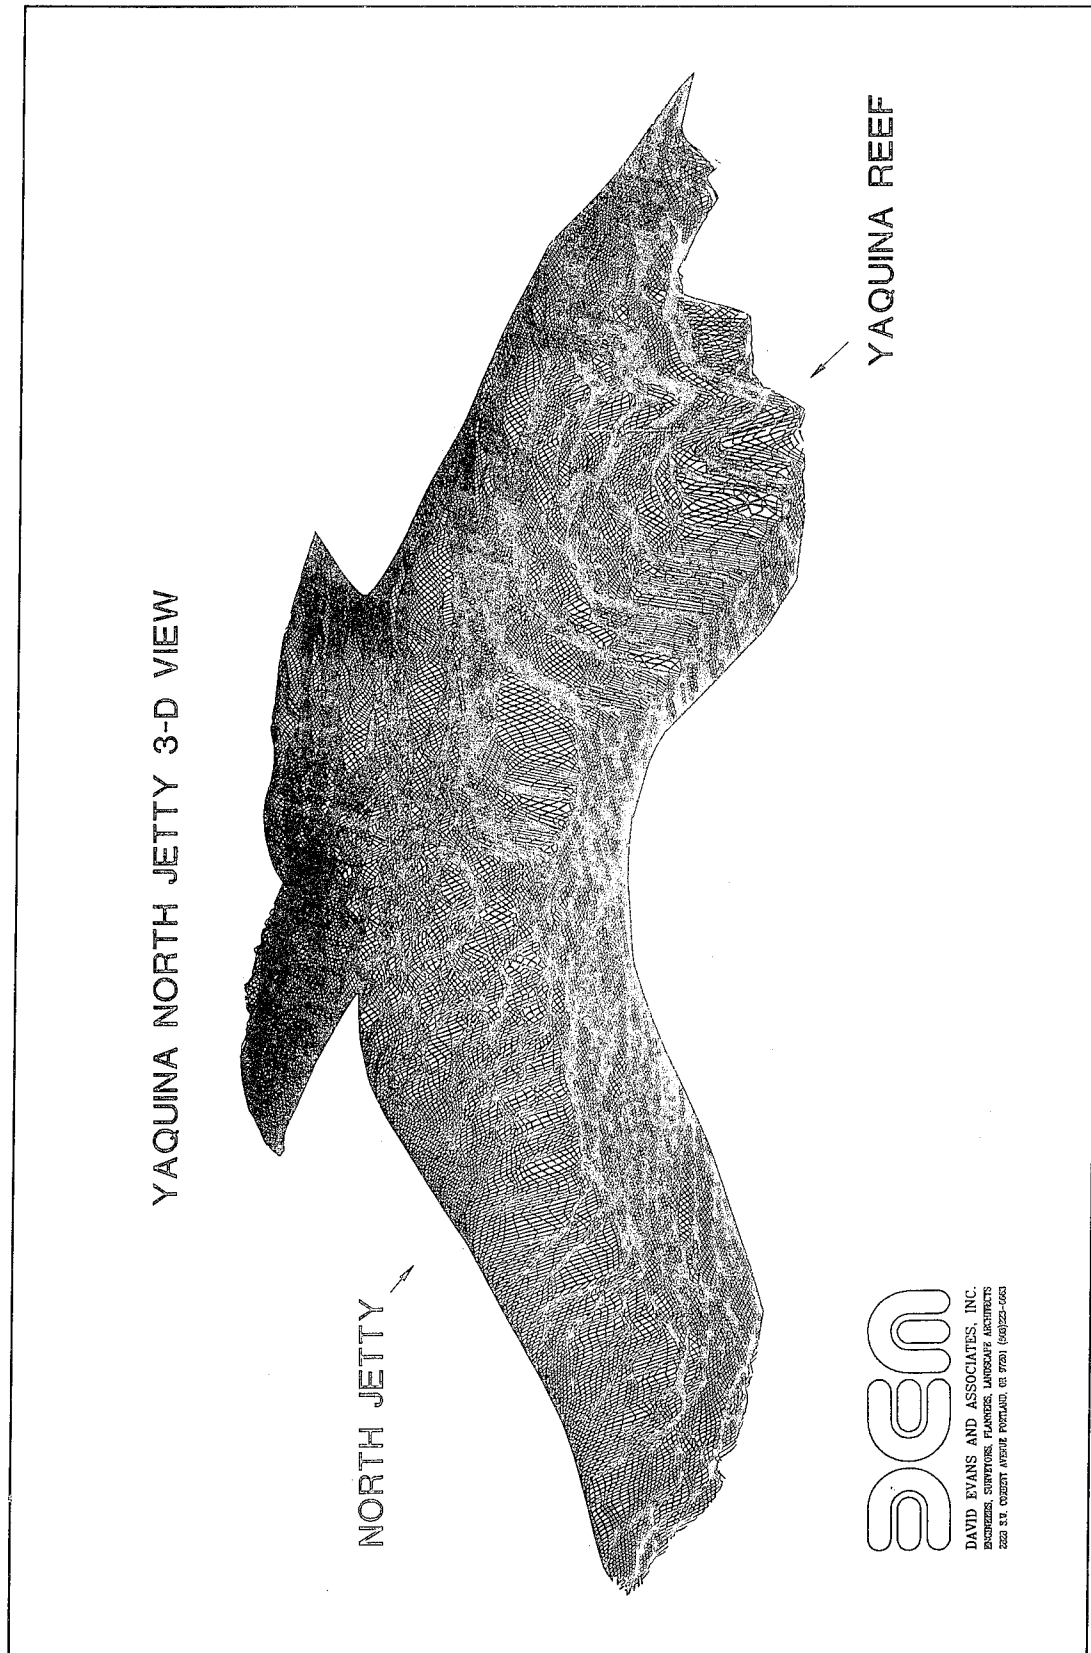
Figure 72. Orthographic "mesh" of Yaquina Bay north jetty and Yaquina Reef below-water bathymetry

Corrected elevation and position data from all the SEABAT tracklines were used in a digital terrain model to create a three-dimensional "mesh" of the seafloor, Yaquina Reef, and underwater portion of the north jetty covered by the survey. Figure 72 presents a view of this mesh from a perspective landward of Yaquina Reef and to the northeast of the north jetty tip. The north jetty is shown extending seaward from the left of the figure and intersecting with the reef. The smooth line to the top of the jetty mesh portion represents the uppermost limit of SEABAT data.

Note in particular on Figure 72 that the north jetty underwater slope becomes very mild toward the location where the jetty intersects with Yaquina Reef. This mild slope is assumed to consist of relic armor stone left from the last two rehabilitations. Also notice the very steep face on the landward side of Yaquina Reef. This reef formation could have significance in helping to direct longshore flowing currents seaward along the jetty.

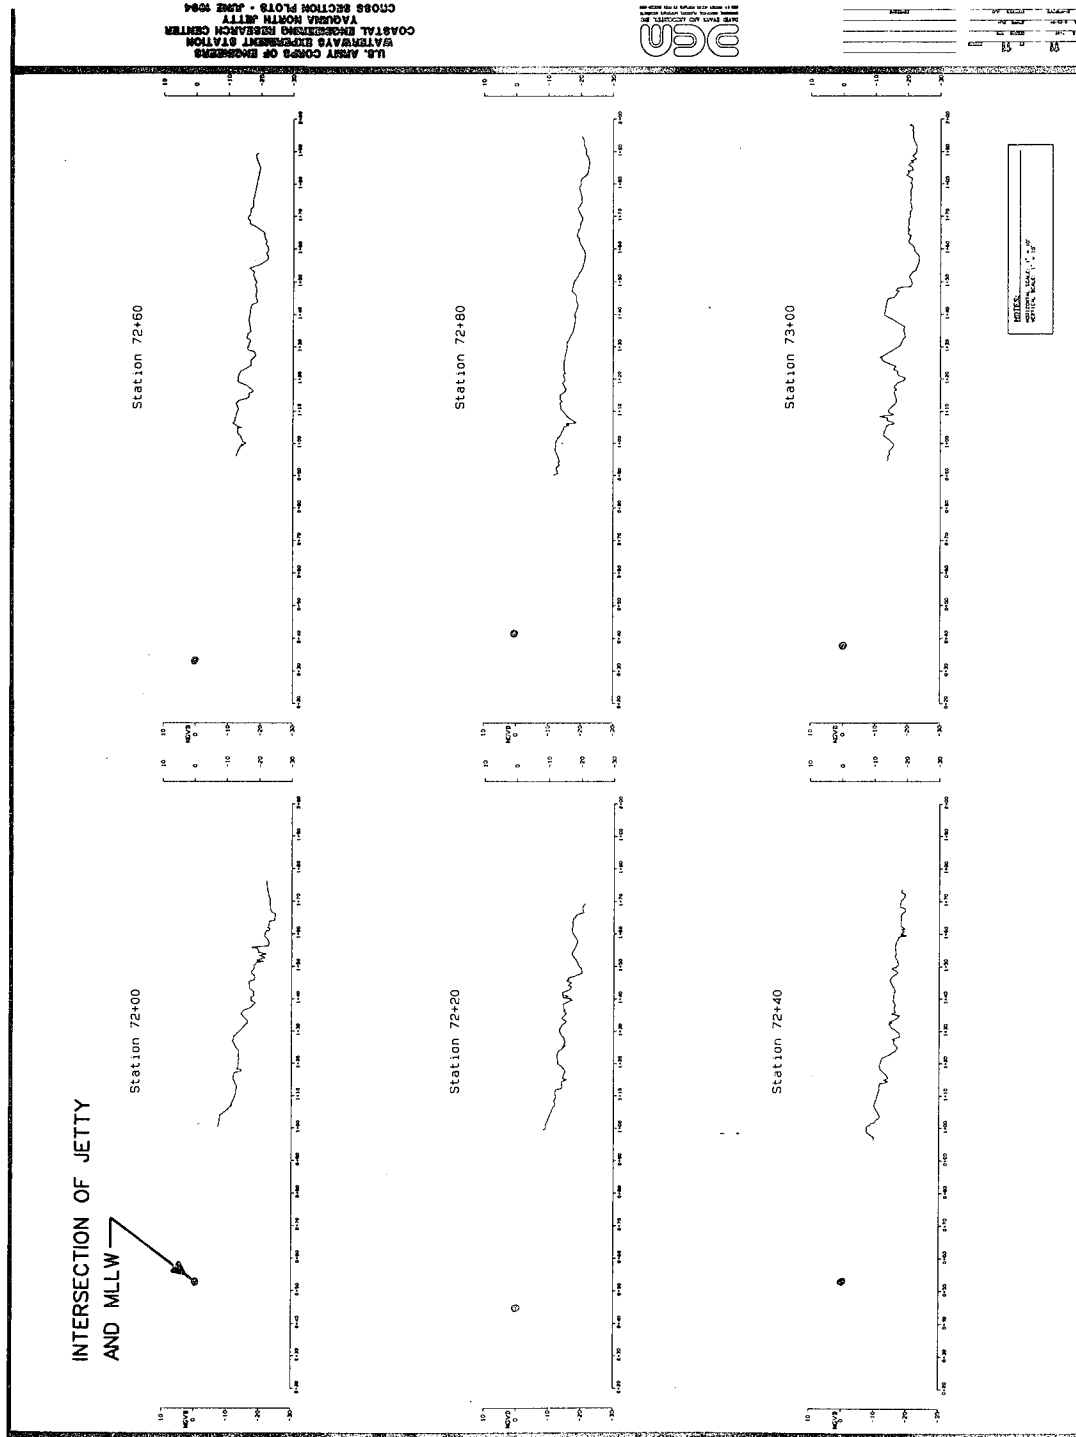
Figure 73. Underwater SEABAT profiles of the north side of the Yaquina Bay north jetty

The SEABAT elevation data were referenced to the same coordinate system used to display the photogrammetric elevation results for the above-water portion of the jetty. This allowed construction of cross-section profiles from the 0.3-x 0.3-m (1-ft x 1-ft) mesh grid that corresponded to selected jetty stations. Underwater profile cross sections for north jetty stations 72+00 through 73+00 are shown on Figure 73. The profiles are drawn at a scale that is only slightly distorted. The black dot drawn on each profile represents the approximate position of the north jetty profile at the mllw datum. The gap

between the dot and the profile is the region of the jetty that could not be surveyed by either photogrammetric methods or by SEABAT.
