USACERL Technical Report 95/02 May 1995

Thermal Energy Supply Optimization for Aberdeen Proving Ground-Edgewood Area

Distribution System Condition Assessment and Recommendations

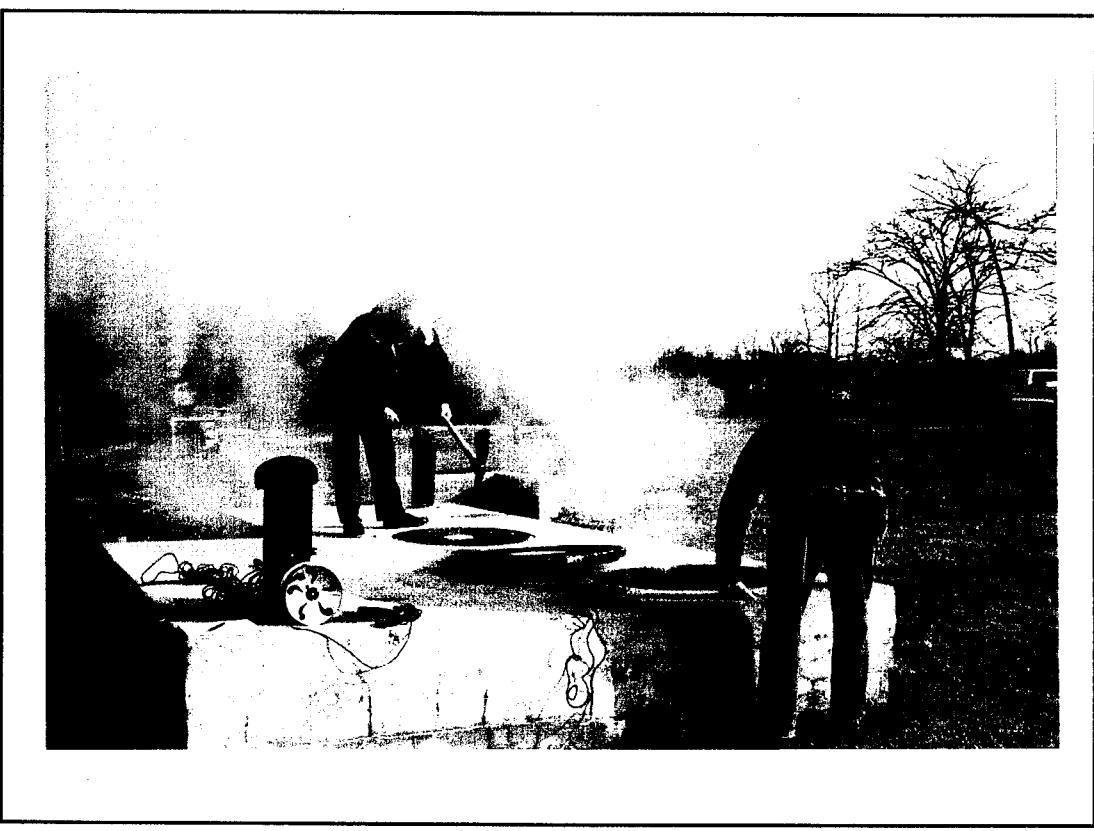
Figure 15. Typical steaming manhole (no. 5220) with standing water.

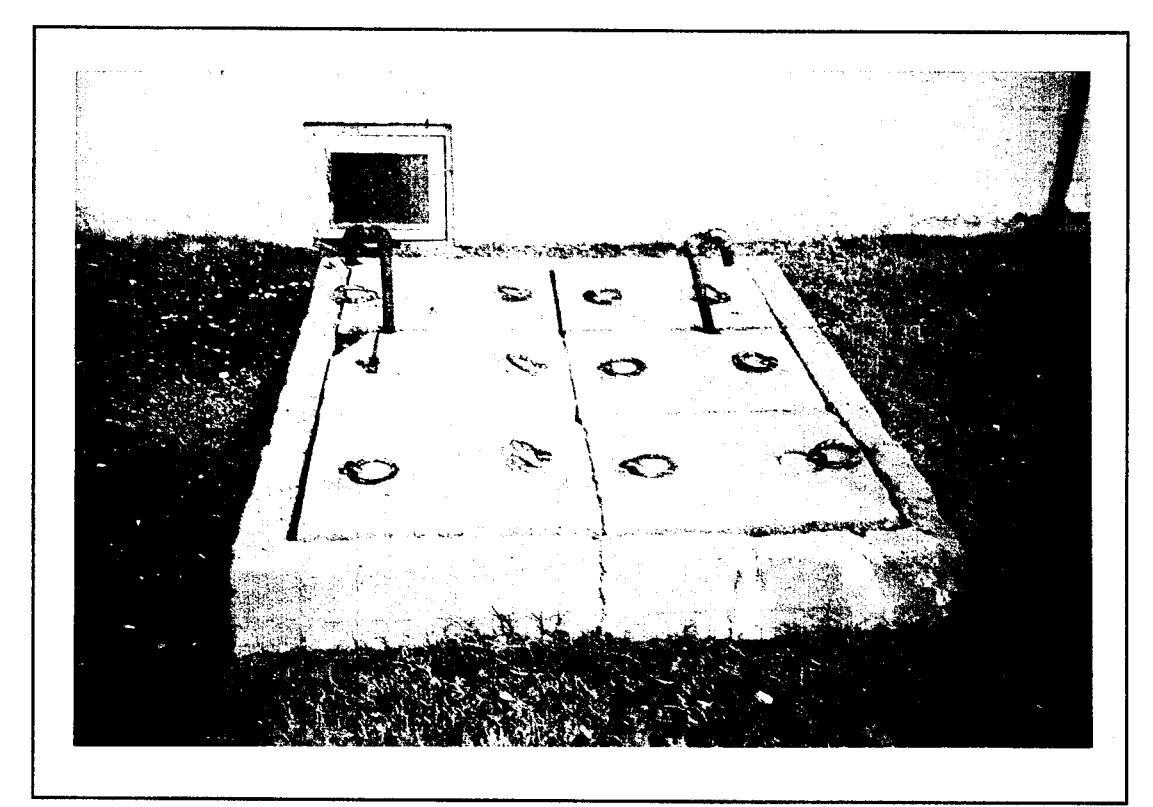
One manhole with an excessively heavy concrete manhole cover was observed (Figure 22). Such manhole covers make it very difficult to perform maintenance or inspections in the manhole.

Figure 22. Excessively heavy concrete manhole cover in the 4000 area.
