1. AGENCY USE ONLY (Leave blank)		2. REPORT DATE 04/00/86	3. REPORT TYPE AND DATES COVERED	
4. TITLE AND SUBTITLE PHASE I OF ROCKY MOUNTAIN ARSENAL SEWER INVESTIGATIONS, INTERIM REPORT			5. FUNDING NUMBERS

INTERIM REPORT:  
PHASE I OF ROCKY MOUNTAIN ARSENAL  
SEWER INVESTIGATIONS

Prepared by  
Morrison-Knudsen Engineers, Inc.  
Denver, Colorado 80290

April, 1986

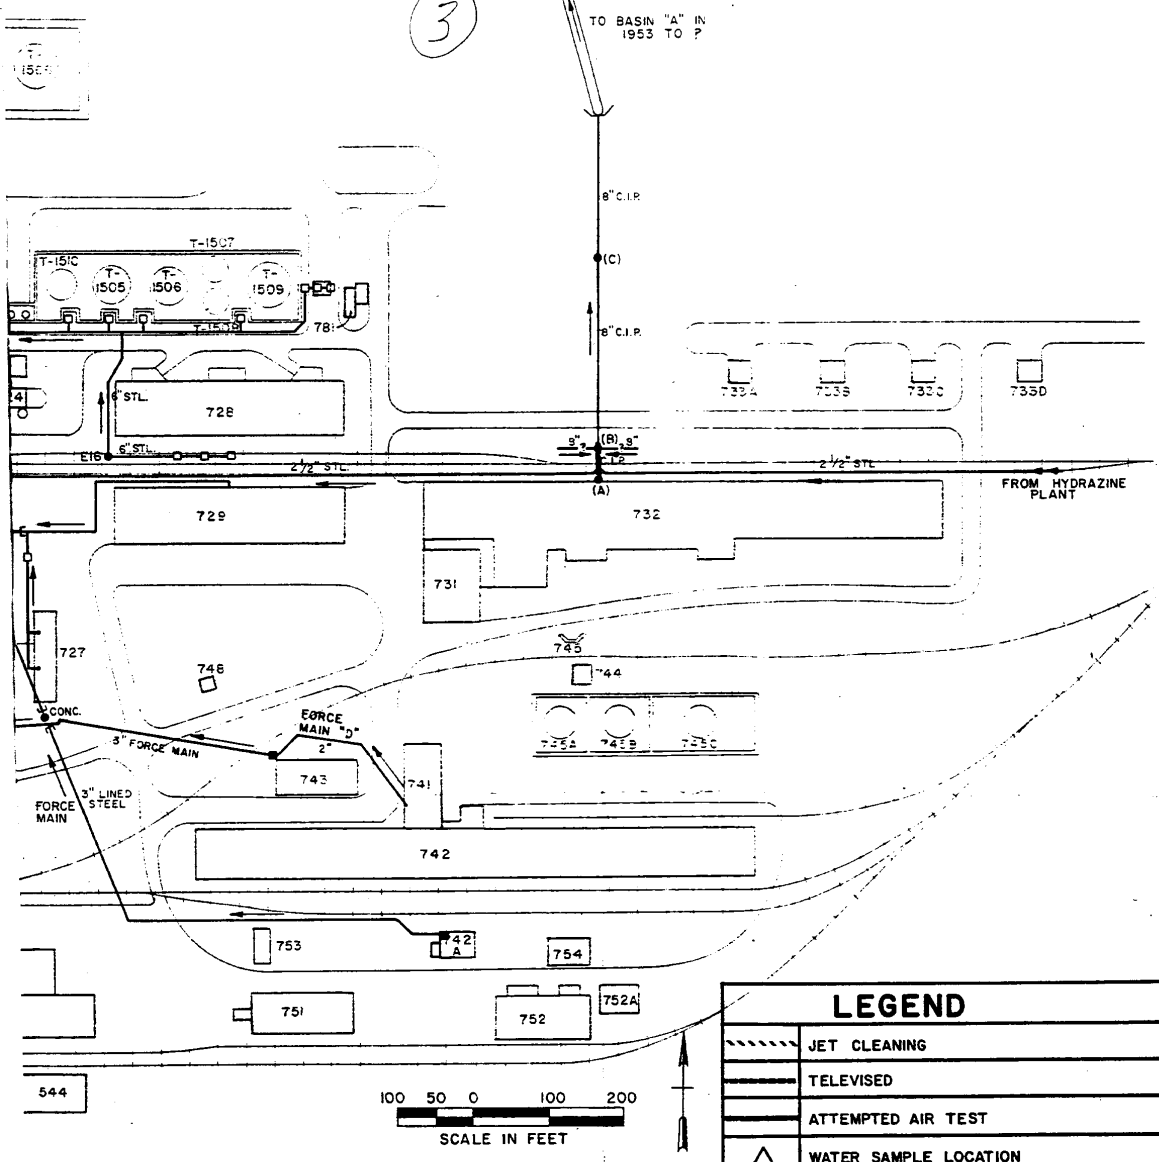
LEGEND			
////	JET CLEANING		
----	TELEVISED		
---	ATTEMPTED AIR TEST		
△	WATER SAMPLE LOCATION		
○	CANDIDATE EXCAVATION SITE		
<b>ROCKY MOUNTAIN ARSENAL SEWER INVESTIGATIONS</b>			
FIGURE 3.8 SAMPLING AND FIELD INVESTIGATION SITES, EAST SIDE OF SOUTH PLANTS CONTAMINATED SEWER			
Drawn By: SMR	Date	Scale: 1"=100'	Exhibit No.
App'd. By: ALN	4-17-86	Date: 4-17-86	
Design By:	Date	Draw. No.:	
App'd. By:			
<b>MORRISON-KNUDSEN ENGINEERS, INC.</b> <small>A MORRISON KNUDSEN COMPANY</small> 1700 Broadway, Suite 1600 Denver, Colorado 80290

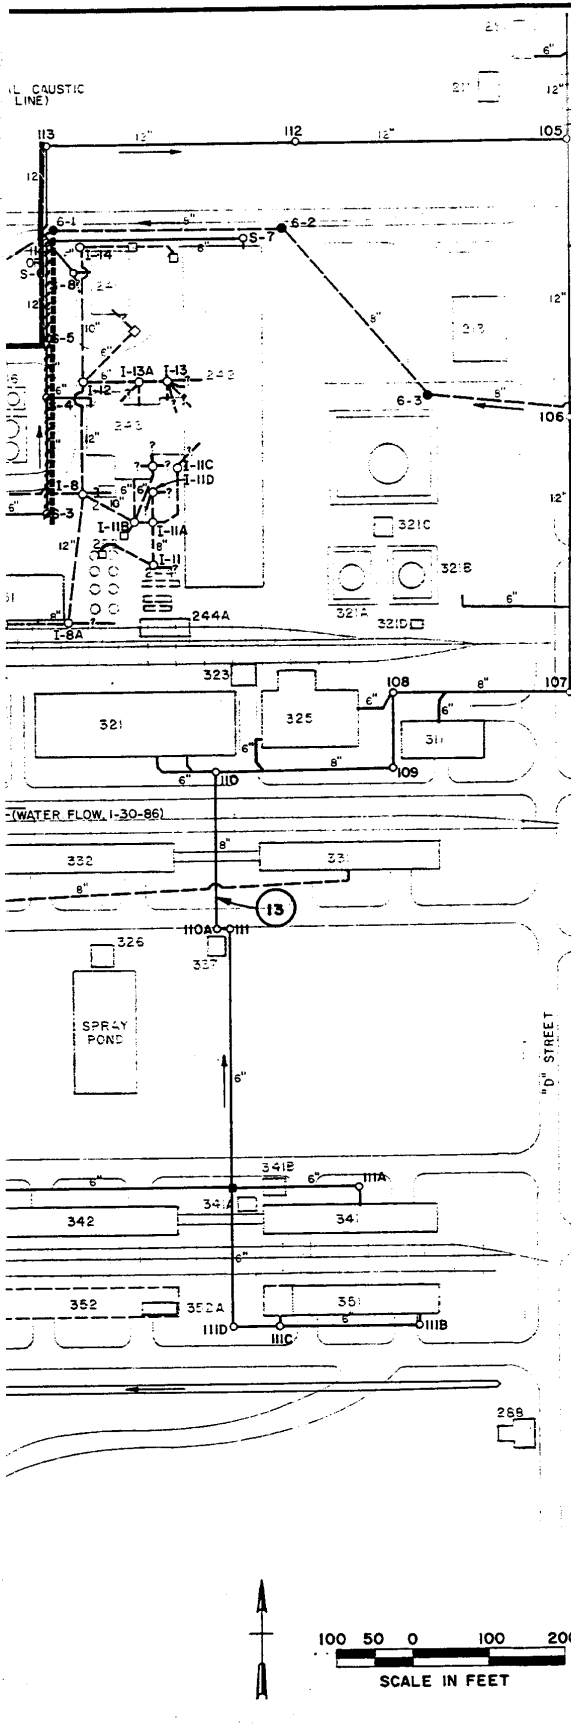
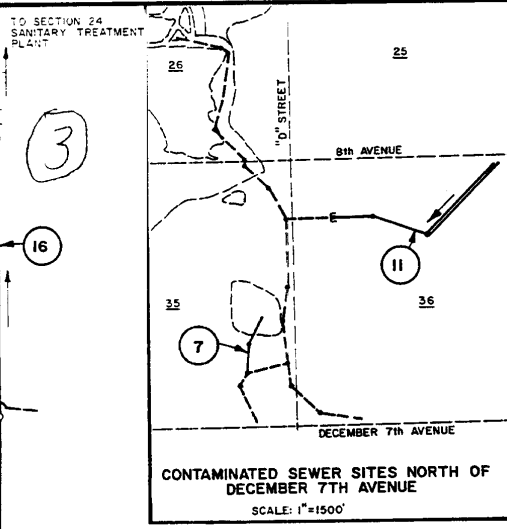
LEGEND			
	JET CLEANING		
	TELEVISED		
	ATTEMPTED AIR TEST		
	WATER SAMPLE LOCATION		
	CANDIDATE EXCAVATION SITE		
<b>ROCKY MOUNTAIN ARSENAL SEWER INVESTIGATIONS</b>			
<b>FIGURE 3.6 SAMPLING AND FIELD INVESTIGATION SITES, WEST SIDE OF SOUTH PLANTS SANITARY AND CONTAMINATED SEWERS</b>			
Drawn By: SMR	Date: 4-17-86	Scale: 1"=100'	Sheet No.:
App'd. By: ALN	Date:	Date:	
Design By:	Date:	Orig. No.:	
App'd. By:			
<b>MORRISON-KNUDSEN ENGINEERING, INC.</b> 1700 Broadway, Suite 1601 Denver, Colorado 80290
