Materials for Oxygenated Wastewater Treatment Plant Construction

(U.S.) Bureau of Reclamation, Denver, CO

July 1978

1. REPORT NO. EPA-600/2-78-136		2.		3. RECIPIENT'S ACCESSION NO.	
4. TITLE AND SUBTITLE MATERIALS FOR OXYGENATED WASTEWATER TREATMENT PLANT CONSTRUCTION				5. REPORT DATE July 1978 (Issuing Date)

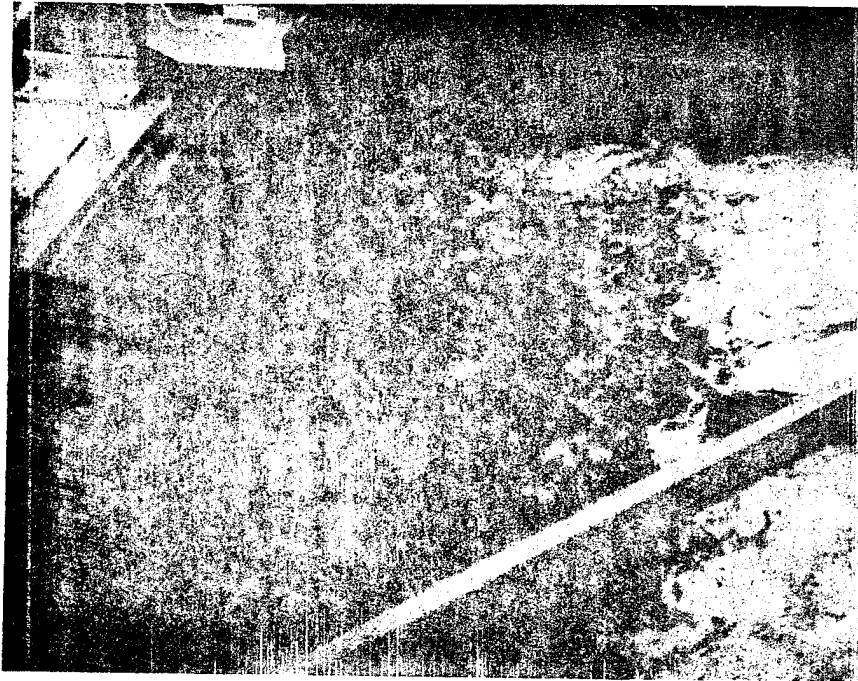
Figure 6. View of site 3 tank with cover removed to show splashing caused by the surface impeller. Test specimens were exposed to this splash zone effect.

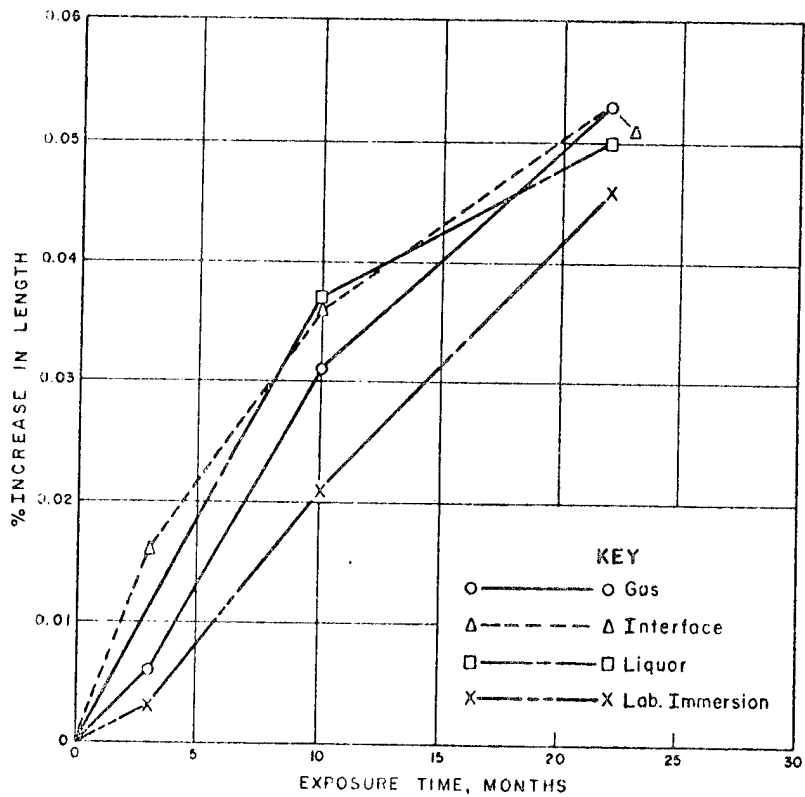
FIGURE 12. EFFECT OF SITE I EXPOSURE AND LABORATORY IMMERSION EXPOSURE ON LENGTH OF POLYMER IMPREGNATED CONCRETE

b. The effect of site exposures and laboratory immersion on the lengths of the PIC specimens are shown in figures 12, 13, and 14. The specimens continue to increase in length with duration of exposure. Although much less water is absorbed by the PIC specimens than the two conventional concretes, their increase in length after 22 and 28 months of exposure is of the same order of magnitude as the conventional concretes.
