USACERL Technical Report 96/77  
July 1996

# Investigation of Preapproved Underground Heat Distribution Systems

USACERL investigated and evaluated the physical condition and general performance of drainable-dryable heat distribution systems installed since 1981.

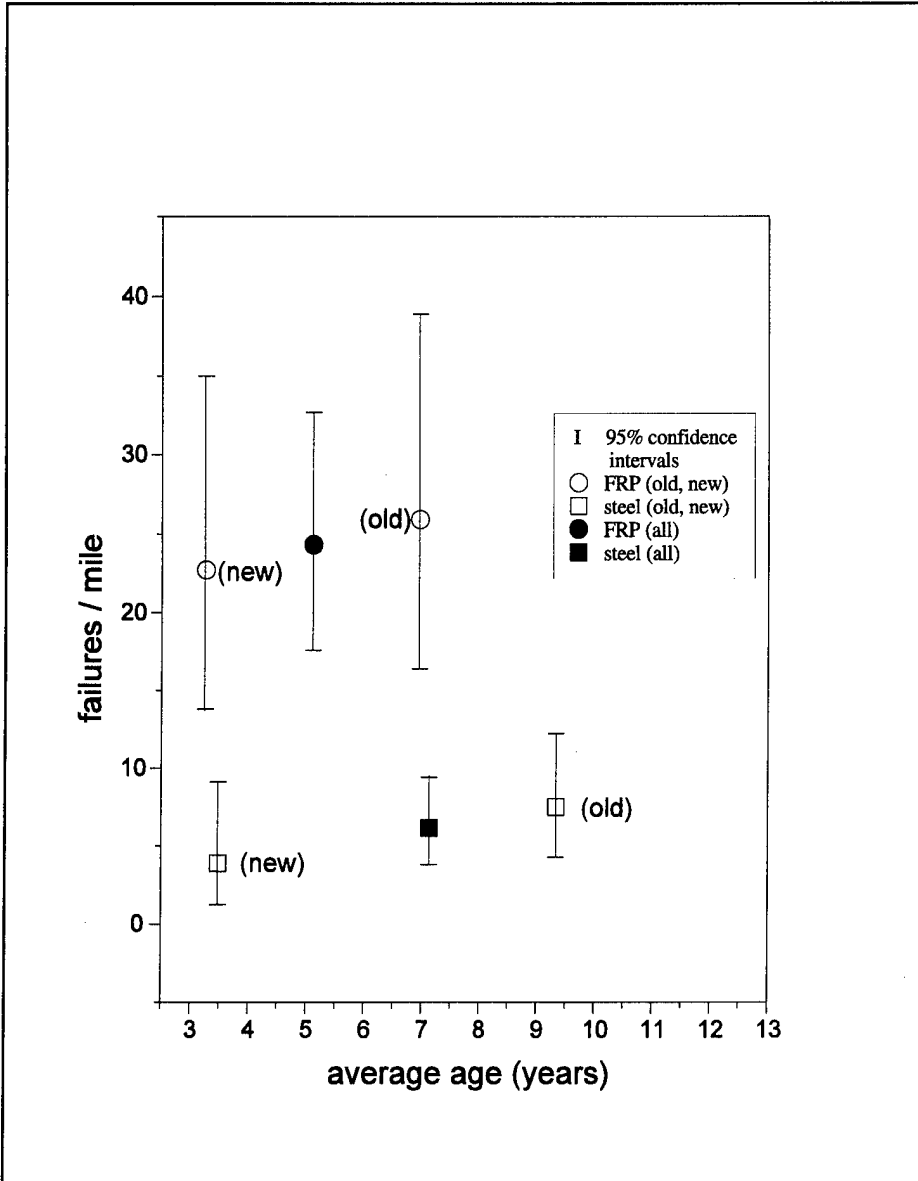
Figure 1a. Failure rates vs. age (Standard I).

However, plotting the results in Tables 11 and 12 may show the general time dependence of the failure rates (Figures 1a and 1b). Accounting for the confidence intervals, the time dependence of the failure rates are not pronounced. The failure rate for FRP conduits appears to decrease slightly as the systems get older. The failure rate for steel appears to increase marginally. However, it would be difficult to call these trends statistically significant.

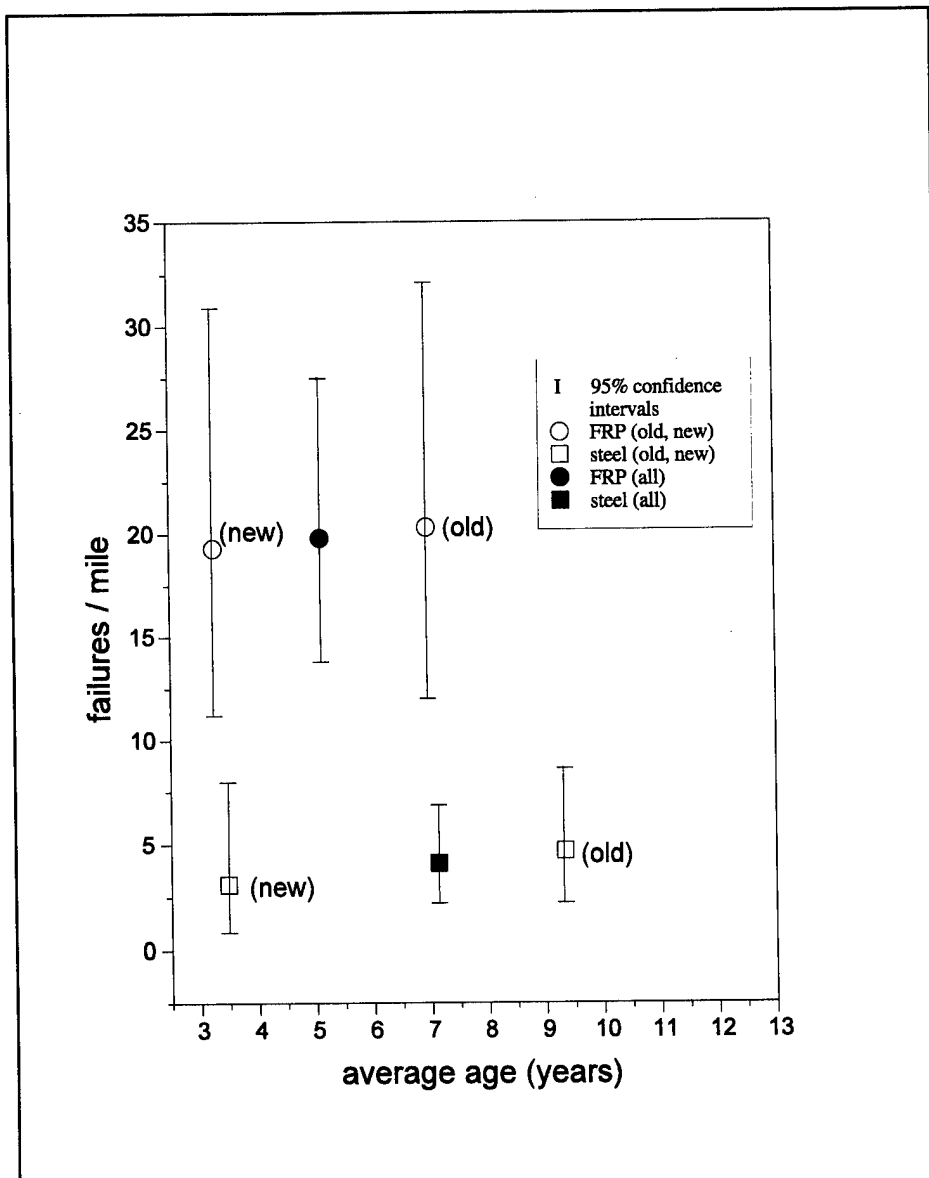
Figure 1b. Failure rates vs. age (Standard II).

Conceivably, some part of the failure rate differences between FRP and steel conduits might be attributed to differences in the ages of the systems being compared. Several analyses of the relationship between failure rate and system age were performed. In the first analysis, the failure rates are compared for "old" systems installed in 1987 or earlier and "new" systems installed in 1988 to the present (Tables 7 and 8). In a second analysis discussed later in this chapter (Tables B1 and B2), failure rates are regressed on the length weighted age of the systems. These tables show that the CIs for the failure rates for old and new systems overlap significantly, whereas those for steel and FRP do not. Therefore conduit material, rather than age, is shown to have the more pronounced and significant effect on the observed differences in failure rates, as presented in Figures 1a and 1b.

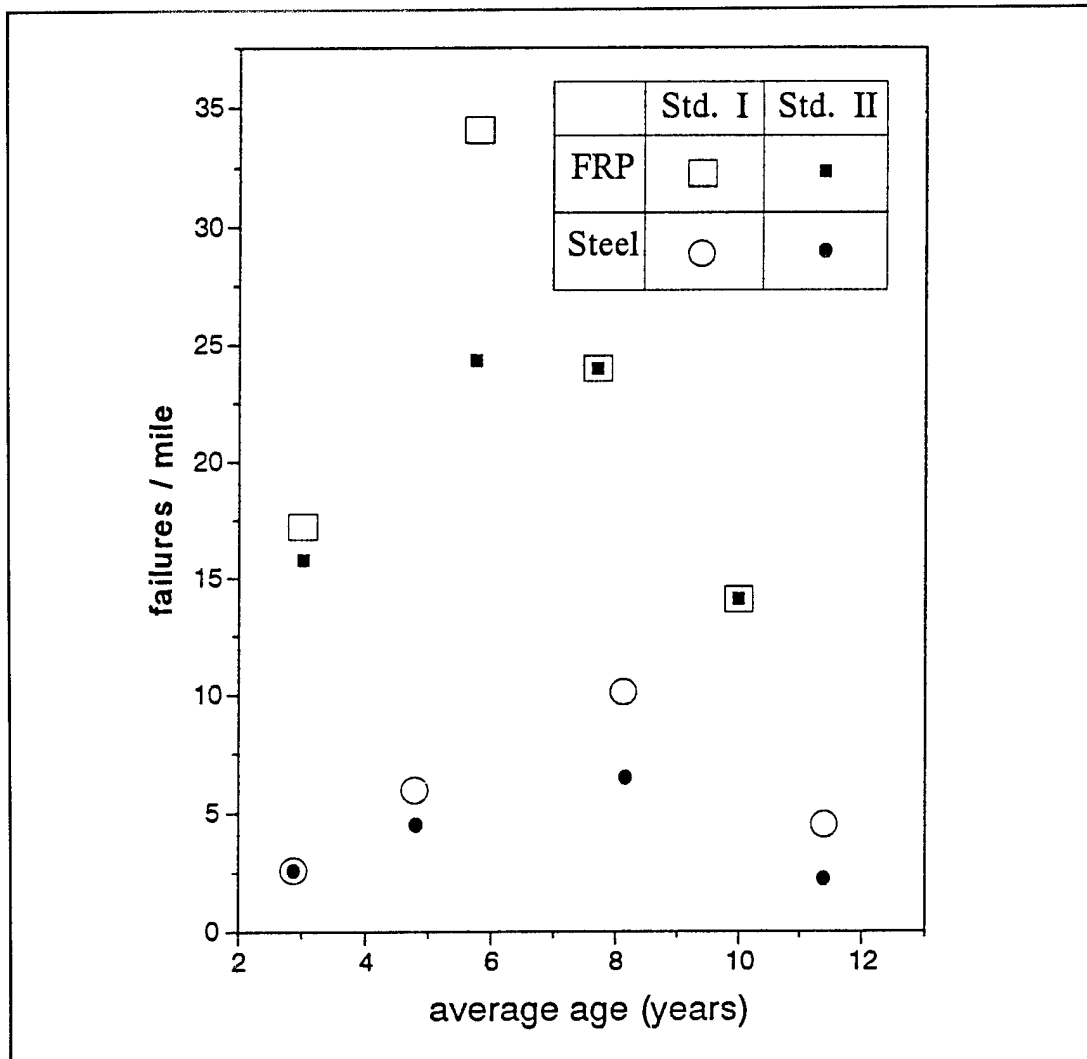
Figure B1. Failure rates versus length-weighted average age for four sequential time periods.

The Pearson correlation coefficient between failure rate and age was found to be quite small ( $R^2 \leq 0.1$ ). A generalized linear model was fit to the data, attempting to explain variation in failure rates with material type (represented by an indicator variable) and

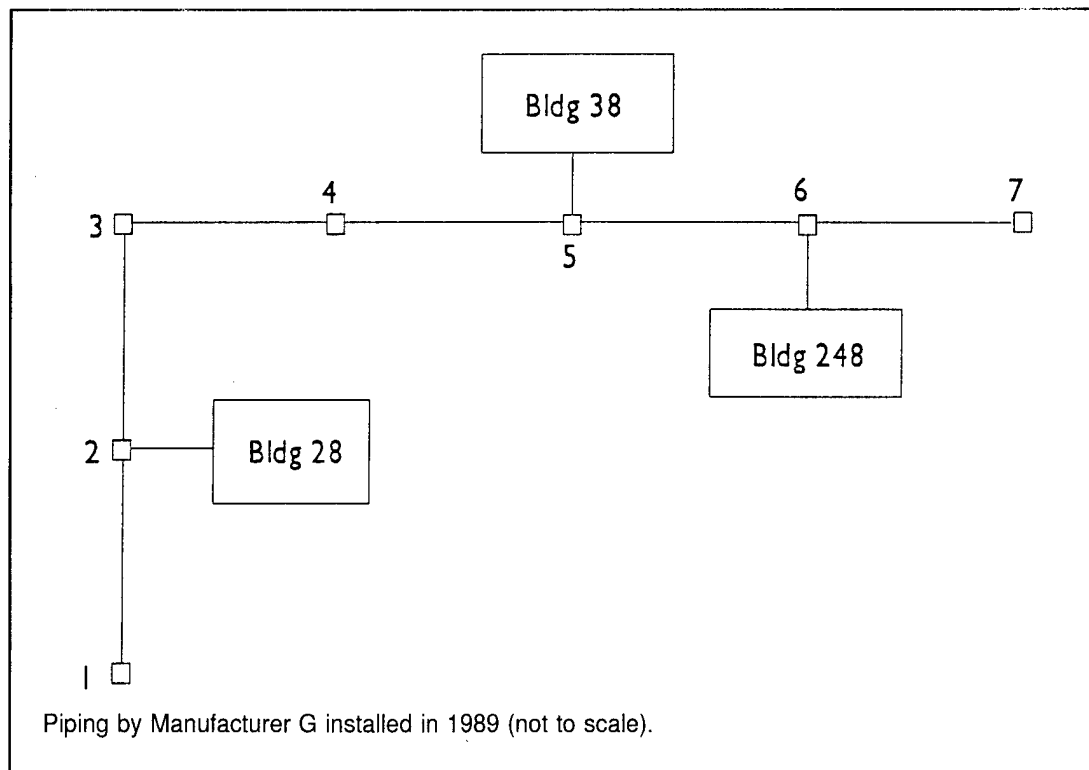
Figure D3. Schematic diagram of System 5 at Wright-Patterson AFB, OH.

encased in conduits of the old polyester resin. The "L"-shaped system runs parallel to Buildings 28 and 38. It then makes a right angle to run along the end of Building 28. Manholes 6 and 7 were in a construction zone and were inaccessible.

c. Pressure Test—The 2-in. line conduit could not be tested because of interference from welded moment guides at both ends of the conduit. The 10-in. conduit was pressurized to 15.25 psi at 9:58 AM. A pressure of 14.5 psi was observed at 11:30 AM when the test was terminated, indicating a slight leakage. This slight drop in air pressure was probably due to incomplete sealing at the gland seals.

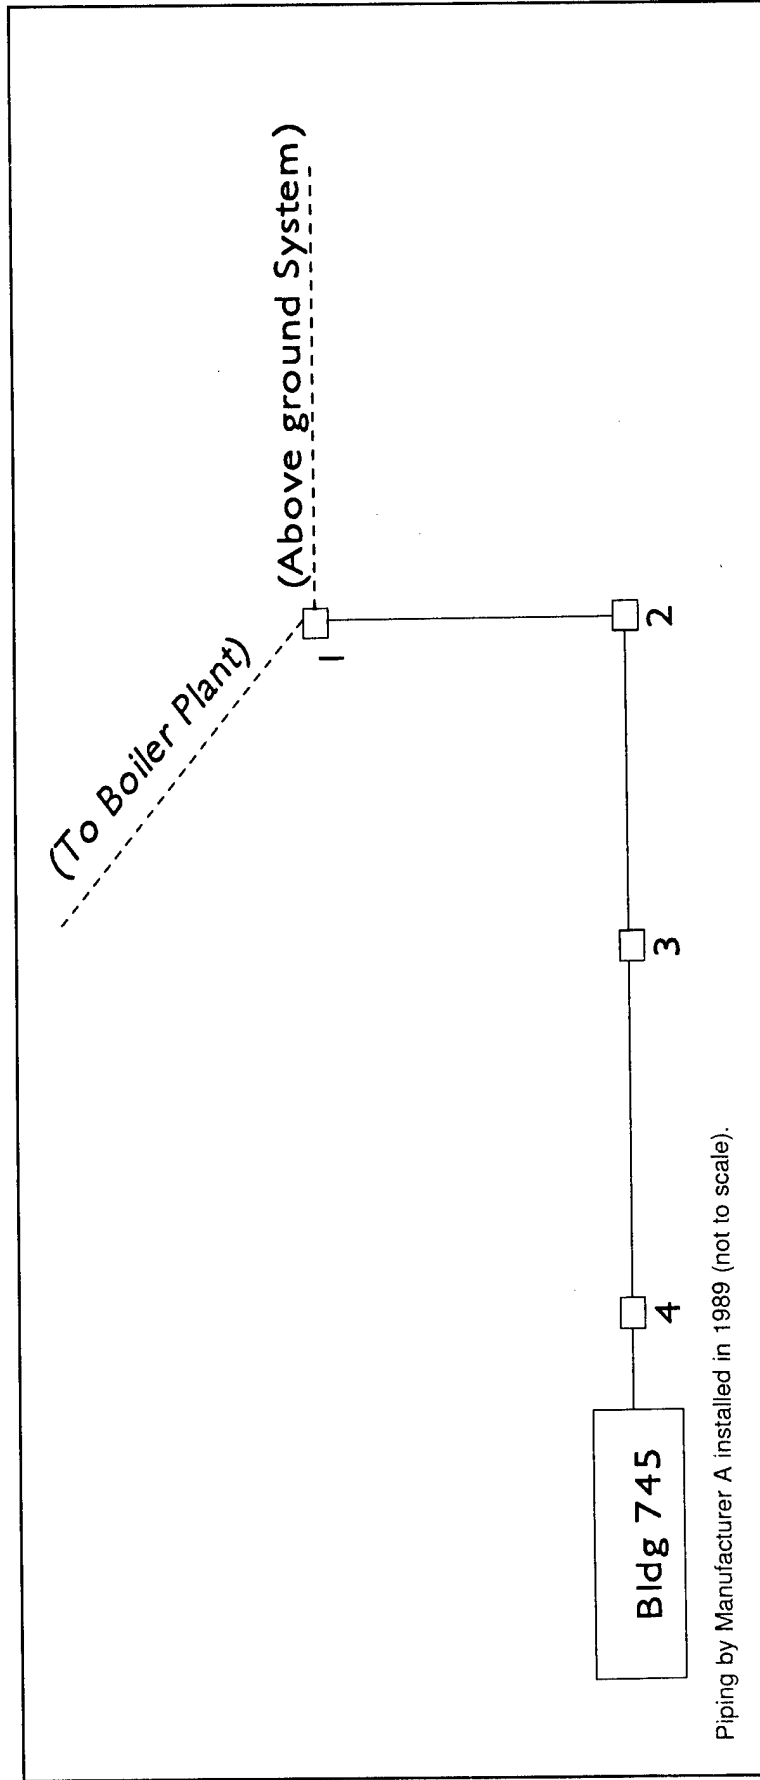
Figure D5. Schematic diagram of System 7 at Wright-Patterson AFB, OH.

8. Detailed Inspection of System #7—This system consists of piping from Manufacturer A and has a steel conduit (Figure D5). The 1989 project was designated WP 54-8, FAC. 07199, and PCF1939. The piping was at the base of a long sloping hill.

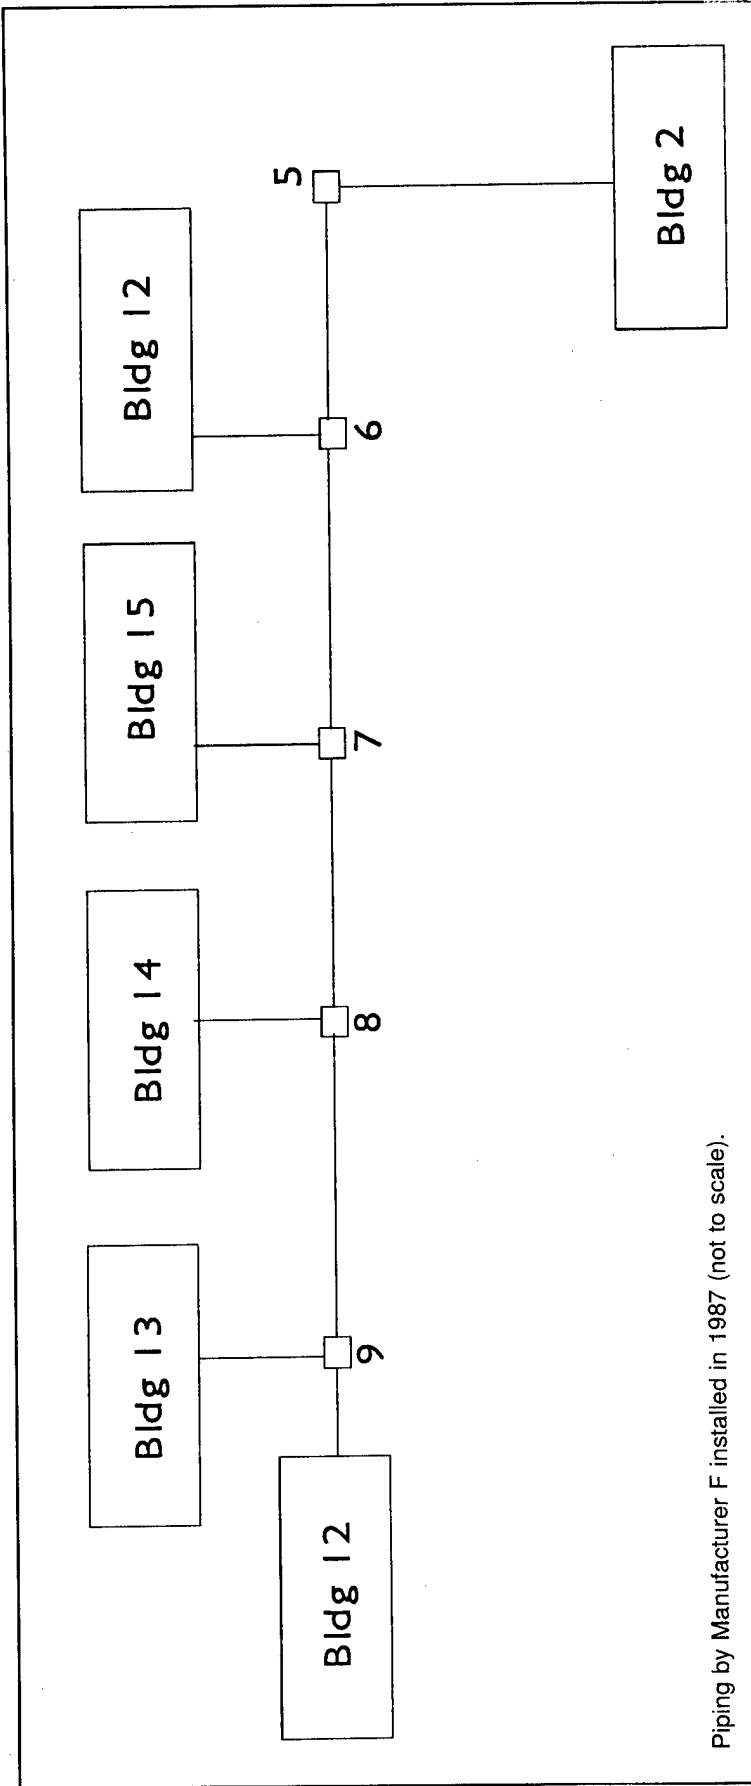
Figure E1. Schematic diagram of System 8 at VA-Bedford, MA.

a. Manhole 5—This manhole was round with a 6-ft diameter, was 9-ft deep, and was a solid concrete top design with a 30-in. manhole cover. No sump pump or means for ventilation were provided, and the manhole contained 3 in. of standing water. A

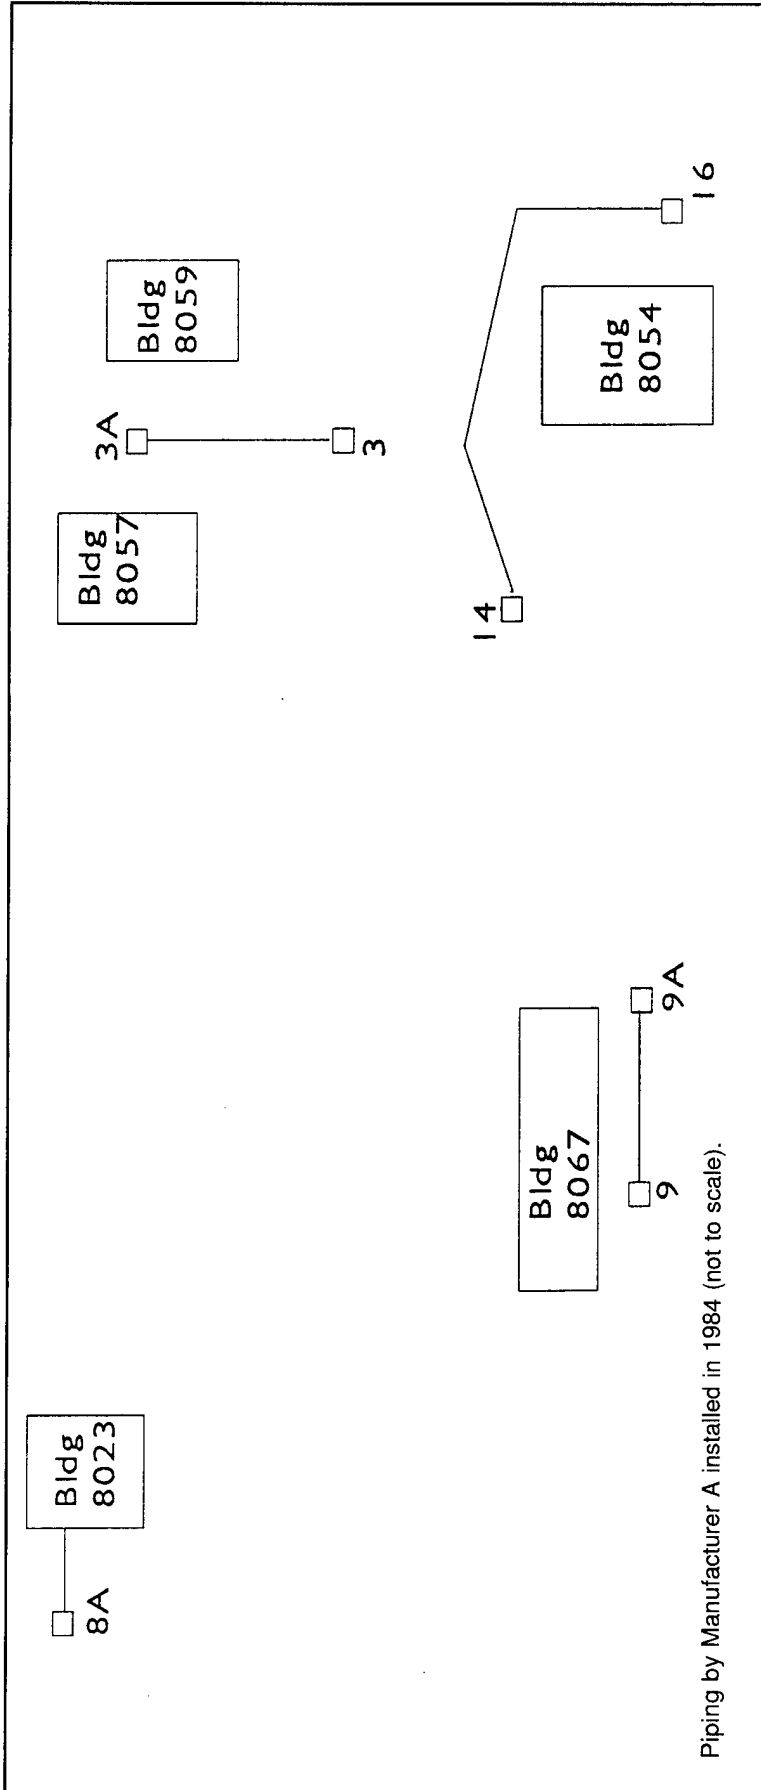
Figure G1. Schematic diagram of System 12 at Fort Riley, KS.

This system consists of piping from Manufacturer A and has a steel conduit (Figure G1). The piping was installed in 1984 and is in the Custer Hill area. Approximately 95 percent of the piping contains both steam and condensate in a common conduit. Cathodic protection has been provided, but many of the isolating flange gasket kits are incomplete. The manhole penetrations for the conduit are sealed only with caulking material.

a. Manhole 3—This manhole was 6 ft × 6 ft × 13 ft deep and was a raised top design with steel plate covers. The transition from a shallow trench system in one wall was made to buried conduits to the other three walls. Each conduit contains both steam and condensate piping. The end plate of the conduit from Manhole 4 was recessed into the manhole wall. All end plates showed minor general corrosion. The manhole was dry, and the sump pump was functioning properly. No evidence of water or steam in the conduits was found.

b. Manhole 3A—This manhole was 6 ft × 6 ft × 9 ft deep and was a raised top design with steel plate covers. All three conduits contained both steam and condensate lines. Each manhole penetration was sealed with caulking material that was badly deteriorated. The manhole was dry, and the sump pump was functioning properly. The dielectric isolation kits on the flanged take offs to Buildings 8057 and 8059 were incomplete. The isolating washers on the flange bolts were missing though steel washers were present.

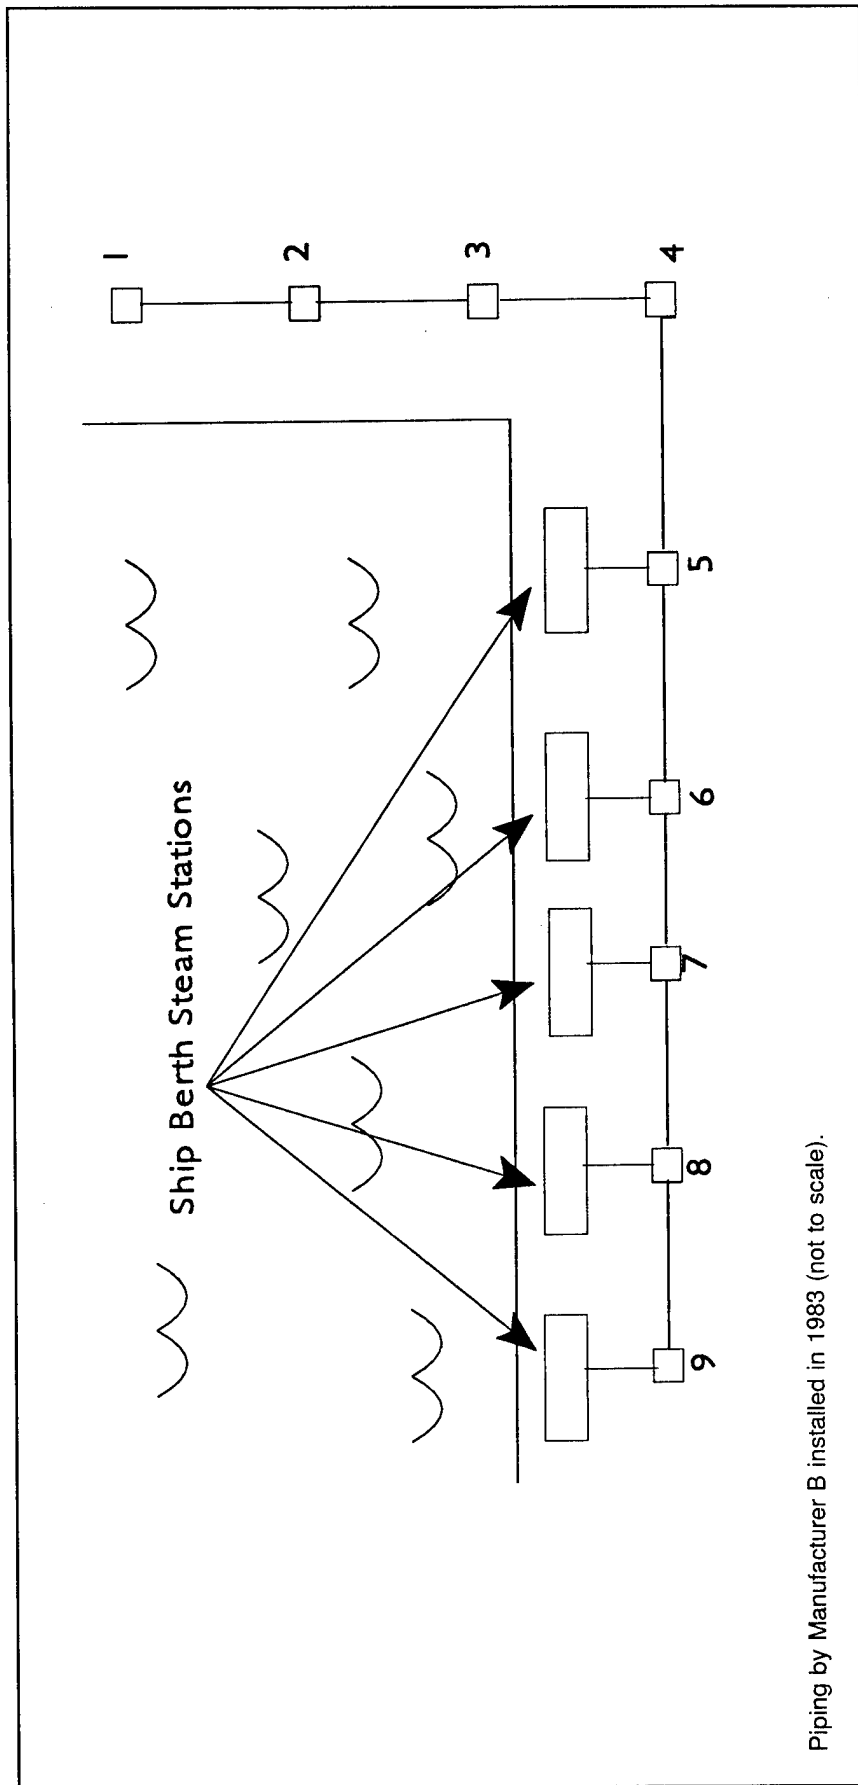
Figure J2. Schematic diagram of System 21 at Mayport Naval Station, FL.

Installed in 1983, this system consists of piping from Manufacturer B and has a steel conduit (Figure J2). A series of nine manholes serves a pier located about 800 ft north of Building 46. No condensate return piping was used. All manholes were of similar construction and design. The manholes were 6 ft × 6 ft × 10 ft deep, and most had one 6-in. manhole vent pipe. Each had solid concrete tops with 30-in.-diameter access with steel covers. No access ladders had been installed. Manhole wall penetrations were cemented and caulked. Gland seals were installed at the conduit end plates. The 8-in. steam line was contained in a 15-in. conduit. Light to very heavy steaming in all but the last manhole prevented entry for inspection. Steam escaping at a fitting was noted in Manhole 8. The last manhole at the end of the pier, Manhole 9, had no steaming but was still too hot to enter. A cathodic protection test station was found near the last manhole, but no dielectric flange connections had been installed.

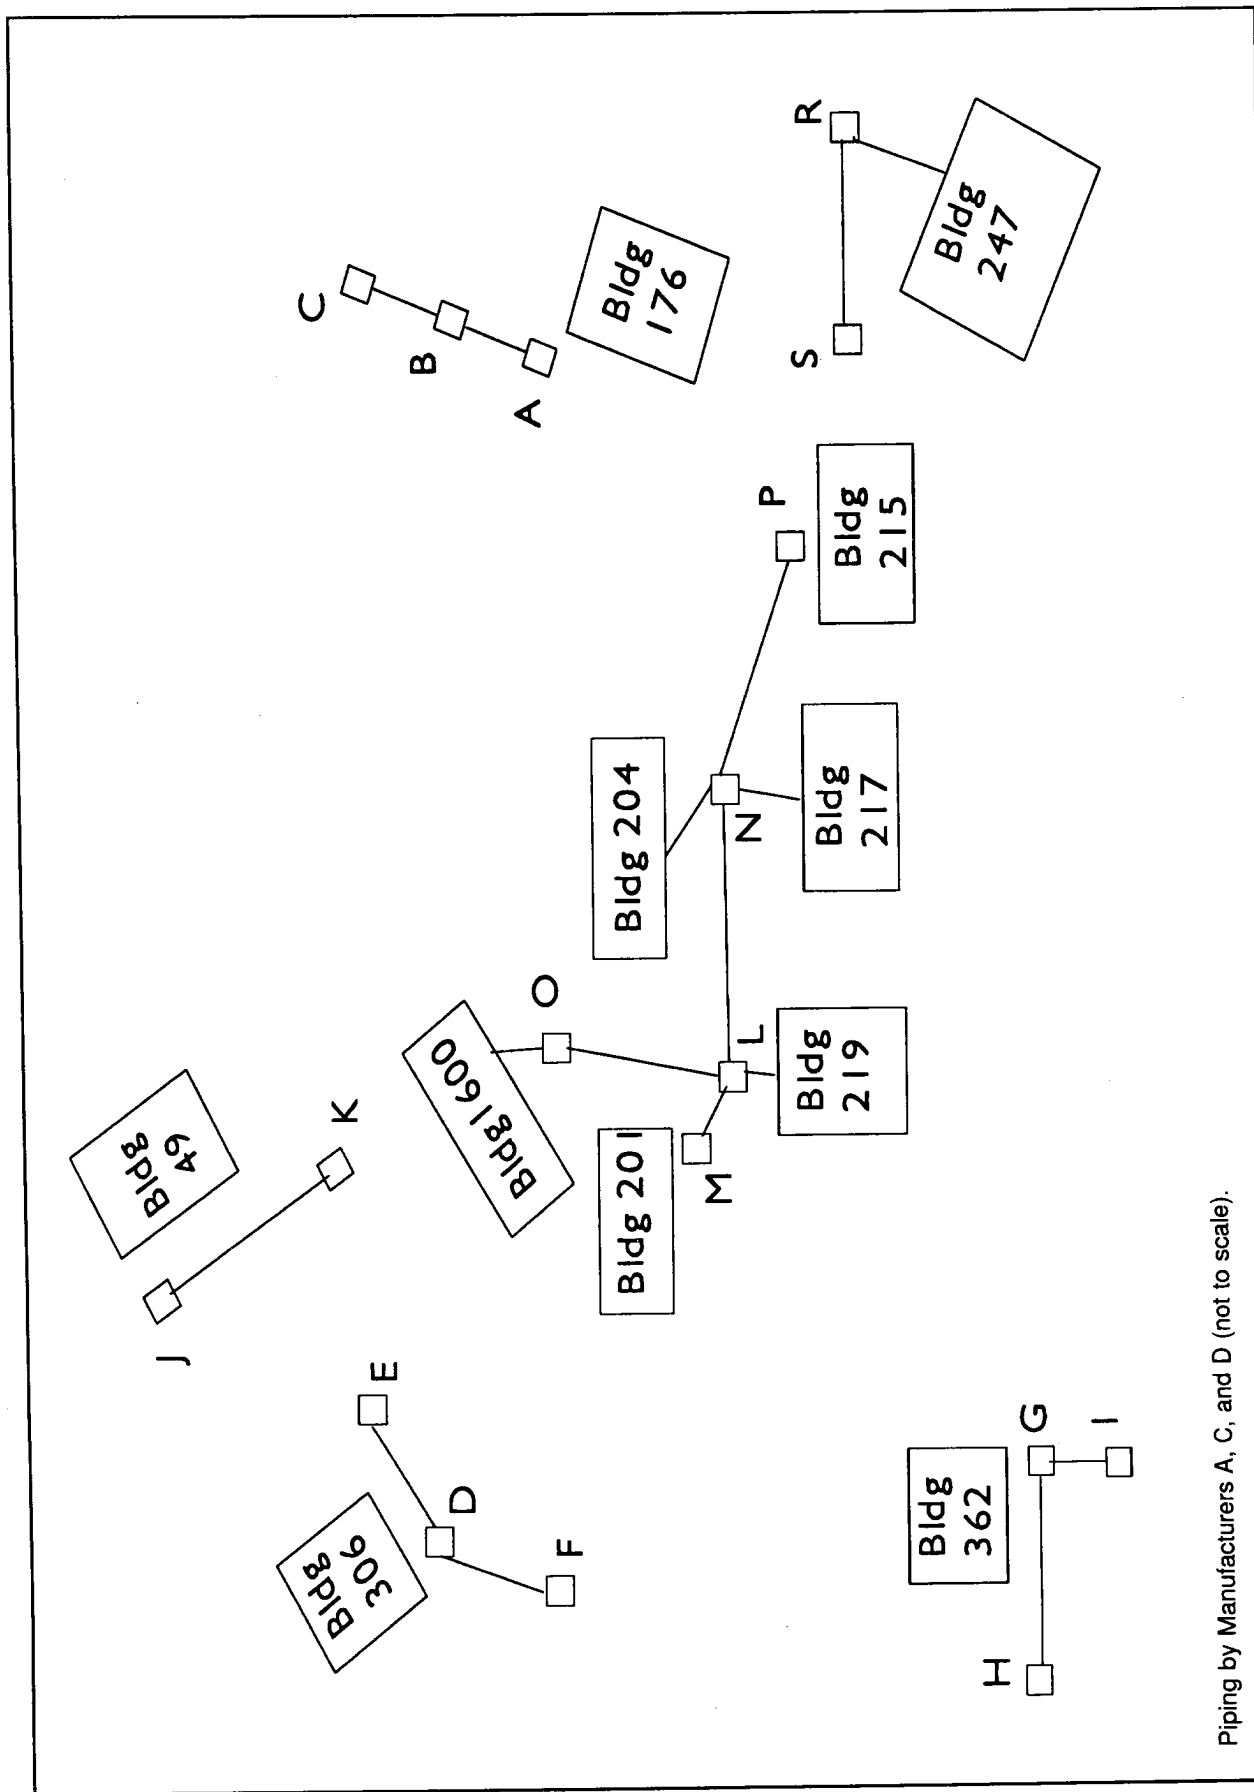
Figure L1. Schematic diagram of System 23 at Charleston AFB, SC.

c. Pressure Test 3—This conduit was installed in the middle 1980s, was supplied by Manufacturer A, and had a steel conduit. The conduit was 106 ft long and extended from Manhole B, described above, to a prefabricated steel manhole, Manhole C, 9 ft in diameter and 12-ft deep. The steel manhole was dry and contained an electric sump pump. The 6-in. line was contained in a 14-in. conduit, which was pressurized to 15.5 and valved off. The pressure readings and times observed were:

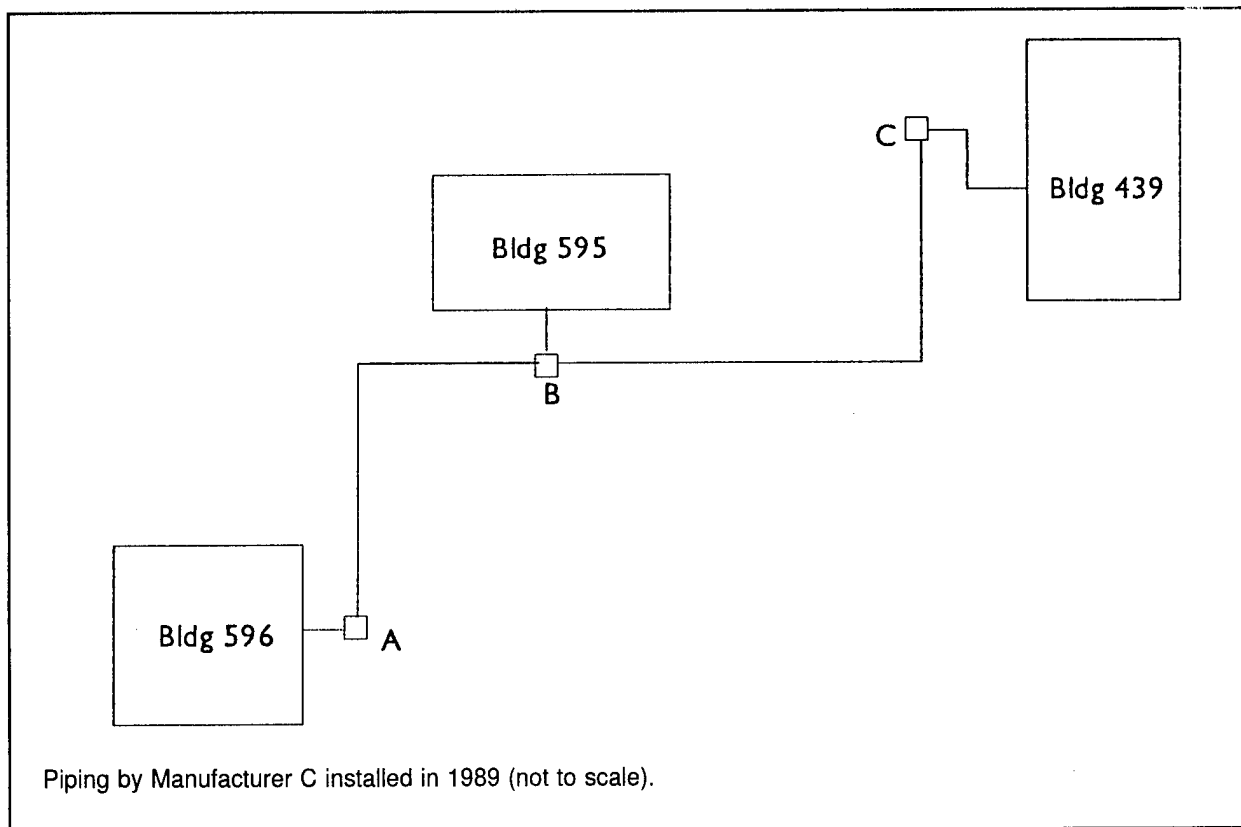
Figure M1. Schematic diagram of System 24 at Grissom AFB, IN.

a. Pressure Test 1— This section extended 20 ft from Manhole A to a pit in the equipment room of Bldg. 596. The concrete manhole was 5.5 ft × 5.5 ft × 6 ft deep, extended slightly above grade and had a solid aluminum plate cover. No access ladder was present and a steam valve gasket had a slight leak. Six in. of water in the manhole was drained after adjusting the float mechanism on the sump pump. The conduit wall penetrations were caulked and cemented. No vapor was evident at the steam line casing vent, but a light dripping was noted at the drain opening. Gland seals were installed at the end plates both at the manhole and the building pit. Building pit dimensions were 4 ft × 4 ft × 5 ft deep. The steam line casing was 10-3/4 in. in diameter and contained a 3-in. pipe.

Pressure was applied to the casing at 10:00 AM to 15 psi. Pressure immediately dropped when the line was valved off due to leakage at the gland seals. The gland seal at the manhole was tightened and the system repressurized with the same results because of a gland seal leak at the building pit. This pit could not be entered because of a leaking flange gasket on the steam line. At this point the pressure test was abandoned.

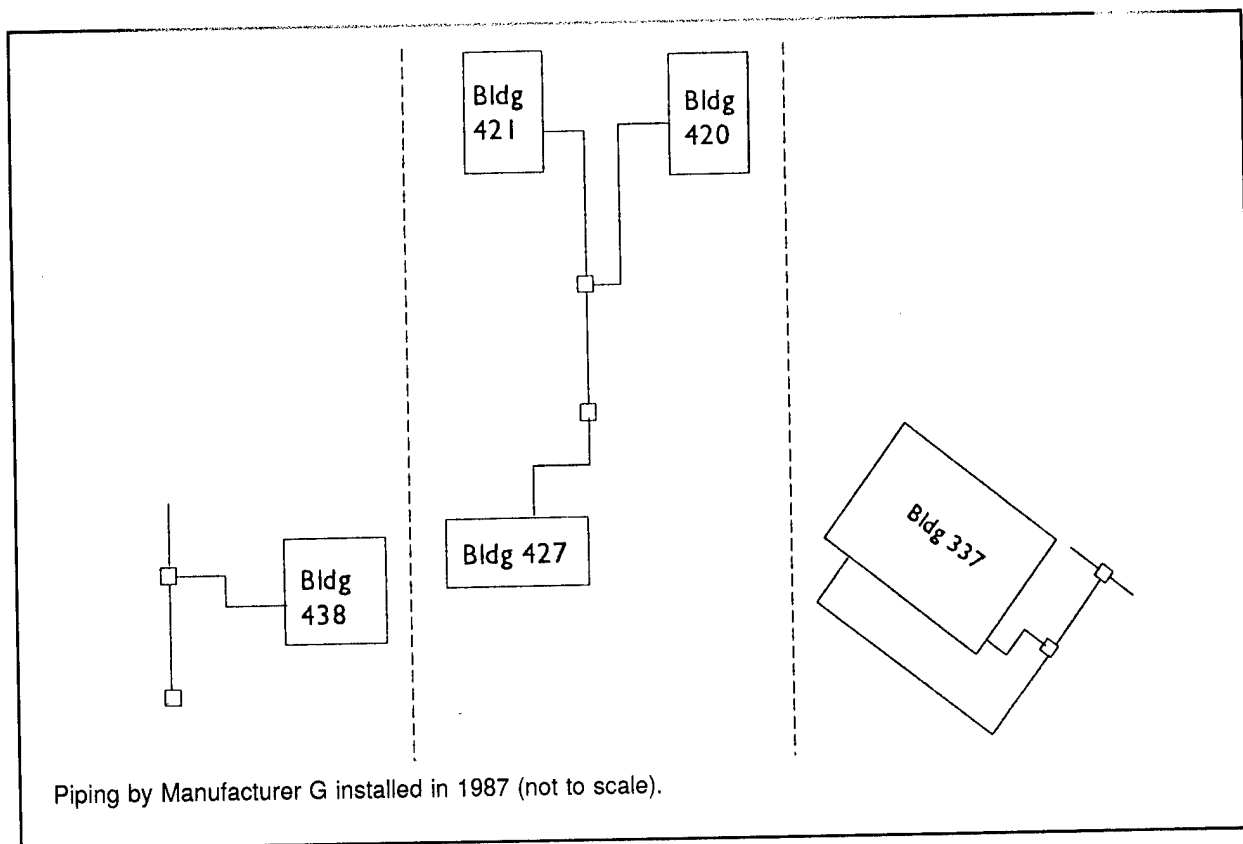
Figure M2. Schematic diagram of System 25 at Grissom AFB, IN.

b. Pressure Test 3—Conduits extend 200 ft from Manhole E at northwest corner of Bldg. 427 to Manhole F feeding Bldgs. 421 and 420. Both manholes were concrete with solid plate aluminum covers and caulked and cemented conduit wall penetrations. Manhole E was 10 ft × 5 ft × 10 ft deep, and Manhole F was 10 ft × 5 ft × 8 ft deep. Manhole E had a leak at the steam water ejector. No gland seals were present

at conduit end plates. The 12-in.-diameter steam supply casing contained a 3-in. steam pipe and the 6-in.-diameter condensate casing enclosed a 1-1/2-in. return line.

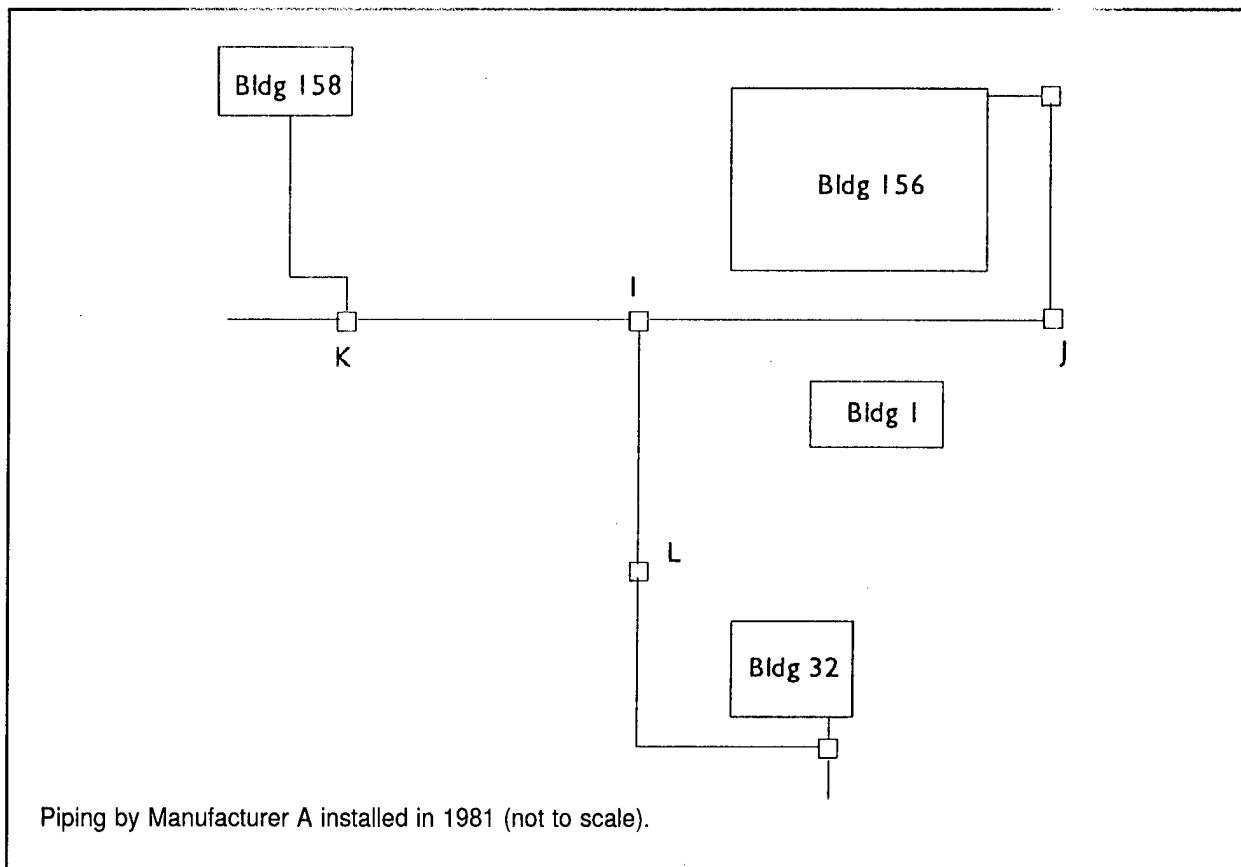
Figure M3. Schematic diagram of System 26 at Grissom AFB, IN.

b. Pressure Test 3—Conduits extended from Manhole I, described above, to Manhole K—a distance of 400 ft. Manhole K was 5 ft × 10 ft × 7 ft deep with an open grate top. Water was pumped out of the manhole after adjustment of the sump pump float mechanism. There was heavy water infiltration into the manhole at a conduit wall penetration. The 20-in.-diameter steam conduit casing contained a 10-in. steam pipe. The 12-in.-diameter condensate conduit casing contained a 4-in. return line.

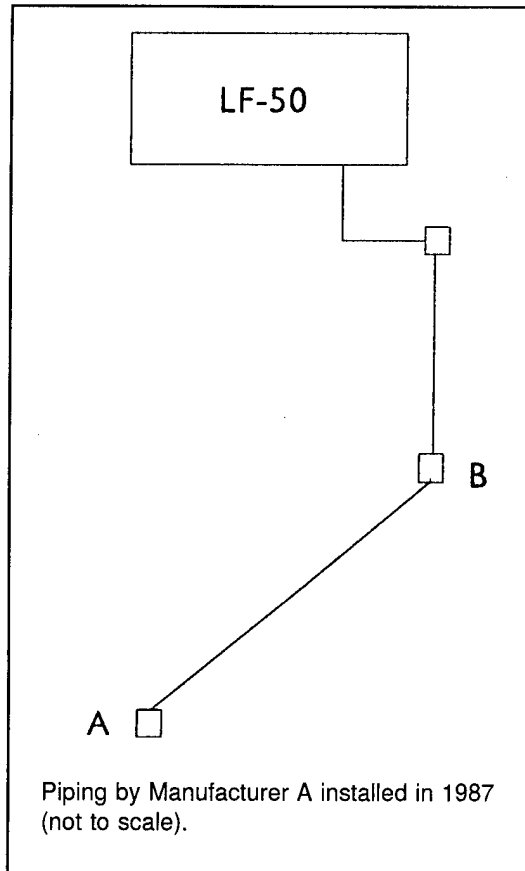
**Figure N1. Schematic diagram of System 27 at Norfolk Naval Station, VA.**

**Pressure Test**—This conduit section extended from Manhole A at the intersection of Toway and Avionics streets under Toway northward to Manhole B south of Building LF-50. The distance between manholes was 200 ft. Manhole A was in a parking area and was constructed of concrete with a solid concrete top flush with the pavement. The top contained 36-in.- and 24-in.-diameter access holes with steel plate covers. No manhole ventilation was provided. Manhole dimensions were 12 ft × 8 ft × 7 ft deep. A slight steam leak was present at the steam ejector sump pump. The heat carrying pipe had no insulation. Wall penetrations were caulked and cemented. Manhole B was concrete with walls extending about 1 ft above grade. The solid concrete top contained two access openings and two 6-in. vent pipes. Manhole dimensions were 9 ft × 12 ft × 8 ft deep. Some minor leakage was observed at the

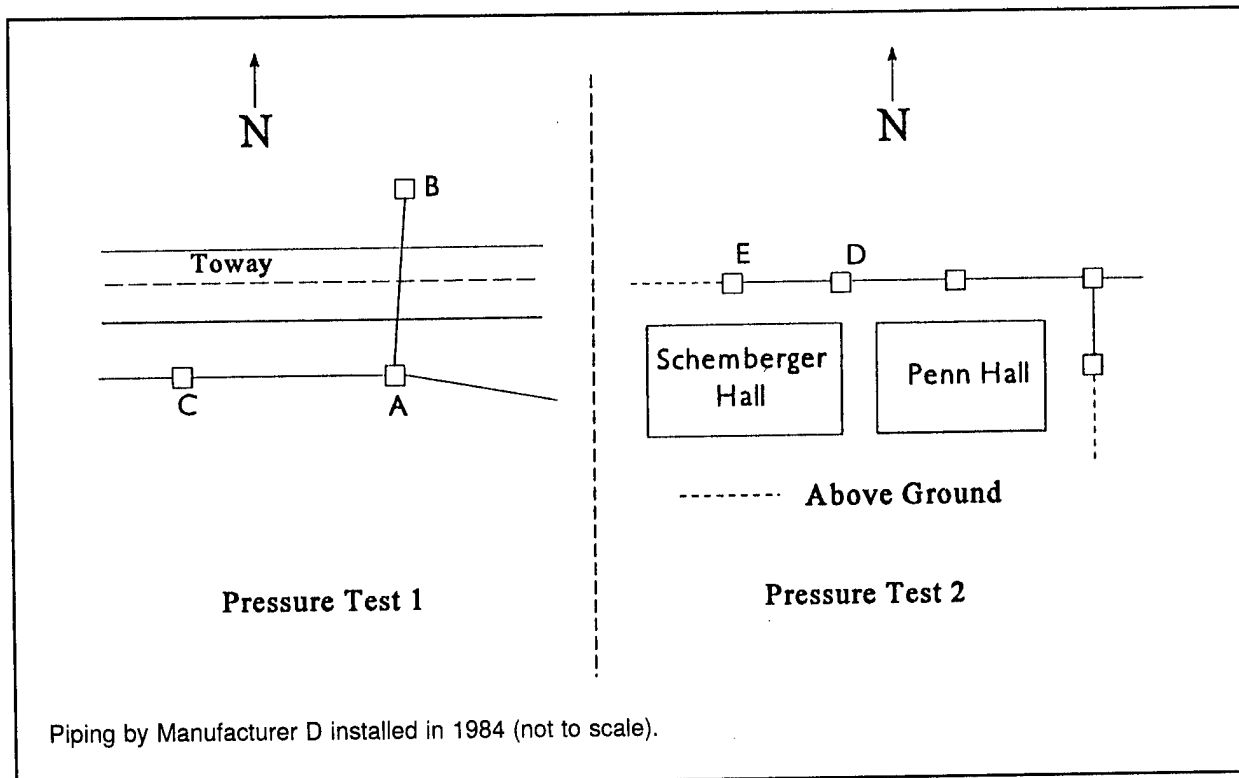
Figure N2. Schematic diagram of System 28 at Norfolk Naval Station, VA.

a. Pressure Test 1—This conduit section extended from Manhole A, described above, westward 170 ft to Manhole C. Manhole C was concrete with a concrete top flush with the parking lot pavement. The top had two access openings but no vent pipes. Manhole dimensions were 6 ft x 12 ft x 7 ft deep. Water was pumped out of this manhole and a portable fan was used to cool the manhole before entry. A gland seal was installed on the supply line at the manhole entry. The gland seal was tightened before pressure was applied to the conduit. One of the flanges on the dielectric flange assembly had been removed so the system was no longer electrically isolated. The conduit casing was 20-in. in diameter and contained a 12-in. steam line. Pressure to 15.0 psi was applied to the casing at 10:33 AM. Pressure readings were as follows:

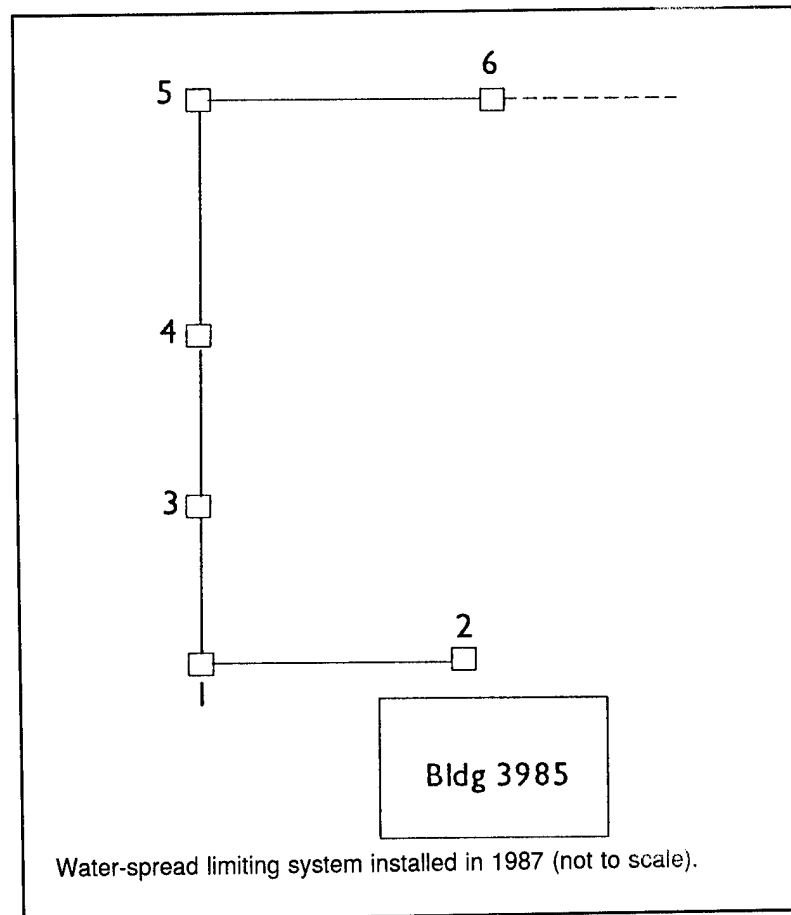
Figure O1. Schematic diagram of System 29 at Fort Lewis, WA.

f. Manhole 6—Located 300 ft east of Manhole 5, this manhole was concrete with top at grade containing two 6-in. ventilation pipes. Manhole dimensions were 5 ft x 7 ft x 8 ft deep. The water-spread limiting system ended at this manhole with the conduit extending 2 ft into the manhole with no end seal. The manhole was dry with a gravity drain. Exit from this manhole was with a steel-cased conduit that continues to Manhole 7 located 100 ft east of Manhole 6. Manhole 7 provides for transition from buried conduit to concrete trench.

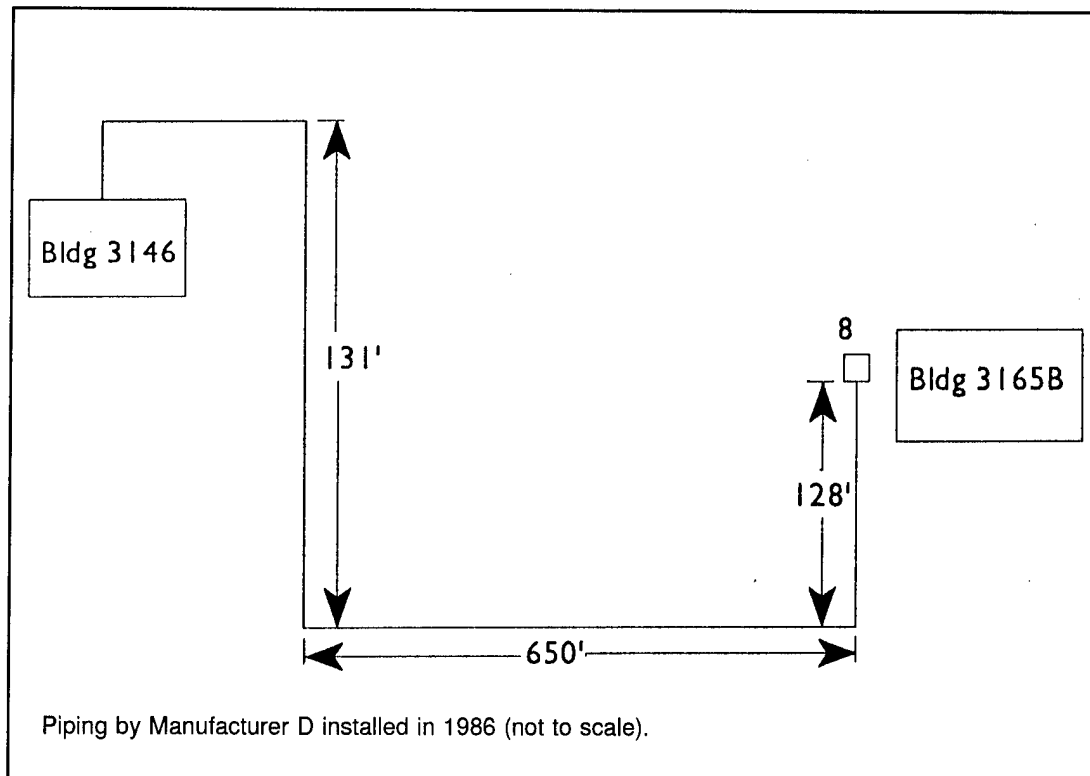
Figure O2. Schematic diagram of System 30 at Fort Lewis, WA.

This system consists of piping from Manufacturer D and has a steel conduit (Figure O2). It was installed in 1986. This section of conduit extended from Manhole 8 (just west of Bldg. 3165B) to the Special Forces Group Complex building. The length of this run was 1120 ft. Manhole 8 was concrete with top at grade containing a 30-in.-diameter access opening. The manhole had no vent piping. The conduit enters the manhole through the wall sleeve with caulking between the sleeve and the casing. Both the drain and vent openings at the end plate assembly were plugged. The

conduit rose through the floor at the equipment room of Bldg. 3146, terminating with a standard end plate. Both vent and drain openings at the end plate were also plugged, which sealed the conduit run.
