Investigation of Fatigue Cracking
on LAU-7/A Launcher Housing

D.S. Saunders, M.G. Stimson,
R. Bailey and E. Kowal

DSTO-TR-0229

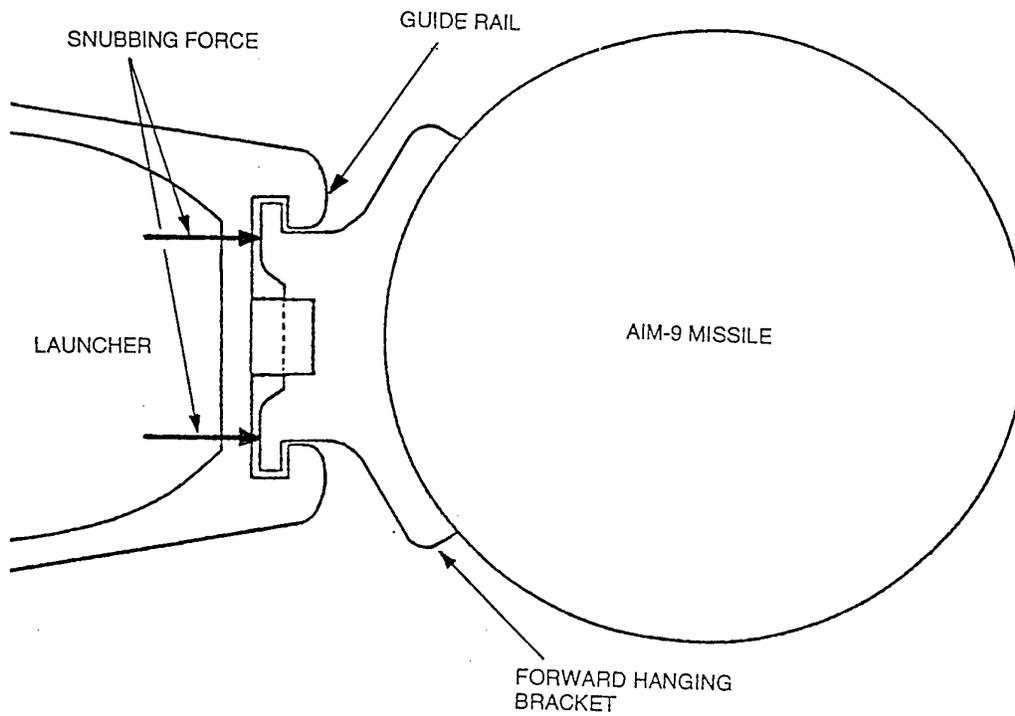
Figure 2. Section through the LAU-7/A launcher guide rail and AIM-9 missile at the location of the forward missile hanging bracket.

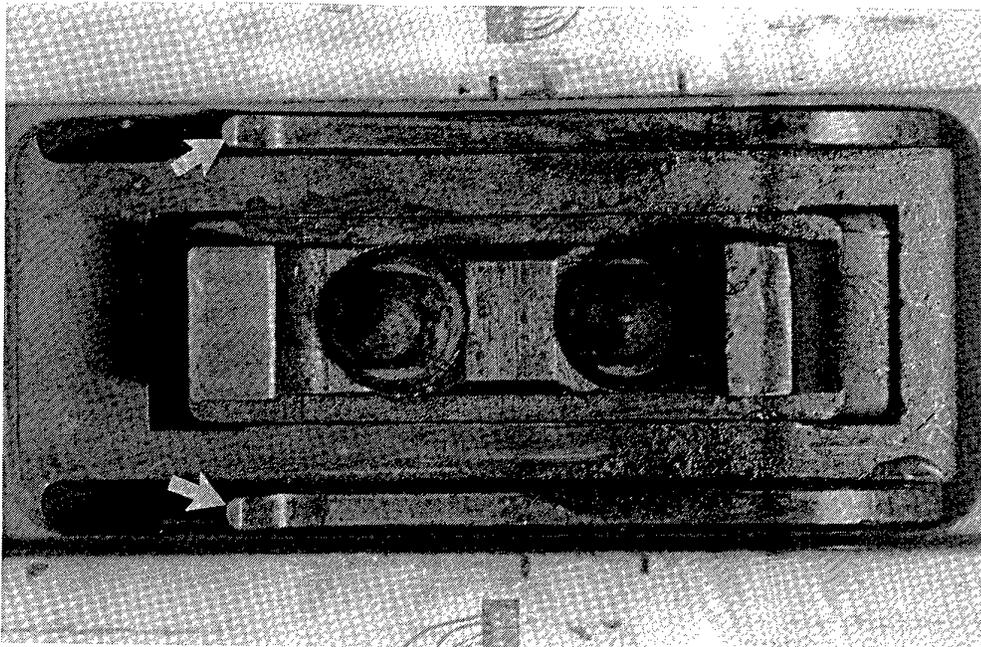
Figure 3. Forward snubber region with forward to the left. The snubber plates (arrowed) are in the engaged position. The hold-back detent mechanism and striker points are visible in the centre.

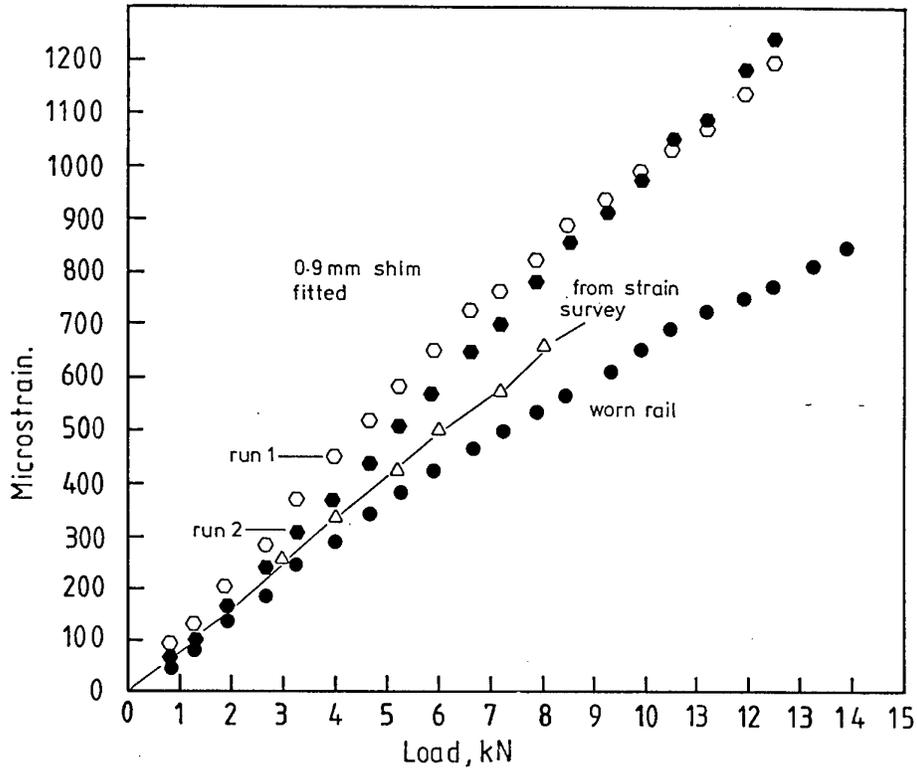
One problem encountered in this preliminary test and in subsequent fatigue tests was the re-distribution of loads during testing. Strains at the upper cracked rail were reduced by approximately 15% as is illustrated in Figure 15 for launcher guide rail 0148. This appeared to have arisen from minor dimensional changes in the guide rail associated with cracking and from wear of the guide rails; thus loading was transferred to the edge of the lower guide rail during testing. To overcome this problem shims up to 0.9mm thick were inserted between the hanging bracket and the contact point on the upper guide rail thus restoring strains in the rail to the higher, earlier values. This is illustrated by the graph of Figure 15 for launcher guide rail number 0148.

Figure 15. *Effect of shimming forward hanging bracket in the guide rails during a fatigue test.*

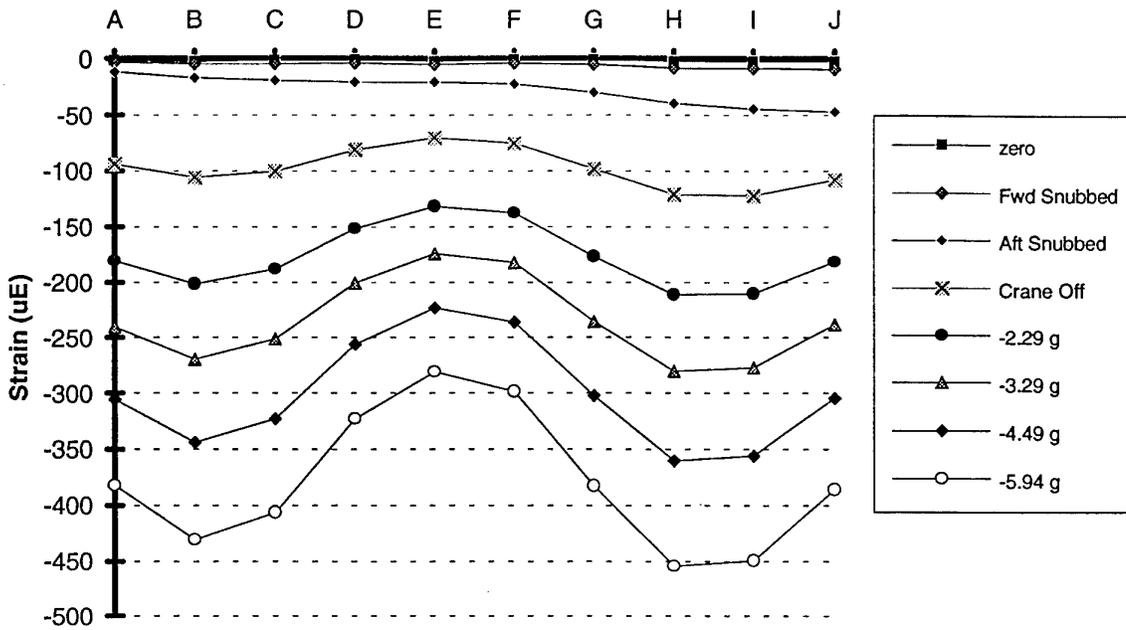
Strip gauges proved useful in detecting the peak strain lobes on the outer rail surface. These lobes occurred either side of the line of extension of the crack. Figure 20 shows the strains measured by the strip gauges for the uncracked rail of Experiment 7.

Figure 20 illustrates the various stages of the snubbing procedure and the strain response of the strip gauge on the upper rail as down loading is increased. Engagement of the forward snubbers produces no noticeable strain in the rail at any location, since the missile weight was at that time supported by the crane. Removing the crane after snubbing and allowing the 1g weight to rest on the launcher produces strain per g increments ($-85\mu\epsilon$) slightly greater than those for the 5.95g down load (-410

Figure 20. Strain results from the strip gauge on the upper rail during snubbing and subsequent down loading to 5.95g (Experiment 7). The two peaks at gauges B and H lie either side of the line of extension of the crack.

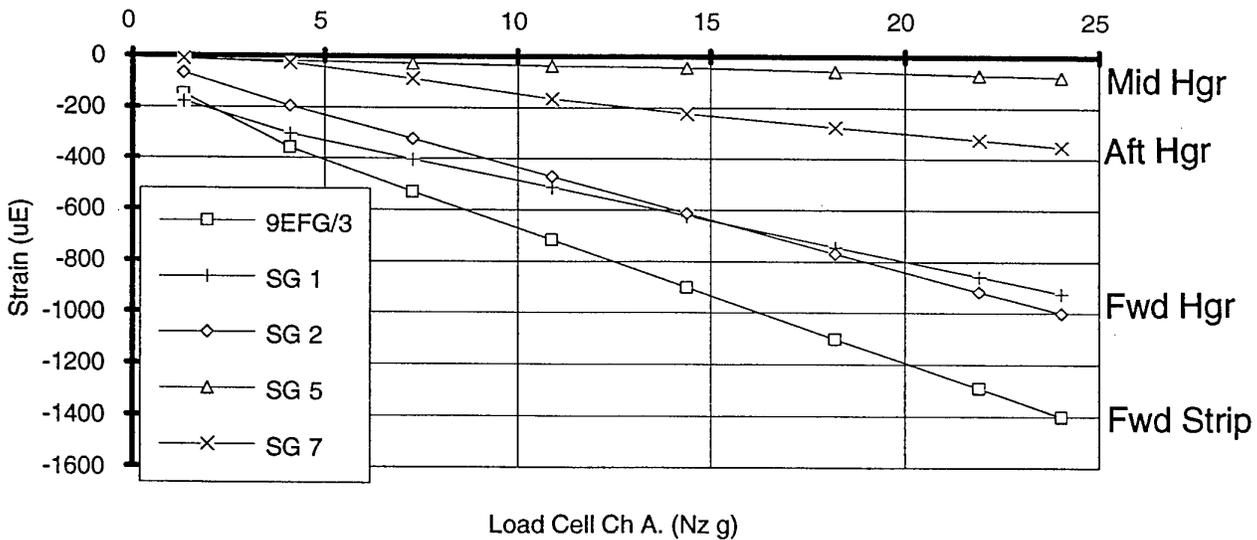
Accordingly, Figure 21 shows a strain comparison from Experiment 27 where the strip gauge results are presented as the average of those three gauges. The maximum load was a 24g download. The strains remain essentially linear above 1g and in the same proportion indicating small load path changes are confined to the low g region.

The aft strain gauges in Fig. 21 show much lower strains than the forward. This observation is common to all the experiments performed, with maximum load strains typically less than -200 to -350 $\mu\epsilon$ when the comparable strain at the forward hanger is between -900 and -1000 $\mu\epsilon$. Additionally, the maximum strain observed for the aft strain gauges 7 and 8, (-350 $\mu\epsilon$) was recorded in this experiment (27) with a down load equivalent to 24g. The corresponding peak strain at the forward hanger was approximately -2000 $\mu\epsilon$ (9H) indicating that the rail at the aft hanger was a less significant load path than the rail at the forward hanger.

Figure 21. "Load shedding" as seen by comparing the strip gauges (average of E, F and G) at the forward hanger with the single gauges at the mid and aft hangers. These strains are from the loaded rail in Experiment 27.

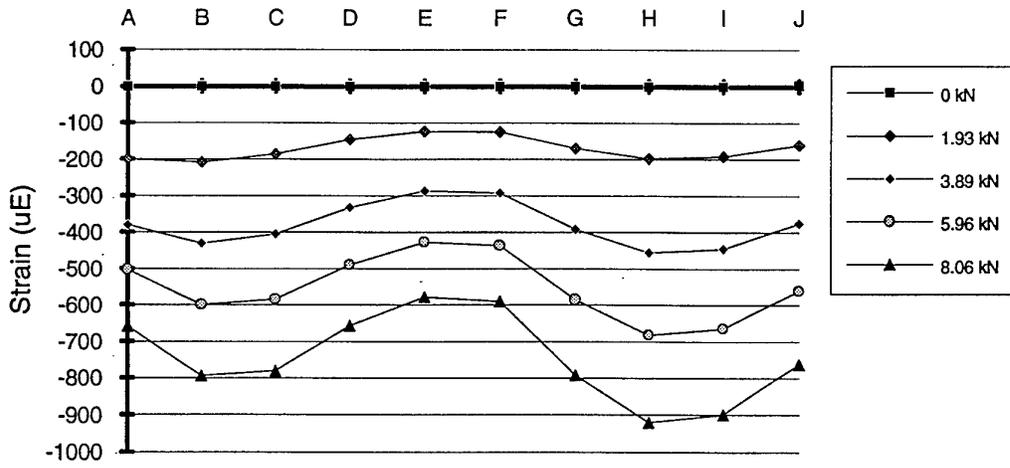
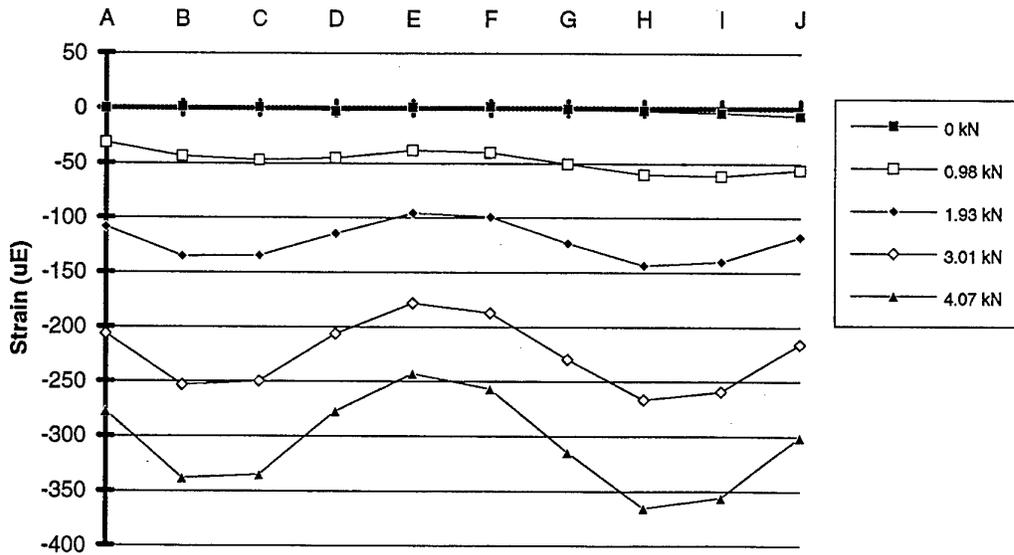
The presence of a crack adjacent to the forward snubbers appears to significantly increase the strain measured on the outer surface of the rail. The effects of rail cracking are summarized in Figure 22 from Experiments 5 and 20. Figure 22(a), from a cracked rail, shows a peak strain recording of approximately -910 $\mu\epsilon$, whilst Figure 22(b), from an uncracked rail, shows only -370 $\mu\epsilon$. Since the up load in Fig. 22(b) is half that of (a), the strain can be doubled to -740 $\mu\epsilon$. Comparison of (a) with (b) then shows that the crack has produced an increase of 23% in the peak strain.

Figure 22 (a). The effect of the crack on strains in the guide rail : Strip gauge strains at the forward snubber on the cracked lower rail during 8.5g up loading of Experiment 5.

Figure 22 (b). The effect of the crack on strains in the guide rail : uncracked lower rail during up load of Experiment 20.
