New Generation Runway Visual Range (RVR) Final Operational Test and Evaluation Report: Volume III

July 1996

DOT/FAA/CT-TN95/32-III

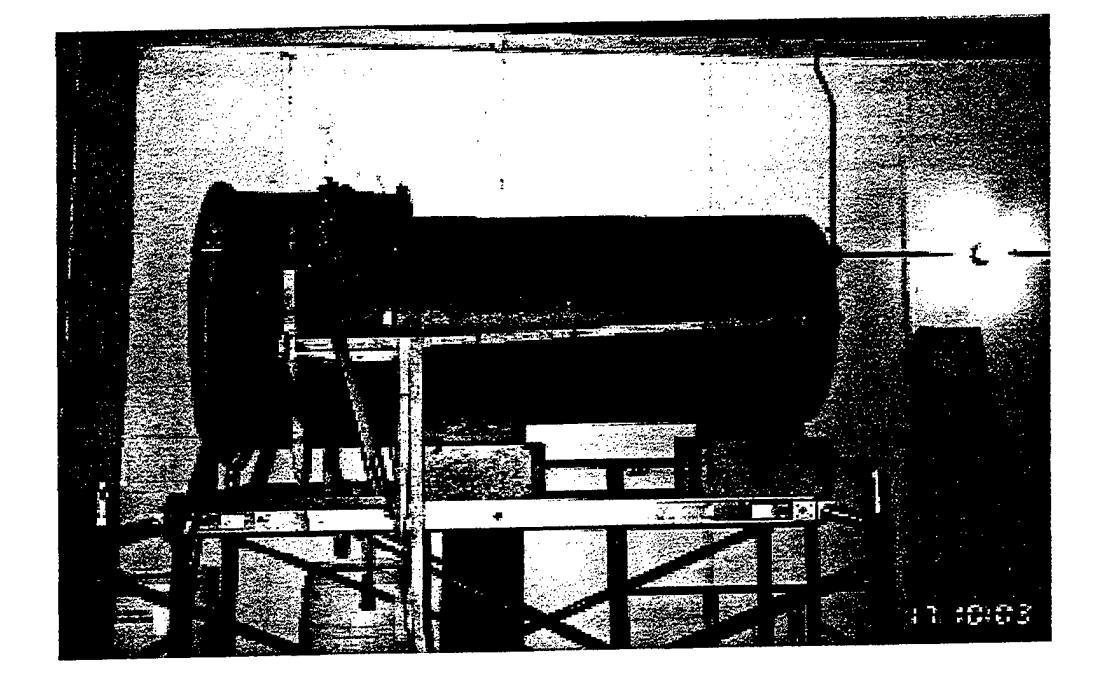
PHOTO 3. CYLINDRICAL WIND TUNNEL

The cylindrical wind tunnel (ref. photo 3) was used for some of the initial tests, but it was discovered that the rectangular wind tunnel (ref. photo 4) provided a more even snow output. The cylindrical wind tunnel produced erratic and uneven amounts of snow that were often bursty. For these reasons, most of the tests utilized the rectangular wind tunnel.

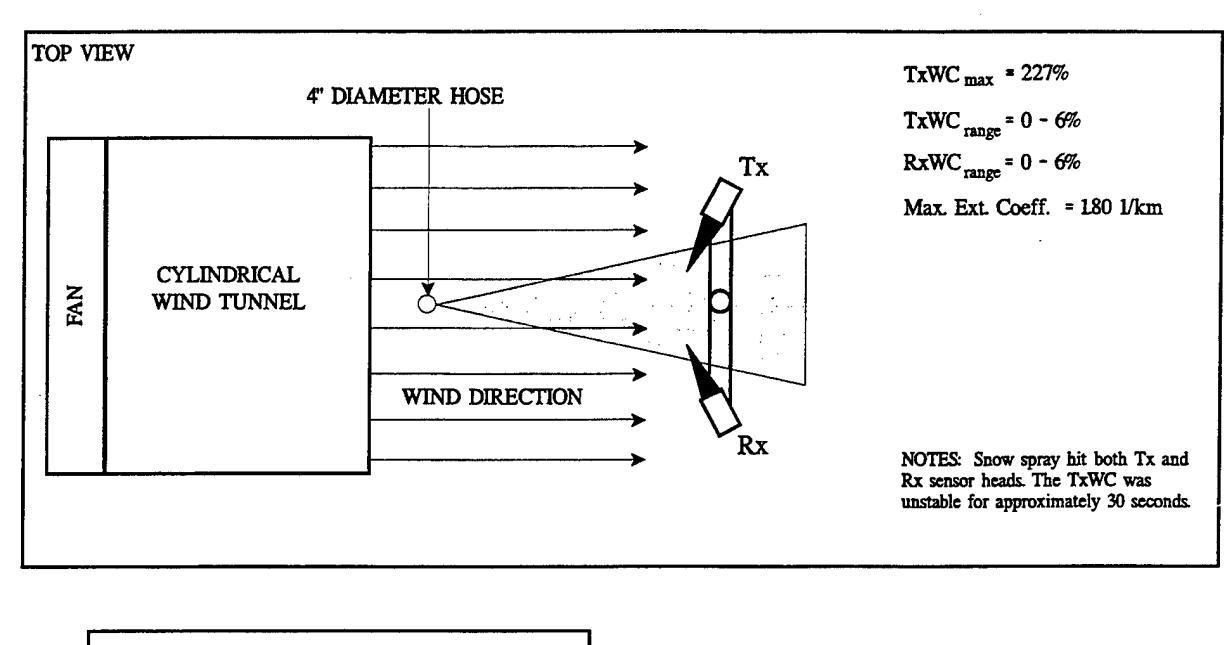
Figure 2. LKDWN VS Volume Density Test 1 - Location: ROWPU Chamber

The snow volume was chunky and was propelled in spurts rather than in a consistent stream. More snow hit the transmitter and receiver components of the sensor than was anticipated. The design of the wind tunnel was determined to be the cause of these problems. Due to all of the aforementioned problems, the baseline determination from this test was not considered reliable.

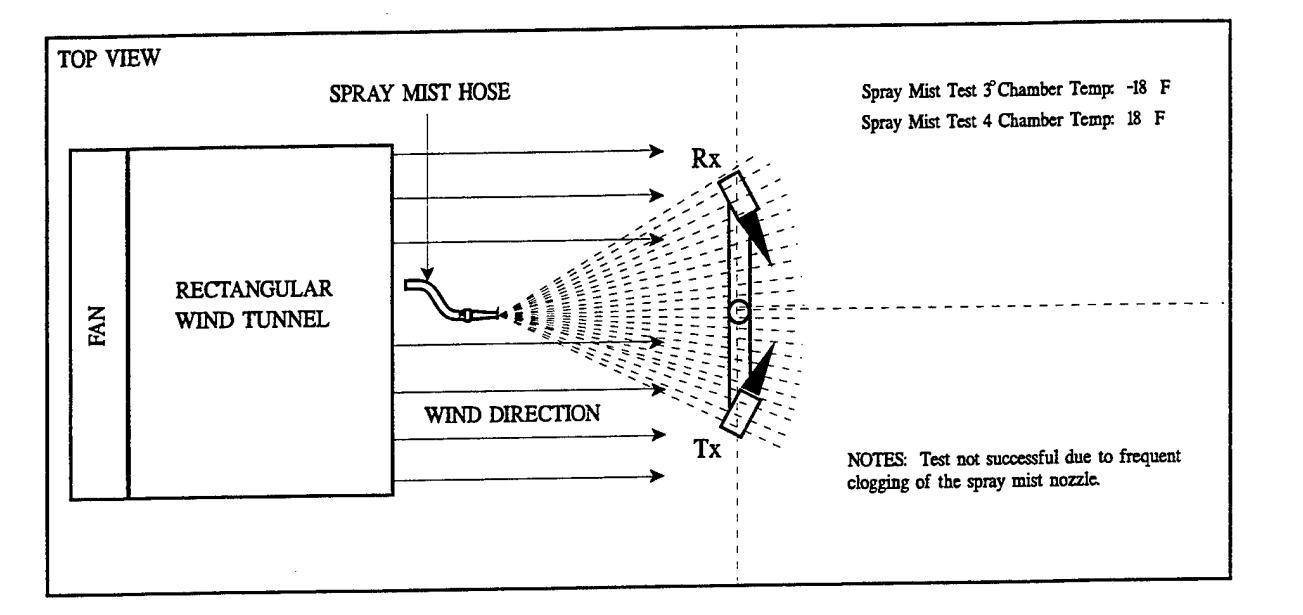
Figure 6. Spray Mist Test - Location: ROWPU Chamber

As in the previous test, there were many stoppages due to clogging of the spray mist device. In addition, some ice build up was noted on the VS hood. As a result, the test objective was not fulfilled.

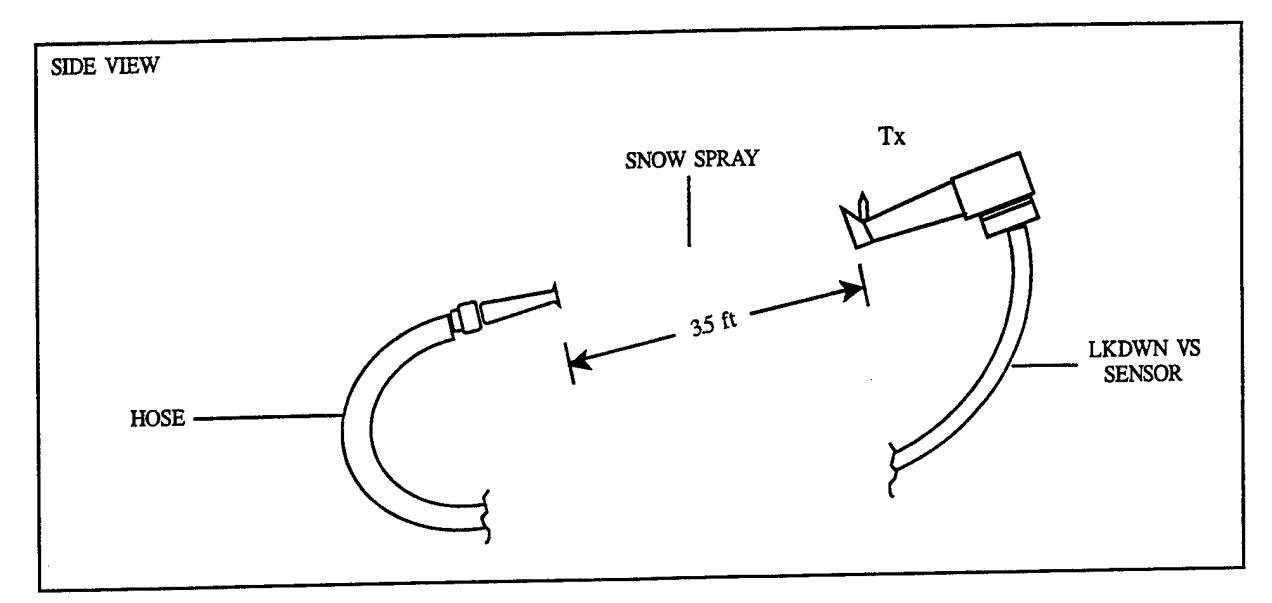
Figure 8. Upward Blowing Snow Test - Location: Navy Chamber

A probable explanation for the extended length of time of the clog is that the design of the hood allows the look-down configuration to be more susceptible to precipitation impinging the VS window at angles rather than directly in front of the window. A similar relationship was noted during the angular blowing snow tests (ref. paragraph 5.2.9) where higher window

signal readings were observed in the look-down configuration than in the look-out. As a result, the increased susceptibility of the sensor lead to a stronger clog.

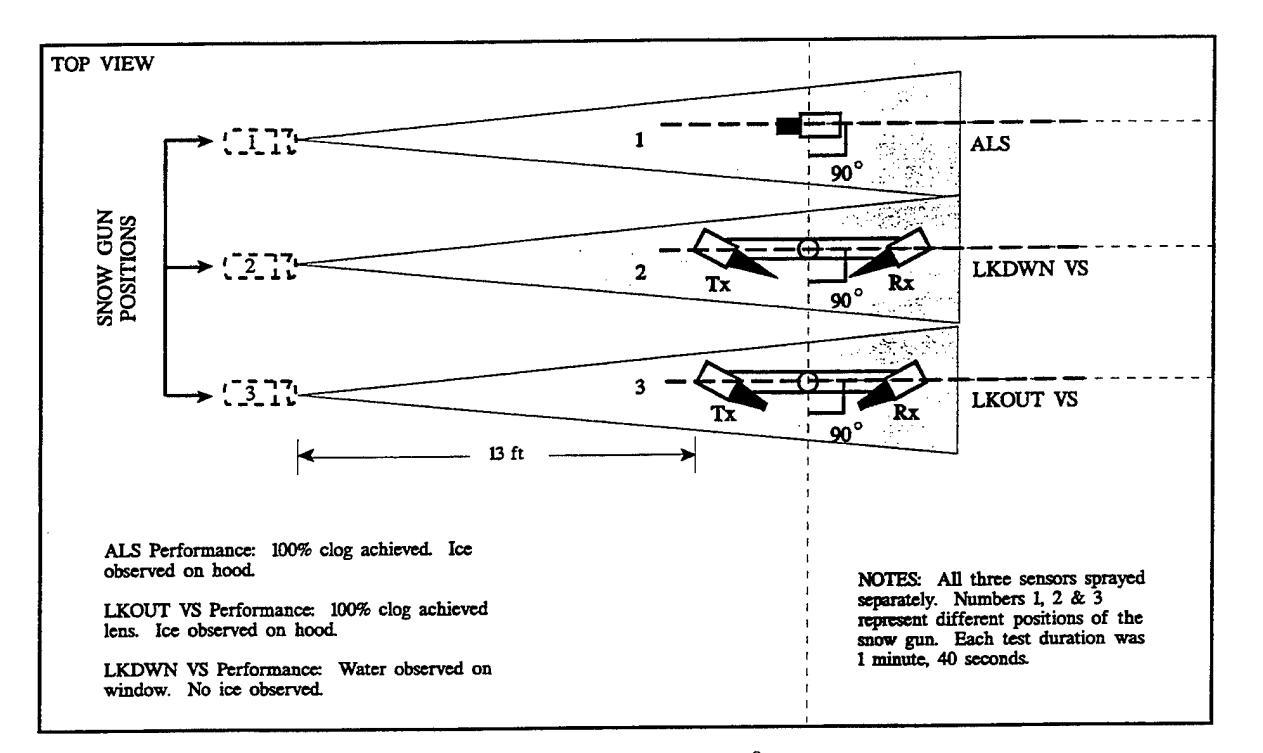
Figure 40. Blowing Snow Test w/ Snow Gun at 90° - Location: ROWPU Chamber

High Intensity Blowing snow tests were performed on August 23, 1993 in the ROWPU Chamber. The test equipment, setup and results are shown in figures 39 through 45. The snow gun was used to blow large amounts of snow on the sensors. The duration of each test ranged from one minute and forty seconds, to two minutes and forty seconds. In the first test scenario, all three sensors (Look-Down VS, Look-Out VS, ALS) were sprayed simultaneously. In the second scenario, each sensor was sprayed individually. The snow liquid equivalent input rate was 1.2 gallons per minute.

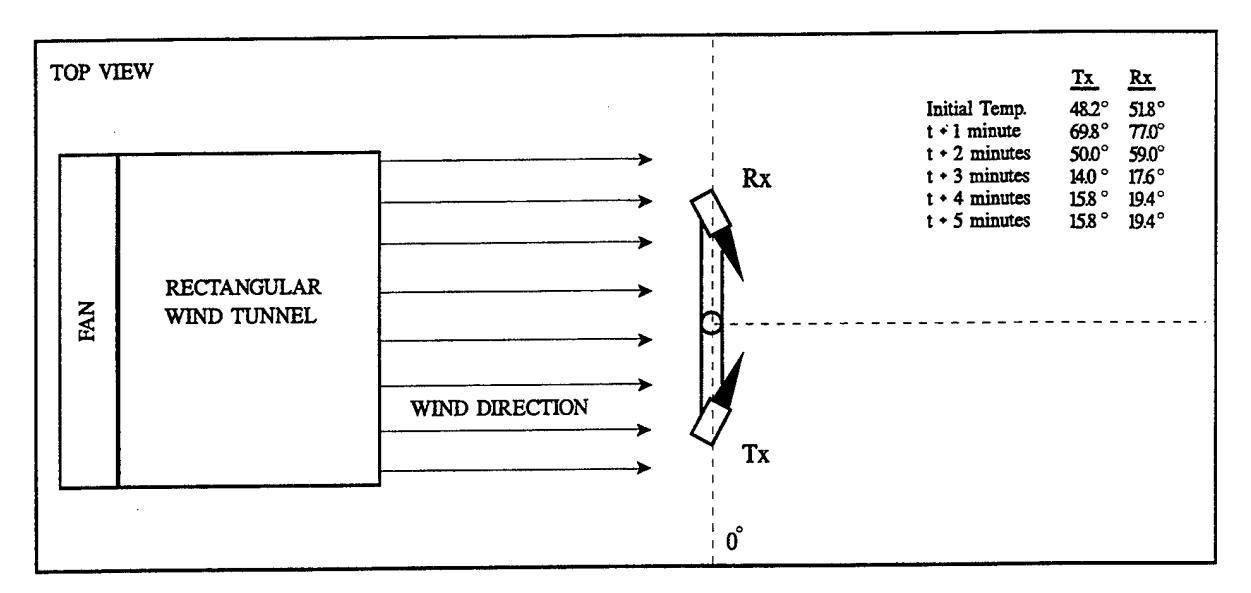
Figure 46. TX RX Temp Diff Test 1 at 0°- Location: ROWPU Chamber

As the results of TX RX Temp Diff Test 1 suggest, wind directed perpendicularly towards the sensor fork axis appears to cause the least temperature difference between the transmitter and receiver.

Although separate transmitter and receiver heater controls could optimize sensor performance in terms of power conservation, the results indicate that the transmitter and receiver temperature differences are small. Hence, a change in heater control scheme based solely on transmitter and receiver temperature differences is not warranted.
