REPORT NO. NADC-77073-30

# REAL-TIME X-RAY INSPECTION OF COMPOSITE AIRCRAFT STRUCTURES

December 1978

FINAL REPORT  
AIRTASK No. OTR Rework  
Work Unit No. GA801

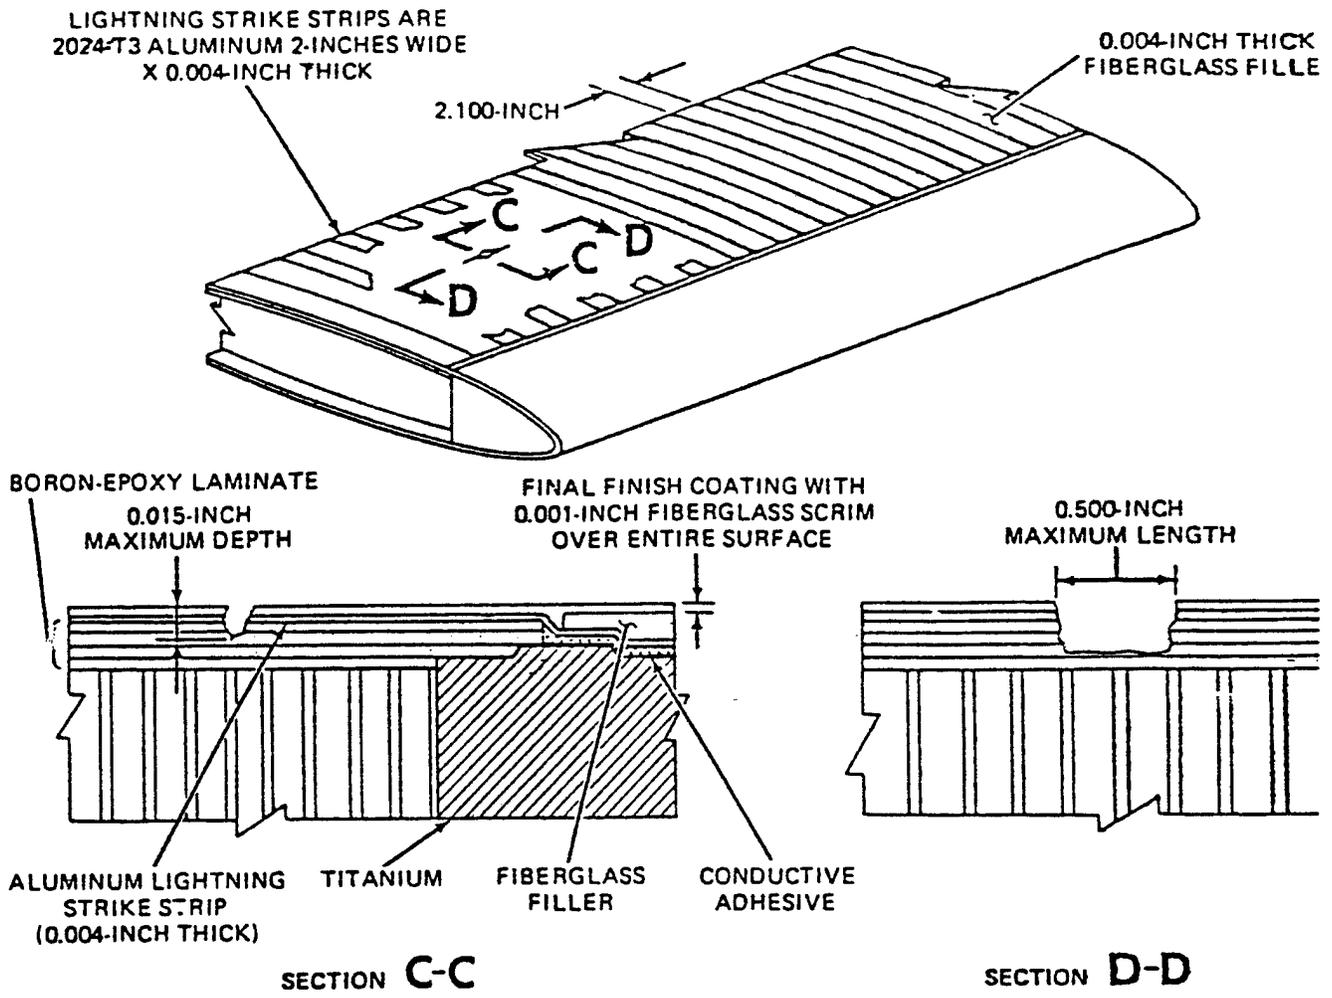
CLASS III DAMAGE - SCRATCHES, CUTS, OR ABRASIONS INTO BORON-EPOXY LAMINATES OR HALFWAY THROUGH LIGHTNING STRIKE STRIPS

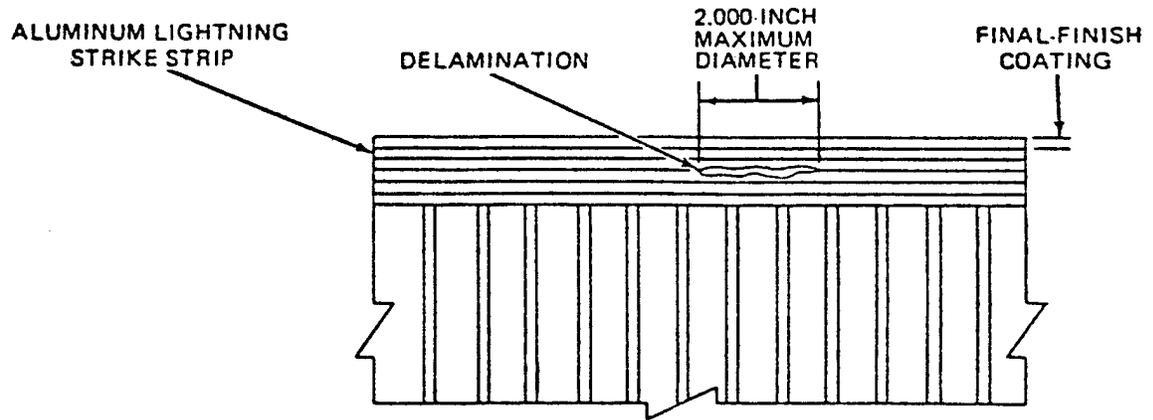
CLASS IV DAMAGE - DELAMINATIONS AND VOIDS

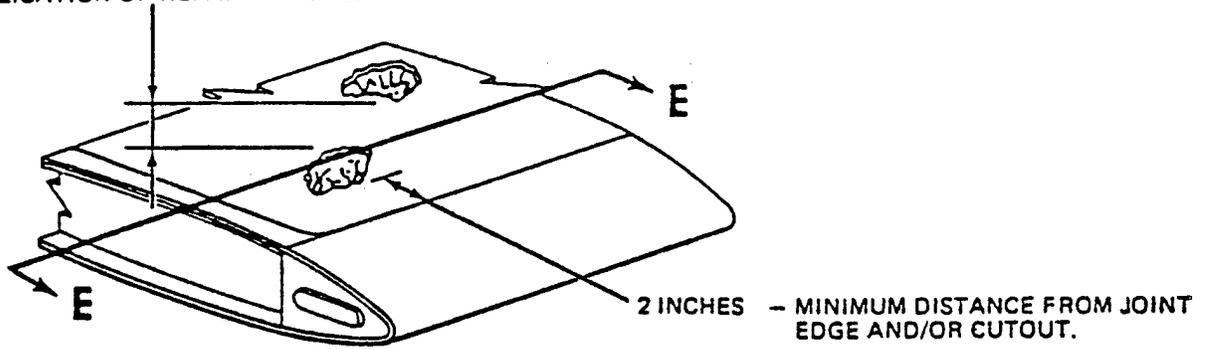
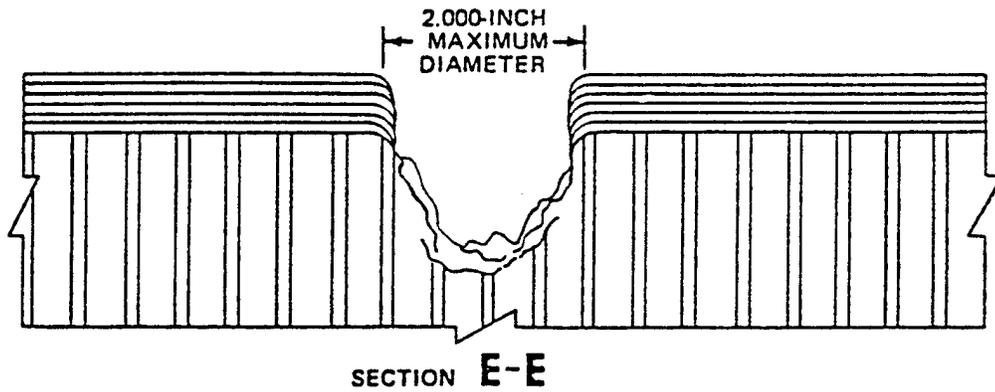
CLASS VIII DAMAGE - HOLE DAMAGE RESULTING  
FROM BALLISTIC OR FOREIGN-OBJECT PENETRATION

SPACING BETWEEN REPAIRS SHOULD  
ALLOW SUFFICIENT SPACE FOR  
APPLICATION OF REPAIR PATCHES

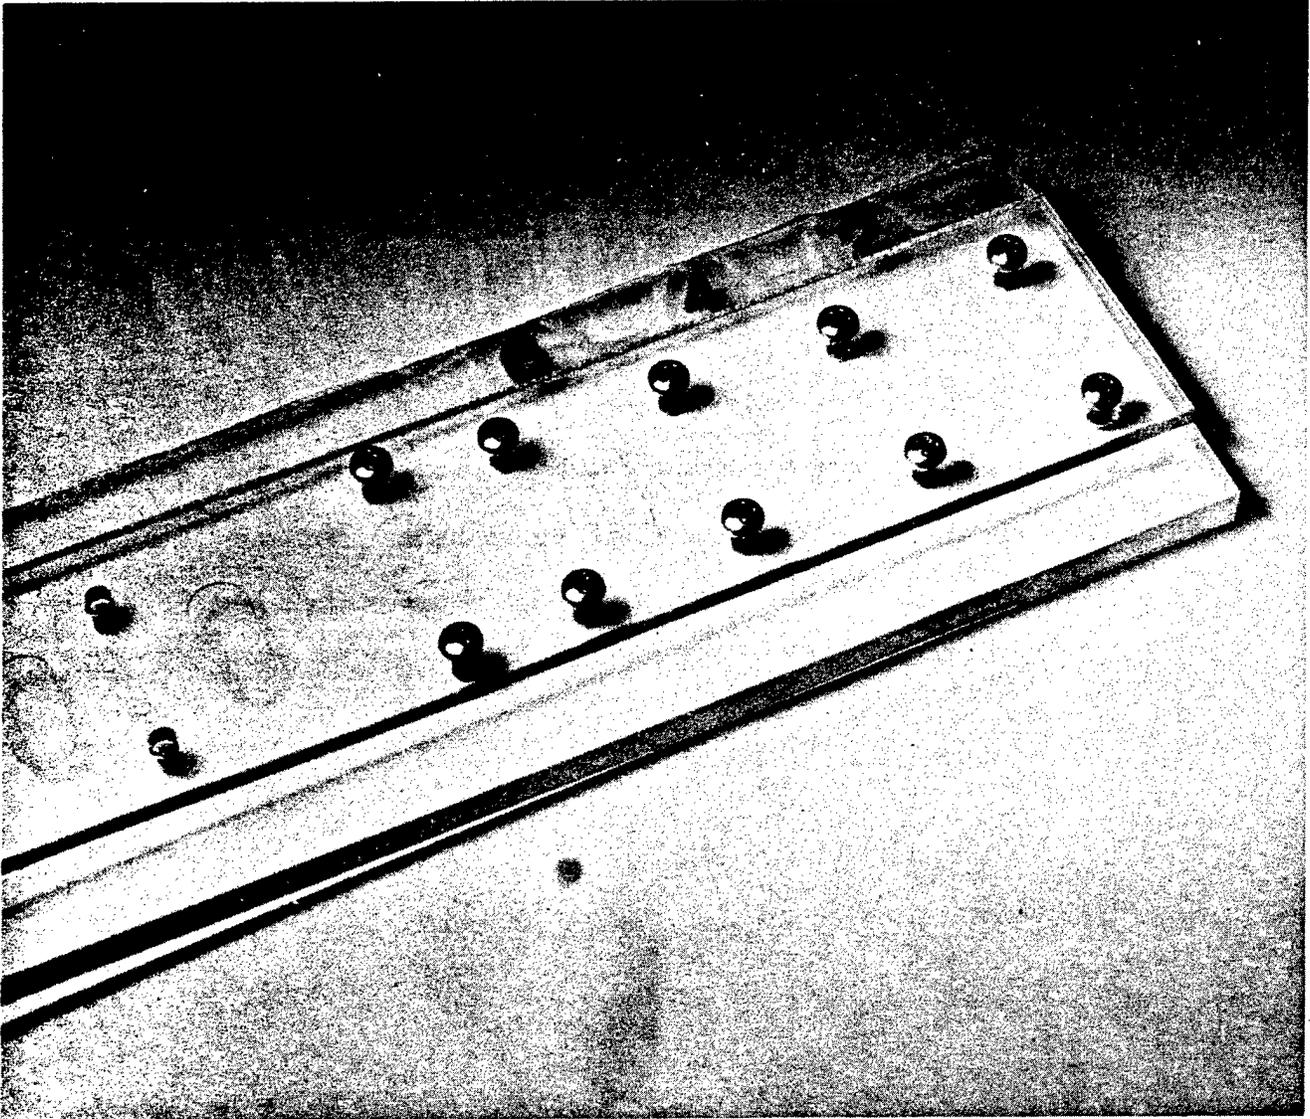
A 10% and 20% aqueous lead acetate solution was prepared to determine the sensitivity of the real-time system for these mixtures. Figure 31 is a photograph of a plexiglass test panel that was fabricated with slots of varying depths from .002 inch to .010 inch to measure the absolute RTR sensitivity. Plexiglass was chosen for the test panel because of its similarity to a composite/epoxy structure. These slots were filled with the liquid and the top plate was attached to control the depth and prevent the solution from seeping out. Figure 32 shows an RTR of the 10% solution with the .002 inch depth barely visible. The next RTR, Fig. 33, shows the 20% solution with the .002 inch depth easily seen. Since the total thickness of the test panel was .375 inch, this indicates an RTR thickness sensitivity of less than 1% ( $.002/.375 \times 100\%$ ) for the 20% lead acetate solution. With the penetrant selected and the RTR sensitivity determined, the penetrant injection system will now be discussed.

Figure 31. Photograph of plexiglass test panel with slots of varying depths. The lead letters 2, 4, and 6 indicate .002 inch, .004 inch and .006 inch depths.

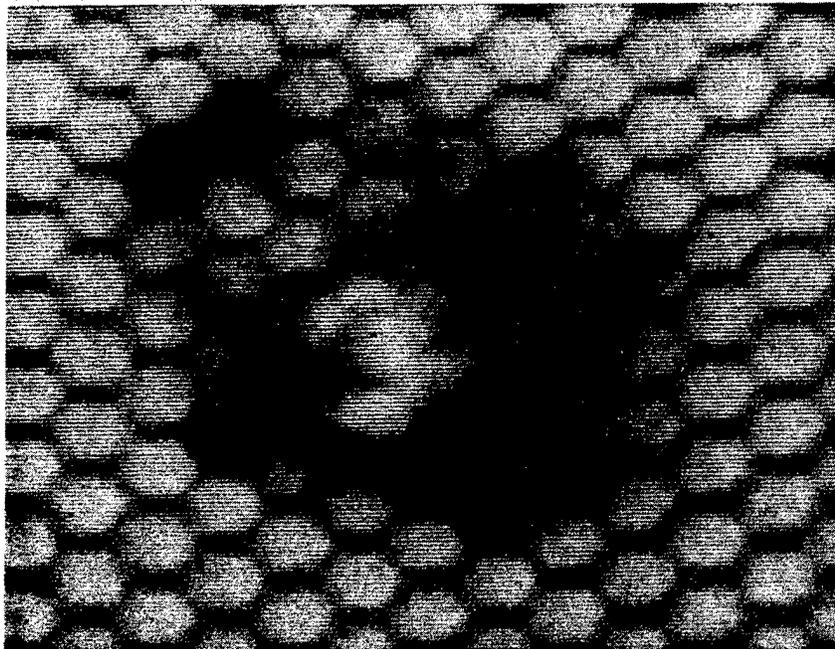
The first sample tested with the system is shown in Fig. 37. This is a graphite/epoxy sample with aluminum honeycomb that was hit with a hammer to produce debonds and delaminations. A 1/4 inch hole was then drilled and the penetrant was forced into the area. Figure 38, the RTR, shows where the liquid has flowed throughout the area illustrating debonds or delaminations. The next RTR, Fig. 39, shows an electronic video enlargement of the same area, showing areas where the liquid is not in the honeycomb, thus indicating that the liquid has flowed in between the graphite/epoxy layers.

Figure 39. Electronically enlarged RTR, Figure 37, illustrating an improvement in detectability. This is a standard feature of the RTR-100 system.
