Technical Report REMR-CS-53
April 1997

Repair, Evaluation, Maintenance, and Rehabilitation Research Program

Applications of Roller-Compacted Concrete in Rehabilitation and Replacement of Hydraulic Structures

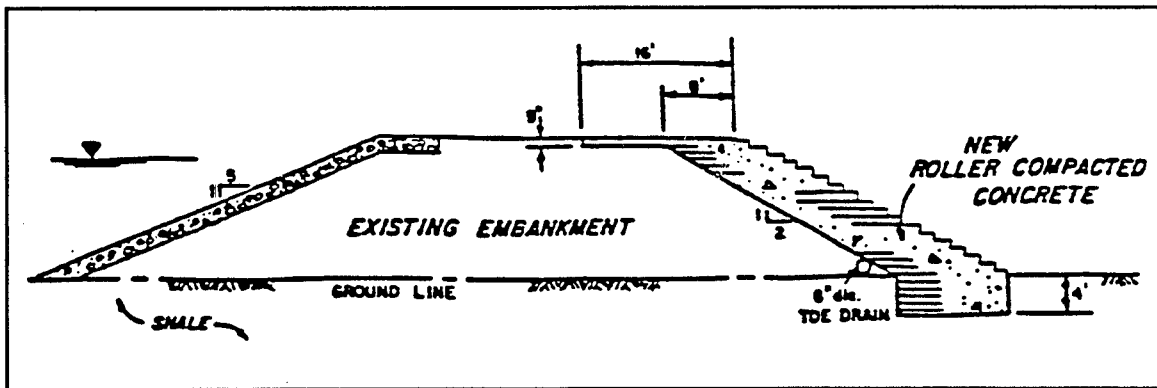
Figure 5. Cross section of modified spillway, Brownwood Country Club Dam (courtesy of Reeves 1985, ASCE). (Multiply inches by 25.4 to obtain millimetres and feet by 0.3048 to obtain metres)

Options considered for increasing the spillway included excavating the right abutment, constructing a reinforced concrete spillway next to the existing spillway, or constructing the spillway with RCC. An RCC spillway was chosen (Figure 5) because it would have the lowest total cost and would require the least construction time (Morsman, Lawler, and Seimears 1985). This was the initial application of RCC to rehabilitate an existing embankment dam.

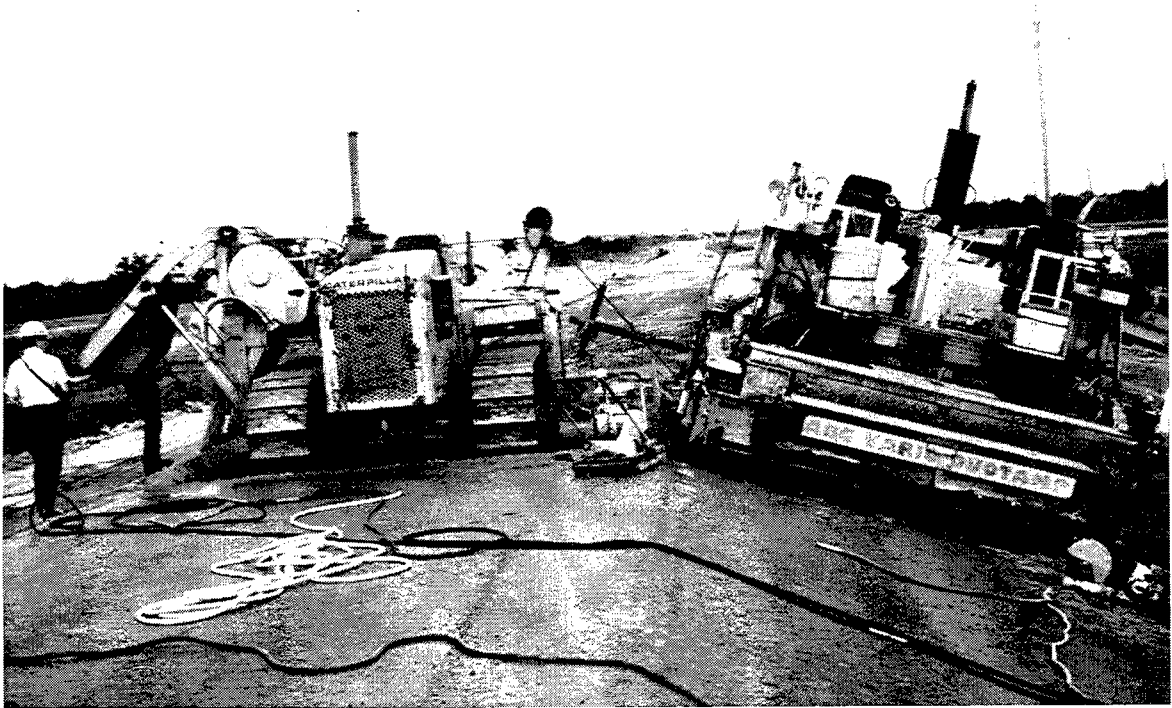
Figure 15. RCC paver connected to a bulldozer for paving slopes at Barker Dam

An additional problem was finding a way to place RCC on the downstream slope of the dams without having the 25,400-kg (56,000-lb) paver slide down the slope. The contractor installed a 18,140-kg (20-ton) winch on the end of the dozer and used it to control a 22.2-mm (7/8-in.) cable attached to the paving

machine; the two machines moved together, the bulldozer riding the crest to provide a counterweight to the paver (Figure 15)

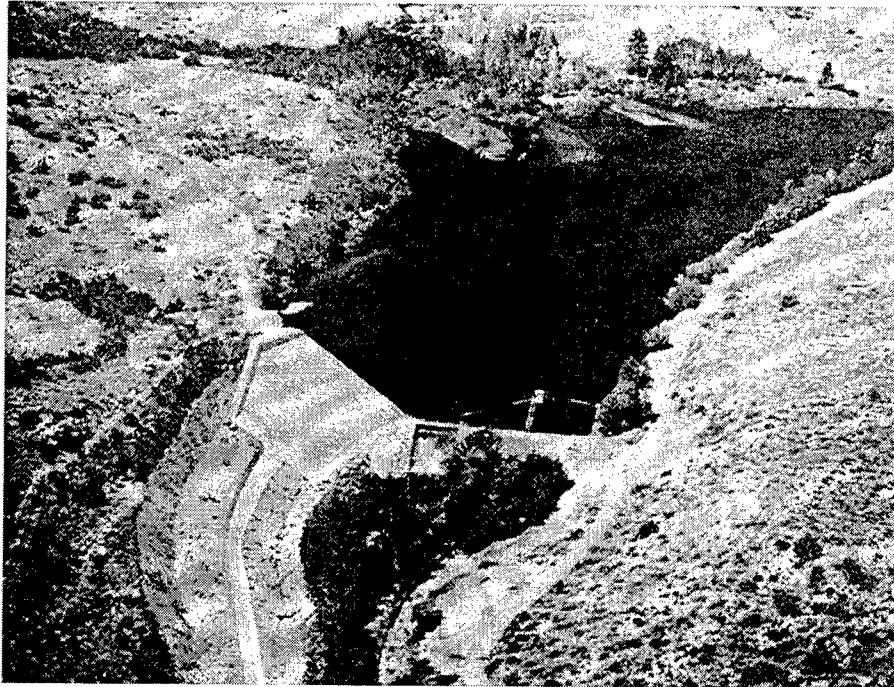
Figure 28. Completed RCC spillway at Bishop Intake No. 2 (courtesy of Throckmorton and Knarr 1991, ASCE)

Work was completed in October 1989 (Figure 28) at an approximate cost of \$958,973. This cost is estimated to be about \$500,000 less than the cost for a structural concrete spillway.

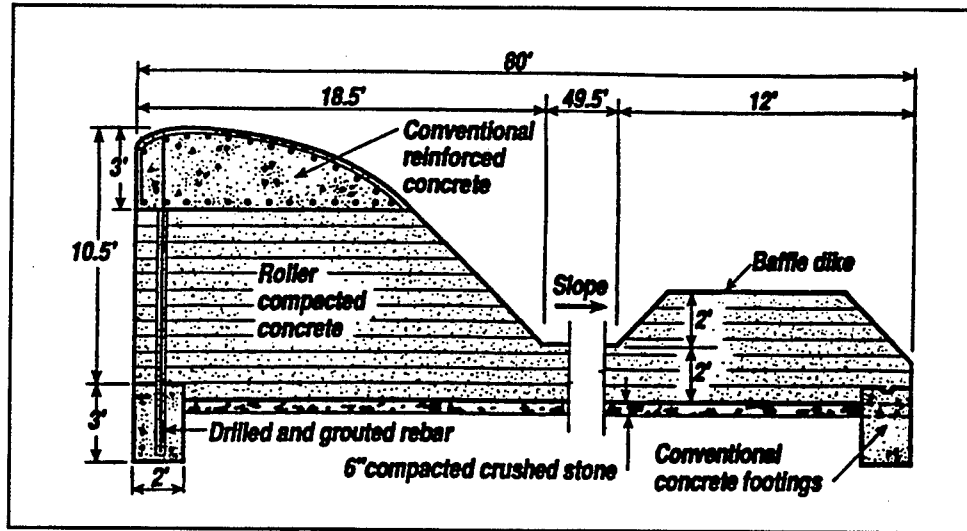
In 1988-1989, the Tennessee Valley Authority (TVA), as part of its on-going dam safety program, concluded that the saddle dam along the reservoir would be susceptible to overtopping and potential failure in the event of the PMF. To prevent dam failure in such an event, TVA decided to replace part of the saddle dam with an RCC emergency spillway (*RCC Newsletter* 1989b). The new ungated spillway is 609.6 m (2,000 ft) long, 3.2 m (10.5 ft) high, and 2.4 m (80 ft) wide. It has an uncontrolled ogee crest of conventional reinforced concrete and slotted end sills or baffle dikes (Figure 33). The crest elevation is at the approximate level of the PMF. The width of the ogee section is 5.63 m (18.48 ft), and the height of the crest is 4.11 m (13.5 ft) from the bottom of the shear key. A horizontal apron-type energy dissipator extends 18.75 m (61.52 ft) downstream of the ogee section; a 0.6-m-, 76-mm- (2-ft-, 3-in.-) high by 4.3-m- (14-ft-) wide endsill at the downstream end of the apron provides additional energy dissipation. RCC was selected for construction of the apron, endsill, and spillway section.

Figure 33. Emergency spillway, Tellico Reservoir Saddle Dam (courtesy of *RCC Newsletter* 1989b)

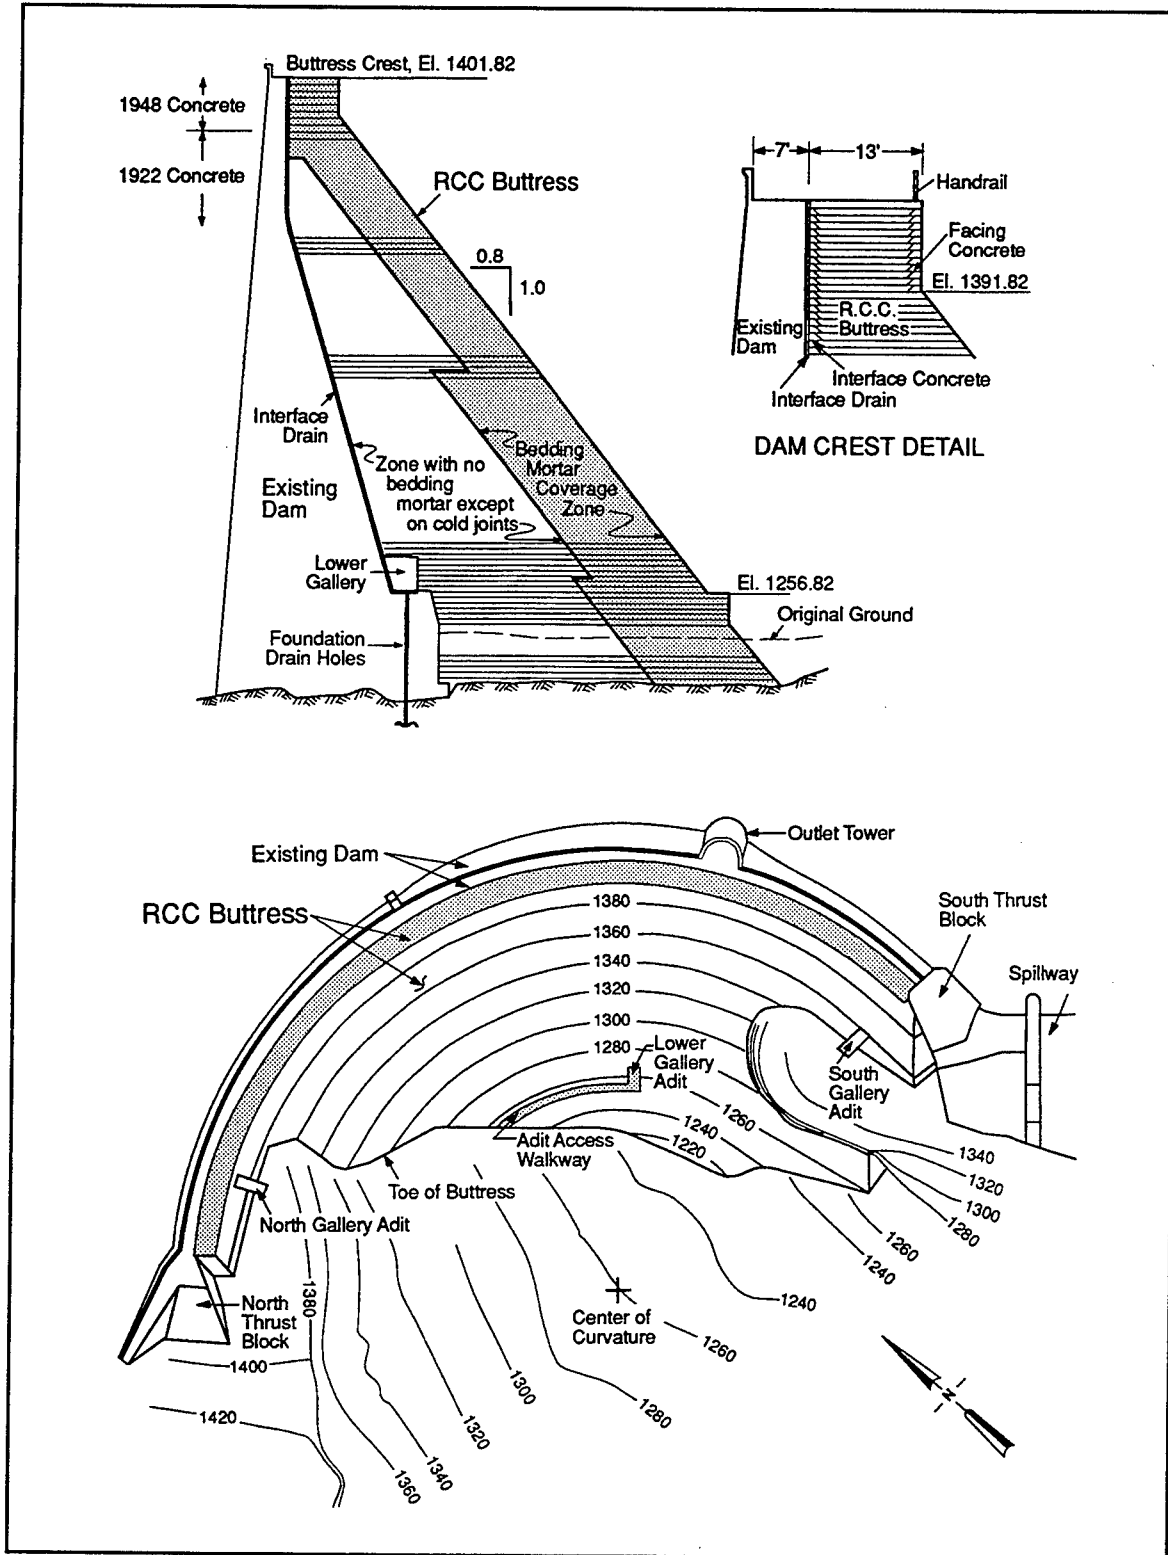
Figure 35. Cross section and plan of RCC buttress, Gibraltar Dam (courtesy of Wong et al. 1992, ASCE)

The RCC buttress increased the width of the dam crest by 4 m (13 ft). The face of the buttress is vertical for the top 3 m (10 ft) and then slopes at 0.8H:1V to the toe (Figure 35). The structural analyses of the RCC buttress were based on the assumption that the strengthened dam will respond to loading as a monolithic structure. Provisions required to ensure adequate bonding between the existing dam and the RCC buttress included sandblasting the downstream face of the existing dam, placement of a zone of conventional concrete at the interface, and installation of interface drainage pipes. A drainage gallery system (Figure 36) was included within the RCC buttress to allow for collection of inflows from the interface drains, foundation drains, and buttress drains and for monitoring and maintenance of the drainage system.

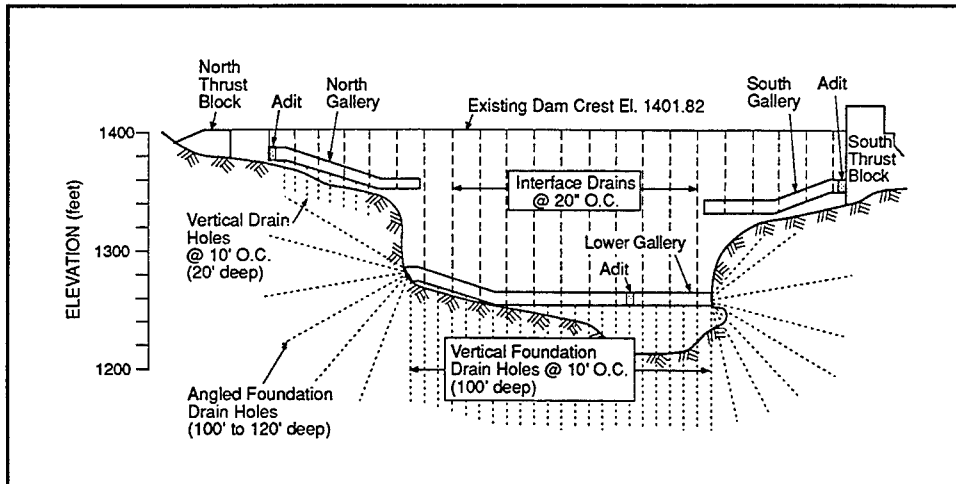
Figure 36. Layout of drainage system, Gibraltar Dam (courtesy of Wong et al. 1992, ASCE). (Multiply feet by 0.3048 to obtain metres)

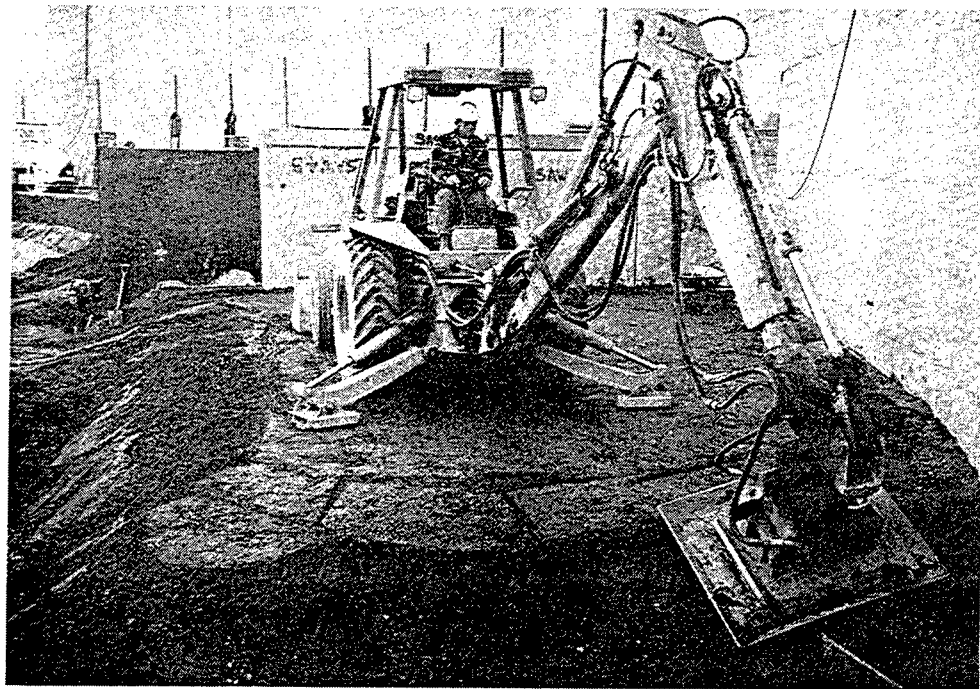
Figure 38. Slope compactor being used at Gibraltar Dam (courtesy of Wong et al. 1992, ASCE)

Thorough compaction was essential at the interface of the existing structure and the RCC. The fluid nature of interface concrete (25- to 102-mm (1-to 4-in.) slump) was such that the 9,070-kg (10-ton) vibratory roller did not effectively compact the RCC within 305 to 381 mm (12 to 15 in.) of the existing dam. Therefore, the contractor used a one-man gas-powered "wacker"-type tamper, vibrating sled compactors, and small 1,810- to 2,720-kg (2- to 3-ton) dual-drum vibratory rollers in these areas. A vibratory plate compactor mounted on a rubber-tired backhoe (Figure 38) was used to smooth and compact the sloped, unformed portions of the downstream face.

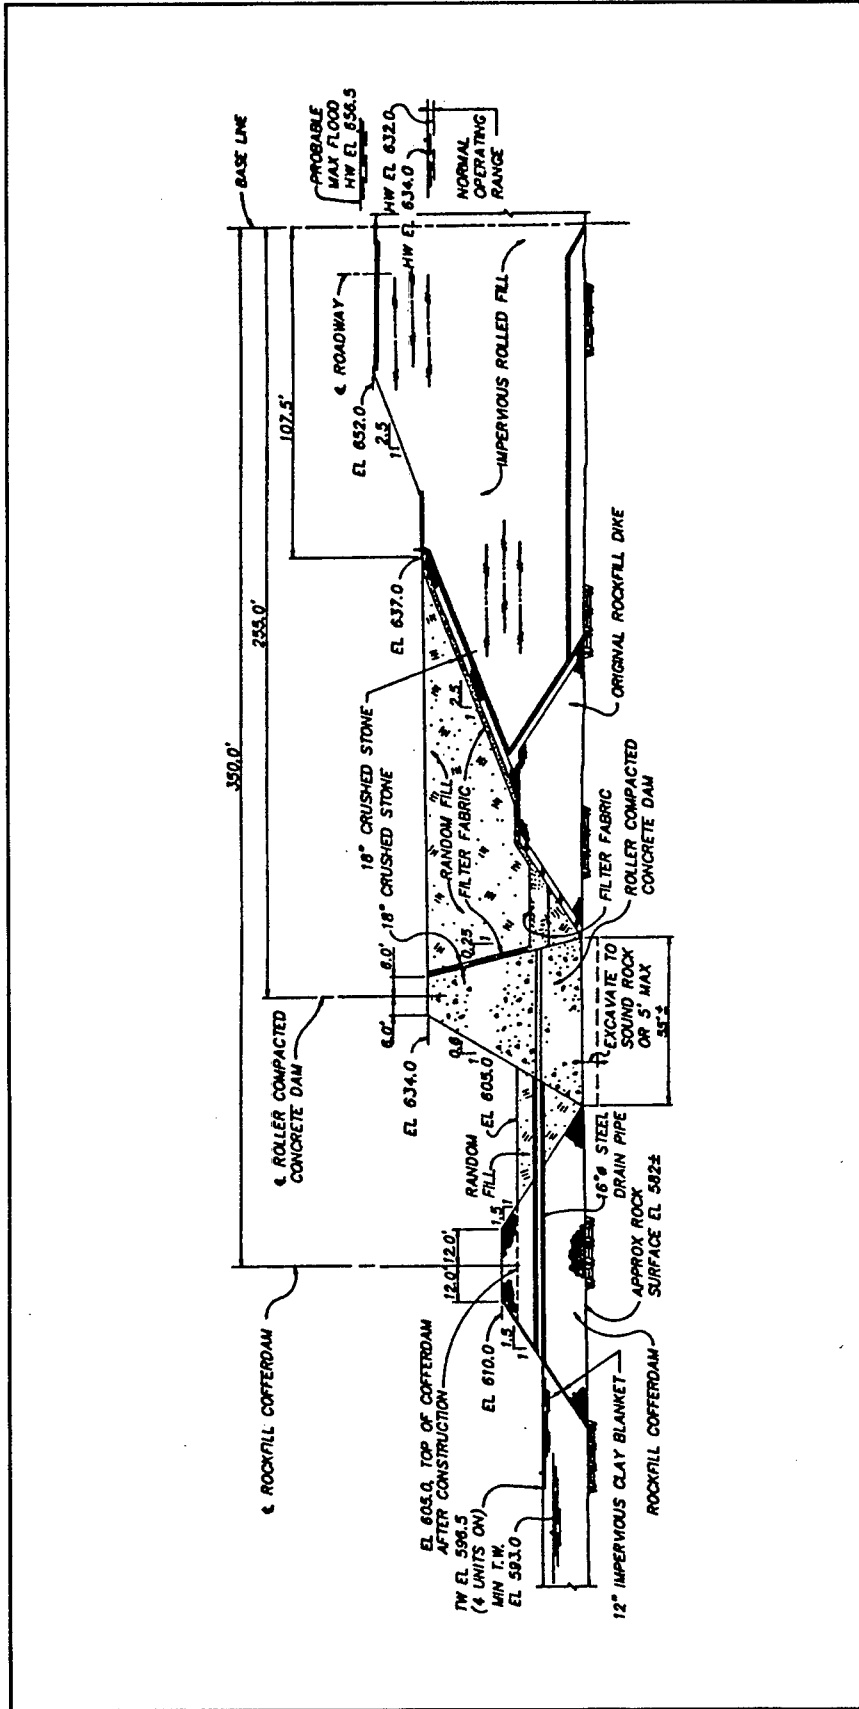
Hydraulic studies conducted during the reevaluation indicated that overtopping of the embankments would occur in floods exceeding 50 percent of the PMF. Larger floods would produce overtopping of sufficient depth and duration to breach and fail the embankments (Newell, Manson, and Wagner 1991).

Figure 41. Right embankment modifications, Nickajack Dam (courtesy of Newell, Manson, and Wagner 1991, ASCE). (Multiply feet by 0.3048 to obtain metres and inches by 25.4 to obtain millimetres)

A decision was made to construct an RCC dam downstream of the north embankment (Figure 41) and to increase the height of the south embankment. During extreme floods, the north embankment would overflow and erode to the top of the RCC dam. The RCC dam would become an emergency spillway that would maintain the normal maximum pool in the reservoir (Newell, Manson, and Wagner 1991).

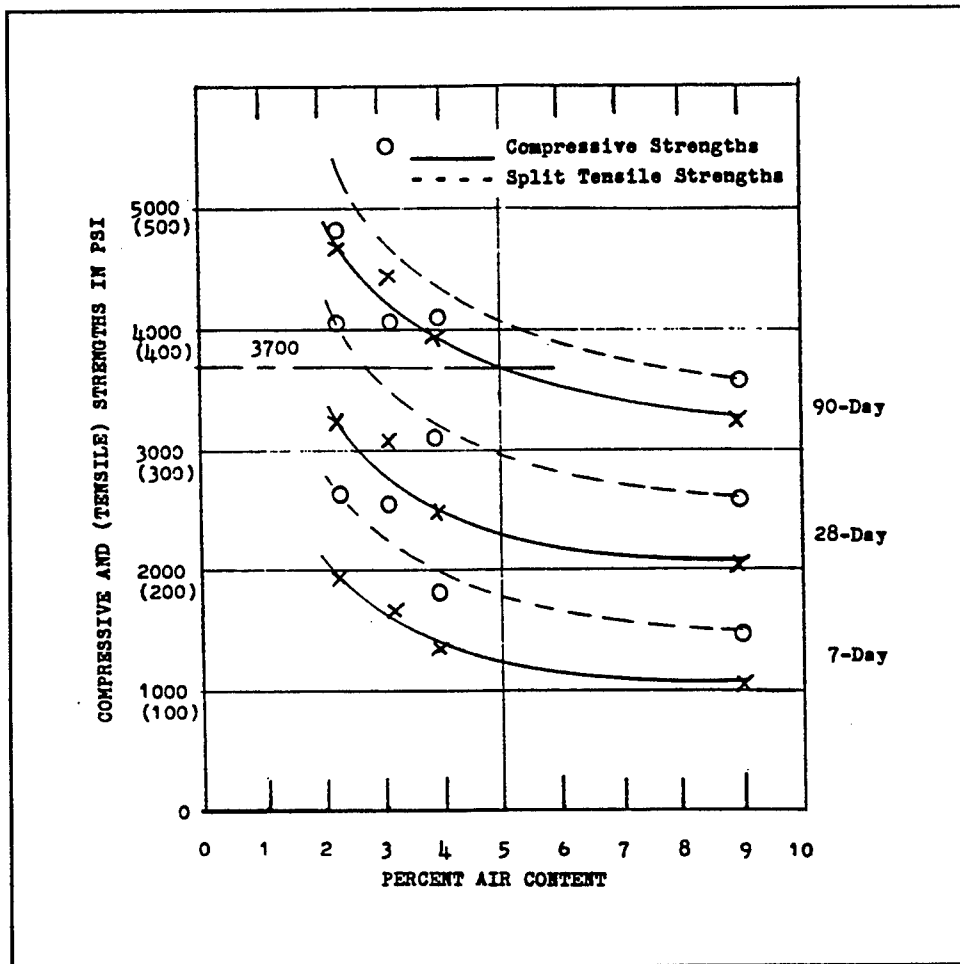
Figure 43. Results of strength tests on RCC mixtures, Nickajack Dam (courtesy of Cannon 1993). (Multiply psi by 0.006894757 to obtain MPa)

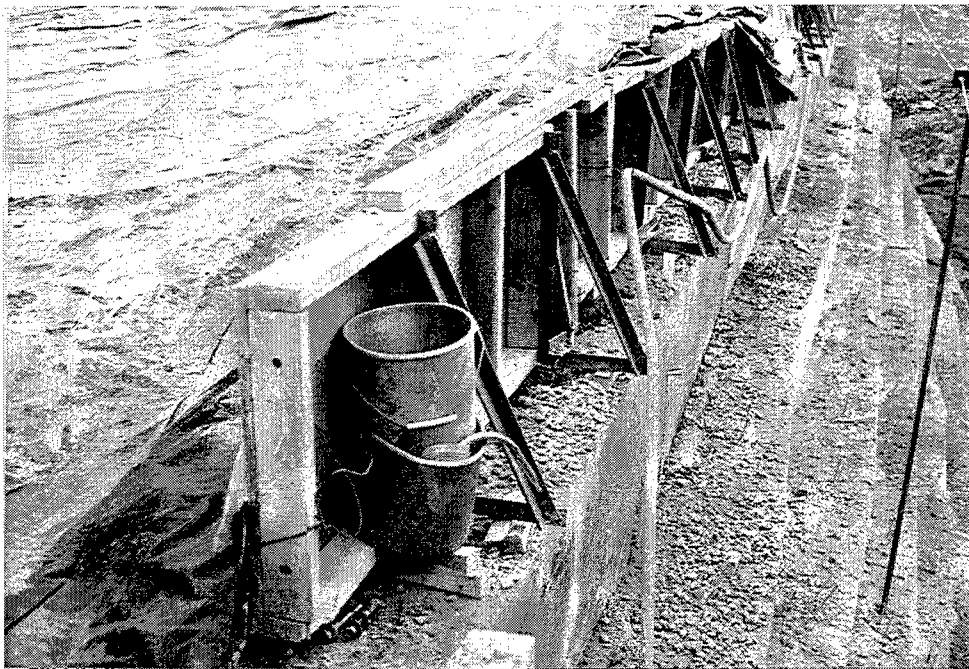
Figure 46. Typical form for downstream face at Nickajack Dam

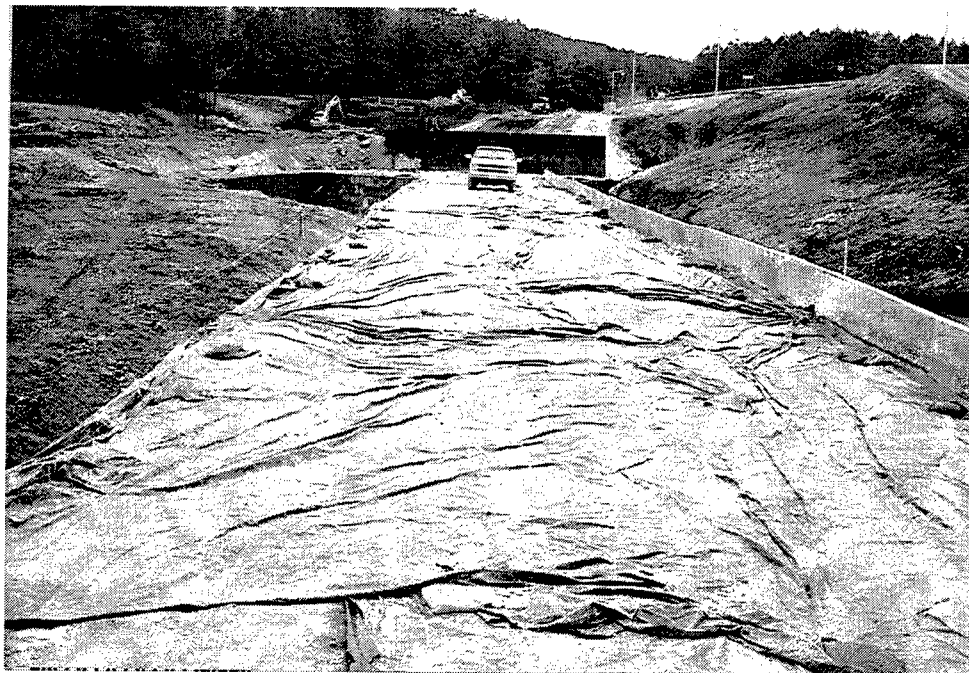
Figure 48. Tarp used for curing RCC at Nickajack Dam

Tensile bonding of the lifts was not considered in the design of the structure; therefore bedding mixtures were used only to cover the foundation rock. Following dumping, the RCC was spread in 0.31-m (1-ft) lifts with a dozer and compacted with a single-drum vibratory roller (Figure 45). The downstream and upstream faces of the dam were formed with 0.6- and 1.2-m- (2- and 4-ft-) high jump forms (Figures 46 and 47). Because of the inefficiency of the smaller compaction equipment used next to the forms, the project manager opted to use conventional concrete along the formed faces. The face concrete mixture (No. 8) was proportioned for a maximum slump of 25 mm (1 in.). Except for being consolidated internally, it was placed in essentially the same manner as the RCC. The results of this change was an improvement in the texture of the surface of the faces (Cannon 1993). The RCC was covered with a tarp for curing (Figure 48).

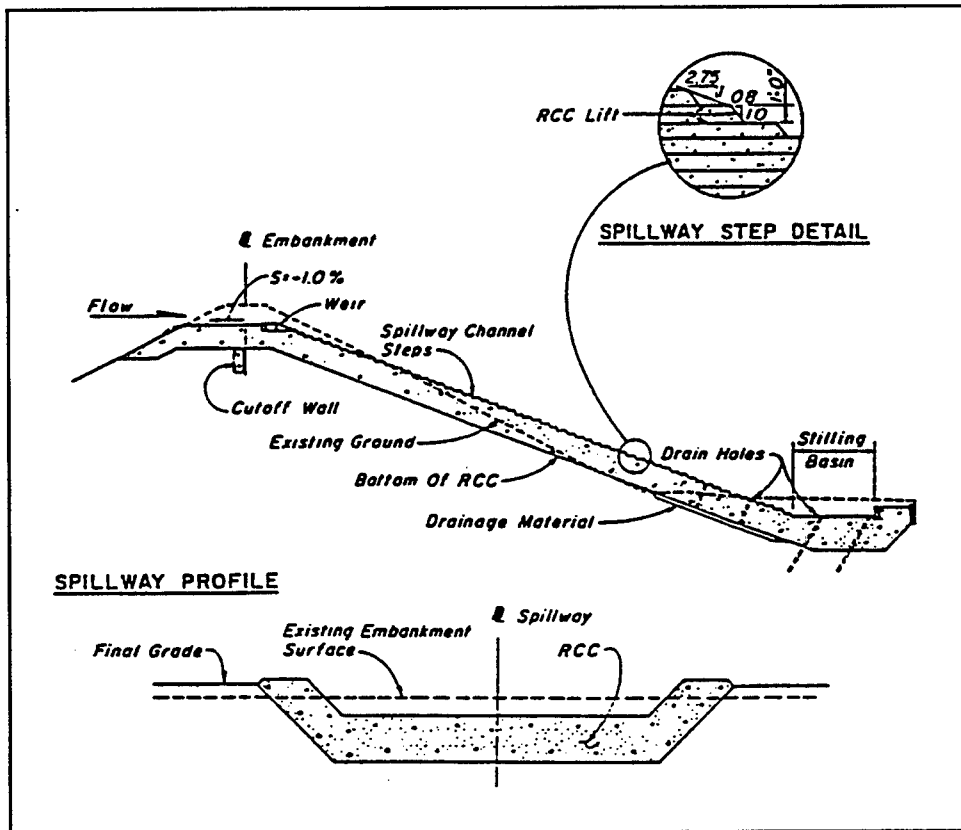
Figure 49. Spillway profile and section, Ringtown No. 5 Dam

The RCC alternative consisted of a 76.8-m- (252-ft-) long, trapezoidal-shaped spillway and stilling basin. The RCC alternative did not require a reduction in the normal operating level of the reservoir because of its wide crest geometry which was attained by constructing the spillway on the embankment. Based on the low bid for the project, the cost of the RCC spillway was about \$500,000 or approximately 40 percent of the total construction cost. The low bid for the RCC, which included furnishing the aggregate, cement, and pozzolan and batching and conveying, was approximately \$291,000 or \$60/cu m (\$46/cu yd). The RCC alternative (Figure 49) was selected because it would not affect reservoir capacity, it was more economical, and the stepped profile would aid in energy dissipation.

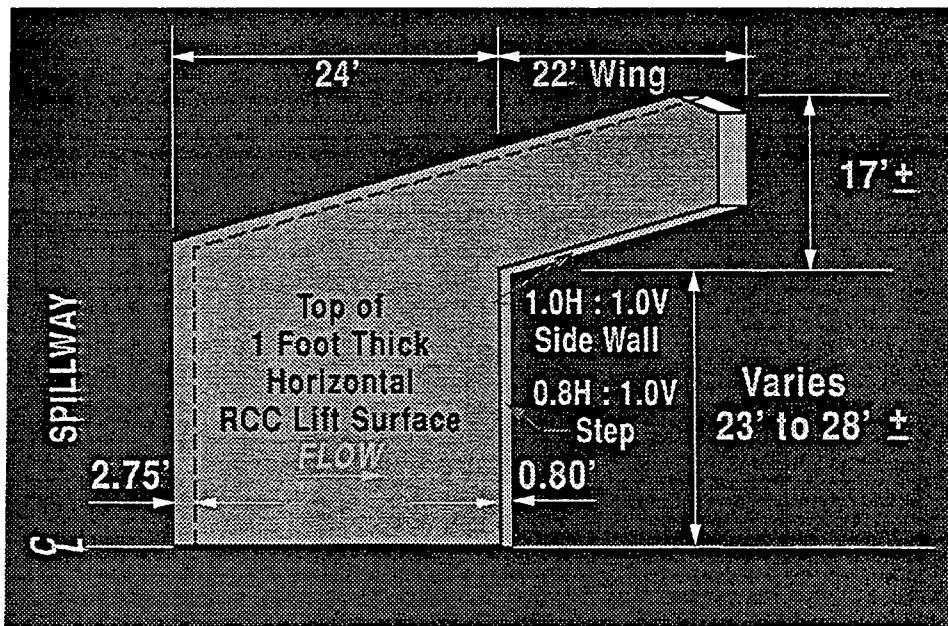
Figure 50. Typical lift plan, Ringtown No. 5 Dam (courtesy of Johnson and Saber 1991, ASDSO). (Multiply feet by 0.3048 to obtain metres)

The unformed channel steps and walls were constructed by stacking and offsetting 0.3-m- (1-ft-) thick horizontal lifts of RCC. A typical lift consisted of a 7.3-m- (24-ft-) long "main" portion and a 6.7-m- (22-ft-) long "wing" portion. Each lift was offset by 0.84 m (2.75 ft) horizontally in an upstream direction from the preceding lift. This method allowed the "wing" portion of a higher elevation to form the side walls for the channel portions of the lower elevation (Figure 50). As elevation increased, the width of the lifts increased.

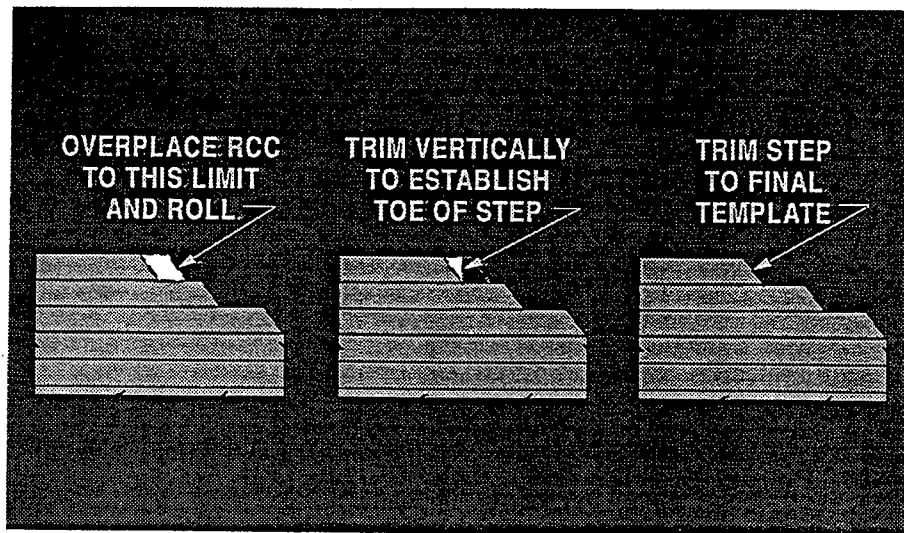
Figure 51. Sequence for step construction, Ringtown No. 5 Dam (courtesy of Johnson and Saber 1991, ASDSO)

The RCC for the steps was overplaced and compacted approximately 0.3 m (1 ft) beyond the proposed step location. The excess material was trimmed to the required 0.8H:0.1V slope (Figures 51 and 52). The trimmed material was mixed into the succeeding lift. The walls were trimmed to a final slope of 1H:1V.

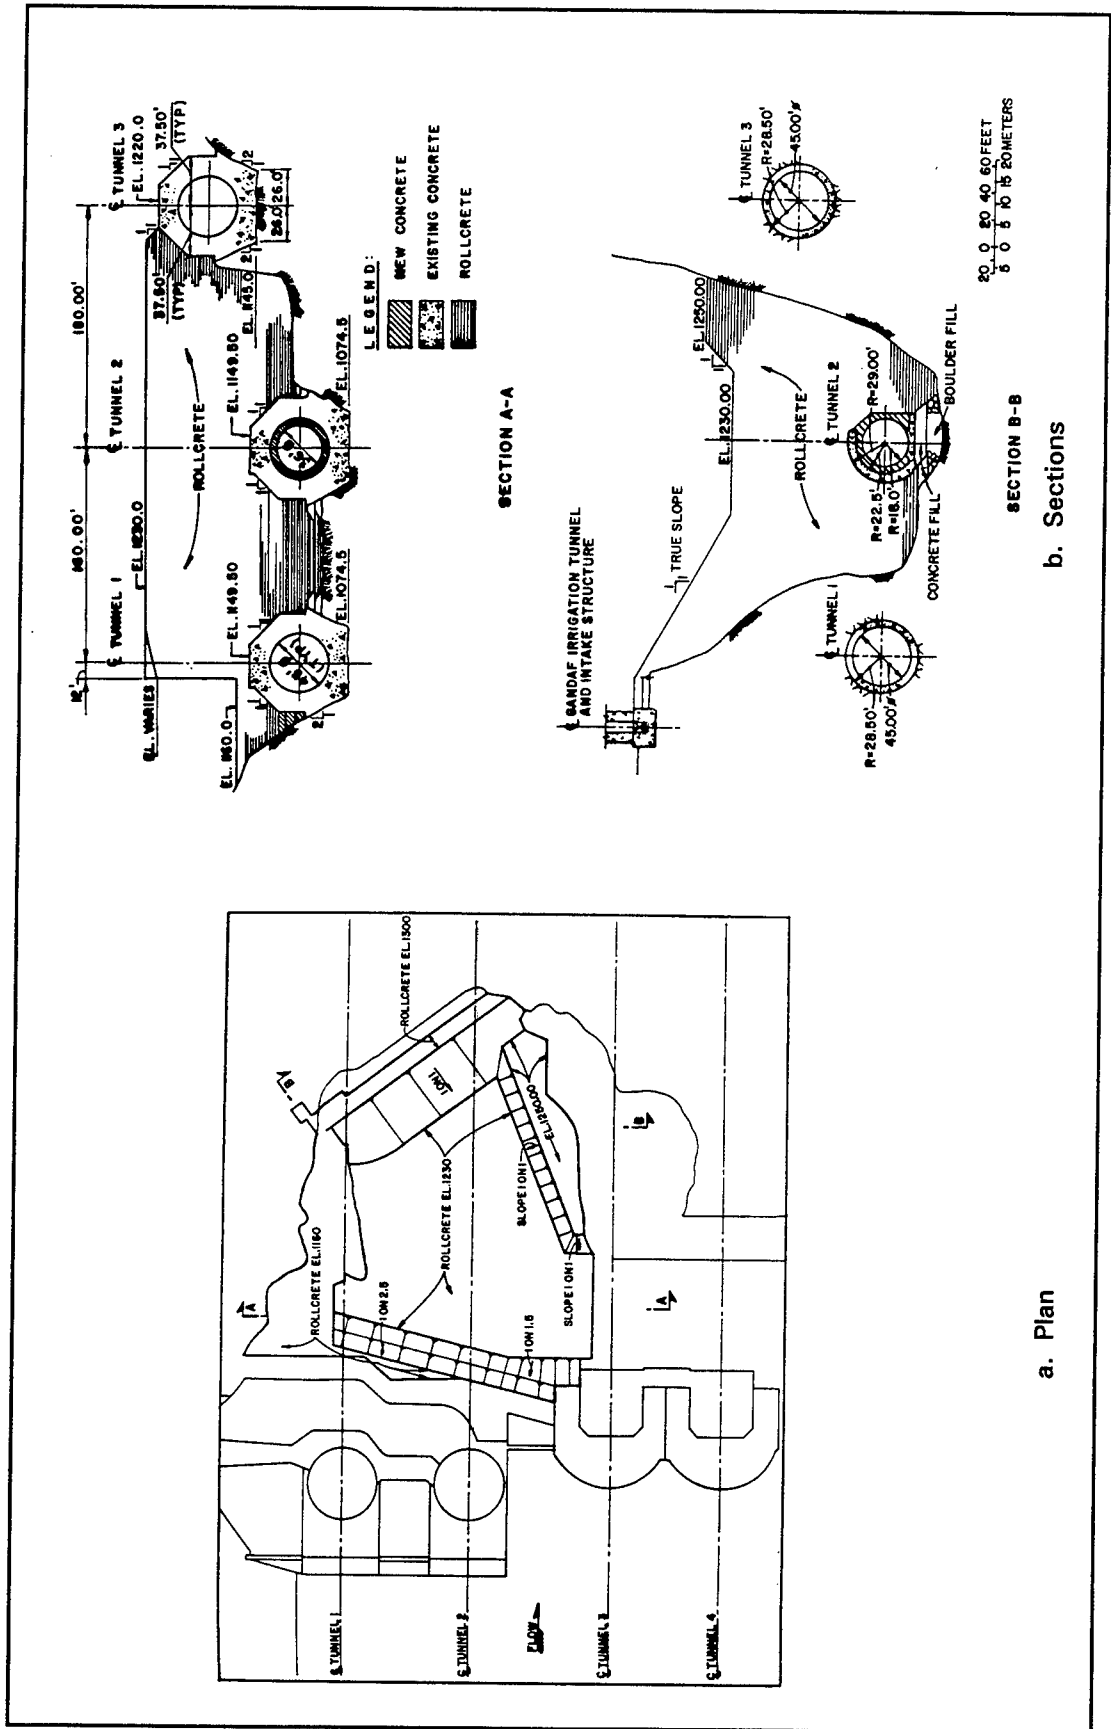
The collapsed portion of Tunnel No. 2 was approximately 76.2 m (250 ft) long. When the collapse occurred, the broken tunnel concrete, some of the reinforcement and supporting ribs, and about 756,000 cu m (1 million cu yd) of overlying bedrock and fill were washed out of the tunnel. The severity of the damage made it necessary to rebuild Tunnel No. 2, the area surrounding Tunnel No. 2, and to provide side support for Tunnels No. 1 and 3. This construction had to be completed within 6 months, before the next flood season.

The original repair plan was to remove the remaining section of the failed tunnel and put sand in the volume to be occupied by the new tunnel section simultaneously with the surrounding rollcrete. Later the sand would be excavated and the tunnel constructed in that space. However, because of the time factor, it became necessary to alter the plan. A decision was made to leave the remaining section of the tunnel in place and provide forming for the rollcrete on the right side of the section to form a cavity for reconstructing the tunnel with an 11-m (36-ft) inside diam, instead of 13.7 m (45 ft) because the larger diameter was no longer required for diversion. Because the conventional concrete production plant onsite was not capable of producing the required amount of concrete in the available time, engineers decided to use RCC. A rough test fill made by mixing cement with rounded boulder gravel (RBG) from the Indus River bed with a dozer confirmed that satisfactory results could be obtained. Most of the material passed a No. 20 sieve; that portion passing the No. 4 sieve was skip graded. Type I cement (the only type available in the required quantities) was used. Time restrictions prevented any action to control temperature in the RCC. However, placement was scheduled for January and February when the air temperature would range from 6.7 to 18.5 deg C (44 to 65 deg F), and the RBG was cool as it was excavated from near-river groundwater level. The repair plan for Tunnel No. 2 intake is shown in Figure 106.

Figure 106. Repair plan for Tunnel No. 2 intake, Tarbela Dam (courtesy of Johnson and Chao 1979)

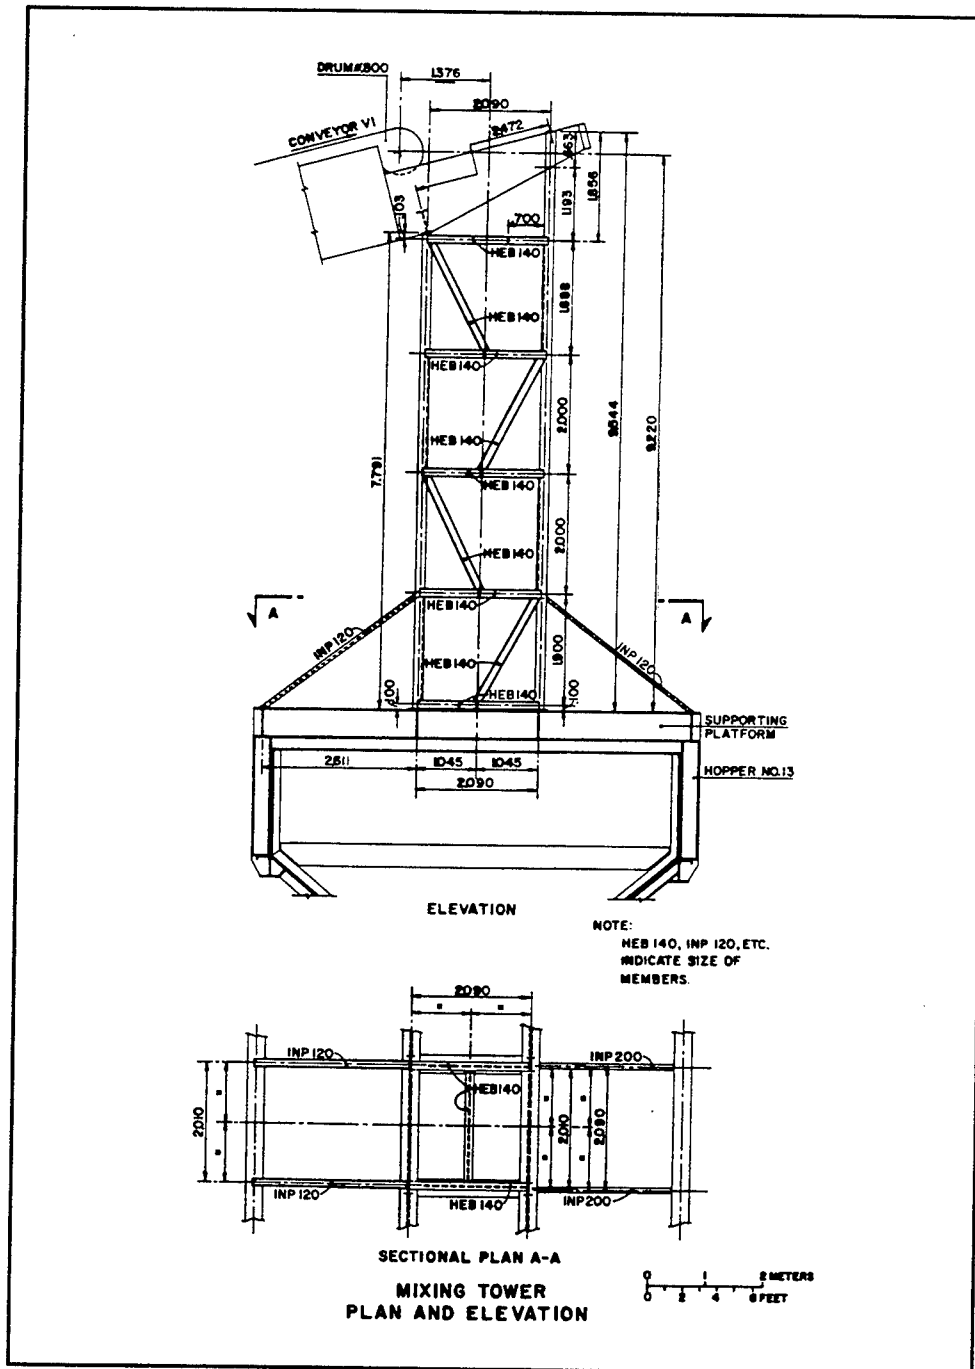
Because of the short construction period, there was no time to import equipment for the mixing plant, so the mixing plant had to be constructed from the materials and equipment available at the site. A mixing tower was constructed that required RBG to be passed through a 229-mm (9-in.) stationary grizzly into a hopper and then elevated by conveyor belt to the top of the mixing tower. Cumulative weighing scales on the conveyor belt controlled the amount of RBG added, typically 1,800 to 2,000 metric tons per hour. Cement was hauled to the plant in bottom dump trucks, dumped into a hopper which fed onto a conveyor belt that sprinkled the cement onto the RBG on the elevating conveyor belt. Mixing water was sprayed on the cement/RBG at the top of the mixing tower. Mixing took place as the materials then fell through a modified rock ladder that was enclosed on all sides. The sections of the ladder were slanted about 30 deg from vertical (Figure 107). Although it was a crude plant, mixing appeared to be satisfactory. Segregation that occurred when the mixture was dumped into the trucks and again on the fill was generally corrected when the RCC was spread with a dozer. The biggest problem with the plant was the lack of a method for controlling the amount of cement added; therefore, the amount varied from approximately one-half to twice the desired amount. Average production for the plant was 13,000 cu m (17,000 cu yd) in two 10-hr shifts.

Figure 107. Mixing tower for RCC used to repair Tunnel No. 2 intake at Tarbela Dam (courtesy of Johnson and Chao 1979)
