Technical Report CHL-97-5
March 1997

Monitoring Completed Navigation Projects Program

Burns Harbor, Indiana, Monitoring Study

Volume I: Overview of Approach and Results

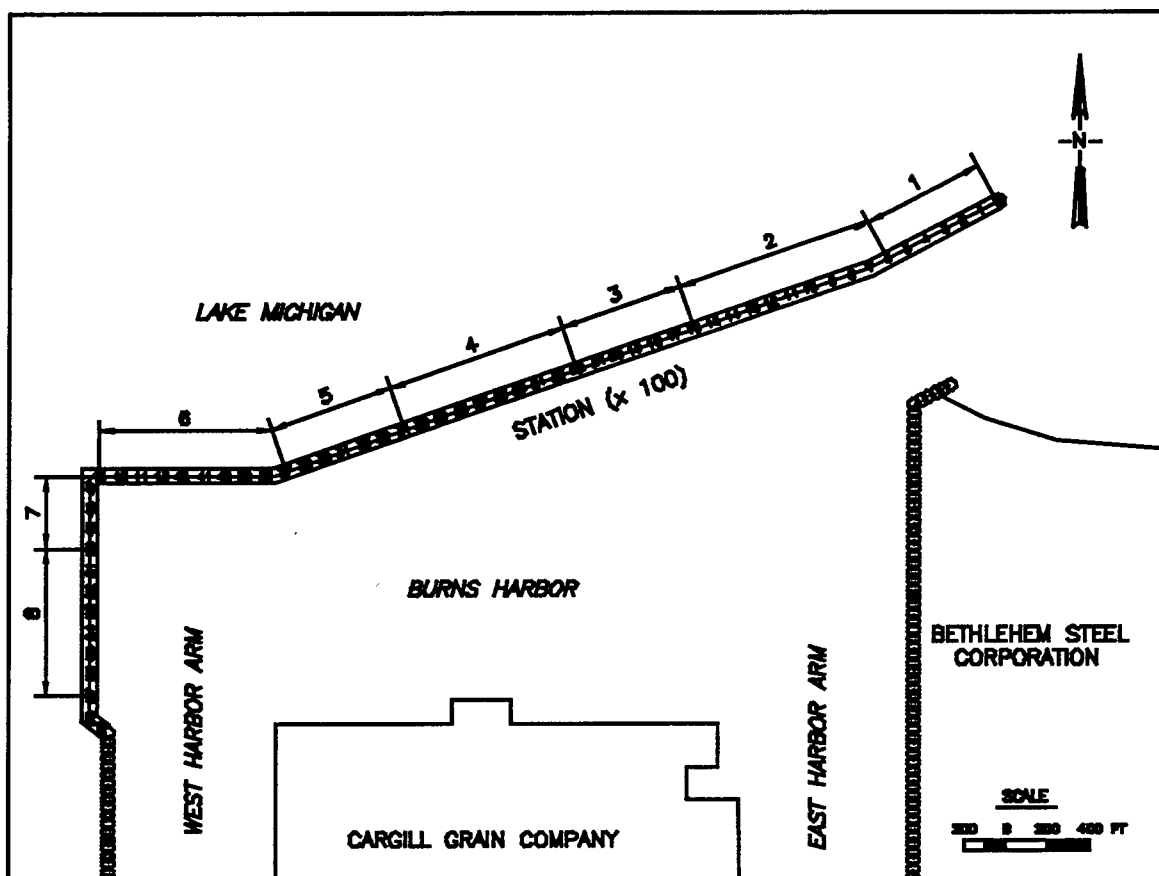
Figure 16. Breakwater segments

Partitioning the structure into segments allowed some reduction, through averaging, of the uncertainty inherent in surveys of individual cross sections, while retaining the capability to localize variations in the condition of the structure. The layout of the eight segments is shown in Figure 16. The segments were defined so each represents a zone of constant orientation where relatively equal amounts of maintenance stone were placed on the harborside and/or lakeside locations.

Of the four possible breakwater responses, trend 2 is assumed to represent the worst-case scenario for breakwater damage. Conversely, the most desirable breakwater response would be trend 3. According to differences between the 1967, 1975, and 1989(92) surveys, breakwater segments 5 and 8 have experienced a trend 2 response. Segments 1, 3, and 4 show trend 3 response. Only segment 7 shows a trend 1 response, with segment 2 showing a trend 4 response. Segment 6 shows no significant change with respect to mean cross-sectional area or variance between 1975 and 1989, despite 17,600 tons of stone being placed on that portion of the breakwater for the same time period.

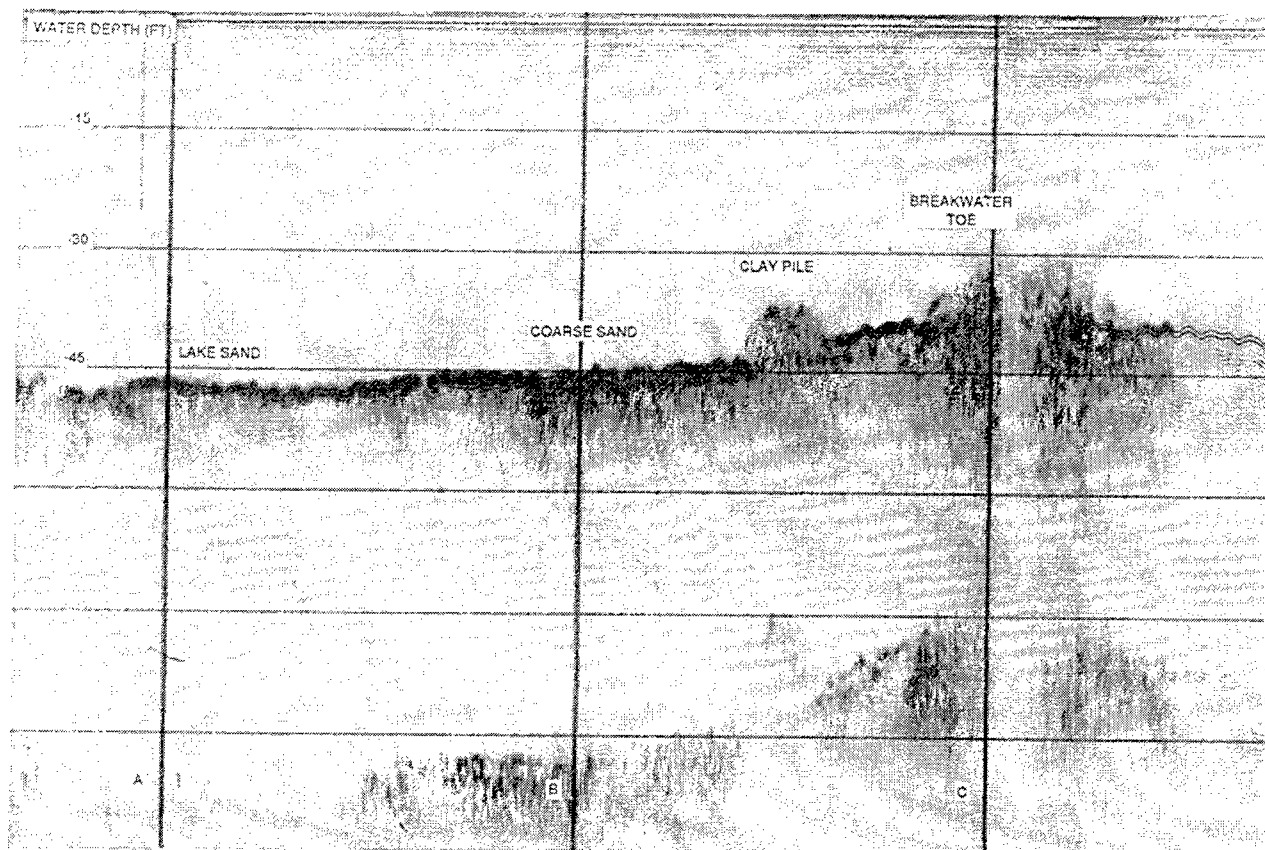
Figure 22. Subbottom sonar sonogram, line 25L

Subbottom sonar surveys. Track lines 16L, 25L, and 33L are shown on Figure 18 with hash marks labelled at corresponding fix marks (A, B, C,...) on the SBS sonograms to identify the features. Figure 22 is the sonogram of line 25L. The shallow relief of the coarse sand deposit, the abrupt outline of the clay mound, and the beginning of the breakwater slope are easily identifiable. Some layering is discernible in the sediments away from the structure.

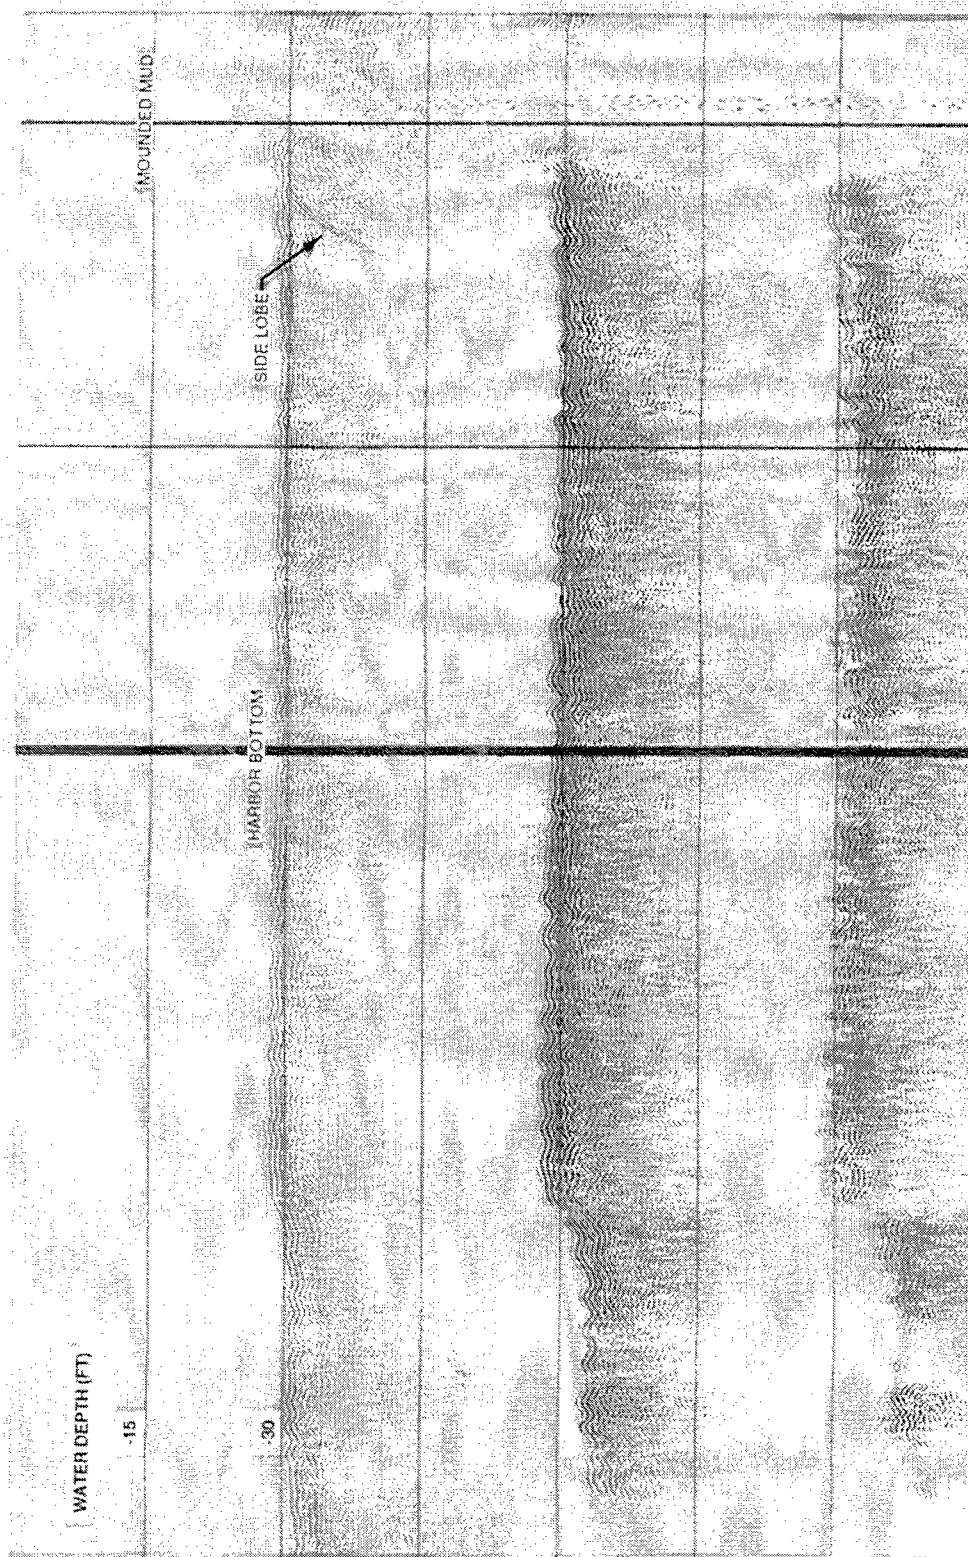
Figure 23. Subbottom sonar sonogram, line 35H

On the harborside, the SBS confirms the featureless bottom seen on the SSS sonogram. Figure 23 is the line 35H. The faint return from the soft clay as it slopes upward to about -20 ft is barely visible at the right end. Its shape is inconsistent with sedimentation due to material settling from above. There is no evidence of a distinct hard return as would be caused by armor stone below this slope. The curved reflection labeled "sidelobe" comes from strong reflections from the armor off to the side of the transducer as it approaches the structure.

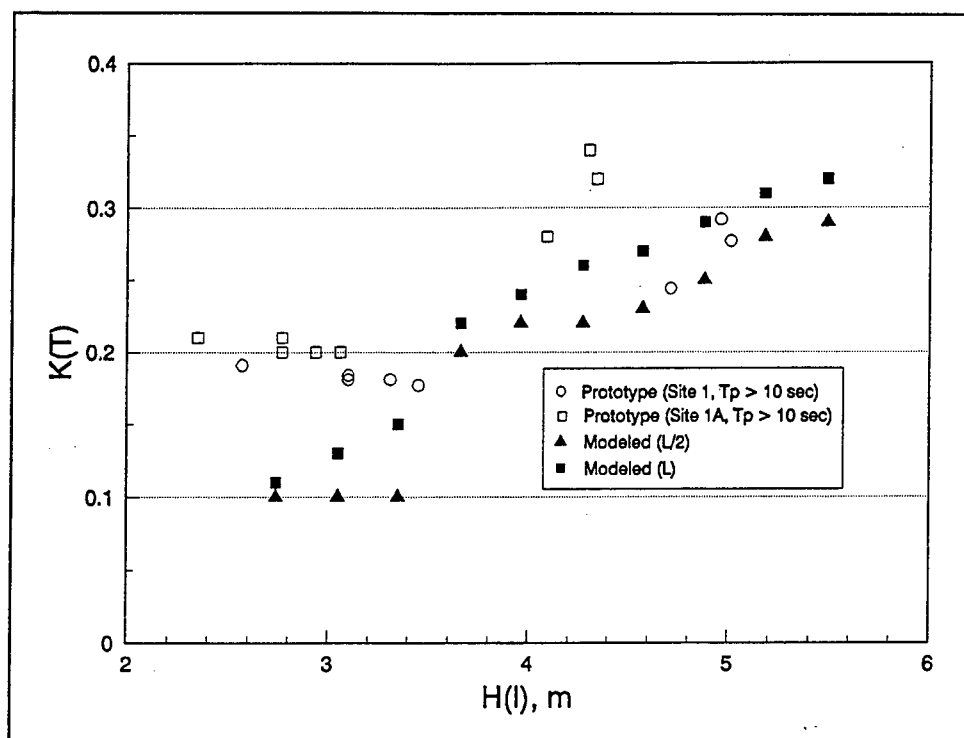
Figure 34. Prototype and modeled transmission coefficient $K(T)$ versus incident significant wave height when $T_p > 10$ sec

The model significantly underpredicted transmission for waves below 3 m, regardless of whether the reflected waves are included. Long-period waves below 3 m are transmitted through the structure without overtopping, and are strongly influenced by the structure's porosity. Results of later research showed that the core material in scaled physical models should be oversized relative to the linear scaling relationship to compensate for viscosity effects (Keulegan 1973). The core material in the 1966 study was sized linearly, like the cover layers, and underprediction may result from the effect of the increased viscous drag, relative to the prototype, at these scales.

Another factor that would tend to increase the measured energy at Site 2, and thus the prototype transmission coefficient, is the effect of energy coming through the entrance, in spite of the attempt to minimize this influence by its position. Finally, the lake level during the more extreme events exceeded the 4-ft LWD used in the model study. Measured data for waves over 3 m are

from storms that occurred on February 8-9, 1987, and March 9, 1987. Lake levels for the February storm, as measured at the Calumet Harbor gage, exceeded 1.8 m (6 ft LWD). This increased water level undoubtedly affected the transmission. The lake level at Burns Harbor during the March event, as measured at Site 1, was very near the 4.0-ft LWD used in the model study.

The model data show an abrupt discontinuity around 3.5 m. It is near this point that the model study indicated overtopping occurred. It seems likely the additional energy coming over the model structure caused the increase in total transmittance. There is not as obvious a jump in the prototype data, though it could be argued that an increase in the rate of transmittance occurs between 3 and 4 m. It is likely that this corresponds to the onset of significant

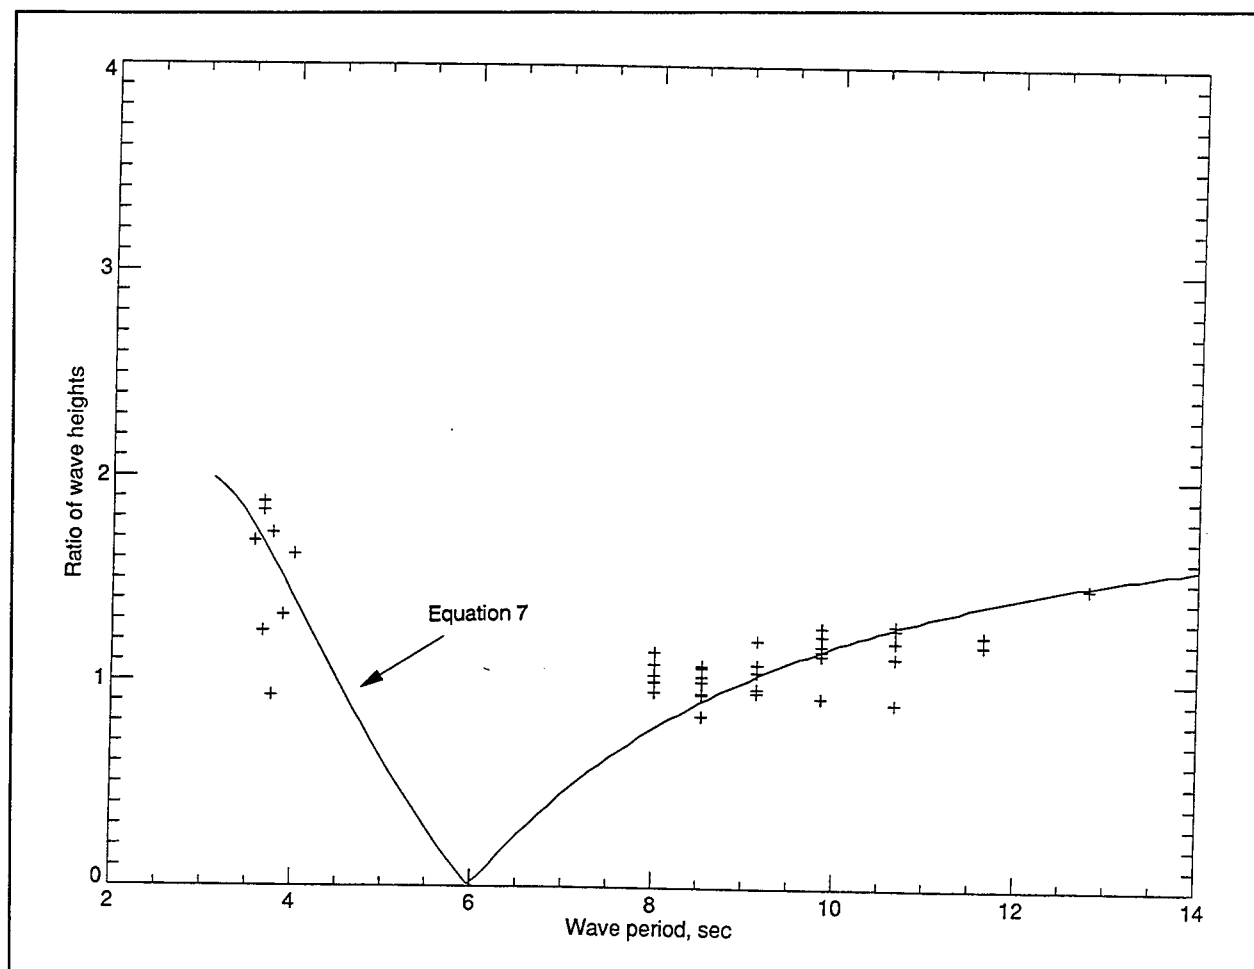
Figure 35. Ratio of significant wave height (Site 3 to Site 2) versus peak period (Site 2)

Figure 35 is a plot of the ratio of measured wave heights at Site 3 to Site 2 against the peak period data at Site 2. Equation 7 is also plotted on Figure 35 for $x = 45$ ft, the distance of Site 3 from the front of the grain dock. L was estimated from the linear shallow-water approximation for a depth of 30 ft. For example, for 6.7 ft, the highest wave measured at Site 3, Equation 7 predicts an incident wave of 4.8 ft, which agrees well with the 4.7-ft wave height

measured at Site 2 at the same time. This indicates wave conditions at the grain dock result from complete reflection of energy transmitted through the breakwater.

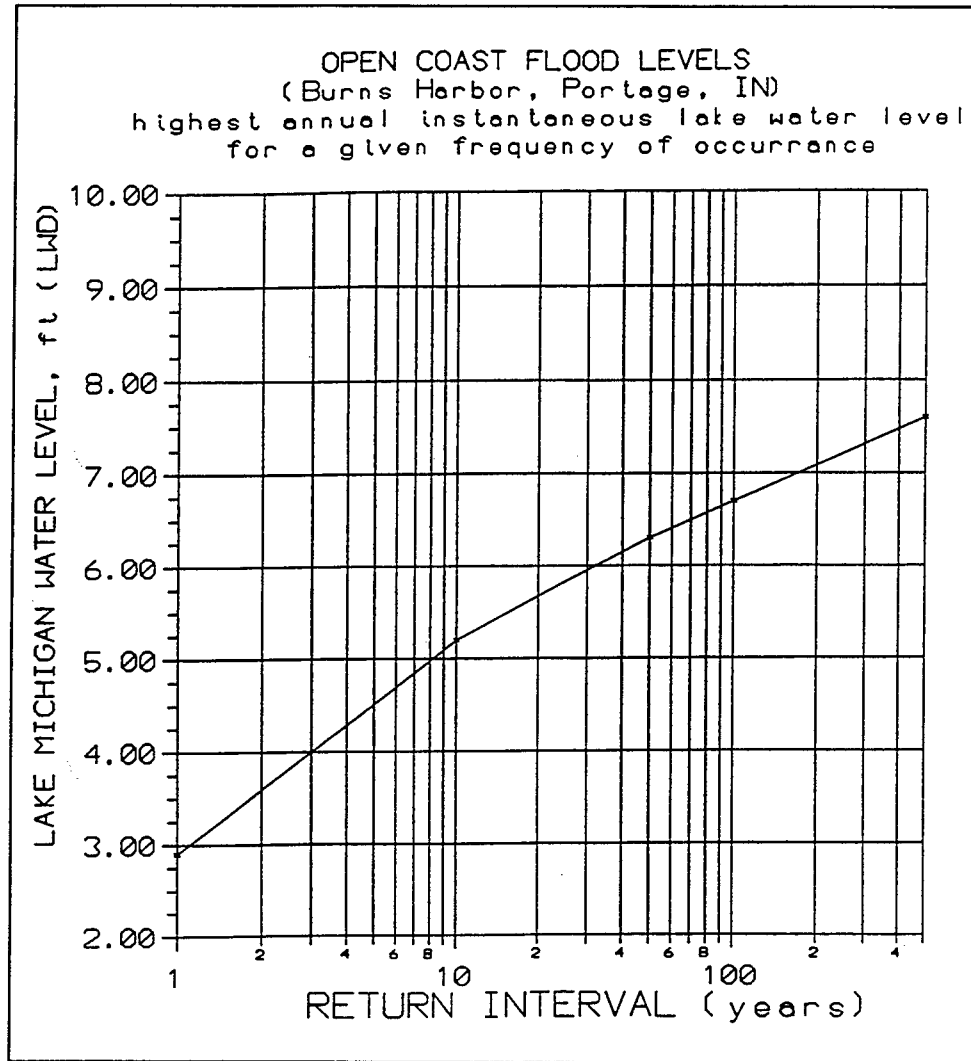
Figure 36. Return interval versus water level

Water level extremal analysis. Either an extremal analysis or a frequency distribution analysis is suitable for the measured water level record, because the time series is nearly continuous, and over-sampled relative to the rate of change of the lake levels. Figure 36 (from the extremal analysis) plots water levels versus return interval for the Calumet Harbor gages as taken from a study conducted by the Detroit District.
