# ENGINEERING TEST REPORT

ETR - 924

TITLE: Test Results of the RAH-66 Main Rotor Ballistically Damaged Flexbeam  
DATE: 4 August 1997  
A/C SERIES: RAH-66  
A/C MODEL: RAH-66 Prototype  
SYSTEM: Main Rotor  
CHARGE NO: CB571-300  
CONTRACT NO: DAAJ02-97-M-0001

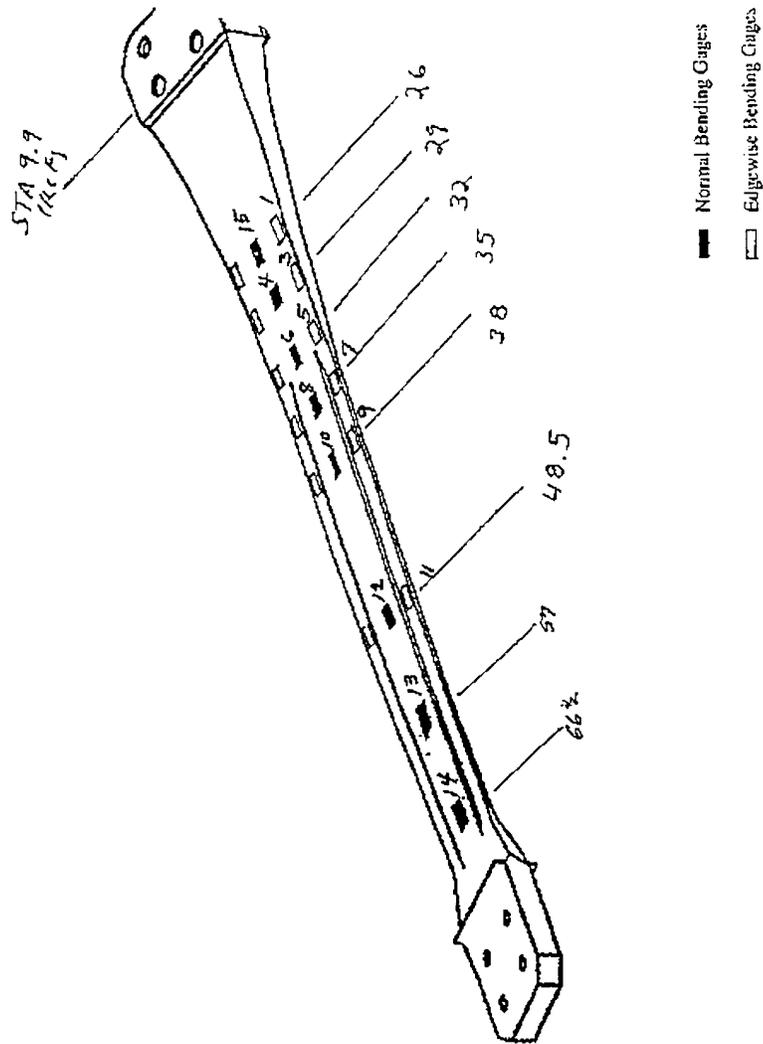
**Figure 4 Ballistically Damaged Flexbeam S/N 0044 Instrumentation**

The S/N 0044 flexbeam was instrumented at AATD with the bending bridges shown in Figure 4. Since the ballistic damage made the centerline flatwise bending bridges inoperative, secondary flatwise bending bridges were installed slightly offset chordwise.
