**EB CURING OF VARTM FABRICATED MARITIME
COMPOSITE STRUCTURES**

Contract USZA22-97-P-0013
CDRL A002

September 19, 1997

DAMILIC Corporation
14670 Southlawn Lane
Rockville, MD 2085

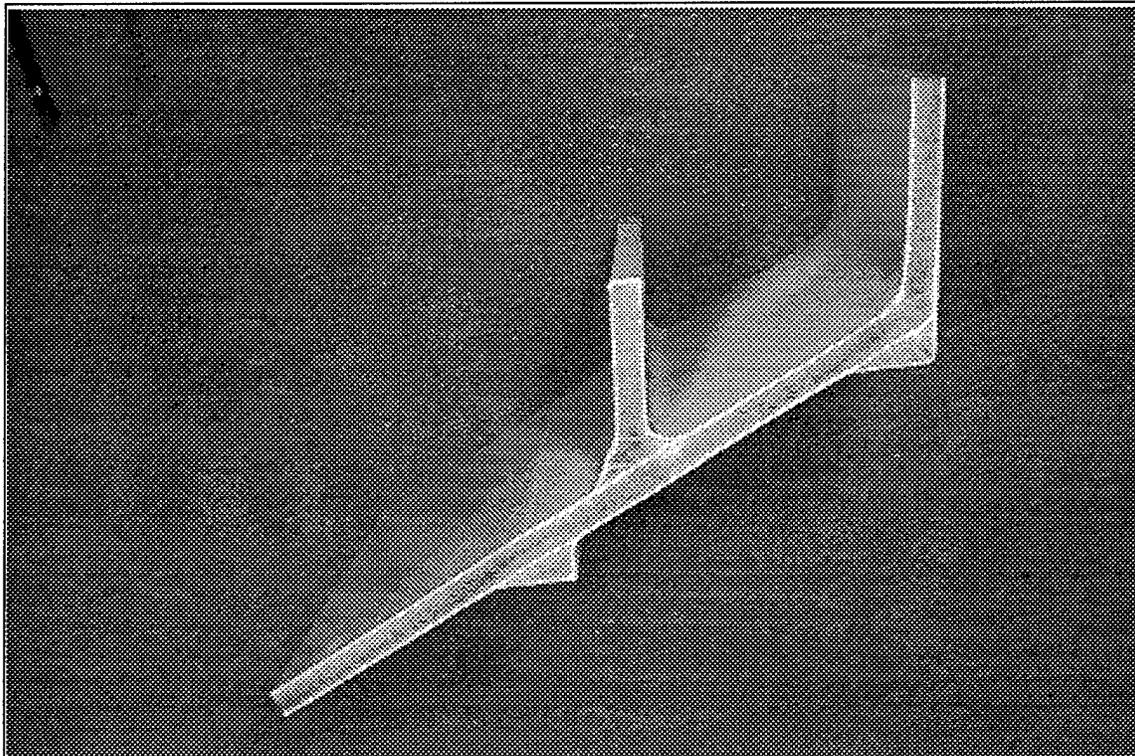
Figure 1: Demonstration section of boat hull cured with EB radiation.

The part was layed up on inexpensive wood/formica tooling. A vacuum assisted resin transfer molding technique was used for resin infusion. Immediately after resin infusion, the part was irradiated as required to achieve satisfactory cure. Although the cure was sufficient throughout the part, delamination was observed in several regions of the part. The delamination zones appear to be "resin starved", implying that the delaminations resulted from the resin infusion process, not the EB curing step.

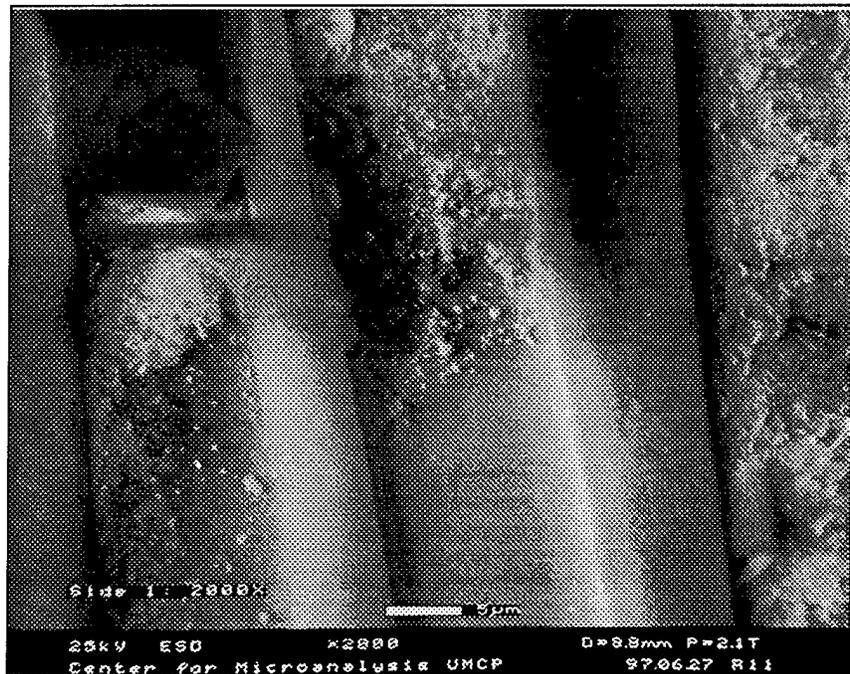
The cause of the delamination appeared to be a lack of proper wetting. Samples of fiber were removed for microscopic evaluation. Optical inspection was not more conclusive, so further magnification to 2000 X using a scanning electron microscope confirmed insufficient wetting in the region of delamination (Figure 10), while the sample from a region having no delamination exhibited complete coverage of the fibers with resin (Figure 11).

Figure 11: Fibers in region with no delamination have complete resin coverage.
